Title
Deterioration model and condition monitoring of aged railway embankment using non-invasive geophysics

D.A. Gunn[a] J.E. Chambers[a] B.E. Dashwood[a] A. Lacinska[a] T. Dijkstra[b] S. Uhlemann[a] R. Swift[a] M. Kirkham[a] A. Milodowski[a] J. Wragg[a] S. Donohue[cd]

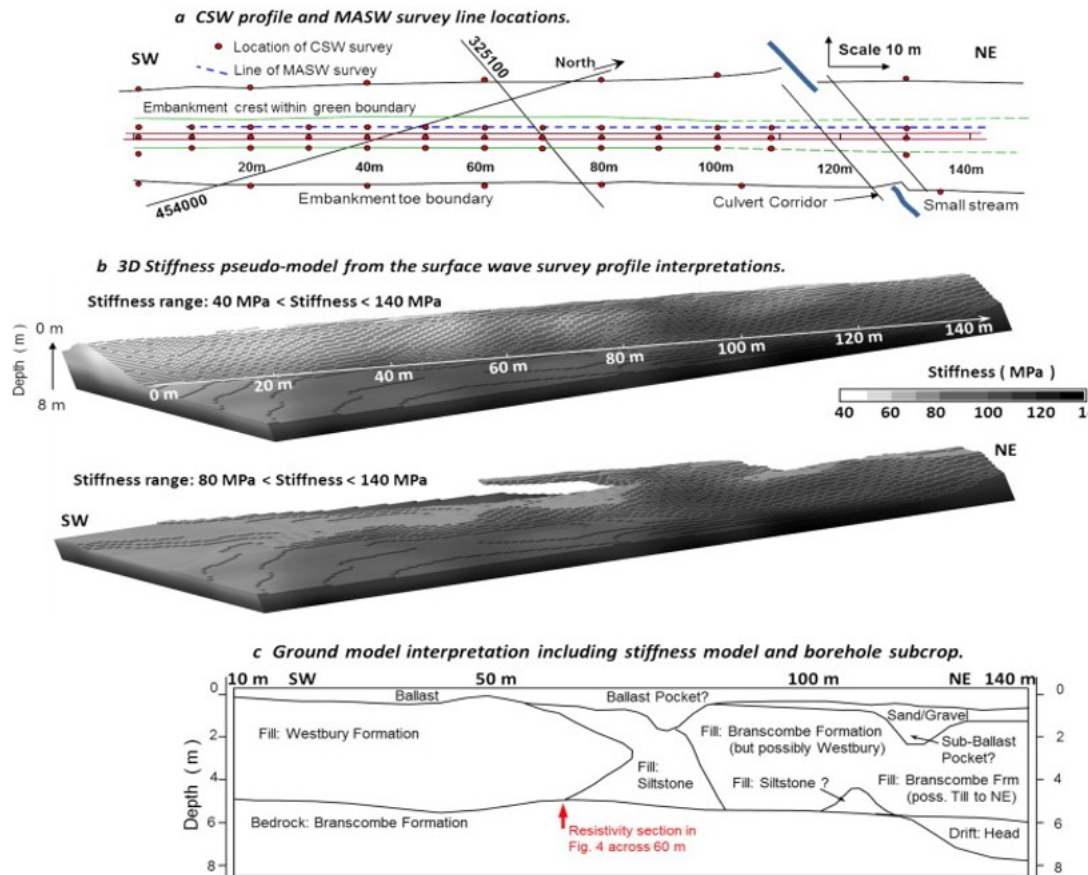
Fig. 4. East Leake embankment model showing the fill distribution overlying the original formation.

Fig. 4 shows a stiffness model that was constructed by infilling a grid between the stiffness-depth logs using an anisotropic inverse distance weighting between neighbouring grid nodes [12], [18]. Interpretation of the embankment model (Fig. 4c) includes soiled modern ballast across the site from the surface to around 0.75 m. Materials underlying the modern ballast in the SW half of the model include the original engineered ballast pavement comprising angular granodiorite gravel over granodiorite cobbles to depths of about 1 m. Ballast stiffness depends upon its packing and can be highly variable, ranging from 20 MPa to 160 MPa. Beneath this, fill in the SW half is dominated by Westbury Mudstone that has degraded to clay in places, which has a stiffness ranging from around 25 MPa to 65 MPa; i.e. missing in model only showing stiffnesses above 80 MPa in Fig. 4b. Glaciofluvial sand and gravel occurs beneath the modern ballast over the NE half up to depths of 2 m. The sand is generally uncemented but occasionally the sand was bound within layers around 100 mm thick by fine, white, powdery non-carbonate cement believed to be gypsum leached from other fill materials. Sandy fill is often stiffer than the Westbury mudstone, generally with stiffnesses around 80–110 MPa. Siltstone occurs within the interval from 2 to 5 m deep towards the NE end of the model, between 75 m and 100 m and also, between 110 m and 120 m. The siltstone is distributed in fan-shaped lenses with stiffnesses to 120 MPa. The morphology of these lenses is consistent with end tipping as the fill progressed away from the SW cutting. Towards the NE, the siltstone just beneath the ballast appears to pinch out into glaciofluvial sand and gravel. A basal, zone below 5 m is associated with the underlying Branscombe Mudstone Formation bedrock, where stiffness is generally over 100 MPa. NE of the large siltstone lens, the bulk of the fill comprises stiff clay, derived either from the Branscombe or the Till. Absence of the clay and mudstone fill in the model showing stiffnesses >80 MPa indicates that these materials exhibit lower stiffnesses than the underlying source formations, whose original surface is broadly bounded by the 80 MPa *iso*-surface. Reworking during construction and subsequent *in situ* deterioration are potential factors causing the lower stiffness of the fill.

c Ground model interpretation including stiffness model and borehole subcrop.

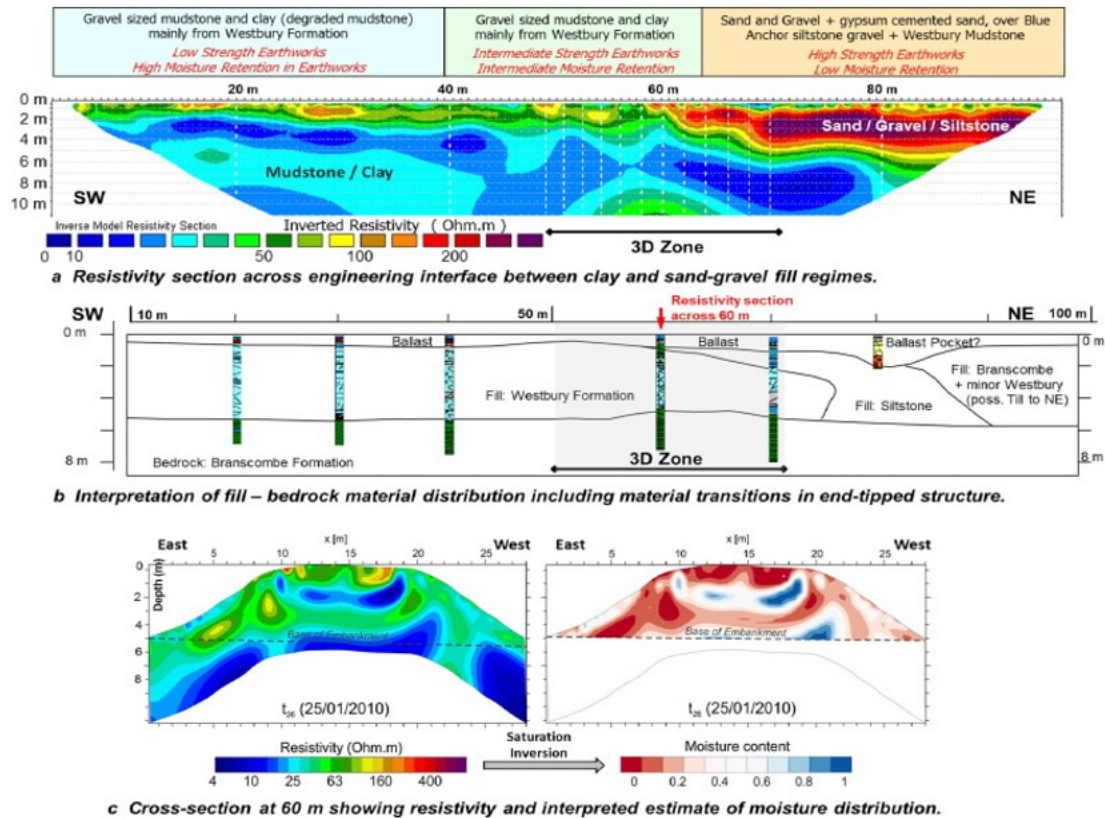
Fig. 5. Resistivity distribution and classification within embankment ground model.

Fig. 5 shows ERT sections, which run through the stiffness model of Fig. 4. (Figs. 4b and 5a share the same lateral axis and Fig. 5c is a transect at 60 m). The ballast cover in the SW produces a layer of high resistivity (>40 Ω.m) from the surface to around 1.5 m deep. From the 0 m to 40 m in the longitudinal section, the resistivity of the interval from 1.5 m to 4 m is generally below 20 Ω.m and this is consistent with values that would be expected for Westbury Mudstone and clay materials. This zone of low resistivity coincides with low stiffness, low penetration resistance and relatively high friction ratios, and has been classed as a zone of high moisture and low strength. The Westbury fill forms the central low resistivity core between 1.5 m and 3 m in the transect (Fig. 5c), where resistivities were as low as 10 Ω.m. Lithoclasts of Westbury mudstone were recovered in core samples from this zone that had the structure of a friable shale, and which had also weathered into a soft, dark grey clay. It is believed that this degraded clay provides a secondary infill within the inter- and intra-clast porosity and acts to retain moisture in this core zone. [Feature Dc in Fig. 8later.]

From the 40 m to about the 60 m station, the resistivity of the interval from 1 m to 3 m was between 20 Ω.m to 50 Ω.m. This has been interpreted as fill predominantly comprising Westbury Mudstone lithoclasts, possibly with occasional siltstone from the Blue Anchor Formation, which also appears to be present at the base of the embankment in the transect. This zone has been classified as intermediate strength and moisture content, and, represents a buffer between the low strength, mudstone, clay-dominant fill and the higher strength, sand, gravel and siltstone-dominated fill. This buffer zone provides the interface between earthworks with very different engineering properties and hence very different performances relating to dynamic loading, drainage, and seasonal property variation. From 60 m a lens of fill comprising sand, gravel and siltstone produces a zone with resistivities above 150 Ω.m. The zone develops from the surface at about the 60 m station and thickens to about the 70 m station such that it extends from just beneath the surface to around 4.5 m depth. This high resistivity zone persists longitudinally under the embankment crest over this depth interval towards the 100 m station. The high resistivity of this zone indicates that the fill has low moisture content and has been shown to be associated with high penetration resistance values and high stiffness values (Fig. 4b).

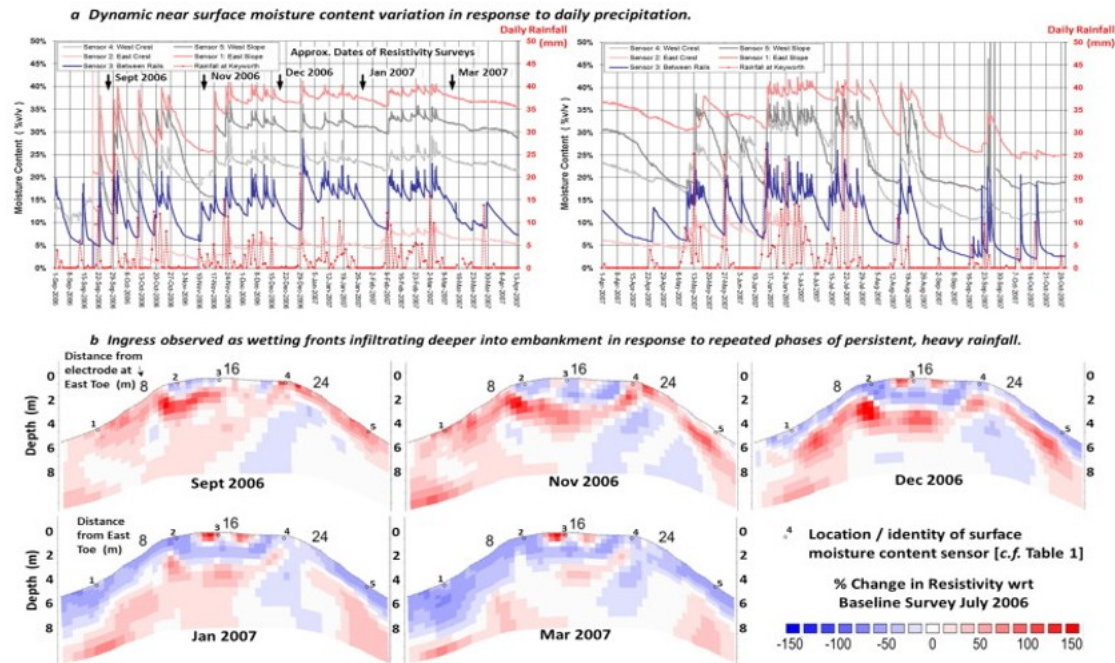
Fig. 6. Spatial and temporal control of surface infiltration and internal ground water transport on the dynamic moisture content distribution within the embankment.

Resistivity is very sensitive to changes in moisture levels and saturation, and because localised moisture increases reduce soil resistivity, the deeper infiltration into the embankment can be visualised using the differences across the transect, of the resistivities recorded during successive surveys. Fig. 6b shows resistivity difference images between a baseline survey in July 2006, taken with the embankment in a relatively dry state and at 5 instances in Sept, Nov and Dec 2006, Jan and Mar 2007, approximately coinciding with the breaks between each of the storm events over the 2006/7 winter. Temporal changes on the moisture content sensors are consistent with the spatial changes in the resistivity difference images and focusing upon sensors 1, 3 and 5, the following correlations can be observed. Moisture levels recorded by sensor 3 (between rails) exhibit the most rapid re-charge/discharge cycles, consistent with the drainage function of ballast. The relative resistivity changes are small at this location, because at all times apart from Nov 2006 they were measured after short periods of drainage during breaks in the rainfall. Moisture levels on sensors 1 (east slope) and 5 (west slope) were relatively low at the time of the Sept and Nov 2006 resistivity surveys, but were then consistently high thereafter. The time lapse resistivity images capture the spatial evolution of the winter moisture ingress as a wetting front that began in Nov 2006, infiltrating deeper into the embankment, leading to substantial saturation in the shallow subsurface within 2 m of the surface. Deeper infiltration at the toe of the east slope is believed, in part to result from localised run-off and flooding. Whereas, localised infiltration beyond 6 m deep beneath the west shoulder is believed to be due to a relatively permeable flow path.

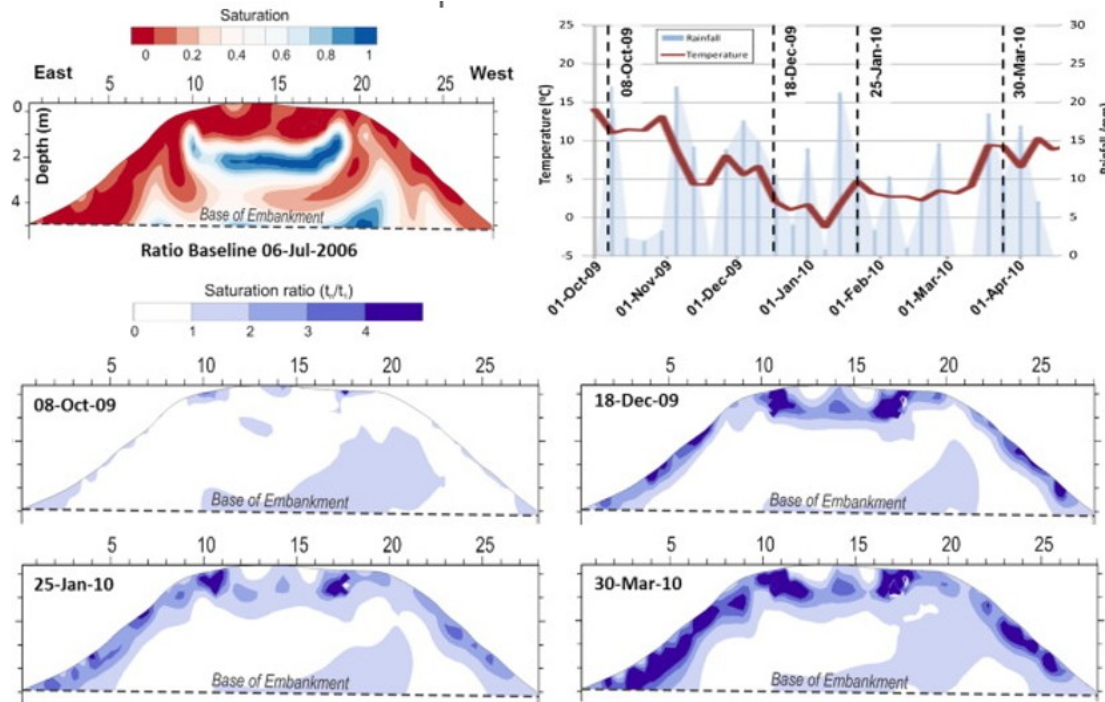
Fig. 7. Dynamic saturation distributions within the embankment arising from the winter 2009–10 ingress.

By attributing a reference resistivity to fully saturated fill materials and following the methods by Chambers et al. [6], resistivity difference images were also transformed into estimates of moisture content and saturation (as shown in Fig. 5c). Even though uncertainty in the resistivity-moisture content transformation leads to errors in the absolute moisture content values, the time-lapse images provide quite credible changes in the dynamic moisture distribution. The images in Fig. 7 show the dynamic saturation changes within the embankment during the 2009/10 winter ingress. In the near surface across the crest and flanks, saturation levels within the July 2006 baseline image are circa 10%, whereas the low resistivity core appears to be close to full saturation. In contrast to the July 2006 baseline, there are minor differences in saturation throughout the earthworks in Oct 2009, prior to progressive increases in relative saturation within 2 m of the surface and deeper into the embankment beneath the east toe and the west shoulder in the following months. Guelph Permeameter tests on pit floors in the ballast and sub-ballast yielded hydraulic conductivity values between 10^{-3} and 10^{-2} ms^{-1}, suggesting the potential for rapid infiltration (minutes / hours) through the pervious fill materials (sand and gravel) 0.5–1 m below the surface. Note, up to 4-fold increases in saturation on the crest either side of the rail track and lower down on both east and west slopes by March 2010, for example suggesting saturations of circa 40%. Saturation of the central core changes little, which is consistent with it being near full saturation, and possibly relatively impervious. Interestingly, the pattern of moisture increases beneath the west shoulder around this central core are consistent with perching and lateral flow about a low permeability core, with further lateral flow and under-drainage deeper into the embankment. Further perching at the base embankment is also possible above the formation.

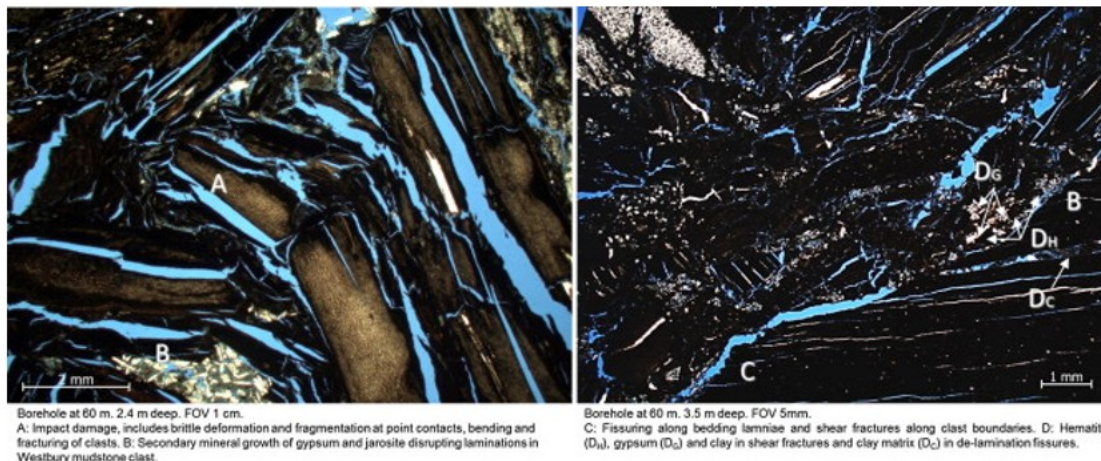
Fig. 8. Thin sections of Westbury Mudstone fill taken from the bottom of the low resistivity 'core' zone in Fig. 5c.

Materials dug out of cuttings and tipped into the earthworks, were compacted by small steam locomotives causing deformation of the aggregate clasts. Impact damage, especially at point contacts has caused shearing, plastic and brittle deformation of clasts leading to disaggregation along bedding planes and micro-fractures, resulting in the production of finer material, see A in Fig. 8. Shearing along clast laminae and inter-clast boundaries (B) increases porosity, opening the fill matrix to percolating groundwater, leading to chemical alteration. The open Westbury Mudstone fill is rich in iron pyrites and evaporites such as gypsum and anhydrite, through which oxygenated groundwater would have percolated. *In situ* oxidisation of the pyrite [$FeS_2 + a.O_2 + b·H_2O \rightarrow Fe(OH)_3 + 4H^+_{aq} + 2(SO_4)^{2-}_{aq}$] liberated sulphate, which dissolved in the ground water to produce weak sulphuric acid. The seasonal moisture supply and subsurface movement of this weakly acidic groundwater would have driven the dissolution and precipitation throughout the fill. Infiltration from storm events would have mobilised the ferrous and sulphate ions throughout the embankment, hence driving secondary mineralisation. Exposure to groundwater causes hydration of anhydrite to gypsum ($CaSO_4 + 2H_2O \rightarrow CaSO_4·2H_2O$), resulting in a significant increase in molar volume(38.5%), in turn causing expansion and disruption of the rock fabric. For example, the disrupted clast lamination (C) and secondary development of minerals (D_G, D_H and D_C) in Fig. 8 may have originally been caused by heave from anhydrite hydration. Hydration would have occurred during wetting early in the embankment's lifecycle and most

Borehole at 60 m. 2.4 m deep. FOV 1 cm.
A: Impact damage, includes brittle deformation and fragmentation at point contacts, bending and fracturing of clasts. B: Secondary mineral growth of gypsum and jarosite disrupting laminations in Westbury mudstone clast.

Borehole at 60 m. 3.5 m deep. FOV 5mm.
C: Fissuring along bedding lamniae and shear fractures along clast boundaries. D: Hematite (D_H), gypsum (D_G) and clay in shear fractures and clay matrix (D_C) in de-lamination fissures.

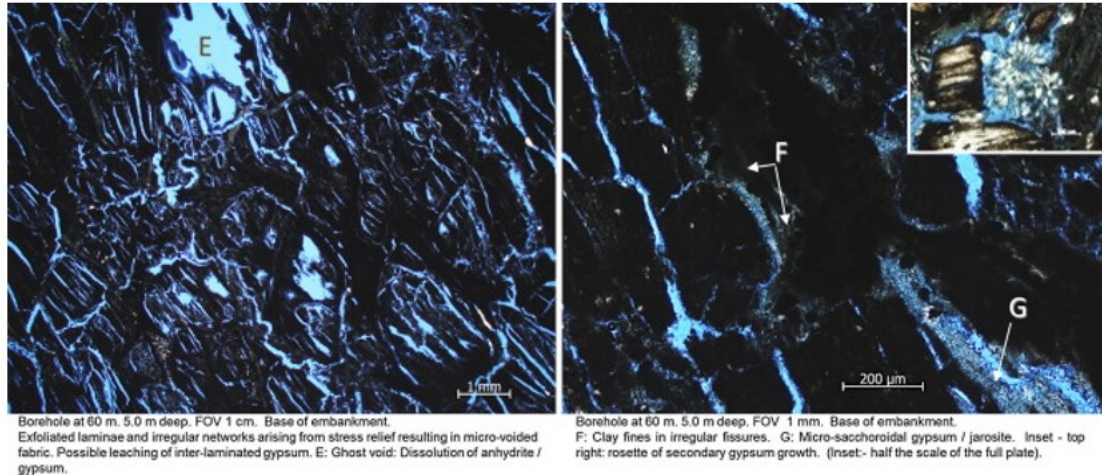
Fig. 9. Thin sections of Westbury Mudstone fill near the base of the embankment.

Stress relief in the mudstone clasts resulted in exfoliated laminae and a fabric cut by irregular micro-fractures, within which percolating ground water mobilised disaggregated clay fines, Fig. 9. Further micro-voiding developed as primary minerals dissolved out of the fabric and fines were removed, with some voids ghosting former locations of lath crystals, see E in Fig. 9. Water infiltrating the fissure network deposited disaggregated clay fines and secondary growths of micro-saccharoidal gypsum and jarosite, Dc in Fig. 8 and F, G in Fig. 9. The inset in Fig. 9 shows a typical secondary gypsum rosette common throughout the Westbury fill.

Borehole at 60 m. 5.0 m deep. FOV 1 cm. Base of embankment.
Exfoliated laminae and irregular networks arising from stress relief resulting in micro-voided fabric. Possible leaching of inter-laminated gypsum. E: Ghost void: Dissolution of anhydrite / gypsum.

Borehole at 60 m. 5.0 m deep. FOV 1 mm. Base of embankment.
F: Clay fines in irregular fissures. G: Micro-sacchoroidal gypsum / jarosite. Inset - top right: rosette of secondary gypsum growth. (Inset:- half the scale of the full plate).
