Lawrence Berkeley Laboratory
UNIVERSITY OF CALIFORNIA

LBID-599

MEMORANDUM

RE: Life Testing on Duro-Test Lamps

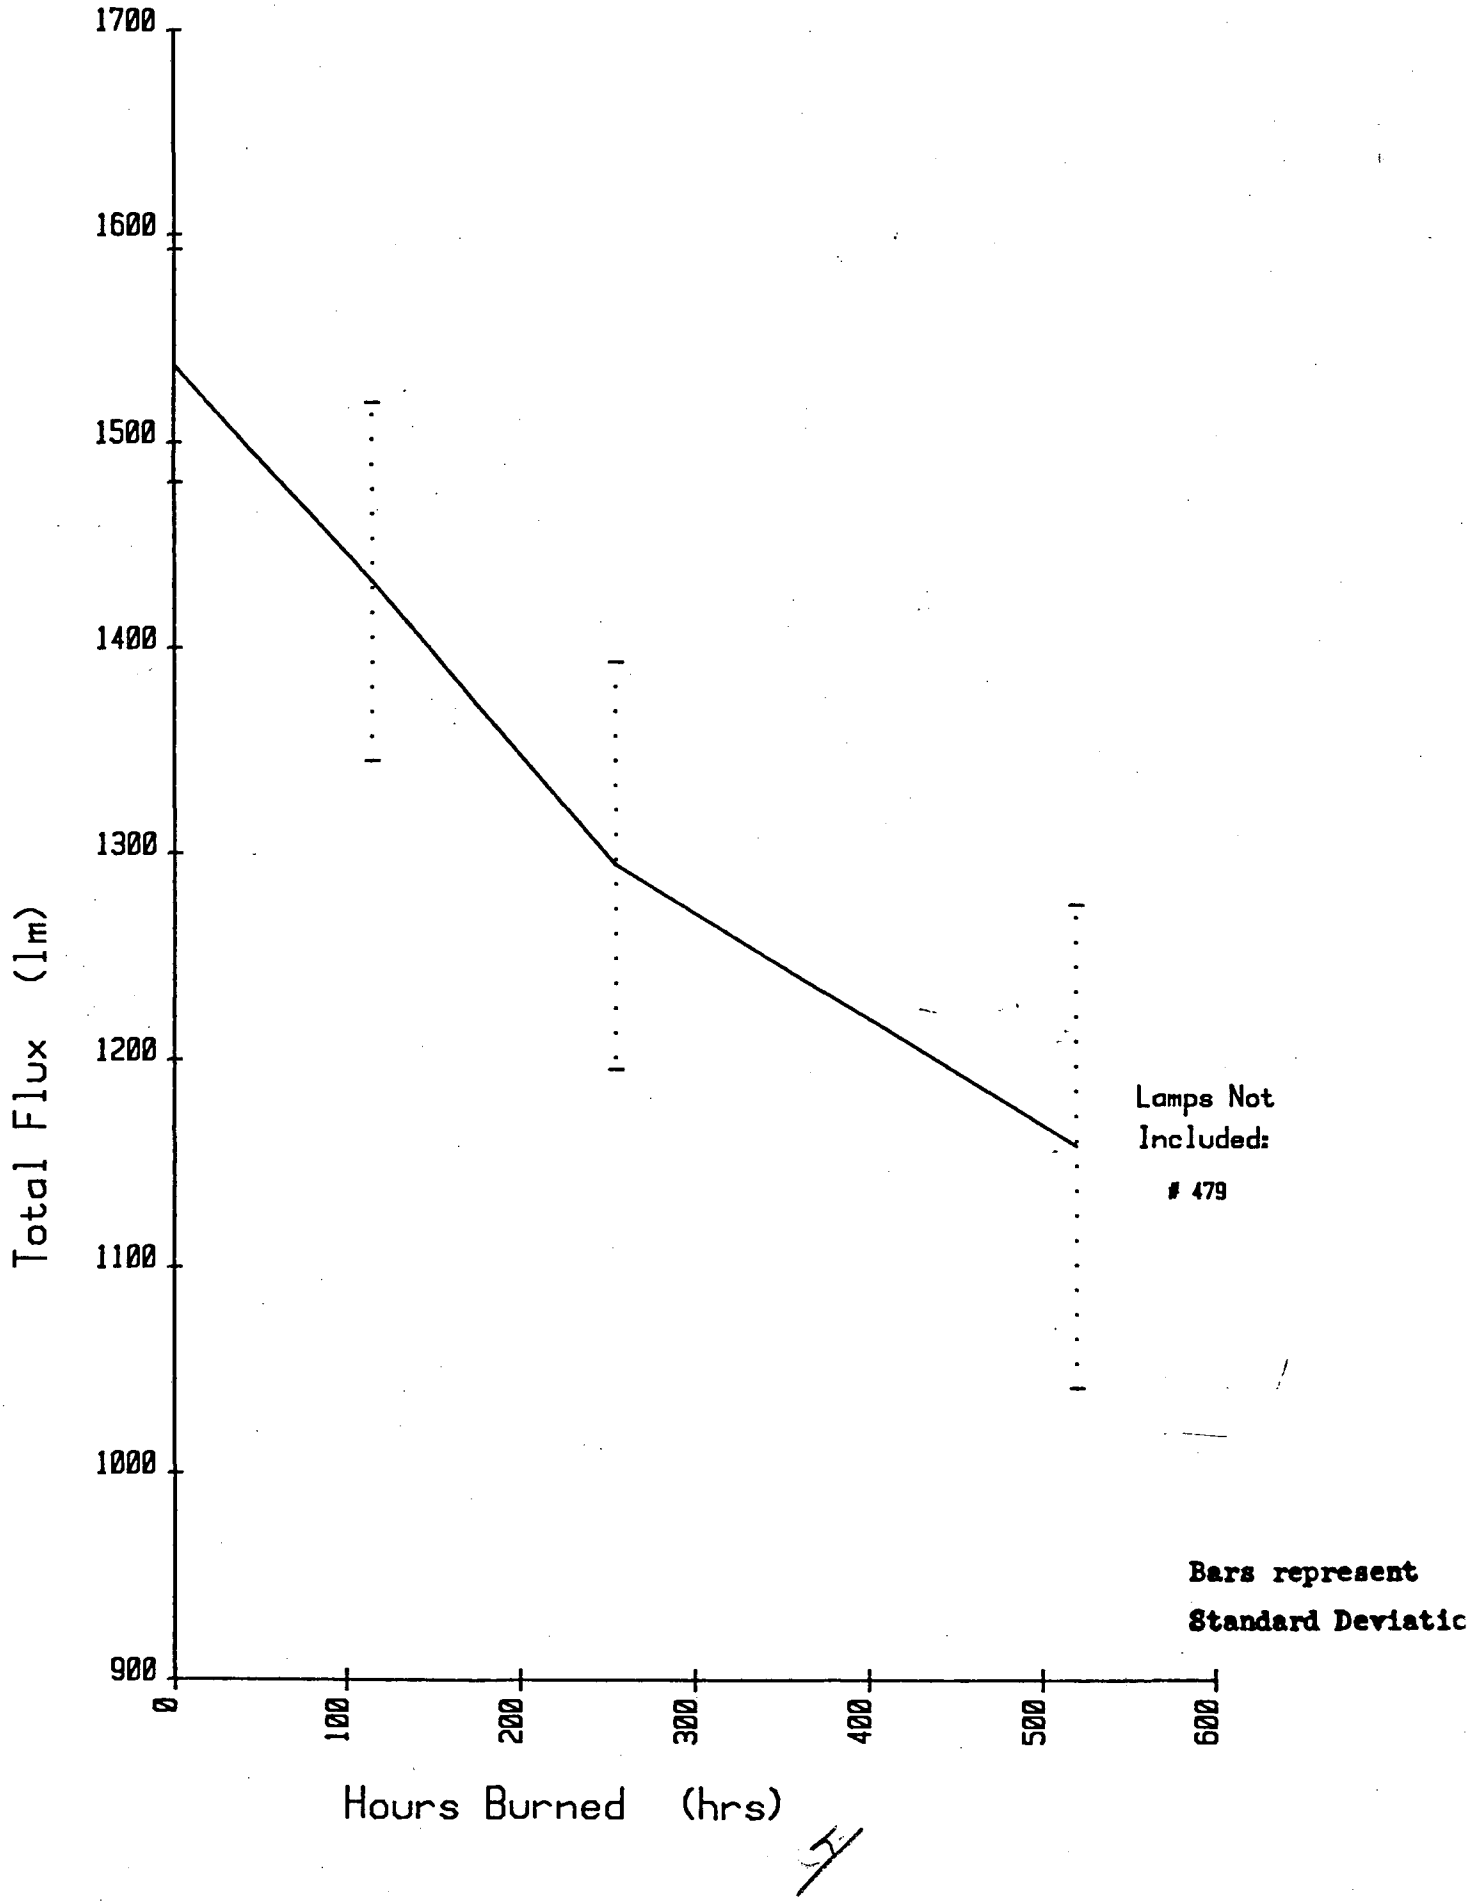
GRAPH 1

The most significant result in the life test measurements is the unusually rapid decline in light output. The average loss in output after 520 hours (roughly 1/5 of the total rated life) was 24%. Two lamps (#497 & #486) had lost near forty percent of their initial luminous flux. These results were not expected because the average decrease in output at the equivalent point in the life of a standard incandescent is about 8%, and there is no obvious reason why light output would decline so much faster in this design.

To a large degree, the depreciation in light output appears to be caused by the deposition of tungsten on the bulb wall, as in most incandescent designs. However, bulbs #497 and #486 showed signs of deterioration in the reflective coating which has assumed a brownish clouded appearance. Also, leakage in the seals of the bulbs could be causing oxidation of the filament and the early burnout of #479 and since then #460 and #476.

DURO-TEST LIFE TEST DATA
TOTAL FLUX vs HOURS BURNED

Although these measurements are not conclusive, they do suggest that further tests should be made on the envelope seal under operating conditions and the stability of the reflective coating.

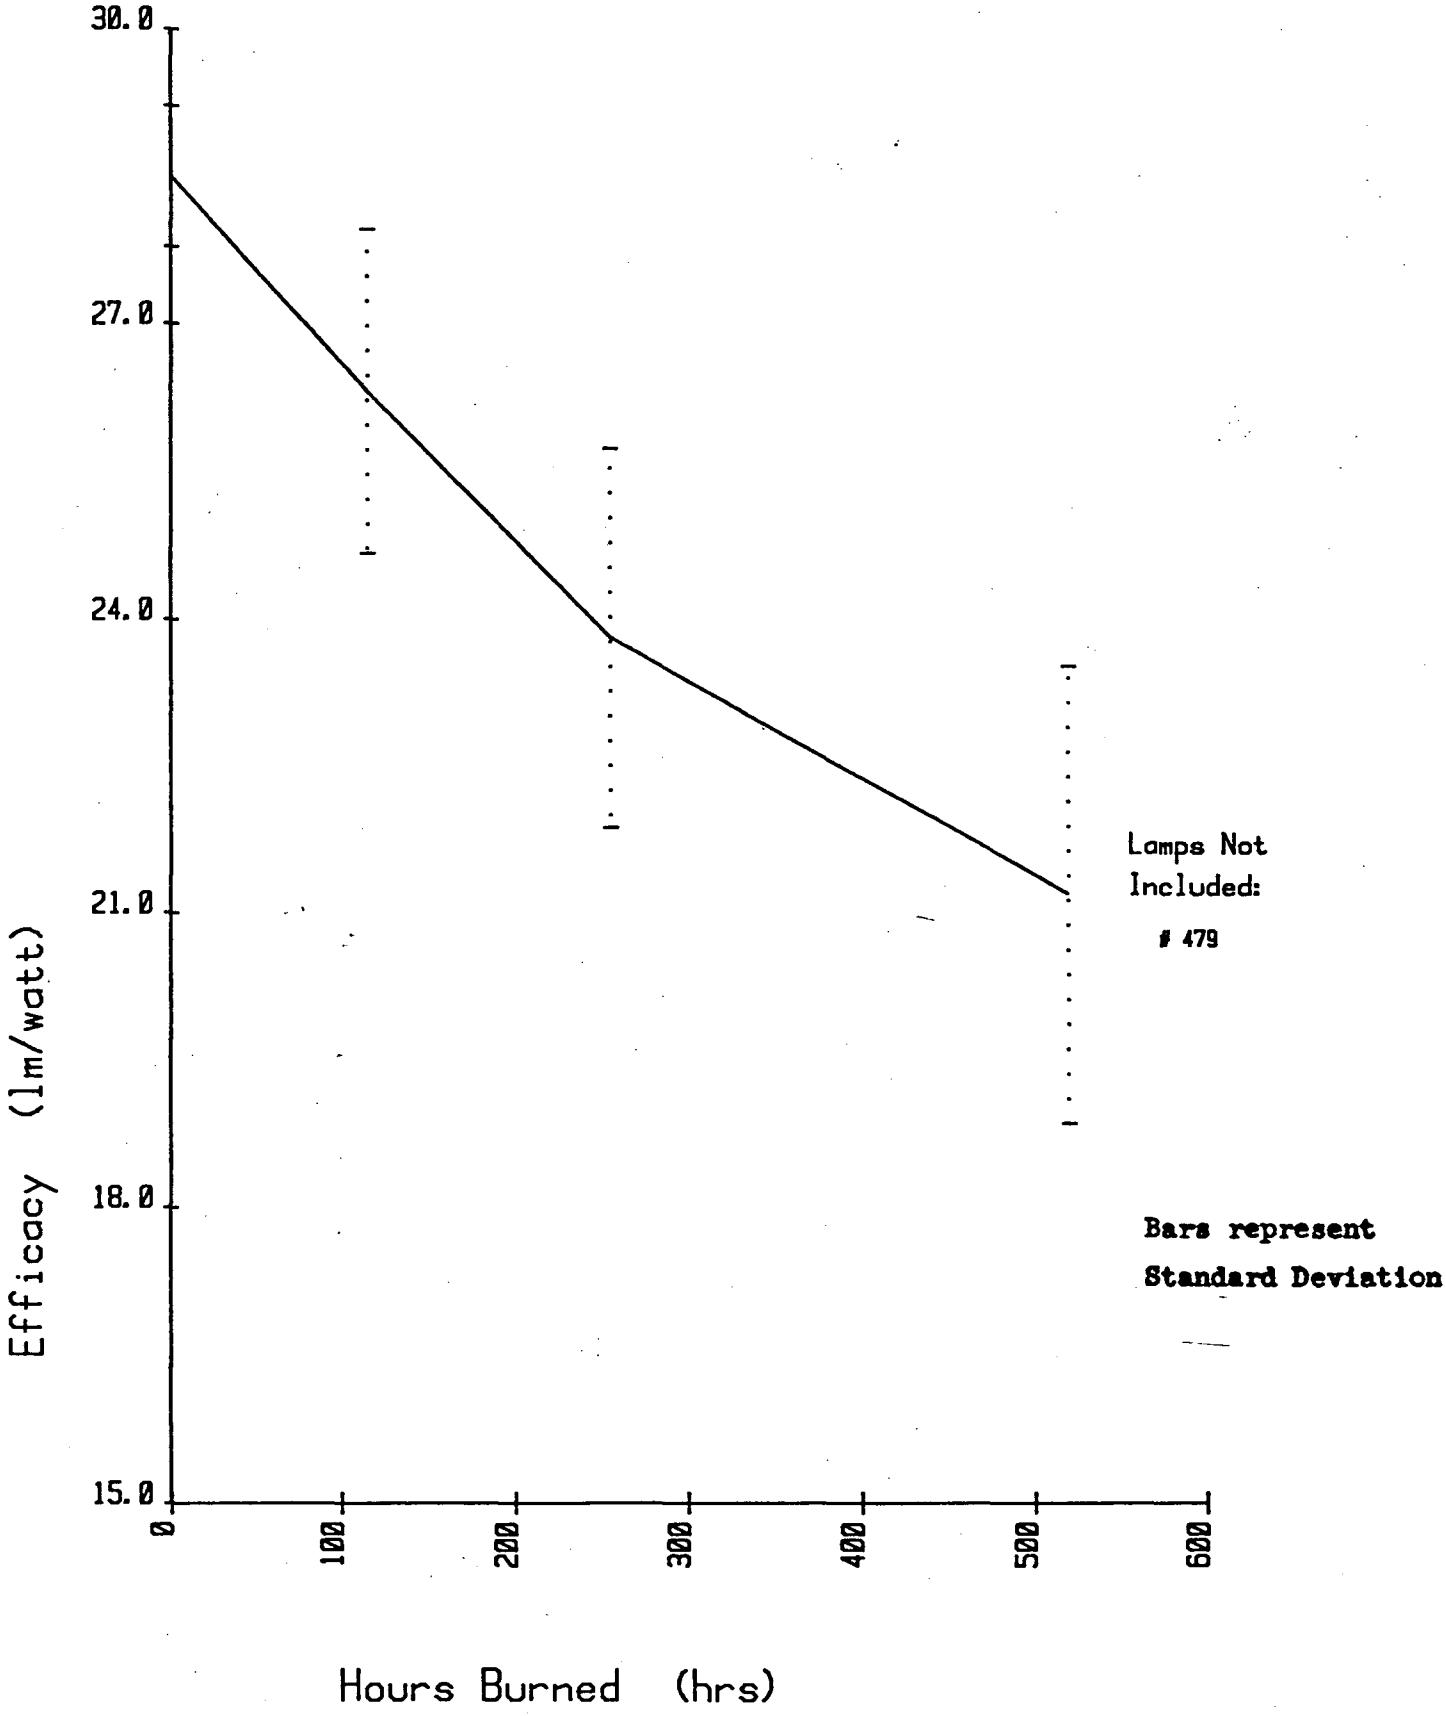
GRAPH 2

DURO-TEST LIFE TEST DATA
EFFICACY vs HOURS BURNED

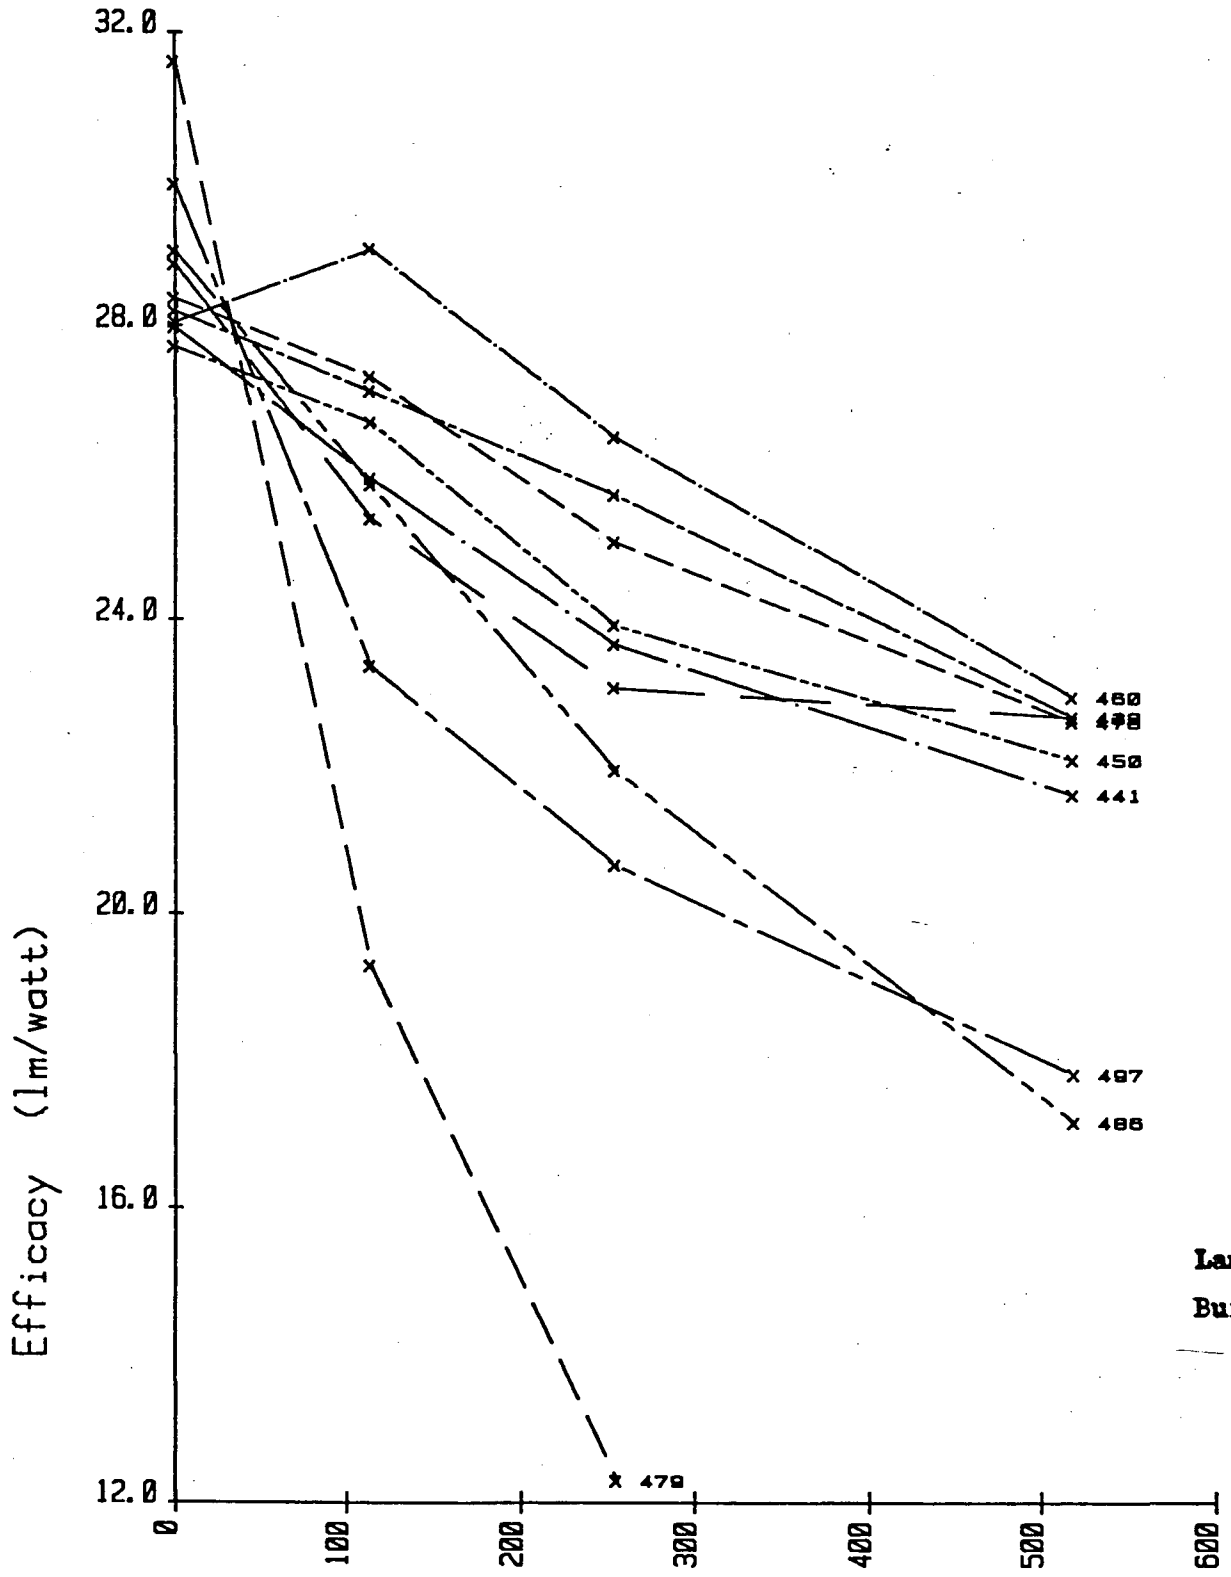
GRAPH 3

DURO-TEST LIFE TEST DATA
EFFICACY vs HOURS BURNED

Lamp #479
Burned out @ 280

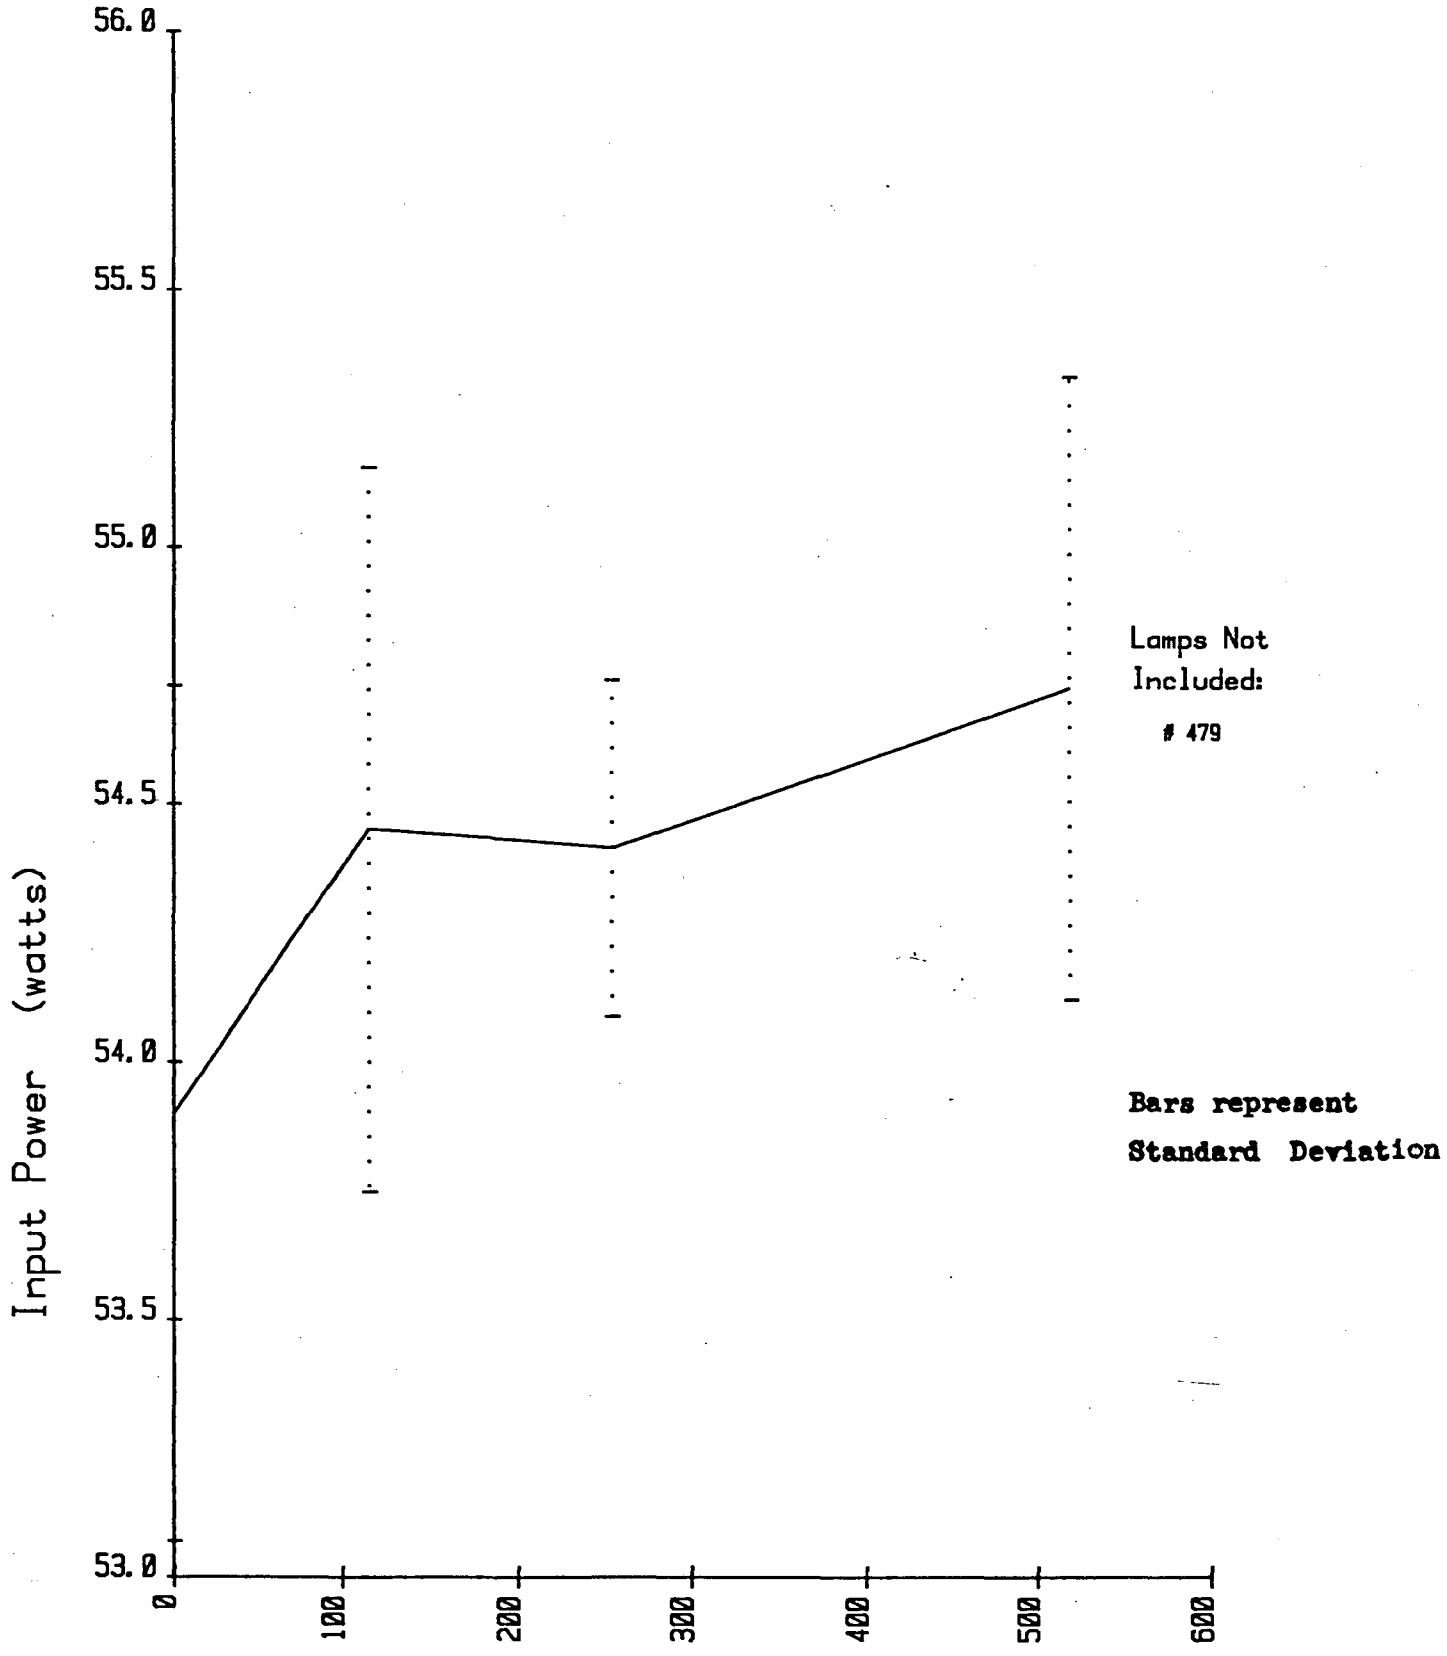
GRAPH 4

DURO-TEST LIFE TEST DATA
INPUT POWER vs HOURS BURNED
