Title
AIR LEAKAGE OF NEWLY INSTALLED RESIDENTIAL WINDOWS

AIR LEAKAGE OF NEWLY INSTALLED RESIDENTIAL WINDOWS

John Weidt and Jenny Weidt

THE MINNESOTA ENERGY AGENCY

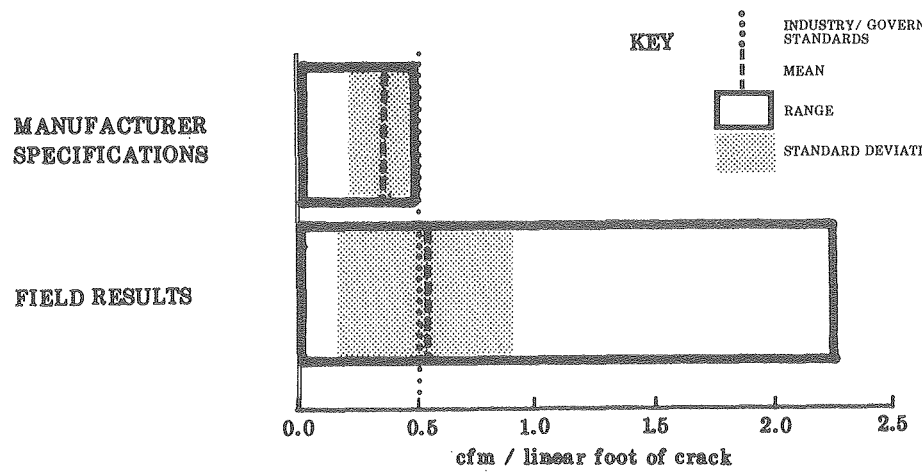
FIGURE 2.1.1 AIR LEAKAGE OF INSTALLED WINDOWS
The graphs compare the range and mean of manufacturer's published air infiltration rates and industry/government standards for air infiltration with results of tests performed on installed windows.

in this report may be found in Appendix C, DATA. Figure 2.1.1 illustrates that the average air leakage of all windows tested was .52 cfm/lfc. 40% of all windows tested possessed air leakage characteristics higher than the industry and government standards of .50 cfm/lfc.

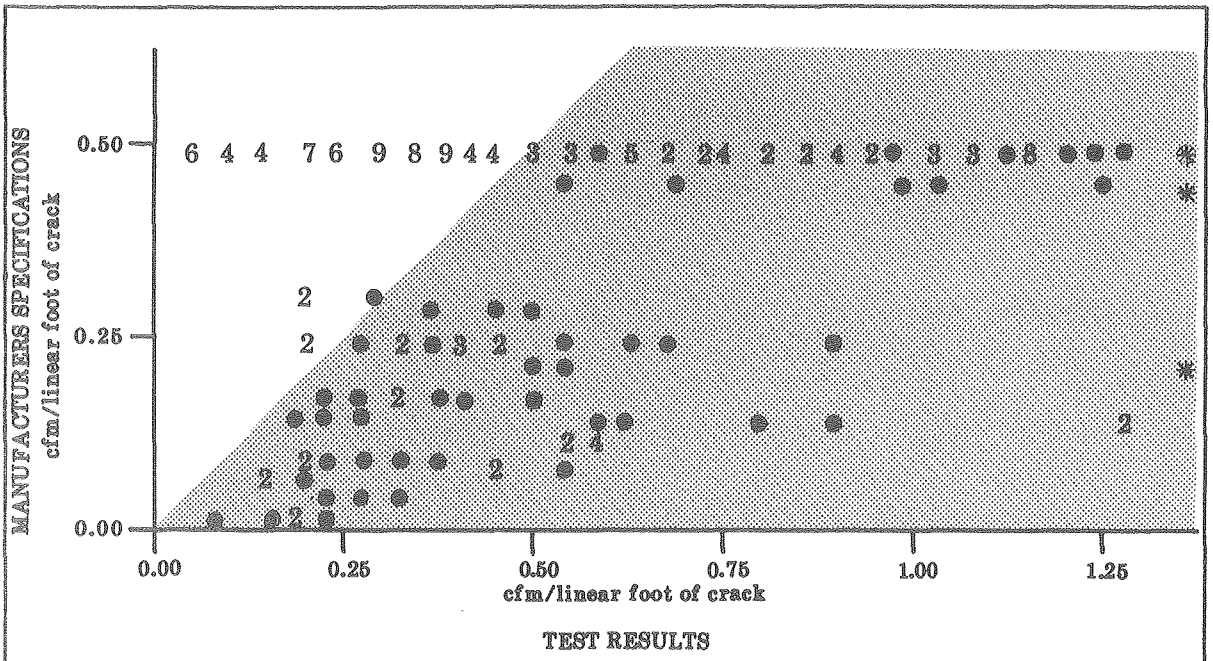
FIGURE 2.1.2 SCATTERGRAM OF FIELD RESULTS
Results of each test are plotted relating their field test performance to manufacturer's specifications. Each number indicates that more than one result occurred at a given point. As an example, a point occurring at X=.75, Y=.25 means that the window's manufacturer reported a lab test at .25, the field-measured leakage of the unit was .75. Points within the grey area relate to windows whose field air leakage were greater than reference. The * designate outliers.

Figure 2.1.2 illustrates that the windows tested in the field had a very wide range of performance. The field air leakage performance of the windows ranged from .01 cfm (an extremely tight window) to 2.28 cfm/lfc (an extremely leaky window) while manufacturers' performance specifications ranged from .01 cfm/lfc to .50 cfm/lfc. The leakage rate of 60% of the windows tested exceeded the specifications published by their manufacturers.

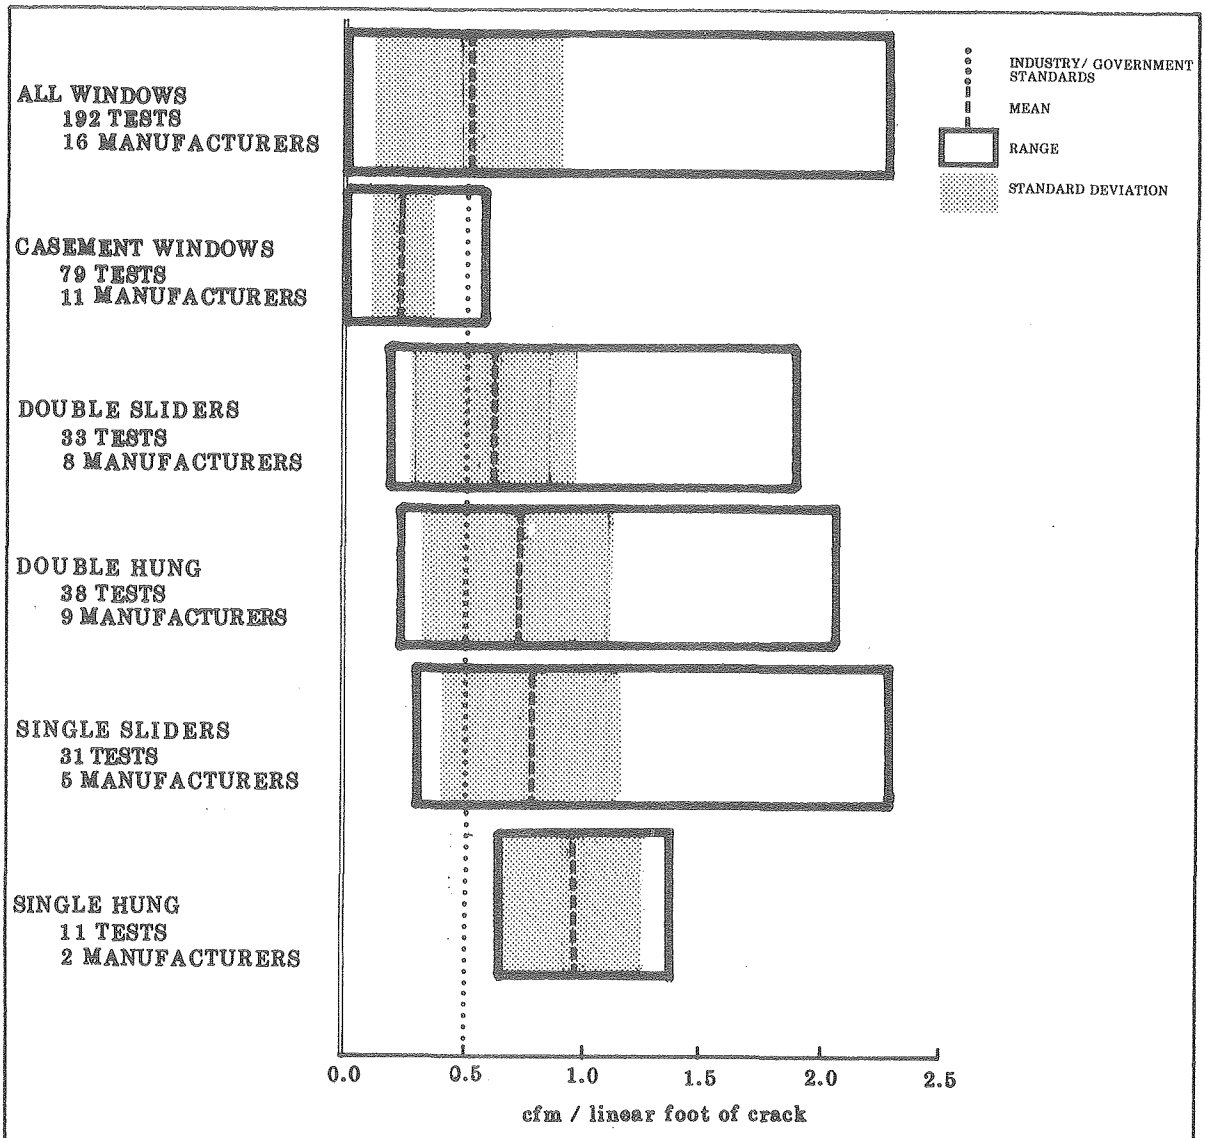
FIGURE 2.2.1 FIELD RESULTS: COMPARISON OF WINDOW TYPES

Results of the field tests were grouped by window operation type to identify patterns of air leakage performance. Analysis of the data indicated that the primary operation type of the window (casement, slider, or hung) was the most important variable in explaining a window's air leakage performance. Figure 2.2.1 illustrates the relative performance of the studied window operation types, and shows the average air leakage performance of casement windows to be .23 cfm/lfc, double sliders to be .61 cfm/lfc, double hung to be .72 cfm/lfc, single sliders to be .79 cfm/lfc, and single hung to be .96 cfm/lfc.

9.1.1.2 The performance of a window is primarily affected by its operation type. Casement windows far outperform sliding and hung windows (Figure 2.2.1).

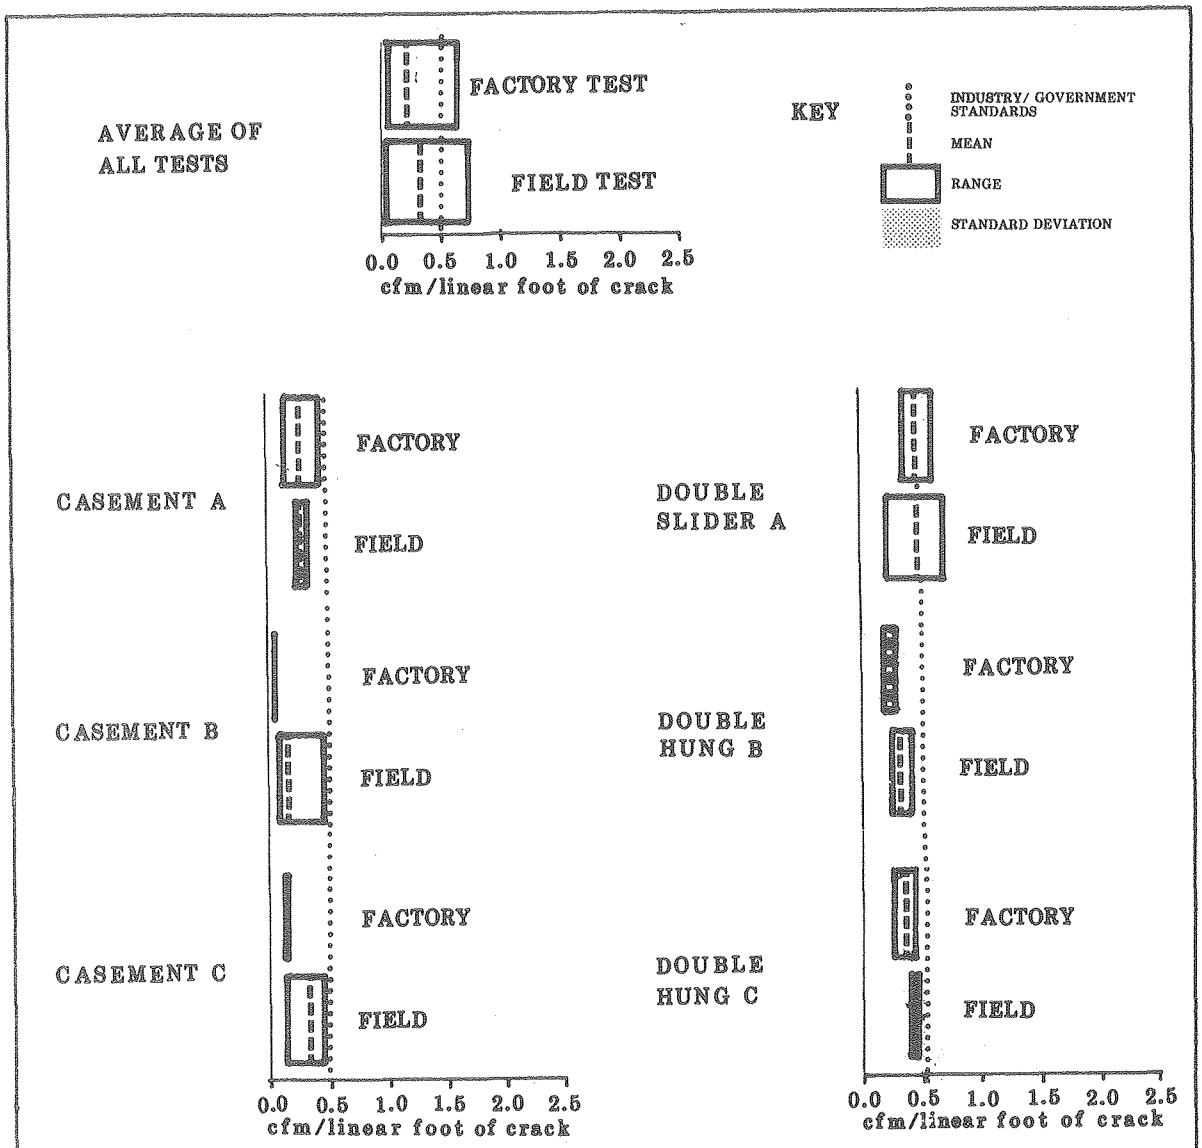
FIGURE 2.3.3 FACTORY/FIELD TEST RESULTS
A comparison of air leakage performance measured in the field with the air leakage rate of similar uninstalled windows tested in the factory.

results obtained on similar windows tested in the field. Figure 2.3.3 illustrates the results of these tests which indicate an average decline in performance of approximately 29% between factory and field.

A limited number of tests indicate that the window declines in air leakage performance between factory and field (Figure 2.3.3).

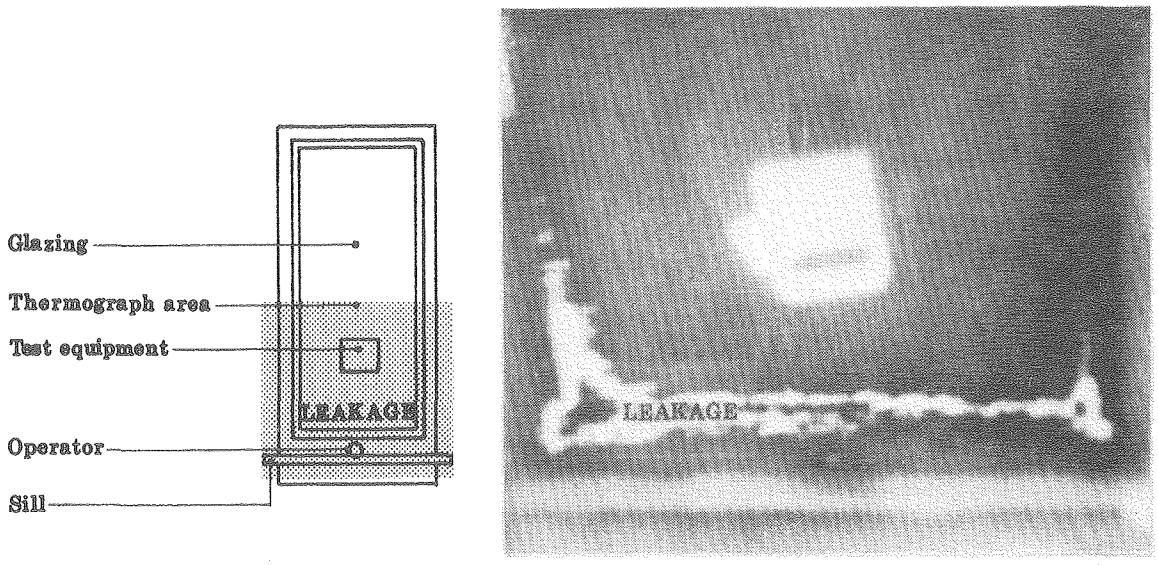
The data indicated patterns in the location of observed excessive air leakage which varied from window operation type to window operation type. 28% of the casement windows tested had one or more observed anomolies. The majority of leakages were observed at the corners (Figure 2.5.2). The average air leakage rates of casement windows with anomolies was 45% greater than the mean performance of all casement windows. 45% of the double slider windows tested had one or more observed anomolies. Leakages were observed at the corners, at the meeting rail and at the sill. The performance of these windows was the same as the average of all double slider windows. 82% of the double hung windows tested had an observed defect. Leakages were observed at the corners, at the meeting rail and

FIGURE 2.5.2 THERMOGRAPH AND SKETCH SHOWING TYPICAL CORNER LEAKAGE OF CASEMENT WINDOWS

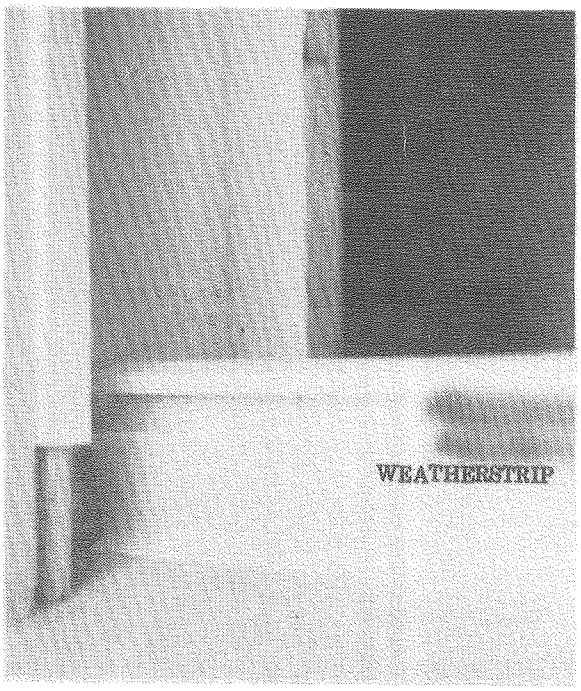
1. WEATHERSTRIP DISCONTINUITY
   The weatherstripping seal around leaky windows was frequently discontinuous. Most commonly this occurred at sash corners, where the weatherstrip at the jamb was not in the same plane as the weatherstrip at the head or sill. There were also cases where the

FIGURE 2.5.3 AIR LEAKAGE DUE TO WEATHERSTRIP DISCONTINUITY
Pile weatherstripping at sill cut short, leaving 2½" gap to jamb.

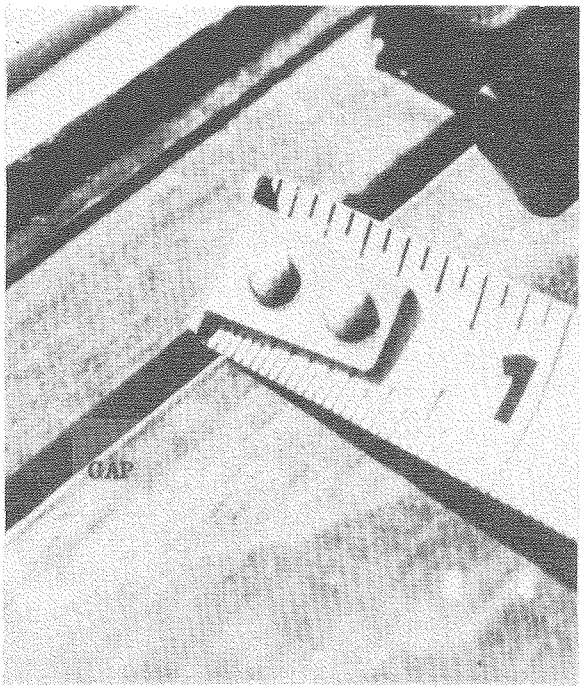
FIGURE 2.5.4 AIR LEAKAGE DUE TO HARDWARE SEAL
Hardware on double hung moved sash away from each other when locked.

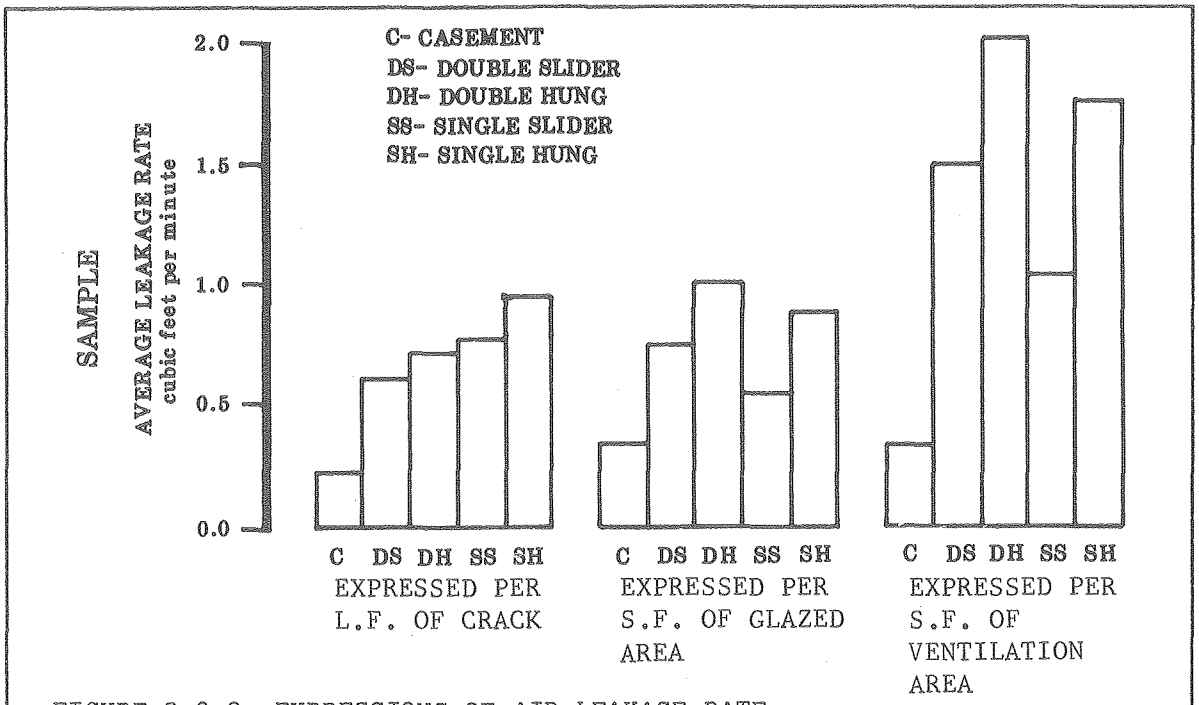
FIGURE 3.0.2 EXPRESSIONS OF AIR LEAKAGE RATE
The results of field testing new windows in new construction were calculated via the three methods displayed above.

Figure 3.0.2 illustrates the air leakage performance of the major operation types measured in this study expressed in terms of linear foot of crack, square foot of sash area, and square foot of free ventilating area. Large

9.1.1.6 Varying the expression of air leakage rate between crack length, sash area and free ventilating area dramatically shifts the relative performance of the tested window operation types. Expressions of air flow per linear foot of crack do not give a ready understanding of the total leakage performance of a window relative to the more common way of thinking of windows - area. Technical variations in the definition of window operation types between manufacturers, and thus the definition of crack length, adds to the confusion when a designer or contractor chooses a window (Figure 3.0.2).

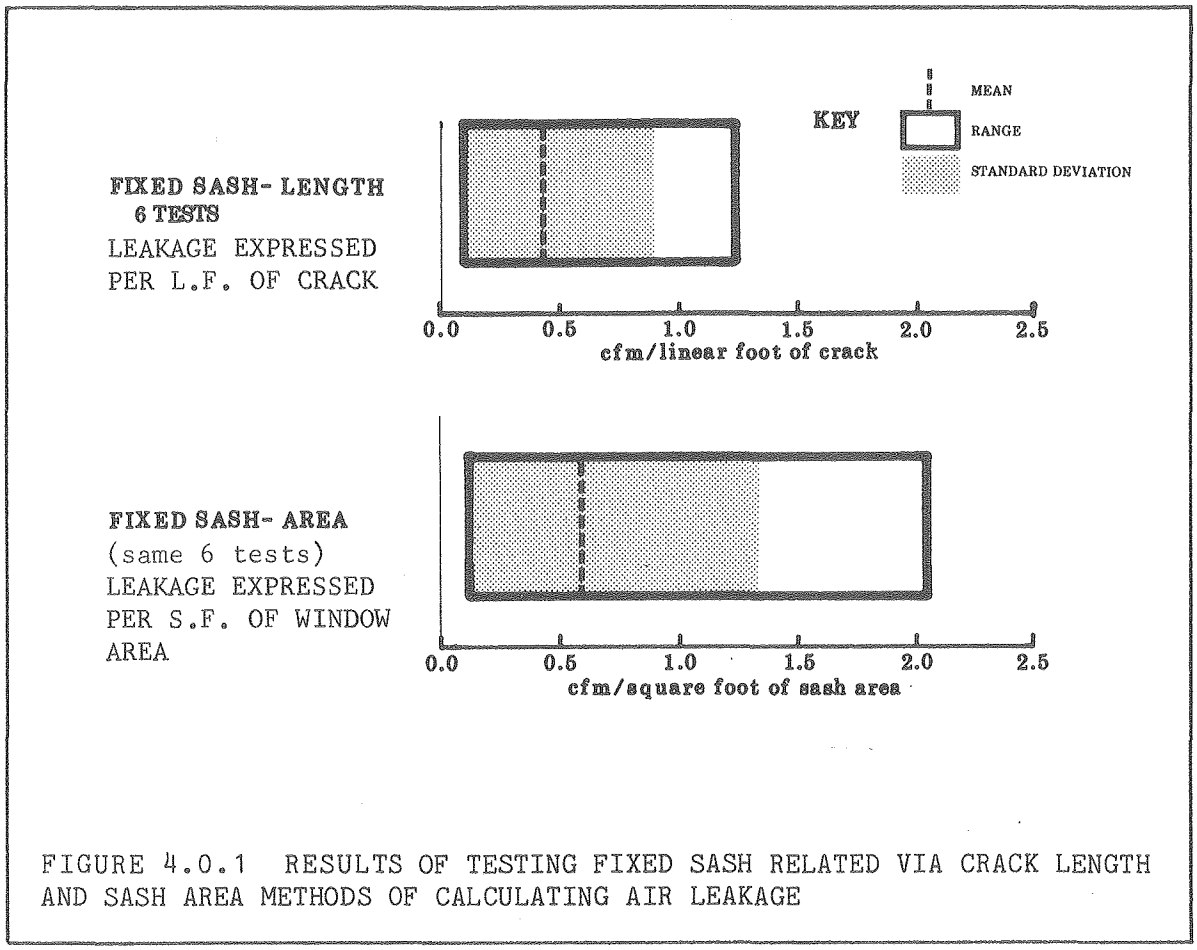
FIGURE 4.0.1 RESULTS OF TESTING FIXED SASH RELATED VIA CRACK LENGTH AND SASH AREA METHODS OF CALCULATING AIR LEAKAGE

Six fixed window units were tested for their installed air leakage performance. Figure 4.0.1 illustrates the results. The fixed windows tested exhibited relatively poor air leakage characteristics, especially considering the relative ease with which fixed sash should be able to be sealed into their frames. Leakage of the units was usually located with smoke and occurred near corners both at the glazing/sash and the sash/frame interface. The poorest performer did not appear to have continuous sealant between the glazing and the sash, as a strip of cardboard could easily be inserted between the sash and lite in several places.

There are currently no standards for fixed residential wood or aluminum windows. Observations from this study indicate that there is a definite need to establish air leakage standards for such windows.

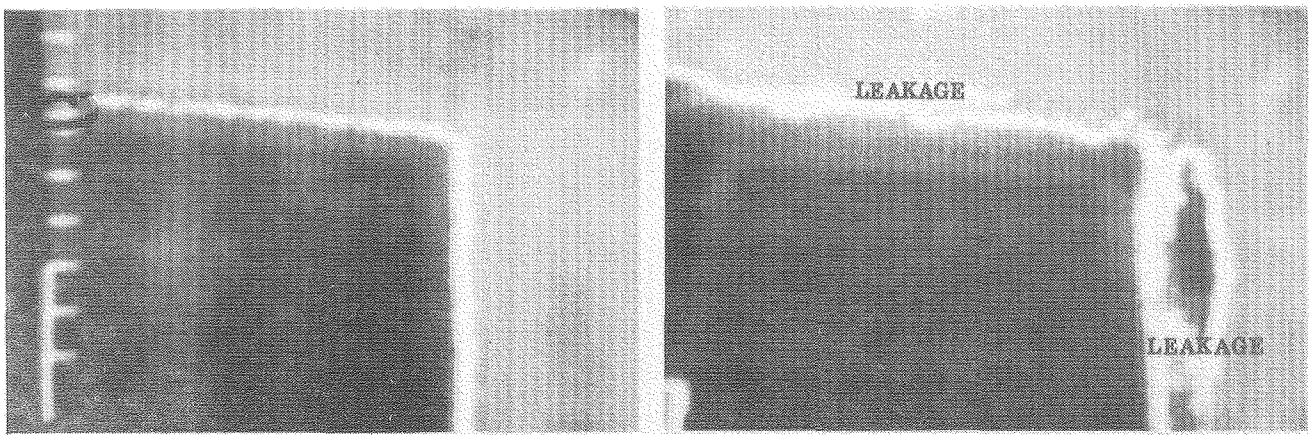
FIGURE 5.0.2 THERMOGRAPH OF FRAME/WALL LEAKAGE
Thermograph before and after room pressurization, cold area above and to right of window unit due to frame/wall leakage.

It is interesting to note the relative impact of total air leakage as measured through the frame/wall crack when compared to the leakage through the sash/frame crack of the installed window unit as displayed in Table 5.0.3. Although the test method allows some degree of imprecision in the absolute measurement of the volume of outside air flowing through the sash/frame crack, it nonetheless indicates that the air leakage performance of the crack between the window unit and the wall has a significant affect on the air leakage performance of the entire window unit as installed. The air flow measurements at the frame/wall crack indicate that air leakage at this location can be nearly that of the window unit itself. Control of air leakage at the frame/wall crack is relatively easy during window installation but cannot be controlled successfully after the window is installed. It is, therefore, imperative that window installers pay close attention to limiting air leakage at the frame/wall crack.

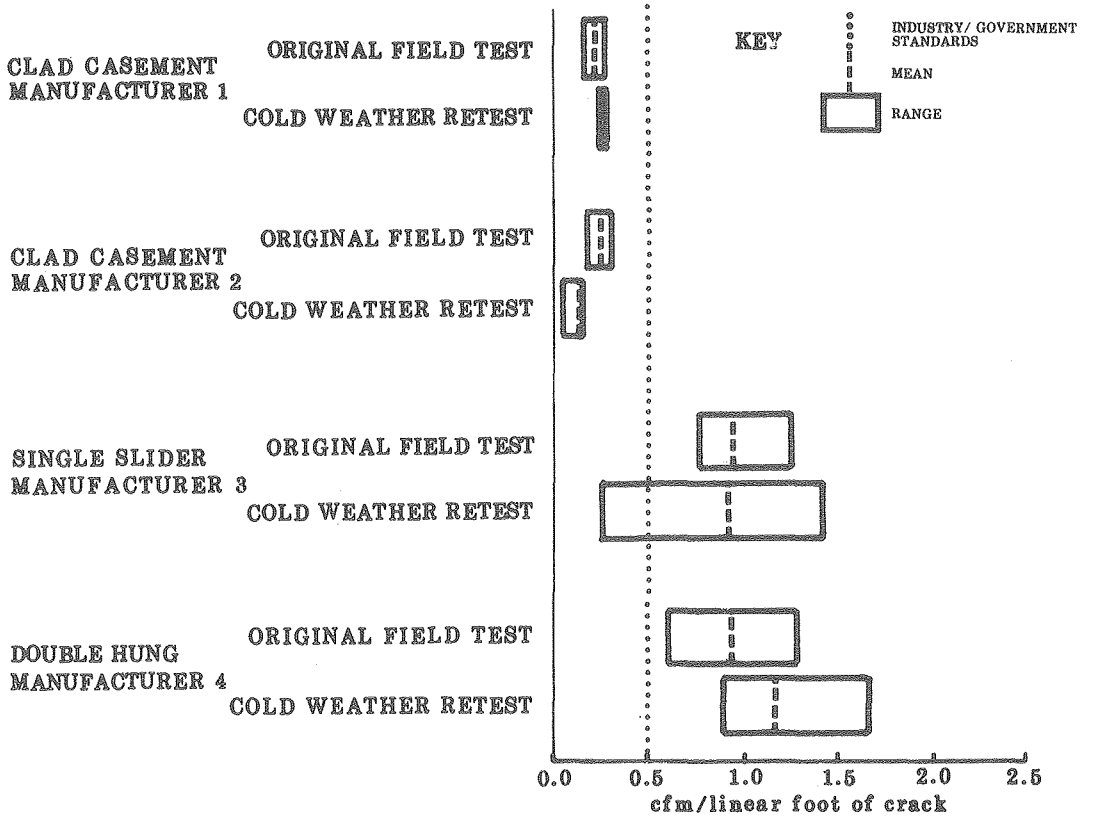
FIGURE 6.0.1 COLD WEATHER RETESTS
A sampling of windows which had been tested during the summer months were retested in the winter to observe performance differences.

A number of window units which had been tested during the new window portion of the program were retested during the winter months to investigate the possibility of poorer performance during cold weather. The average outdoor temperature encountered during the initial testing was 60.2 F, while the average outdoor temperature encountered during cold weather retesting was 7.8 F. Figure 6.0.1 displays the results of the retesting work. The results obtained indicate no significant degradation in the air leakage performance during cold weather. After each opening and closing of a window unit, its performance will vary since factors such as dirt and the care of the operator in closing the unit can greatly affect its seal; the difference of the two results (original versus cold weather) could be attributed to the variation in performance that is to be expected with normal operation of the unit.

9.2.1.1 Windows retested during this project in cold weather that had been tested during warm weather showed no significant tendency to decrease in over-all performance levels. The windows retested during cold weather represented less than 10% of the total number of windows tested (Figure 6.0.1).

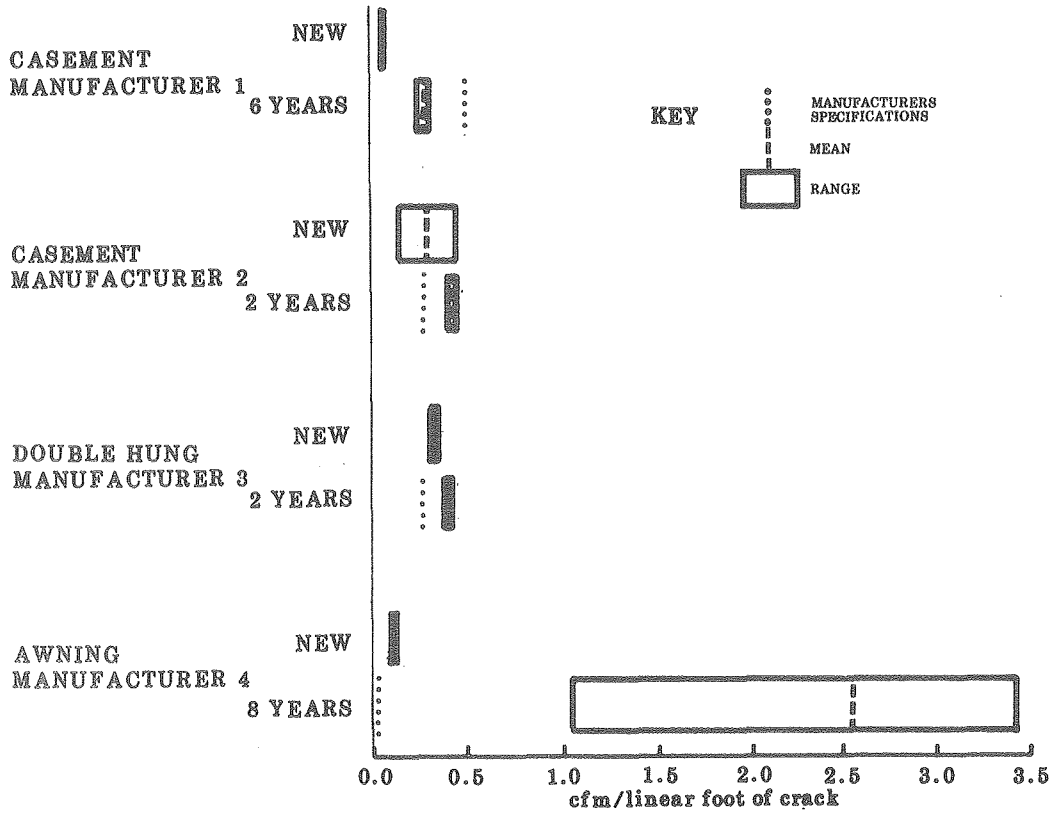
FIGURE 7.0.1 PERFORMANCE OVER TIME
A relation of the performances of new windows to their counterparts two to eight years earlier.

The ability of a window to maintain its air leakage performance over a period of years is an important energy conservation attribute. In this project, ten tests were made on windows which had been installed for from 2 to 8 years, and for which manufacturers' specifications from the installation year were available. The results of these tests were compared to the performance of new windows of the same operation type as illustrated in Figure 7.0.1. The performance of 7 of the 10 older windows tested did not degrade appreciably from the performance of new windows of the same operation type, although none performed as well as may have been anticipated from the manufacturers specifications.

There was substantial degradation of performance in 3 of the older windows tested, which were awning units. The sash was equipped with a roto operator at the center of the right jamb and a locking mechanism at the center of the left jamb. Ice, resulting from condensation on the unit, built up between the sill stop and the sash and, as it expanded, pushed the sash outward until the teeth on the roto operator snapped and the sash warped. Although only 3 of these units were tested, this condition was observed in a total of 22 similar window units. It appears that this degradation in performance can be attributed to a design flaw of the manufacturer; no positive lock was provided at the window sill.

9.4.1.1 Ten older windows, representing four manufacturers, were tested during the project. The performance of the products of three of the manufacturers had similar air leakage characteristics to those of new windows of the same manufacturer and operation type, the performance of the product of the fourth manufacturer was far worse than the similar new windows tested. The results indicate that window air leakage performance does not have to substantially degrade over time, but may degrade due to improper window design. (Figure 7.0.1).

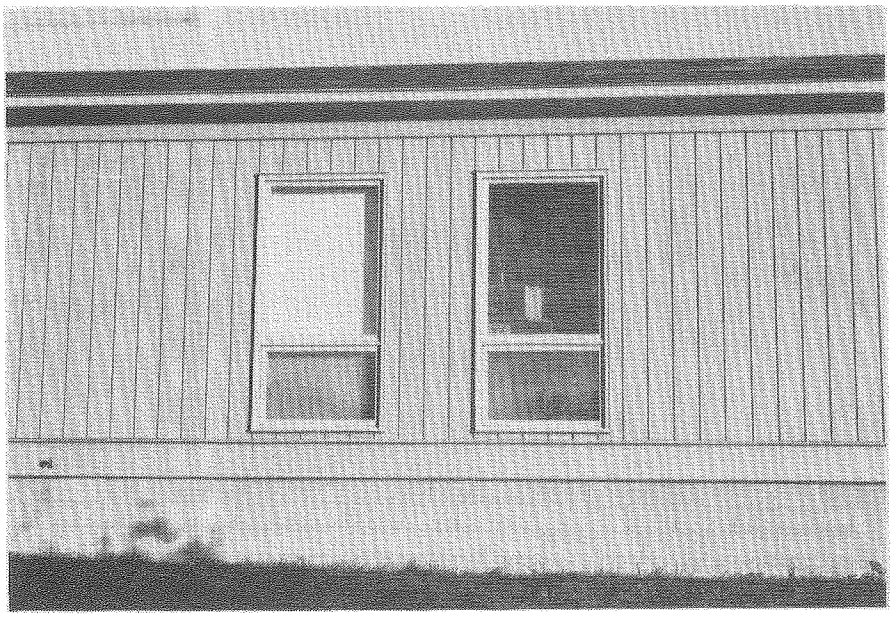
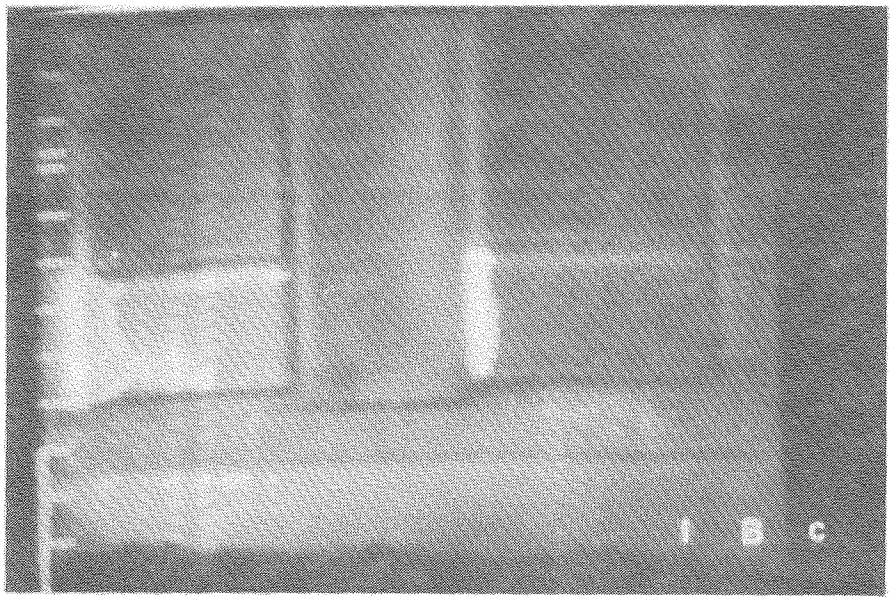
THERMOGRAPH

Figure 7.0.2 is an interior thermograph of one of the leaky awning window units under pressure. The lightest areas are zones of exfiltration and are typically at the roto operator side of the sash.

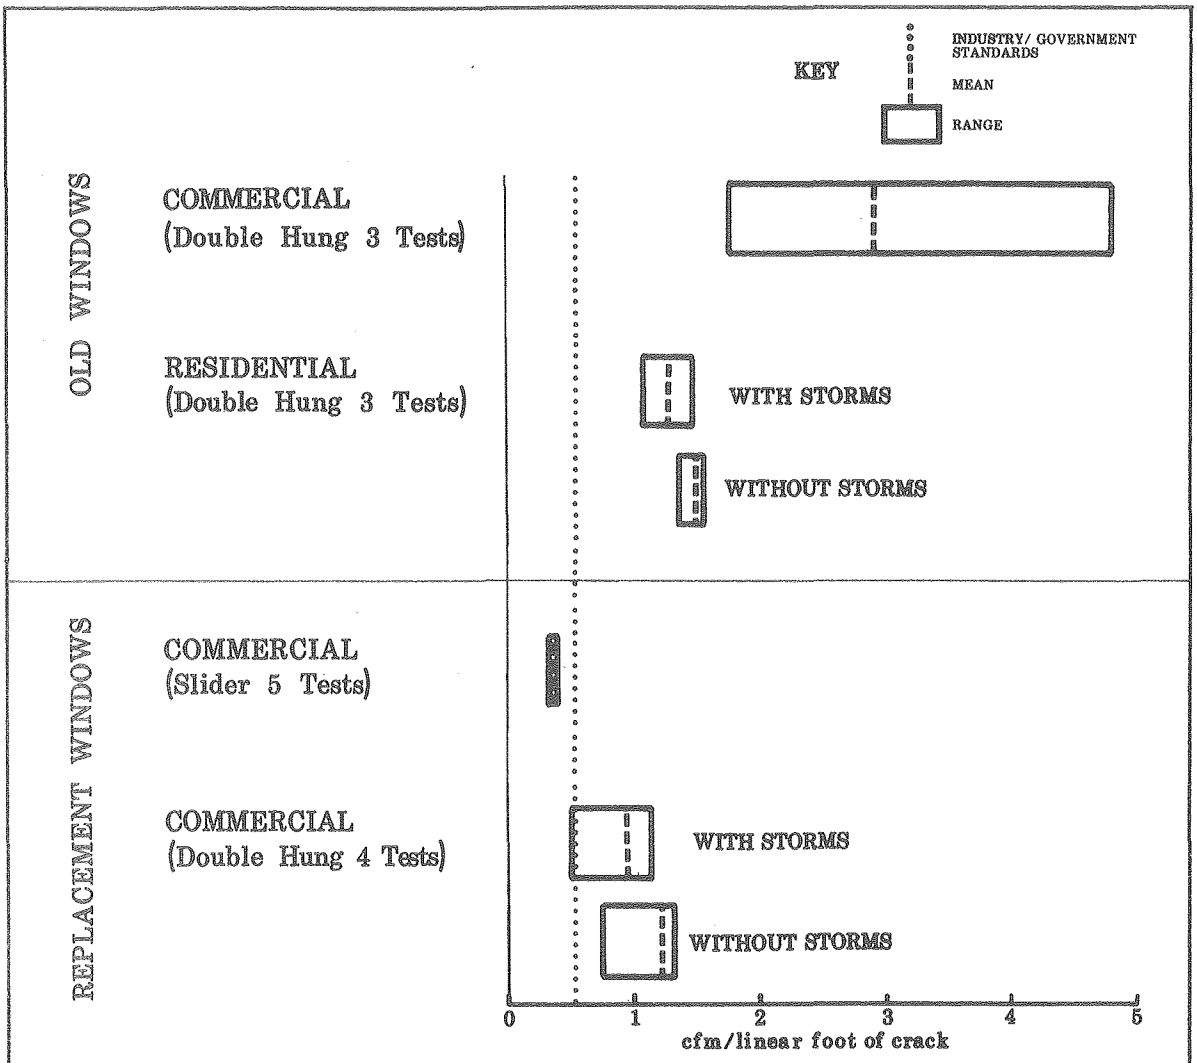
FIGURE 8.0.1 FIELD AIR LEAKAGE PERFORMANCE OF OLD AND RETROFIT WINDOWS

Field air leakage measurements were made on six older residential and commercial windows 25-50 years old and on nine commercial replacement windows made by three manufacturers. The results of the tests are displayed in Figure 8.0.1. The old commercial windows lacked weatherstripping and were in generally poor condition, contributing to their considerable air leakage. These older commercial windows tested were being refitted with new replacement windows, and tests performed on the replacement windows indicate a considerable improvement in air leakage performance. Where tests were performed on old and retrofit windows each both with and without storms, the storms reduced the rate of air leakage.

It should be noted that the volume of air leakage of the old commercial double-hung windows exceeded the capacity of the test equipment, and that the data displayed in the table is extrapolated and therefore approximate. Conversion of air infiltration at one pressure to air infiltration at another pressure should not be done - it was done here for graphic comparison only. The actual air leakage of the three tested units was:

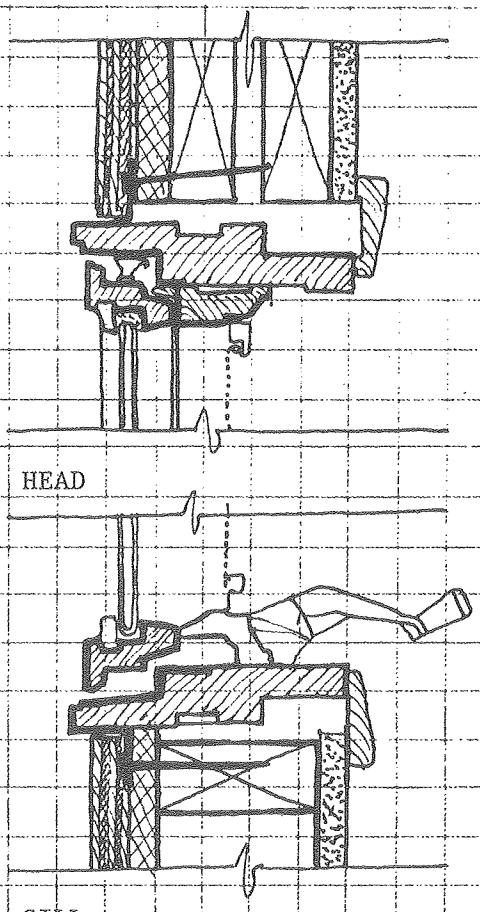
Note: no shims, frame not set on sill-- window suspended by cladding
