Weather Impacts on Solar PV Operations Summary of the Current Body of Knowledge and Implications for Further Investigation

Prepared for the
Department of Energy – Solar Energy Technologies Office (SETO)
U.S. Department of Energy

December 2021

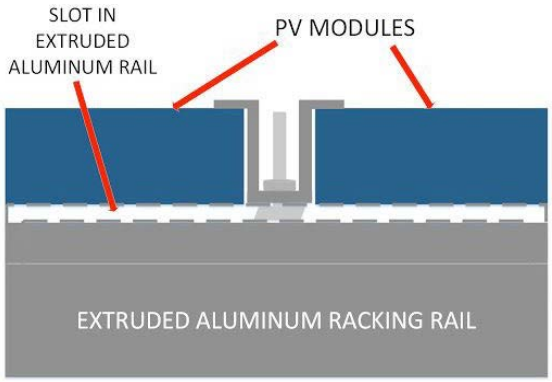
Figure 16. Soft joint: Top-down clamp

Slotted t-bolts (Figure 16) are often made of a grade of stainless steel.

For the top-down clamping assembly to adequately hold modules in place under adequate clamping forces, the bolt would need to reach a pre-loaded state when tightened (put under tension). However, given the hardness of the stainless bolt, the pre-load on the bolt may not be achieved, as the soft aluminum components yield or bend, causing the joint to relax before bolt rated pre-loading is achieved or sustained.

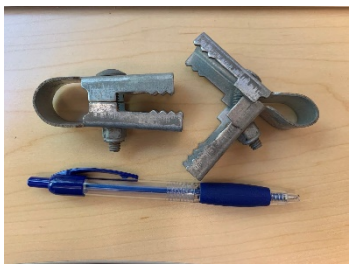
Figure 21. Back-of-module frame clamps

A few racking designs utilize back-of-module frame clamps (Figure 21). These concepts have low strength, and in one field inspection failed under a 70 mph wind generated by an afternoon thunderstorm.

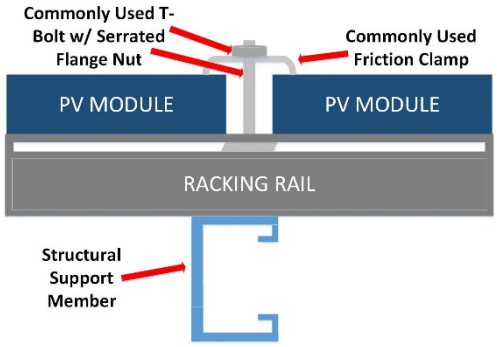
Figure 22. Common style of top-down mid-clamp

Figure 22 illustrates a common style of top-down mid-clamp that is used to secure the inside edge of two neighboring modules.

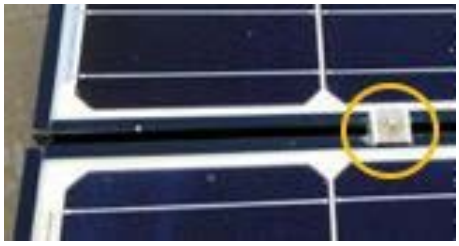
Figure 23. Top-down mid-clamp in the field

Figure 23 shows the clamp in a picture taken from the field holding the inside edges of the two modules.

Figure 24 shows the fastener assembly with the clamp, slotted t-bolt, and flange nut. This style (as well as several others like it) is particularly vulnerable to failure if and when one of the two neighboring modules breaks free (is dislodged).

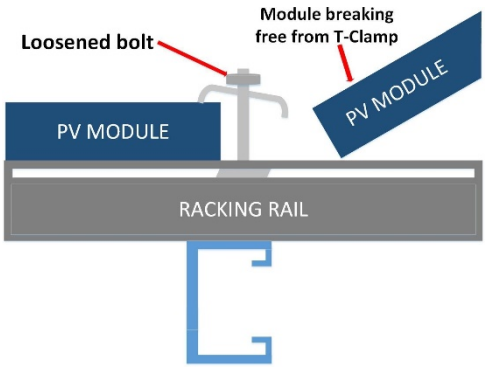
Figure 25. How module breaks free from a t-clamp

The fastener will tip off the remaining module (Figure 25) once one of the neighboring modules has broken free from such events as high wind pressure or a debris strike.

Modules are most often arranged in rows with end- and mid-clamps securing models to the racking rails. Once one module is dislodged during a weather event, the entire row will be found lost in a kind of “domino” effect. This “row domino” problem has been observed repeatedly by those that undertake field inspections, and it is suspected to be one the major causes of module loss during a storm.

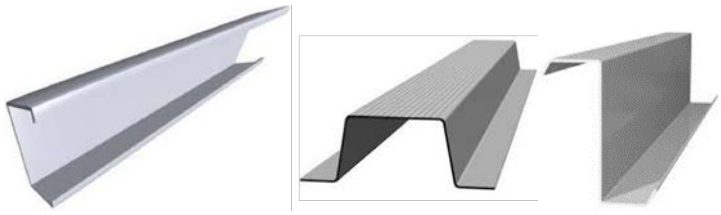
Figure 27. C-channel, hat channel, and Z channel

As evidenced by field inspection, array assemblies are exposed to highly dynamic wind forces that cause unanticipated load paths along racking members and through modules. Some designs utilize light gauge (20–22 gauge) cold rolled metal channels. Common profiles seen are often C-channel, hat channel, or Z channel (Figure 27).

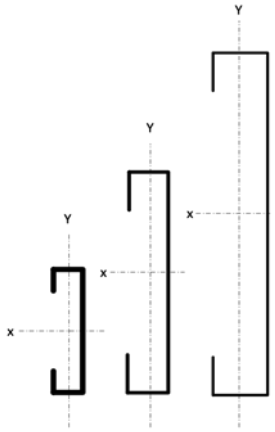
Figure 28. Sectional view of c-channel: Loading on the y-axis.

Based on damage observed in the field, it appears that structural engineers generally consider loads along the Y-axis (shown in Figure 28); however, the actual load paths under dynamic wind loading result in uneven lateral forces across an array.

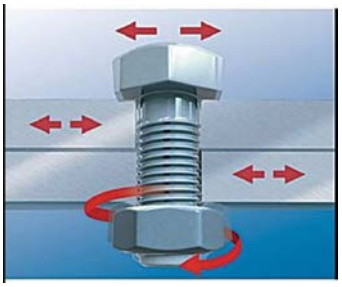
Figure 32. Transverse slip

coefficient of friction between the bolted surfaces. Transverse slip is very effective in loosening threaded fasteners. When winds speeds reach a critical threshold, the clamping forces between two metal surfaces is defeated, and slippage occurs (Figure 32).

Corroborations between system operators and field inspections have illustrated the prevalence of chronic fastener loosening. Fastener loosening, if left unchecked, will often result in the entire loss of fastener assembly (bolt, nut, and washer); the entire threaded system will vibrate out and fall to the surface below.

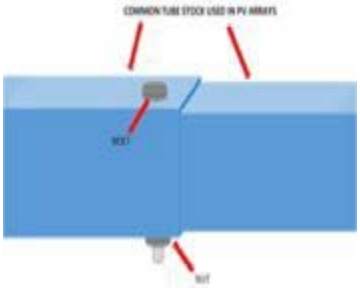
Figure 35. Slide view of a slip joint

Some racking systems utilize a type of slip joint created when one tube or square stock of metal slides and fits inside another, allowing field adjustments. Figure 35 shows a side view of a slip joint, and Figure 36 shows the end profile of a slip joint.

When tubular stock is through-bolted and fastened, the hollow shape will deform easily, causing the loss of pre-load and a resulting loosening. Figure 37 shows a wall of square tube stock deforming when the fastener is pre-loaded.

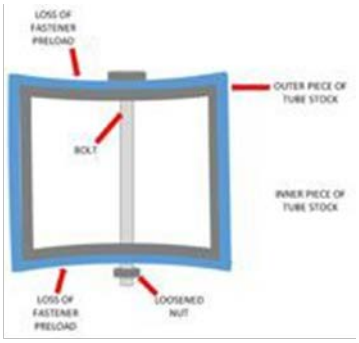
Figure 37. Wall of square tube slip joint

Once this kind of bolted joint loosens, the fastener can easily disassemble and fall out. In cases where the fastener stays in place, the joint is loose, and the tubular elements will move, elongating the bolt hole and wearing down the bolt shaft, eventually leading to full shear off.

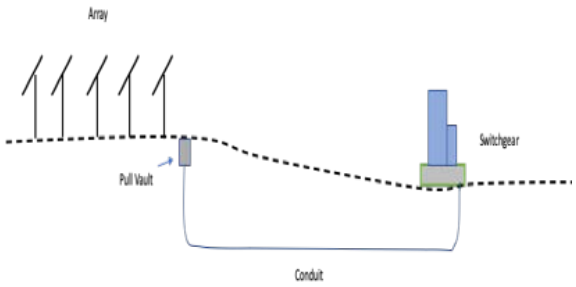
Figure 41. Elevation of BOS equipment in St. Croix array field. Source: G. Robinson, LBNL.

Field inspections of hurricane damaged ground arrays found incidences where water entered wire pull vaults and then underground conduit, resulting in flooded inverters and electrical switchgear. Underground conduit effectively can act as a drain pipe, delivering high volumes of water into BOS equipment. In one case in St. Croix, U.S. Virgin Islands, the pull vaults located in the array field were at a slightly higher elevation than the BOS equipment; the conduit was sloped toward the gear (Figure 41).

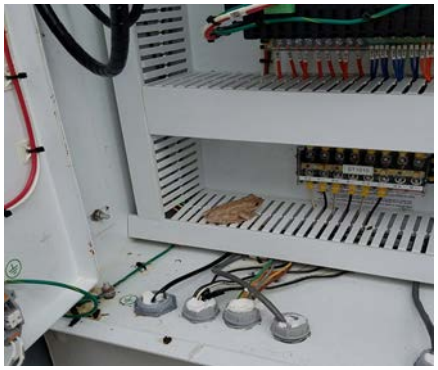
Figure 42. A frog who traveled with water flooding conduit into an electrical cabinet. Source: G. Robinson, LBNL

In the St. Croix case inspected by lab staff, they found incidents where frogs had apparently traveled with water flooding conduit into electrical cabinets (Figure 42).

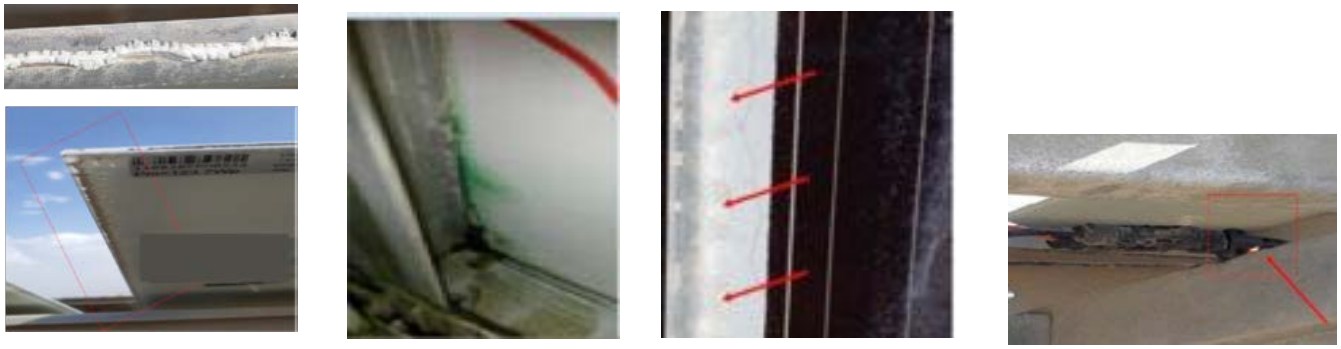
Figure 47 shows conditions of modules after submersion, ranging from failed sealants, water ingress, and shorting MC4 connectors.

Failure of sealants **Moisture ingress on backsheet** **Moisture ingress on backsheet** **MC4 Connector - Arcing**

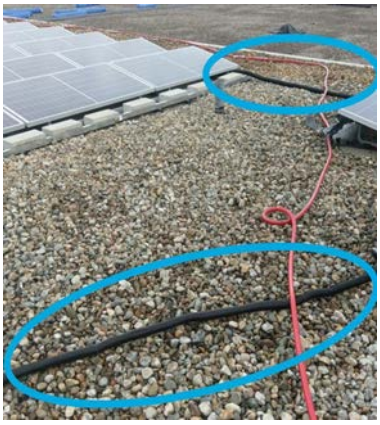
Figure 76. Exterior-rated PV wires laying across a roof

PV wire that is exposed directly to sunlight (UV exposure) will degrade, and the wire insulation will become brittle. Upon agitation from other weather elements like wind, snow, and rain, the brittle wire insulation can break apart, exposing the energized copper strands. All PV wires, even types that are rated to be used outdoors, must be protected from the weather elements. Figure 76 shows exterior-rated PV wires that are laying across a roof. These wires are exposed to direct sunlight as well as wind, rain, and snow. The solution in this case would most likely be to route the PV wires through conduit.
