Crimp Induced Leaflet Damage and Calcification of Transcatheter Heart Valves

Effect of stent crimping on calcification of transcatheter aortic valves

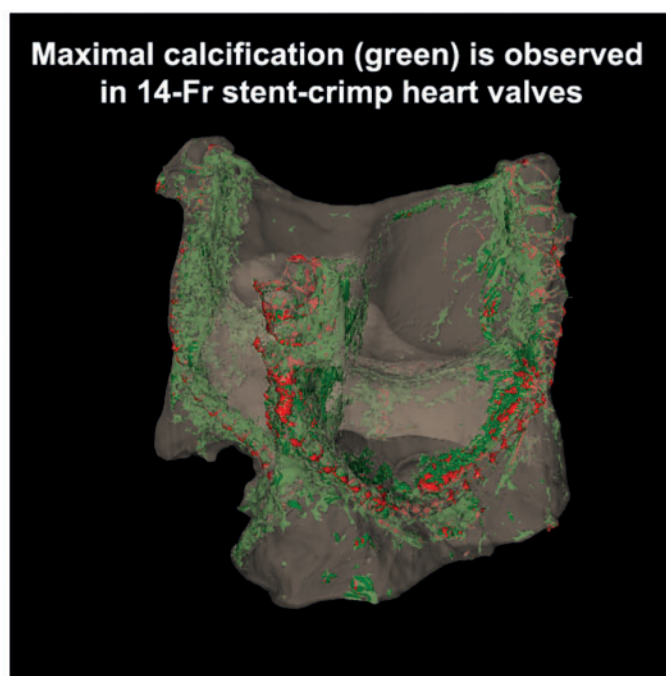
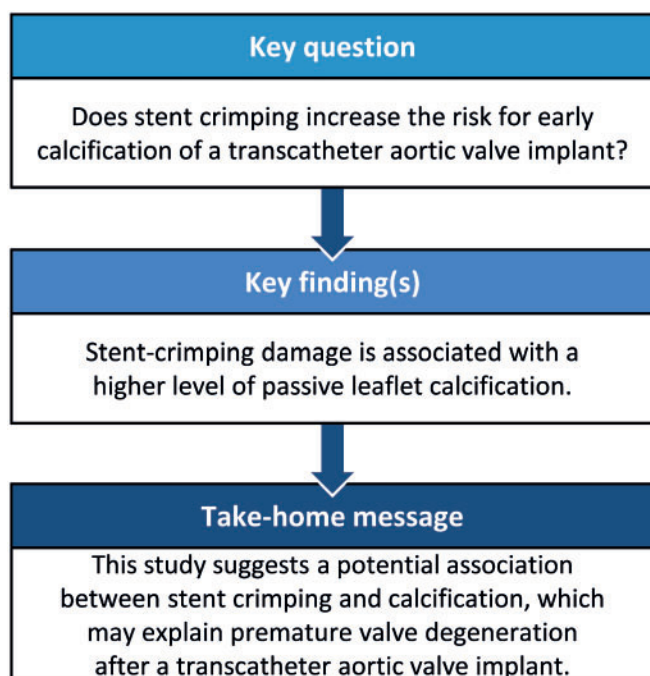
Maximal calcification (green) is observed in 14-Fr stent-crimp heart valves

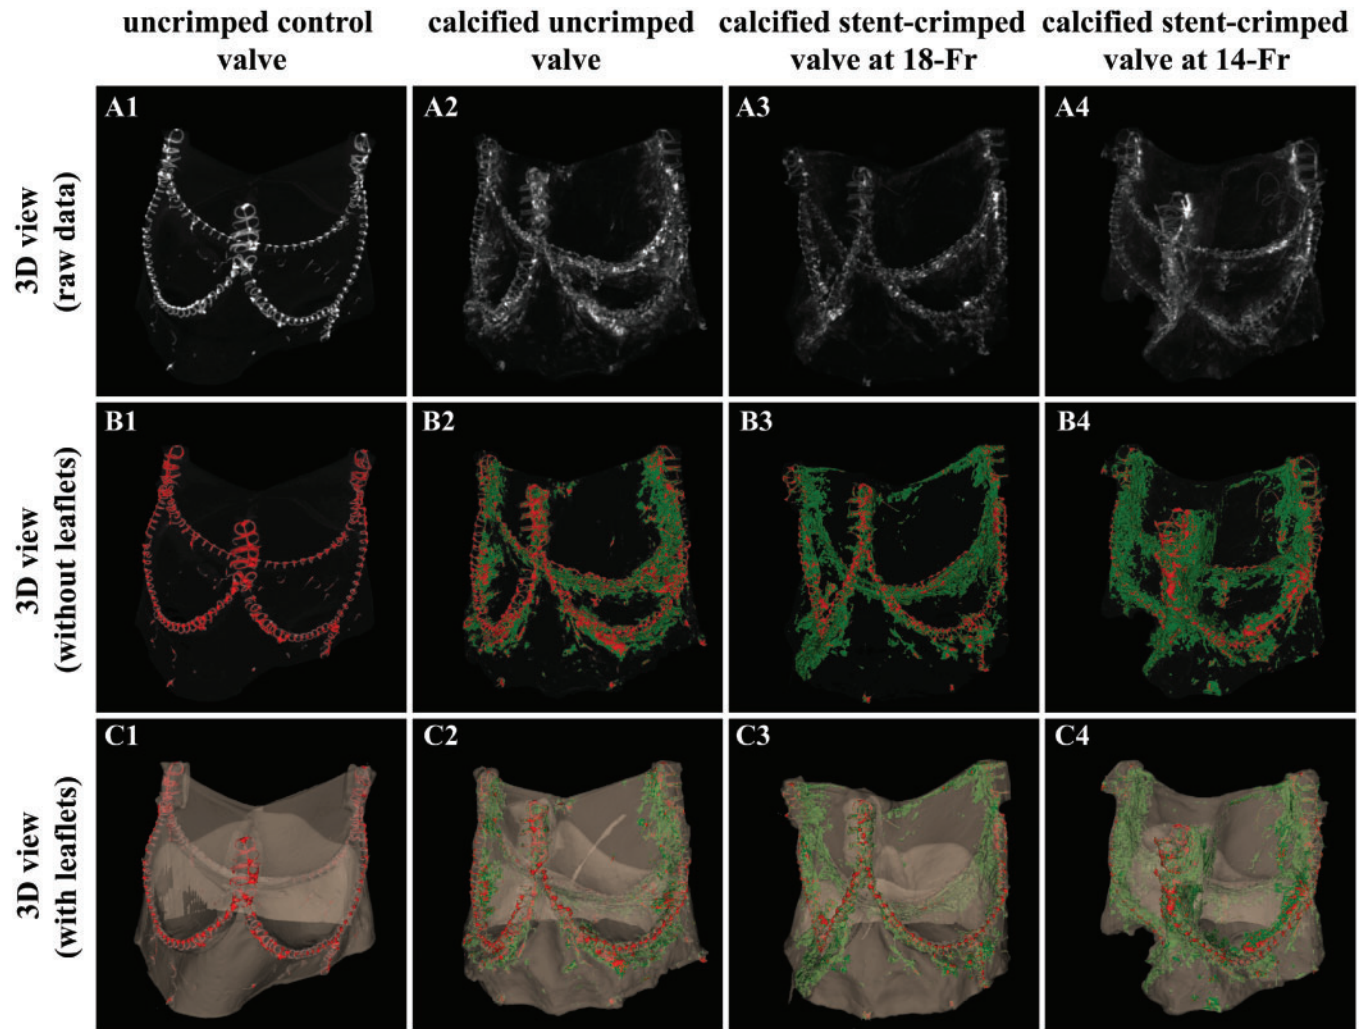
Quantification of valve calcification. The leaflet calcification is compared among the different groups in Fig. 2. The sutures and calcification regions are distinguished by red and green, respectively. Figure 3C and D compare the total measured calcification among the studied groups. The total volume of calcification in the uncrimped valves was 77.31 ± 1.63 mm^3 vs 95.32 ± 5.20 mm^3 for 18-Fr and 110.01 ± 8.33 mm^3 for 14-Fr stent-crimped, respectively. Based on the pairwise non-parametric analyses, the volume of calcification in the uncrimped valves ($N = 2$) was less than that in the crimped valves at 18-Fr ($N = 2$) and at 14-Fr ($N = 2$); as well, this quantity was different between both crimped groups (Mann–Whitney $U_{Minimum} = 0$, $n_2 = n_3 = n_4 = 2$).

Figure 2: Comparison between stent-crimped and uncrimped valves after 50 million cycles of the accelerated wear test. The raw data representing 3D microcomputed tomographic (micro-CT) scans of an uncrimped control valve (**A1**); a calcified uncrimped valve (**A2**); a calcified stent-crimped valve at 18-Fr (**A3**); and a calcified stent-crimped valve at 14-Fr (**A4**). The 3D view of the quantified micro-CT images of an uncrimped control valve (**B1**), a calcified uncrimped valve (**B2**), a calcified stent-crimped valve at 18-Fr (**B3**) and calcified stent-crimped valve at 14-Fr (**B4**) showing the valve's sutures and calcified regions in red and green, respectively. The 3D views of the quantified micro-CT images of an uncrimped control valve (**C1**), a calcified uncrimped valve (**C2**), a calcified stent-crimped valve at 18-Fr (**C3**) and calcified stent-crimped valve at 14-Fr (**C4**) along with the valve's leaflets. 3D: 3-dimensional.

As validated by histological analysis, our micro-CT data show that calcification is more prominent in the regions around the valve sutures and at the valves' posts (Fig. 2), which are under high mechanical stress. Stented valves crimped at 18-Fr and 14-Fr (Fig. 3D) exhibited more calcification than the uncrimped valves; however, the difference between the 2 stent-crimped valve groups was not noticeable, denoting that more aggressive crimping than 18-Fr may not lead to further passive calcification. However, because it was previously shown that more aggressive stent crimping is associated with deeper tissue damage [21], the new results should be considered with caution, and further validation with a large cohort of valves may be needed to confirm them. Furthermore, we found that the crimped leaflets (Fig. 5B) were thicker than the uncrimped leaflets after 50 million

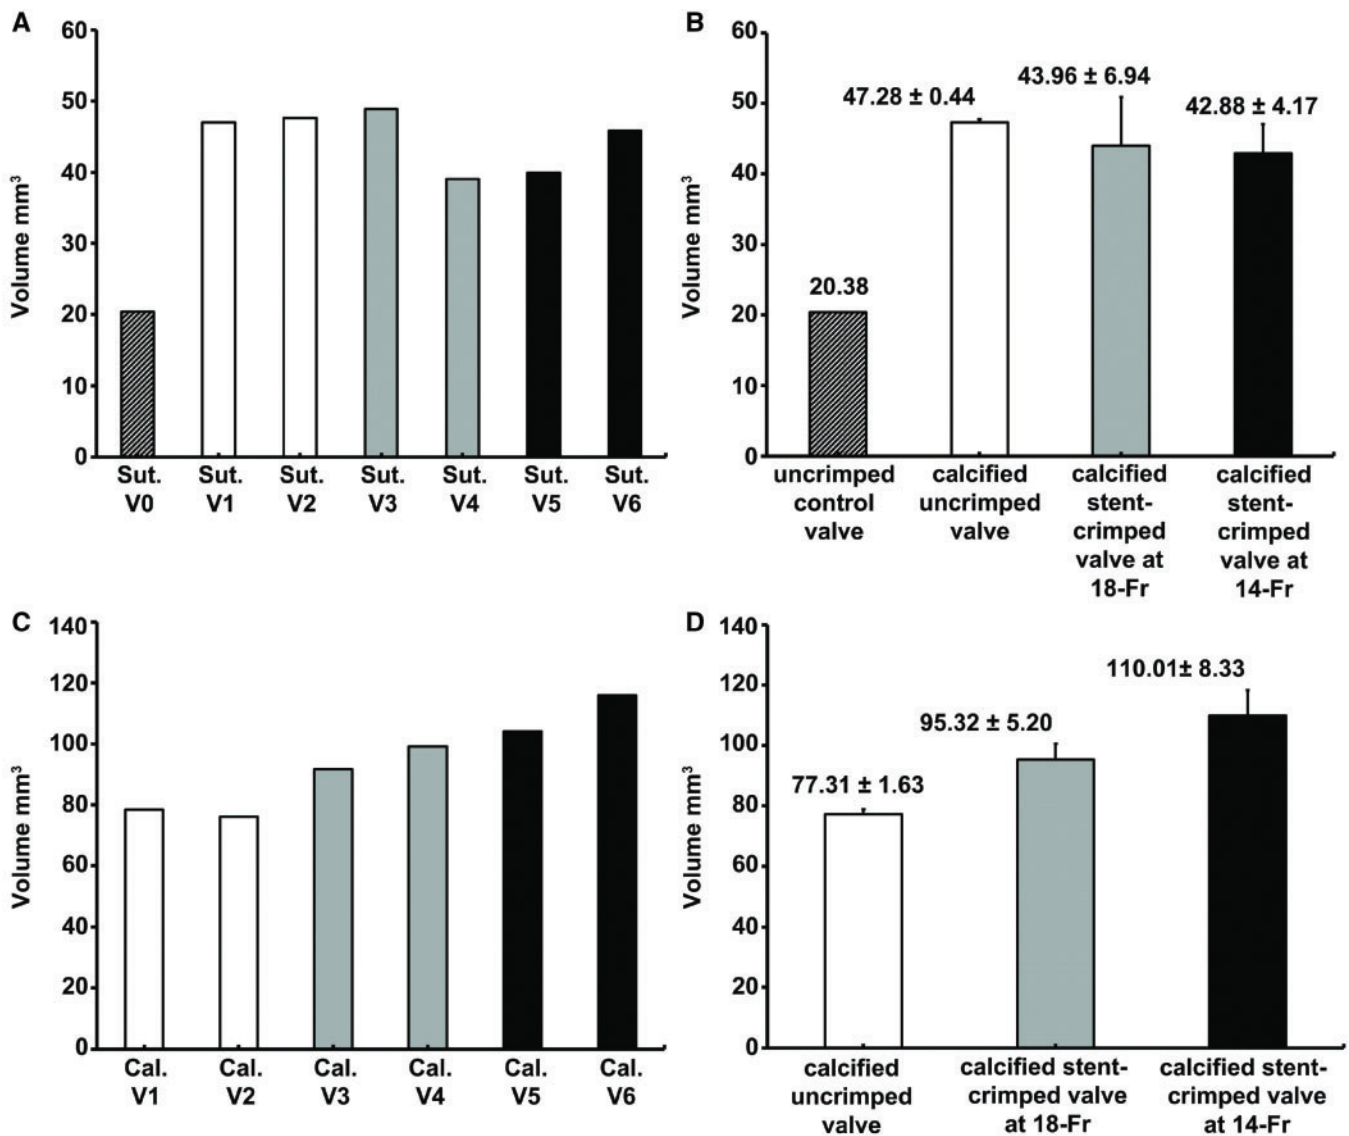
Any increase to the suture volume beyond the baseline value after the 50-million cycle test was attributed to the deposition of calcium over the sutures. However, since calcification around the sutures is not related to our hypothesis considering the effect of

stent crimping, we did not consider that increase in volume as calcium deposition in the leaflet. Nevertheless, these changes in the volume of the sutures are reported in Fig. 3B. The volume of the baseline sutures in the control uncrimped valve was 20.38 mm^3 ($N = 1$), whereas the total volume of the sutures had increased to $47.28 \pm 0.44 \text{ mm}^3$ ($N = 2$), $43.96 \pm 6.94 \text{ mm}^3$ ($N = 2$) and $42.88 \pm 4.17 \text{ mm}^3$ ($N = 2$) for uncrimped, 18-Fr and 14-Fr crimped valves, respectively (Fig. 3B). According to the non-parametric analyses, the total volume of sutures in group 0 was different than that in groups 1–3 (Mann–Whitney $U_{Minimum} = 0$, $n_1 = 1$, $n_{2,3,4} = 6$). This finding suggests that calcium deposition occurs around the sutures in valves exposed to a calcifying solution, regardless of stent crimping.

Figure 3: Quantification of calcified regions using microcomputed tomographic scanning. (**A**) Total suture volume was quantified for each valve. (**B**) The quantified suture volume for each group is shown as the mean ± standard deviation. (**C**) Total calcification volume is quantified for each valve. (**D**) The quantified calcification volume for each group is shown as mean ± standard deviation. Cal: calcification; Sut: suture; V0: (valve 0) uncrimped control; V1: (valve 1) calcified uncrimped; V2: (valve 2) calcified uncrimped; V3: (valve 3) calcified crimped valve at 18-Fr; V4: (valve 4) calcified crimped valve at 18-Fr; V5: (valve 5) calcified crimped valve at 14-Fr; V6: (valve 6) calcified crimped valve at 14-Fr.

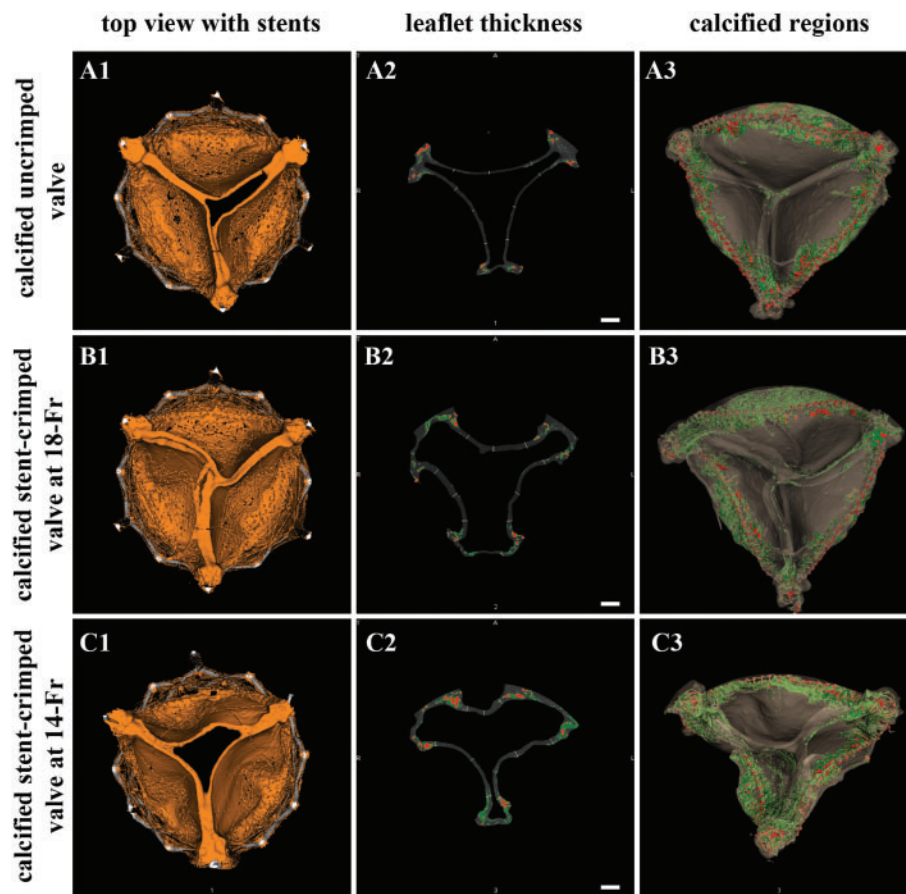
Quantification of leaflet thickness. Following 50 million cycles of AWT, the thickness of the valve leaflets was measured at 9 different locations, as discussed previously (Fig. 4). The average thickness of the uncrimped control leaflets was $0.30 \pm 0.04 \text{ mm}$, whereas the average thickness of the uncrimped/calcified and

Figure 4: Association between the thickness of the leaflets and calcification. Microcomputed tomographic (micro-CT) views of a calcified uncrimped valve (**A1–3**); a calcified stent-crimped valve at 18-Fr (**B1–3**); and a calcified stent-crimped valve at 14-Fr (**C1–3**). **A1**, **B1** and **C1** show the top views of the valves; **A2**, **B2** and **C2** show how valves are quantified at each slice from the z-stack. **A3**, **B3** and **C3** show the fully analysed CT images of the valve, differentiating between sutures (red) and calcification regions (green), respectively. Scale bars are 2.5 mm.

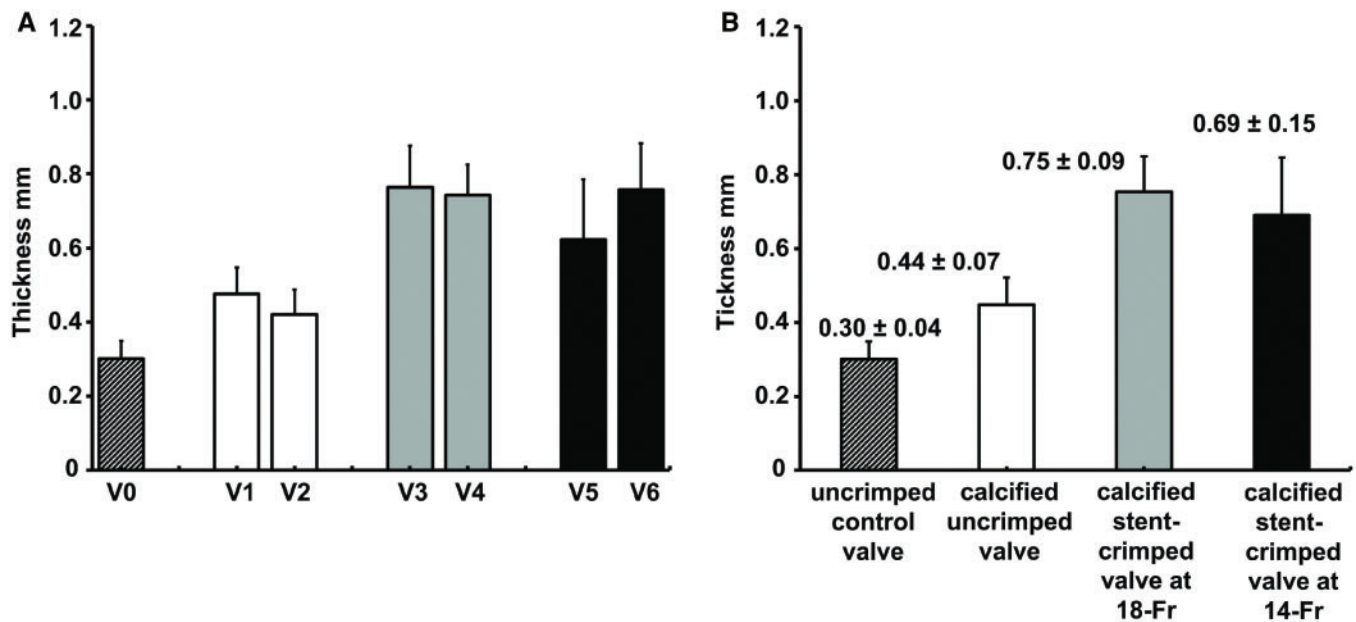
stent-crimped leaflets at 18-Fr and 14-Fr was $0.44 \pm 0.07 \text{ mm}$, $0.75 \pm 0.09 \text{ mm}$ and $0.69 \pm 0.15 \text{ mm}$, respectively. Figure 5B shows a comparison of the leaflet thickness among the studied groups. The average thickness of the uncrimped control leaflets differed from that of uncrimped/calcified leaflets (Mann–Whitney $U_{Minimum} = 5 < U_{Critical} = 42$, $n_1 = 9$, $n_2 = 18$). As well, the average thickness of the uncrimped/calcified leaflets differed from that of the stent-crimped leaflets at 18-Fr (Mann–Whitney $U_{Minimum} = 2 < U_{Critical} = 99$, $n_2 = 18$, $n_3 = 18$) and to stent-crimped leaflets at 14-Fr (Mann–Whitney $U_{Minimum} = 25 < U_{Critical} = 99$, $n_2 = 18$, $n_4 = 18$). Nevertheless, the average thickness of the stent-crimped leaflets at 18-Fr did not differ from that of the 14-Fr (Mann–Whitney $U_{Minimum} = 125 > U_{Critical} = 99$, $n_3 = 18$, $n_4 = 18$).

Figure 5: Valve thickness measurement using microcomputed tomographic scanning. (**A**) The measured thickness of the leaflets for each studied valve. (**B**) The measured thicknesses of the leaflets for each studied group. The measured thicknesses of the leaflets are shown as the mean ± standard deviation. V0: (valve 0) uncrimped control; V1: (valve 1) calcified uncrimped; V2: (valve 2) calcified uncrimped; V3: (valve 3) calcified stent-crimped valve at 18-Fr; V4: (valve 4) calcified stent-crimped valve at 18-Fr; V5: (valve 5) calcified stent-crimped valve at 14-Fr; V6: (valve 6) calcified stent-crimped valve at 14-Fr.

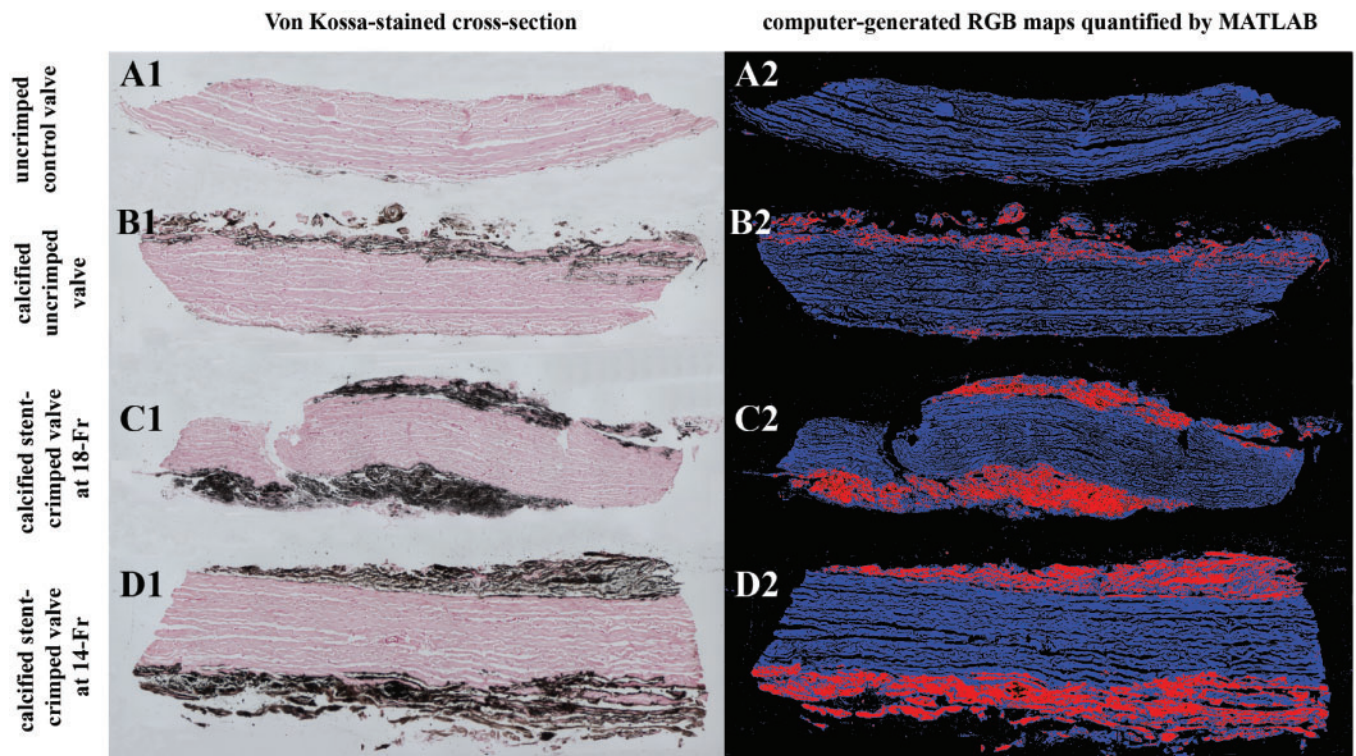
Figure 6A1 shows the Von Kossa staining of a control uncalcified/uncrimped leaflet with cells and cytoplasm in red and pink without any calcified regions. Figure 6B1–D1 represent Von Kossa

staining of the calcified valves. The calcified regions are clearly detectable in the images as black regions (Fig. 6B1–D1), and the top and bottom tissue layers were calcified and degenerated compared to the leaflet tissue core. The uncrimped valves showed calcification in the superficial layers of their leaflets (Fig. 6B1), whereas the stent-crimped valves were deeply calcified at both the ventricular and aortic sides of the leaflets (Fig. 6C1 and D1). Subsequently, the calcified regions were quantified and measured by an in-house MATLAB code that detects and counts the pixels stained by Von Kossa. The ratio of the calcification to the whole tissue cross-section (expressed in terms of percentage) was calculated for each valve's posts and then averaged for each study group (Fig. 7A and B). The data indicate that the uncrimped leaflets showed an average calcification of 5.34 ± 3.97% vs the stent-crimped leaflets, which had an average calcification of 19.97 ± 6.18% and 27.64 ± 13.17% at 18-Fr and 14-Fr stent crimping, respectively. The non-parametric test shows that the average

Figure 6: Von Kossa staining for quantifying calcification. The panels compare Von Kossa staining of representative samples of 4 different studied valve groups along with their computer-generated RGB map: a sample from the uncrimped control valve (**A1–2**); from a calcified uncrimped valve (**B1–2**); from a calcified stent-crimped valve at 18-Fr (**C1–2**); and from a calcified stent-crimped valve at 14-Fr (**D1–2**). A1, B1, C1 and D1 are Von Kossa-stained cross-sections of 4 different valves. Black regions demonstrate the calcification. A2, B2, C2 and D2 are computer-generated RGB maps quantified by an in-house MATLAB routine. Blue and red represent uncalcified and calcified regions, respectively. RGB: red, green and blue.

leaflets [26], which may increase the aggregation and deposition of calcium in the tissue [27–29]. Figures 6 and 8 illustrate the crimp-induced damage to the elastin and collagen fibrils of the leaflets. Other studies have also reported the damaging effects of stent crimping on valve leaflets [4, 6, 30]. Our durability data corroborate those of previous studies, indicating that stent crimping may damage the ECM of the leaflets [4, 6, 25, 30] and show for the first time that stent-crimped valves may be prone to further passive calcium deposits on their leaflets.

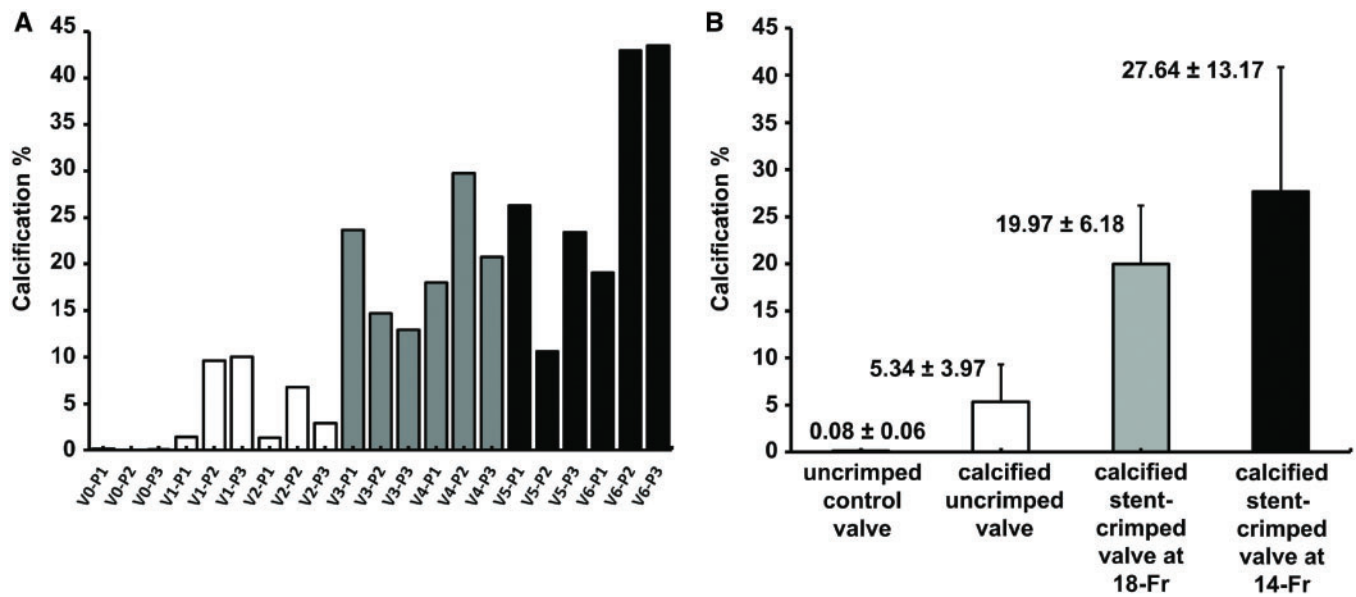
calcification of the uncrimped/calcified valve compared to that of the crimped/calcified valves at 18-Fr (Mann–Whitney $U_{Minimum} = 0 < U_{Critical} = 5$, $n_2 = 6$, $n_3 = 6$) or between the uncrimped/calcified valves and the crimped/calcified valves at 14-Fr differed (Mann–Whitney $U_{Minimum} = 0 < U_{Critical} = 5$, $n_2 = 6$, $n_4 = 6$). No difference was observed between the valves crimped at 18-Fr and 14-Fr (Mann–Whitney $U_{Minimum} = 12 > U_{Critical} = 5$, $n_3 = 6$, $n_4 = 6$).

Figure 7: Quantification of calcified regions using histopathological analysis. (**A**) Total calcification ratio in terms of percentage quantified for each valve's post according to the computer analyses of the Von Kossa staining. (**B**) The average calcification in terms of percentage for all the valves' posts in each studied group is shown as mean ± standard deviation. V0: (valve 0) uncrimped control; V1: (valve 1) calcified uncrimped; V2: (valve 2) calcified uncrimped; V3: (valve 3) calcified stent-crimped valve at 18-Fr; V4: (valve 4) calcified stent-crimped valve at 18-Fr; V5: (valve 5) calcified stent-crimped valve at 14-Fr; V6: (valve 6) calcified stent-crimped valve at 14-Fr; P1, P2 and P3 denote valve posts 1, 2 and 3, respectively. Three punch biopsies were taken from each valve, adjacent to the valve's post.

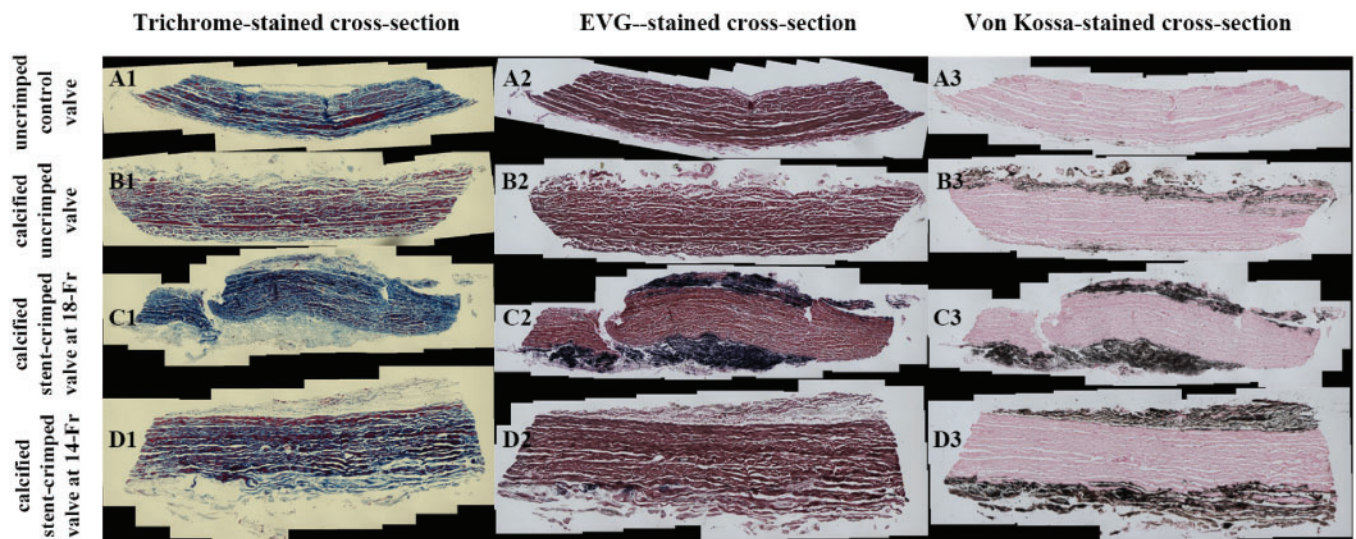
Figure 8 presents the tissue cross-sections from each valve's post, stained with trichrome, Verhoeff-van Gieson and haematoxylin and eosin. Figure 8 shows the staining of control, uncrimped, 18-Fr and 14-Fr stent-crimped valves, respectively. The cross-sections of the uncrimped leaflets show the normal structure of the cells and the extracellular matrix (ECM) (Fig. 8A1–3) with elastin and collagen fibres in pink and blue staining, respectively (Fig. 8A1–3). Figure 8B1–3, C1–3 and D1–3 demonstrate that the ECM of the calcified tissue possesses a

different structure in all the studied valves, which is more pronounced at the calcified regions. The superficial layers of the leaflets show the effect of calcification on the ECM, whereas the core of the leaflets remained intact. Based on trichrome and haematoxylin and eosin staining, the calcification led to degeneration of collagen and elastin fibres at the superficial layers of the calcified heart valves. In uncrimped valves, collagen and elastin fibres were degraded only at the superficial layers of the leaflets (Fig. 8B1–3), whereas in both groups of stent-crimped valves, collagen and elastin fibres were degenerated on both the aortic and ventricular sides of the leaflets (Fig. 8C1–3 and D1–3). In these valves, degradation of the collagen and elastin advanced to the deeper tissue layers of the leaflets. Figures 6C1–D1 show that the calcified regions evolved from the superficial layers towards the tissue core.

Figure 8: Association between the leaflet's extracellular matrix degeneration, elastin degradation and calcification. Trichrome (**A1–D1**), Elastic tissue fibres - Verhoeff-van Gieson (**A2–D2**) and Von Kossa staining (**A3–D3**) of the representative samples from each of the 4 studied groups: an uncrimped control valve (**A1–A3**); a calcified uncrimped valve (**B1–B3**); a calcified stent-crimped valve at 18-Fr; and (**C1–C3**) a calcified stent-crimped valve at 14-Fr (**D1–D3**). EVG: Elastic tissue fibres - Verhoeff's van Gieson.
