Engineering Reconnaissance of the 24 August 2016 Central Italy Earthquake. Version 2

Geotechnical Extreme Events Reconnaissance Association

Report No. GEER-050B

22 November 2016

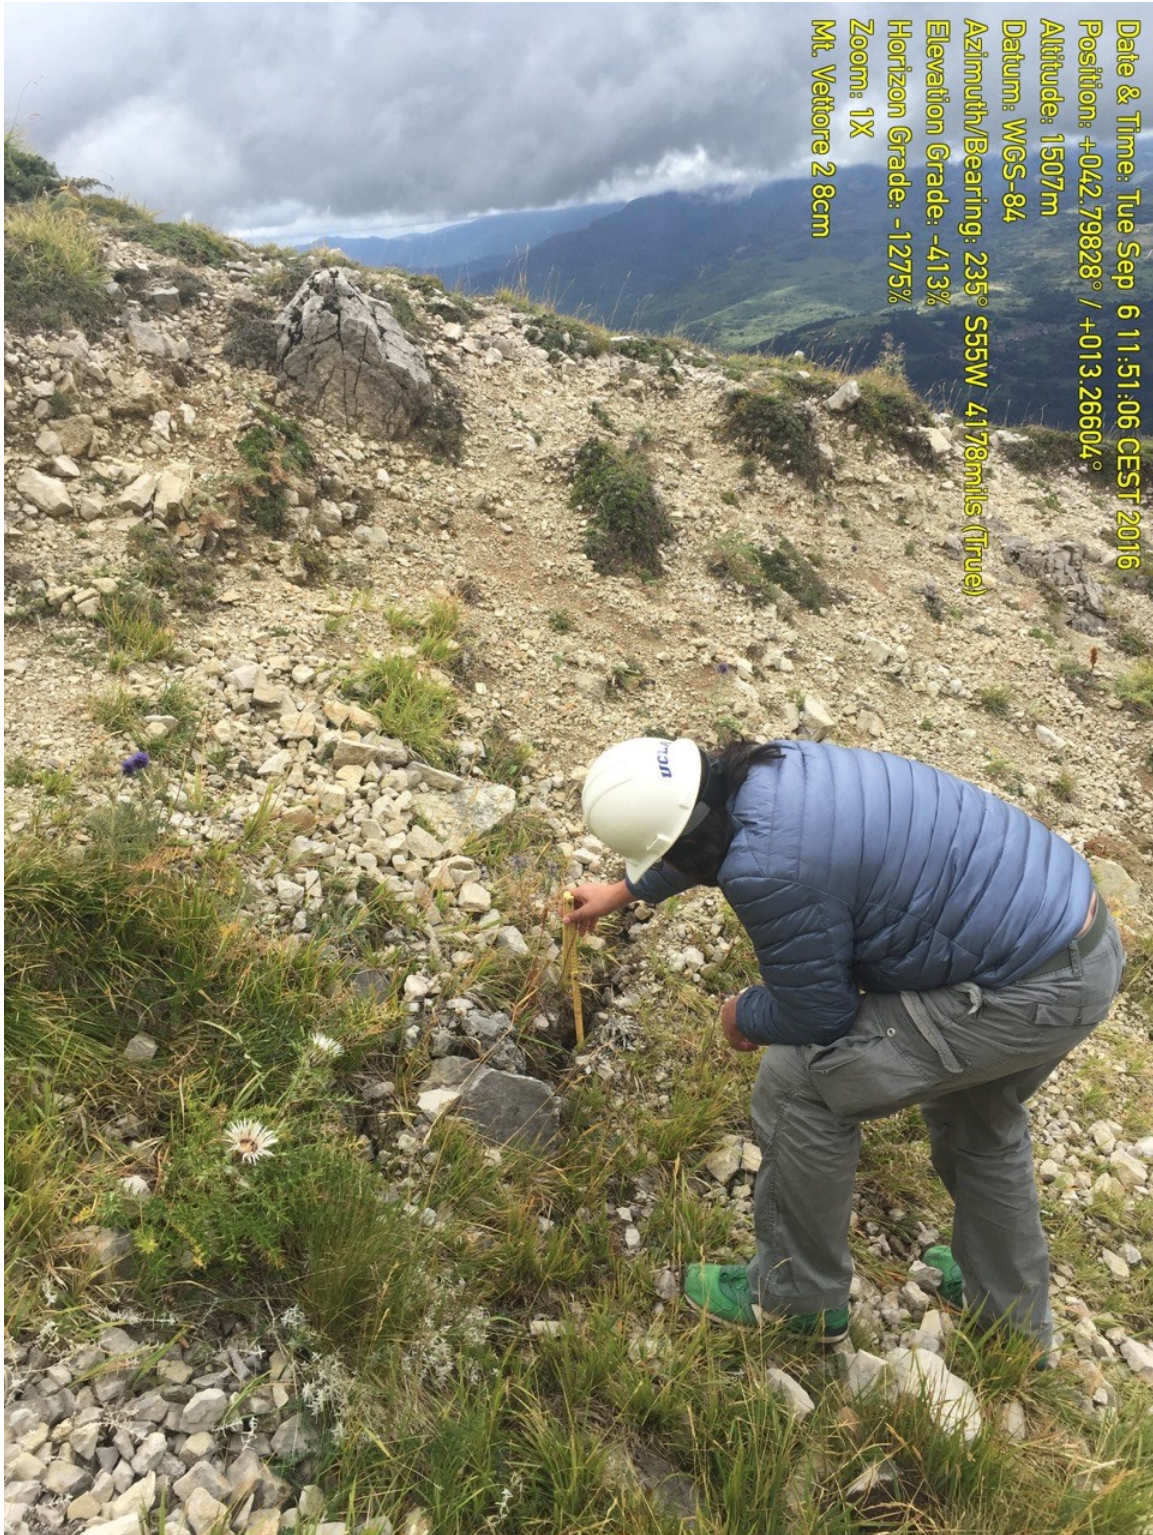
Figure 2.19d. t. Vettore fault Site 2 at a WGS84 ellipsoid elevation of 1507m. The normal fault displacement at this site was 8 cm down toward the west (Latitude and Longitude are annotated on the image).

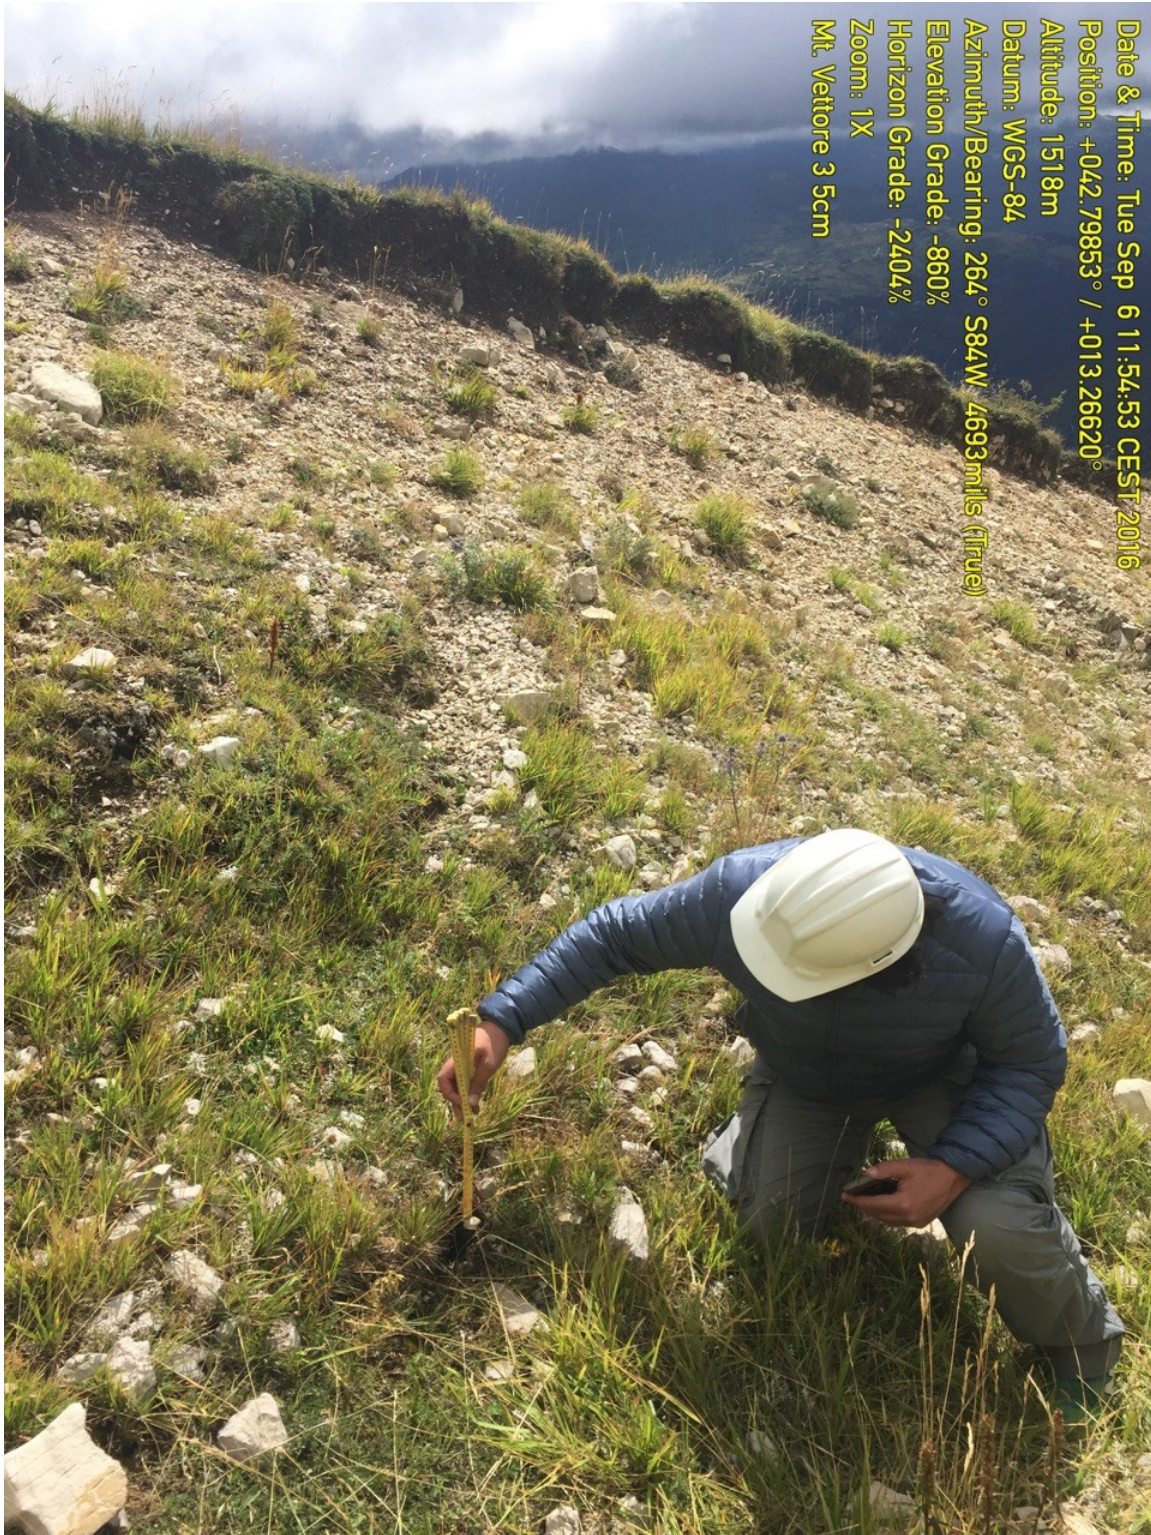
Figure 2.19e. Mt. Vettore fault Site 3 at a WGS84 ellipsoid elevation of 1518 m. The normal fault displacement at this site was 5 cm down toward the west (Latitude and Longitude are annotated on the image).

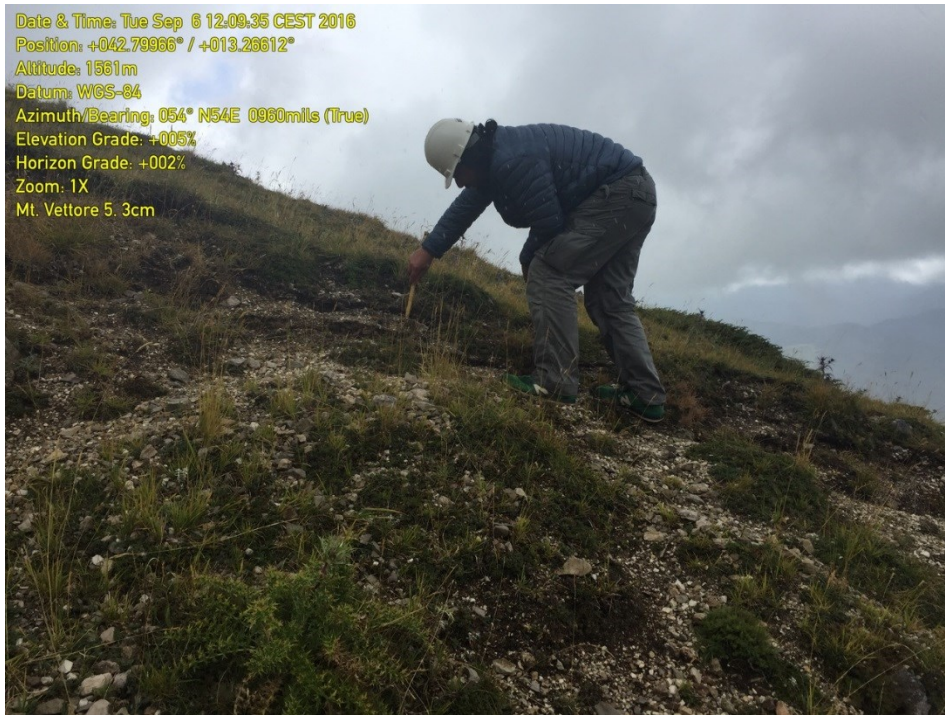
Figure 2.19g. Mt. Vettore fault Site 5 at a WGS84 ellipsoid elevation of 1561 m. The normal fault displacement at this site was 3 cm down toward the west (Latitude and Longitude are annotated on the image).

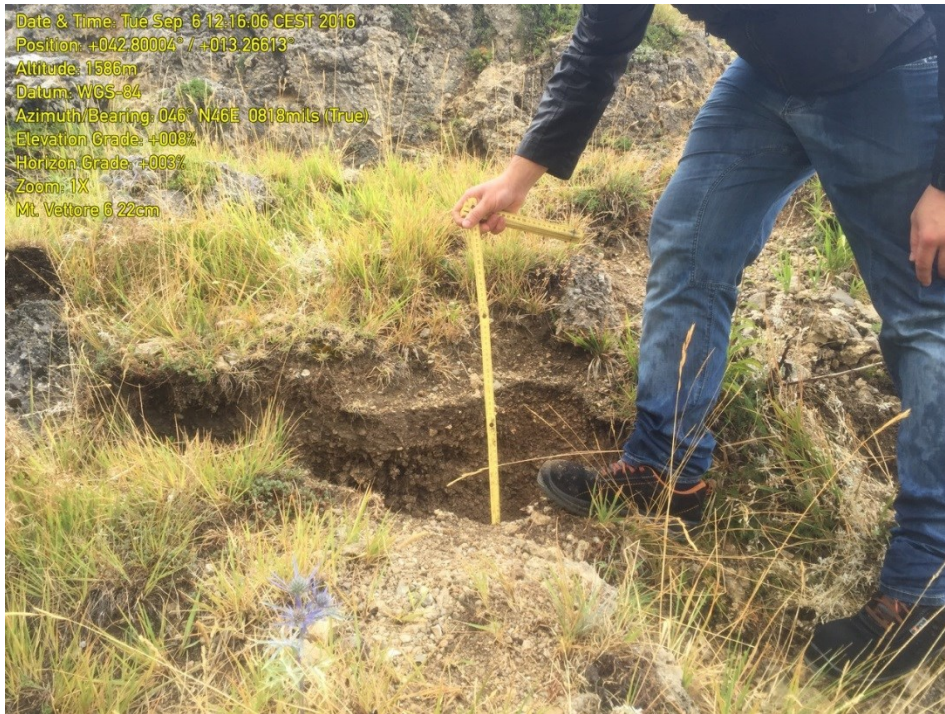
Figure 2.19h. Mt. Vettore fault Site 6 at a WGS84 ellipsoid elevation of 1527 m. The normal fault displacement at this site was 22 cm down toward the west (Latitude and Longitude are annotated on the image).

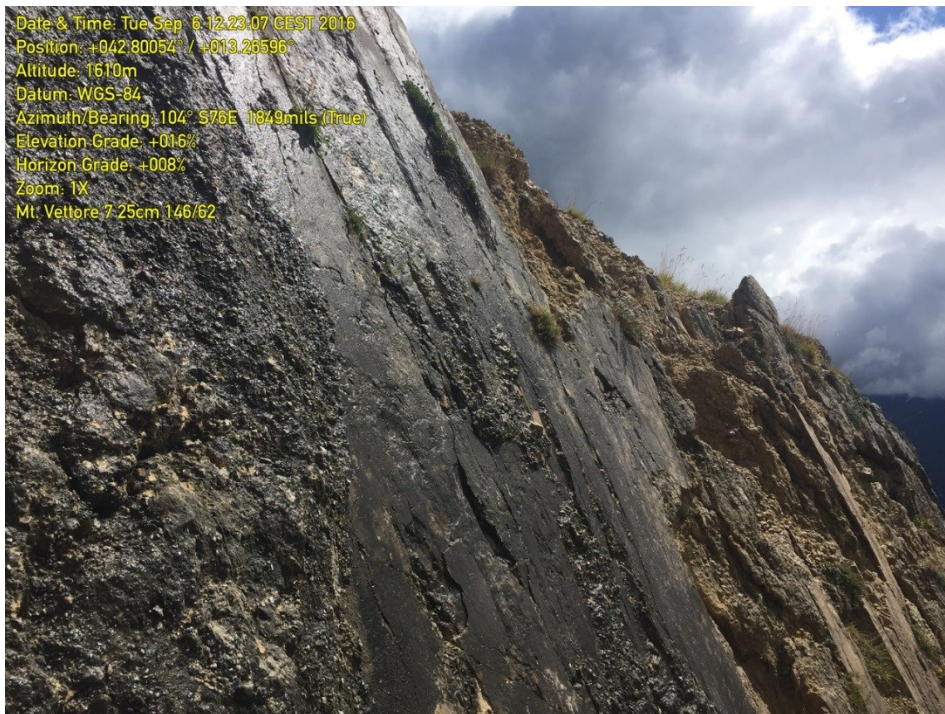
Figure 2.19j. Mt. Vettore fault Site 7 at a WGS84 ellipsoid elevation of 1527 m. The normal fault displacement at this site was 25 cm down toward the west. The strike of the bedrock fault was 146°, dipping 62° (Latitude and Longitude are annotated on the image).

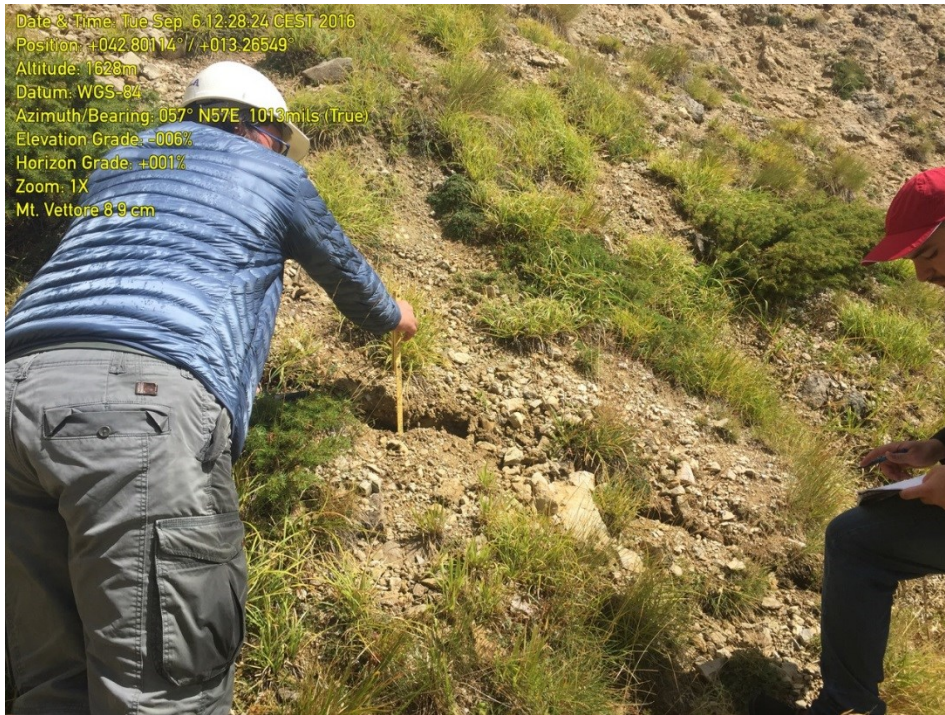
Figure 2.19k. Mt. Vettore fault Site 8 at a WGS84 ellipsoid elevation of 1628 m. The normal fault displacement at this site was 9 cm down toward the west (Latitude and Longitude are annotated on the image).

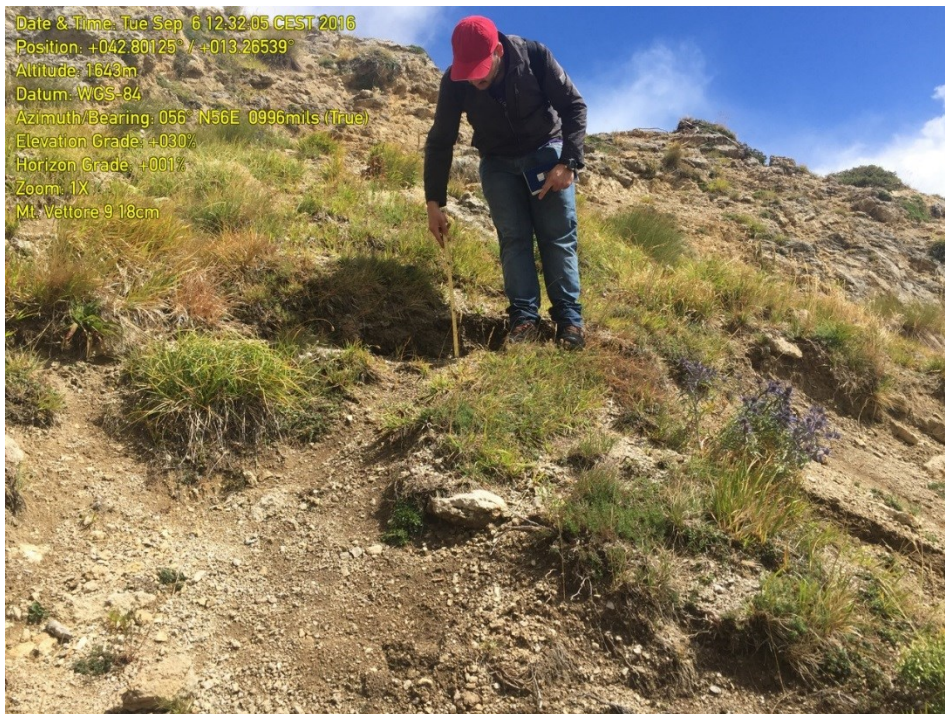
Figure 2.19l. Mt. Vettore fault Site 9 at a WGS84 ellipsoid elevation of 1643 m. The normal fault displacement at this site was 18 cm down toward the west (Latitude and Longitude are annotated on the image).

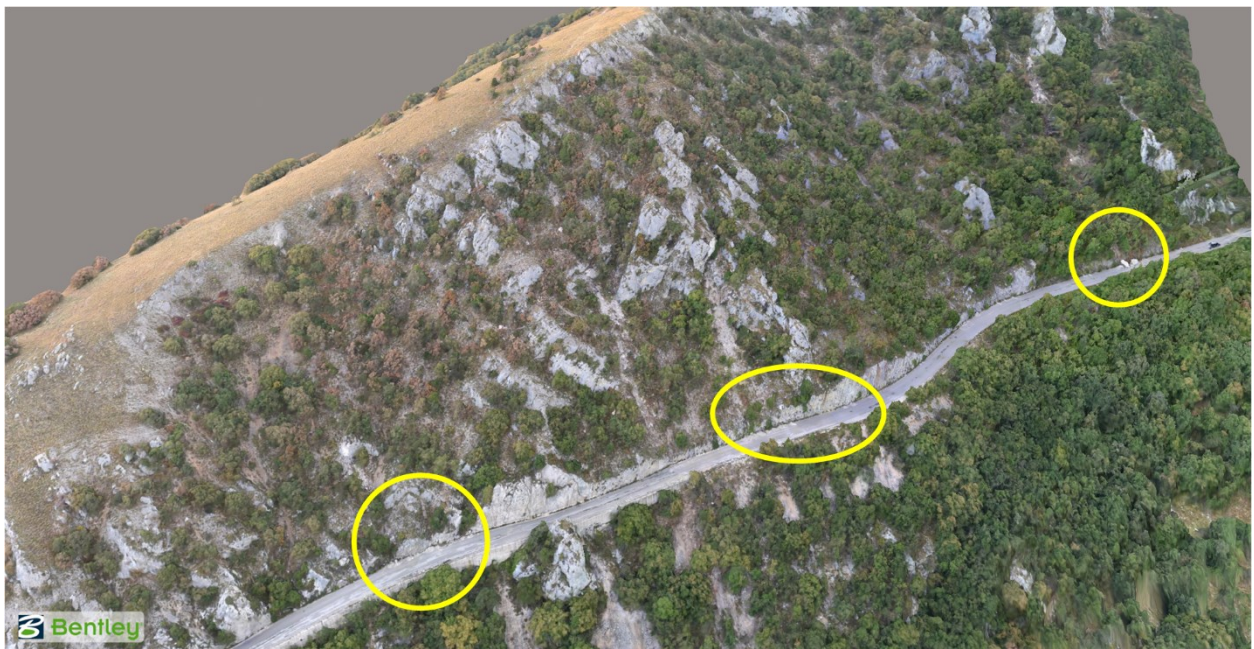
Figure 4.19. 3D model image of the SP 477 rockfall. Visible rocks and debris on the road are circled in yellow (42.7661 N 13.1669 E).

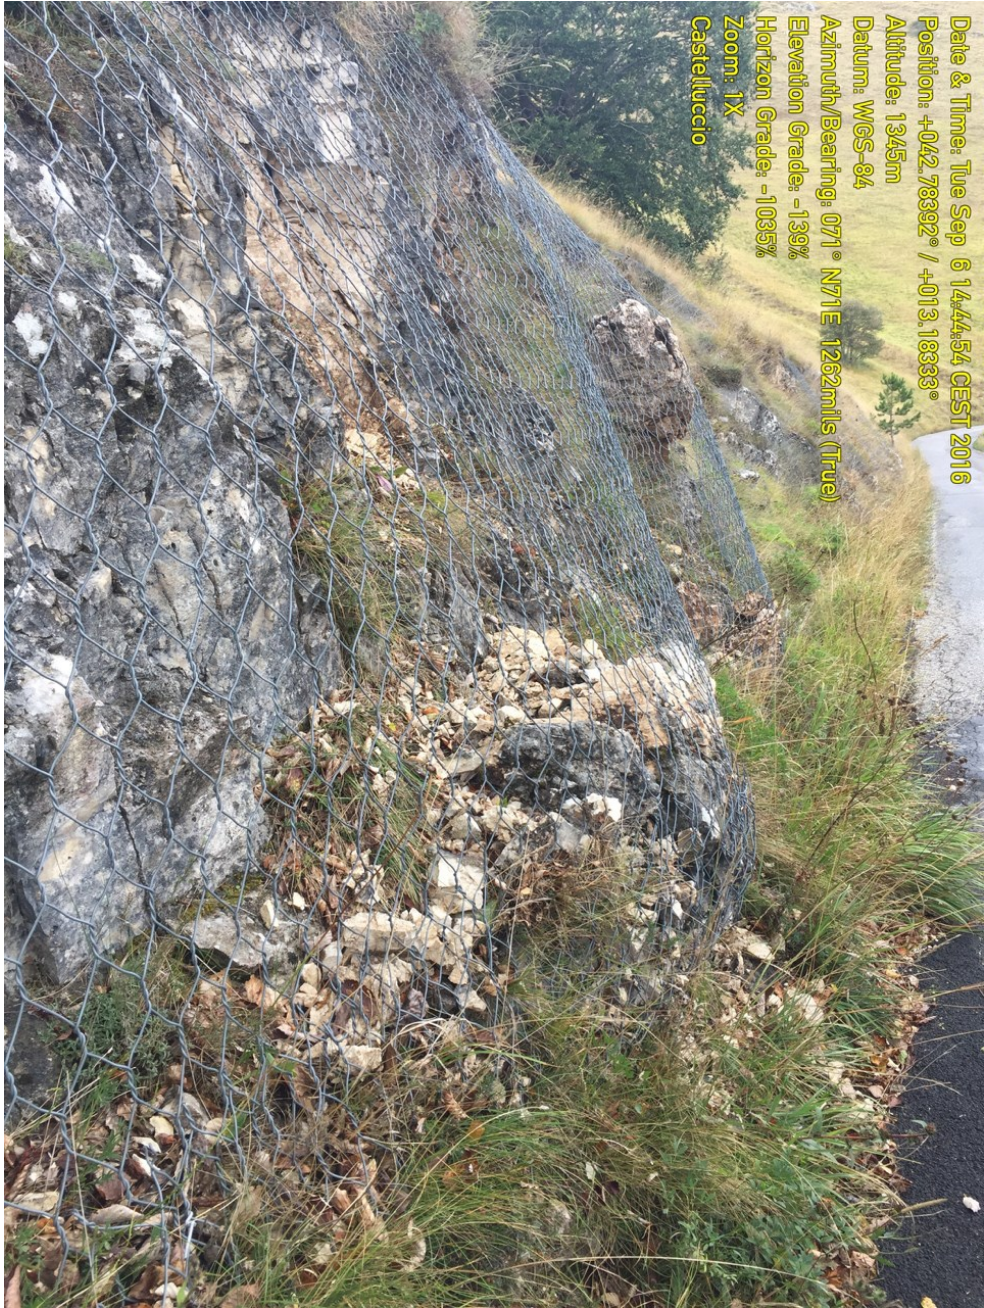
Slope protection in the form of rock bolts, tiebacks, retaining walls, and rockfall nets and fences were deployed in the epicentral region, and seemed to be effective at protecting roads and structures below. Figure 4.20 shows an example of falling debris caught behind rock-nets on the road to Plano Grande and Casteluccio. These successful applications of rock-net protection allowed roads to remain functional after the earthquake and provided critical access to the severely damaged town of Castelluccio immediately after the earthquake.

Figure 4.20. Rock-net protection with captured debris from the earthquake, including minor small debris in the foreground and a large ~0.5-m block in the background (42.78392 N 13.18333 E).

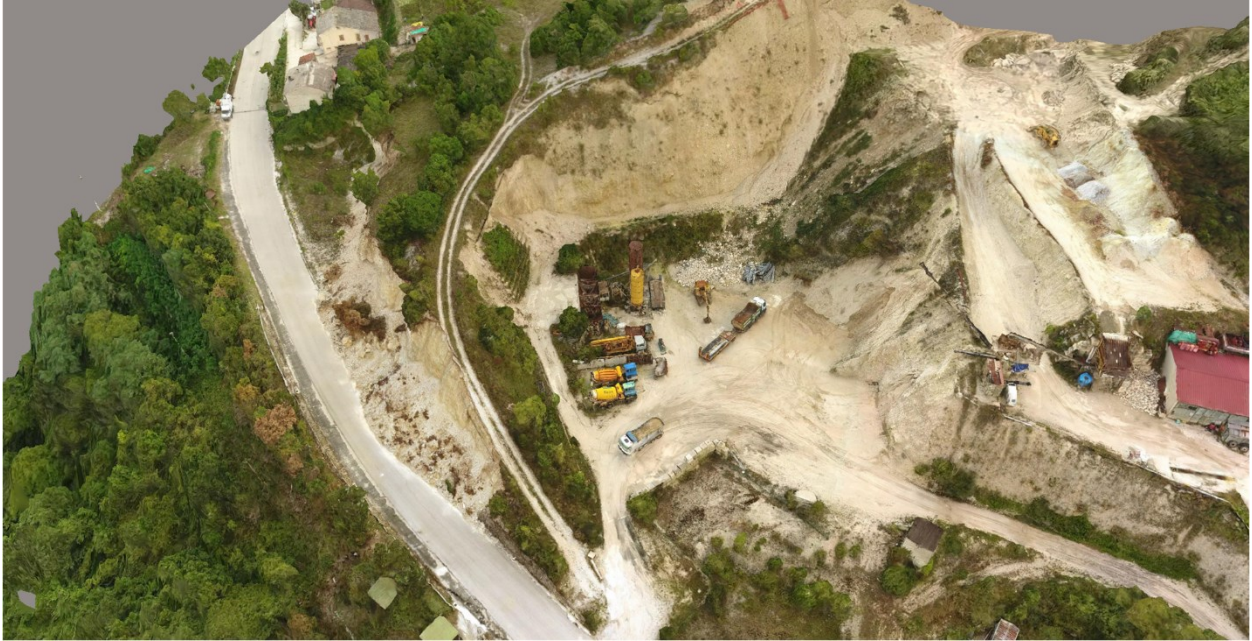
Figure 4.35. Overview model image of the gravel pit in Pescara del Tronto (42.74985 N 13.26893 E).

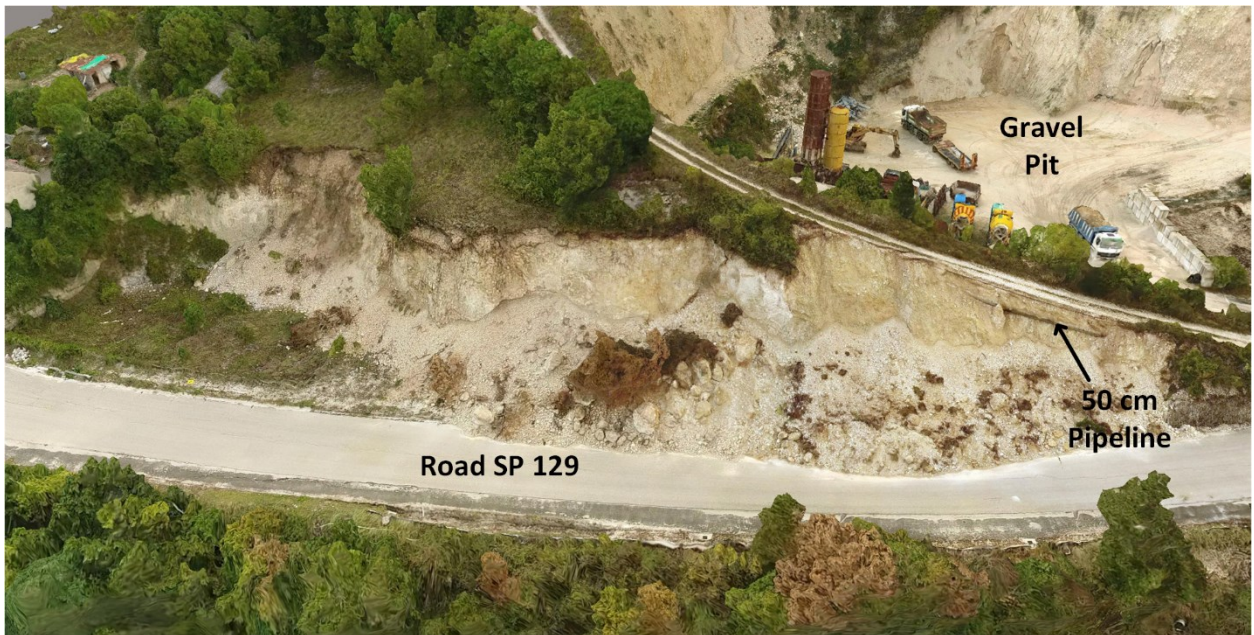
Figure 4.36. Model image of landslide near gravel pit and Road SP 129 that exposed a 50 cm-diameter pipeline (42.74950 N 13.26958 E).

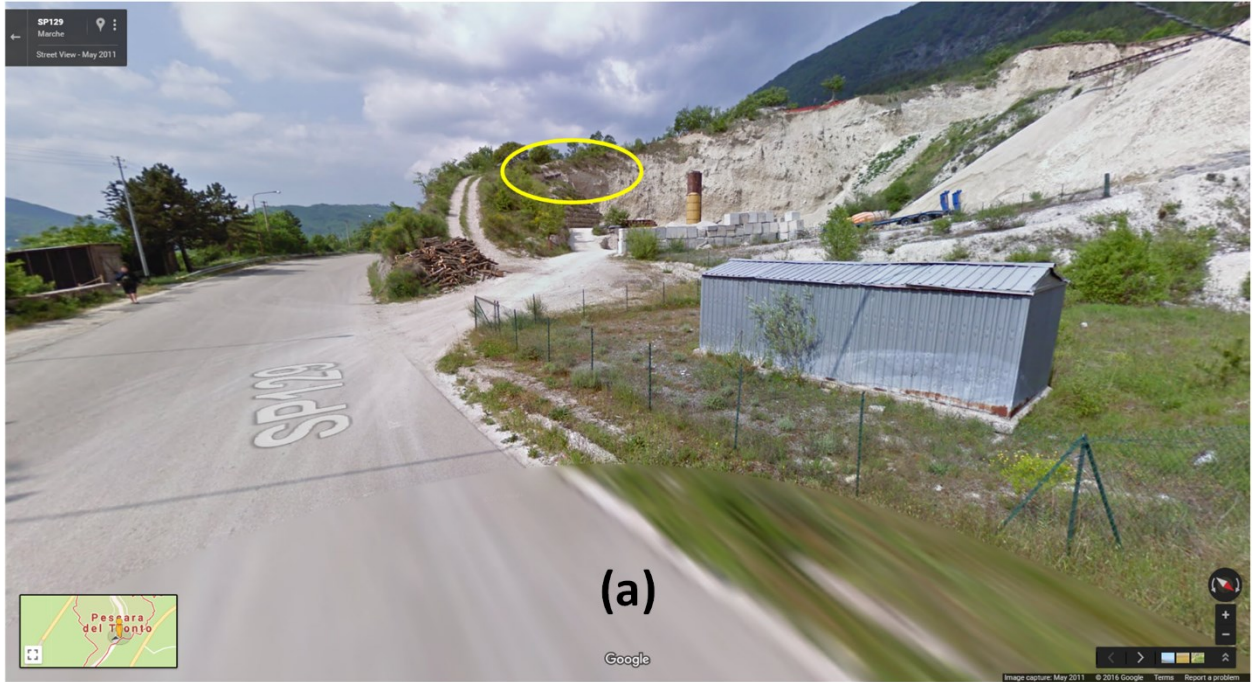
Figure 4.38. Pre-earthquake (a) and post-earthquake (b) images of the haul road slope inside the gravel pit, with exposed pipeline. Pre-earthquake imagery courtesy of Google. From these images, it appears that the earthquake and subsequent landslide into the gravel exposed 10 meters more of the pipeline.

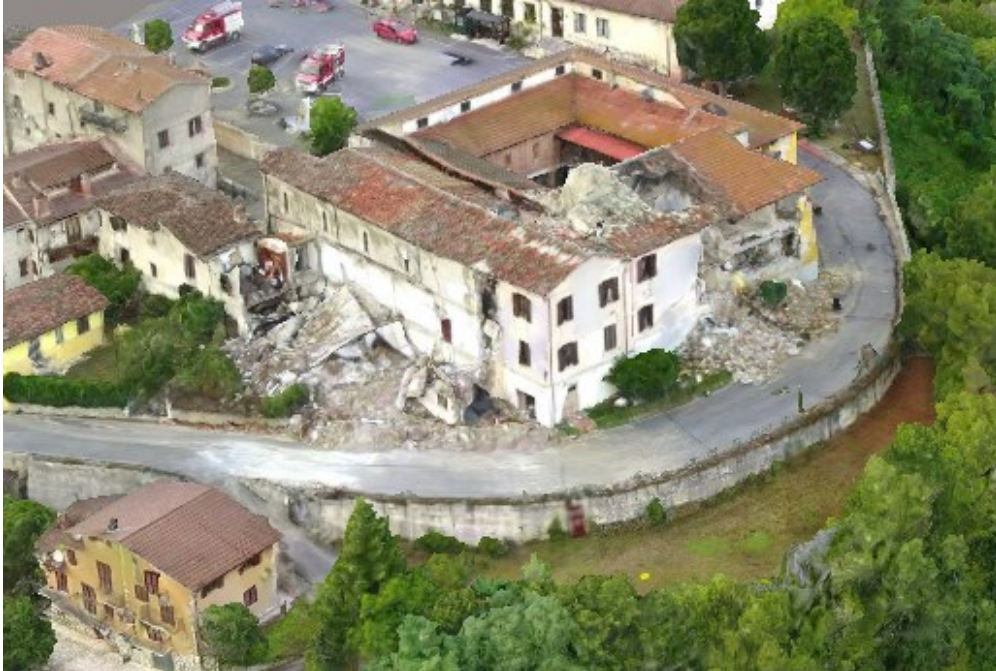
The most severe damage was observed at the easternmost margins of the village, likely associated with the specific ground conditions. The presence of man-made fills is likely in the area, considering the local topography. The damage observed on the earth retaining walls at the eastern edge of the village may indicate possible relative movements associated with instabilities, as discussed further in Section 4.4.6. Damage in other portions of the village is more homogeneous, and local variations are likely associated with different building vulnerabilities.

Figure 5.3. Excerpt of the 3D model with the most damaged portion of Accumoli (easternmost part of the village).

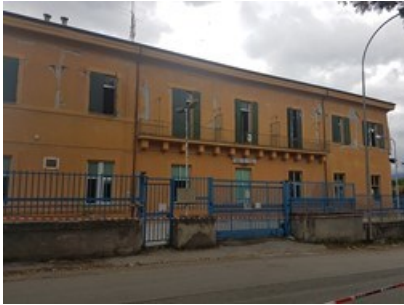
P11

Major damage was observed in critical buildings, such as police stations (the one of the *Carabinieri* corps, which is a three-story masonry structure strengthened with steel ties, P15 and P16 in Figure 5.9, and the one of the Highway Patrols, P11) and a school that, despite previous interventions, collapsed partially (P17). Also evident are structural members that were individually strengthened (P18). Multi-story reinforced concrete buildings behaved relatively well, mainly exhibiting in-plane shear failure of infill panels (P19) and minor to moderate damage at their beam-column joints (P20).

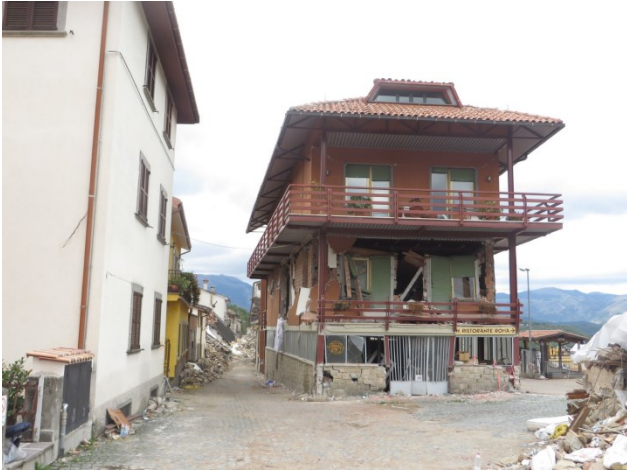
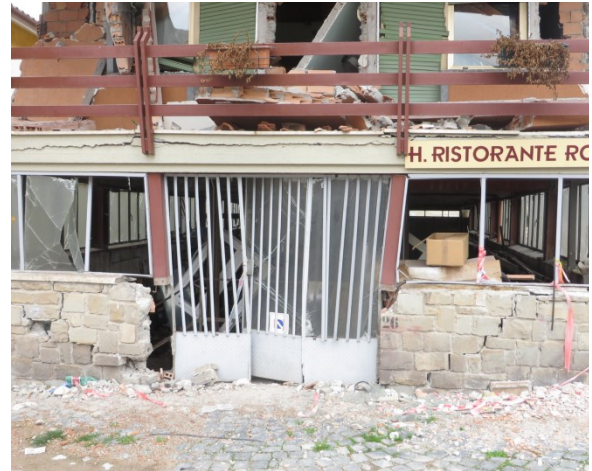
Figure 5.15. Photos of a characteristic steel building with minor-to-moderate damage (DS2, P33-P34) next to Hotel Roma, a collapsed R/C building (P35, P36).

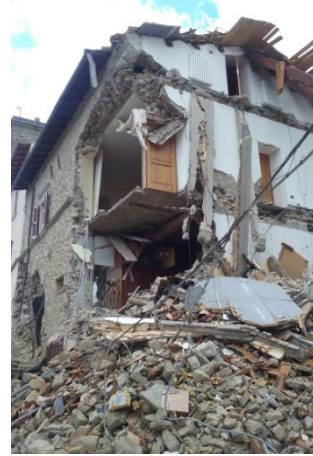
P11

Damage patterns evaluated from aerial image analysis of Arquata are presented in Figure 5.20. No information is provided for Borgo. The higher degree of damage in Arquata, located near the top of the ridge, relative to Borgo was captured on average. Again, a decreasing degree of damage was observed away from the edge. The cases of full collapse were generally captured by the aerial image analysis (P13 and P14 were reproduced, while P12 was reported as highly damaged). The degree of damage to highly damaged and partially collapsed buildings was sometimes underestimated and identified as “negligible to slight damage” (e.g., P11).

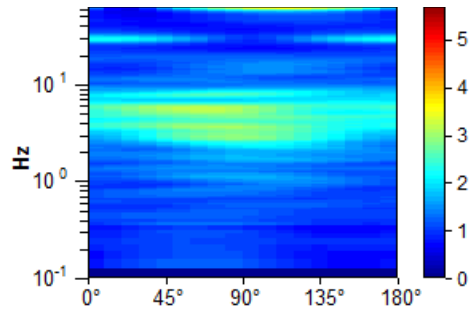
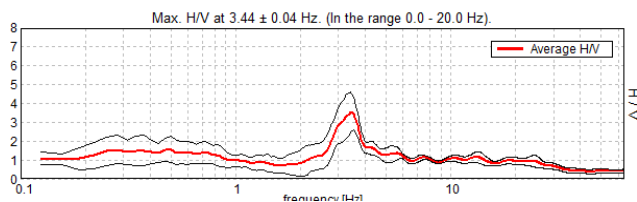
No significant H/V peaks can be observed in T1 measurements. A pronounced H/V peak was identified at about 3-4 Hz in T2, indicating possible site effects that may have contributed towards the damage observed in the NW portion of the Borgo hamlet. In this area, an MASW test was carried out in the level 1 seismic microzonation study, which highlighted an impedance contrast between gravelly covers (thickness in the range 12-18 m and $V_s=200-300$ m/s) and the underlying Flysch bedrock ($V_s\approx 800$ m/s). The fundamental frequency of the gravel cover reasonably matches that measured from H/V.

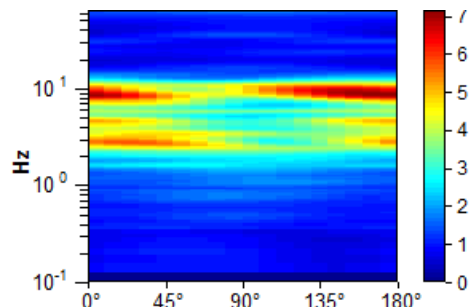
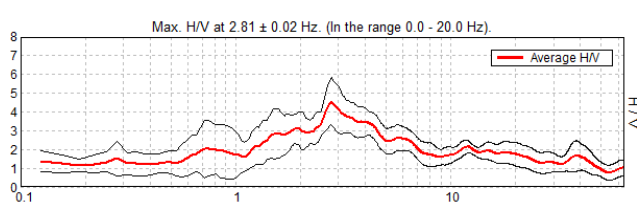
T3

In Arquata, two noise measurements were carried out (T3 and T4) both of which indicate H/V peaks around 3 Hz, with horizontal motion polarized in the NS direction, i.e., roughly perpendicular to the axis of the major ridge. Close to the edge, a second peak at about 10 Hz was observed, again with NS polarization. These results are preliminary and the HVSR technique for complex topographies is far from ideal for the applicability of the method. Similar results for other regions have been obtained previously (Pagliaroli et al. 2015).

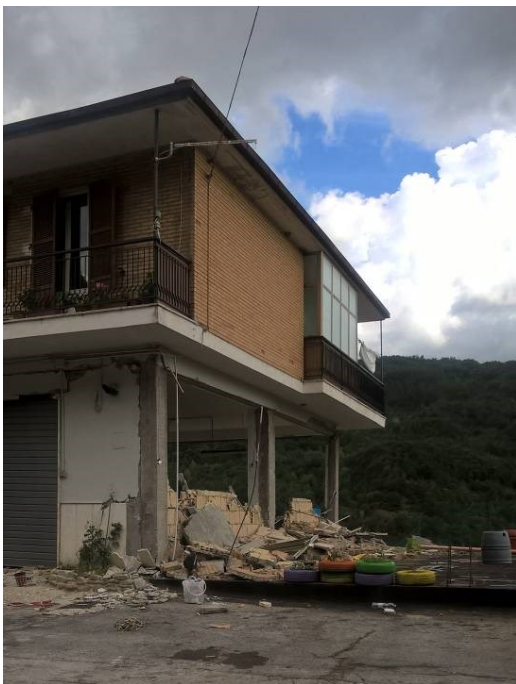
P01

Buildings in the village mainly consisted of un-reinforced masonry structures 2-3 stories in height. Very few of the structures were retrofitted (see for instance P11). Isolated, relatively modern reinforced concrete structures can be found along the road to access to the village and were subjected to relevant damage (P01).

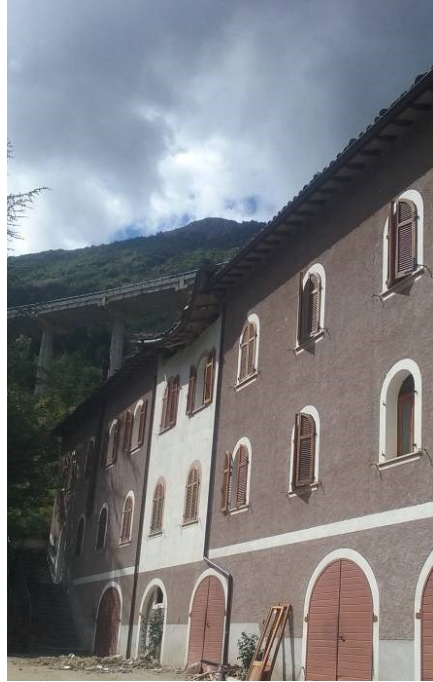
Picture	DATUM	Location		Damage Level	Notes
		Lat.	Long.		
P01	WGS-84	42.753147°	13.273536°	D3	
P02	WGS-84	42.752496°	13.271350°	D3	
P03	WGS-84	42.752434°	13.270156°	D2	
P04	WGS-84	42.752046°	13.270447°	D2-D3	<i>Partial collapse of the roof</i>
P05	WGS-84	42.752469°	13.272192°	D4	
P06	WGS-84	42.752295°	13.272490°	D5	
P07	WGS-84	42.751717°	13.270616°	-	<i>collapse of retaining wall (size: 0.25x1x5 m)</i>
P08	WGS-84	42.751558°	13.271005°	D5	
P09	WGS-84	42.750950°	13.270979°	D4-D5	
P10	WGS-84	42.751137°	13.270225°	D4-D5	
P11	WGS-84	42.751332°	13.271040°	D3	
P12	WGS-84	42.751986°	13.271575°	D4-D5	
P13	WGS-84	42.750423°	13.271891°	D4-D5

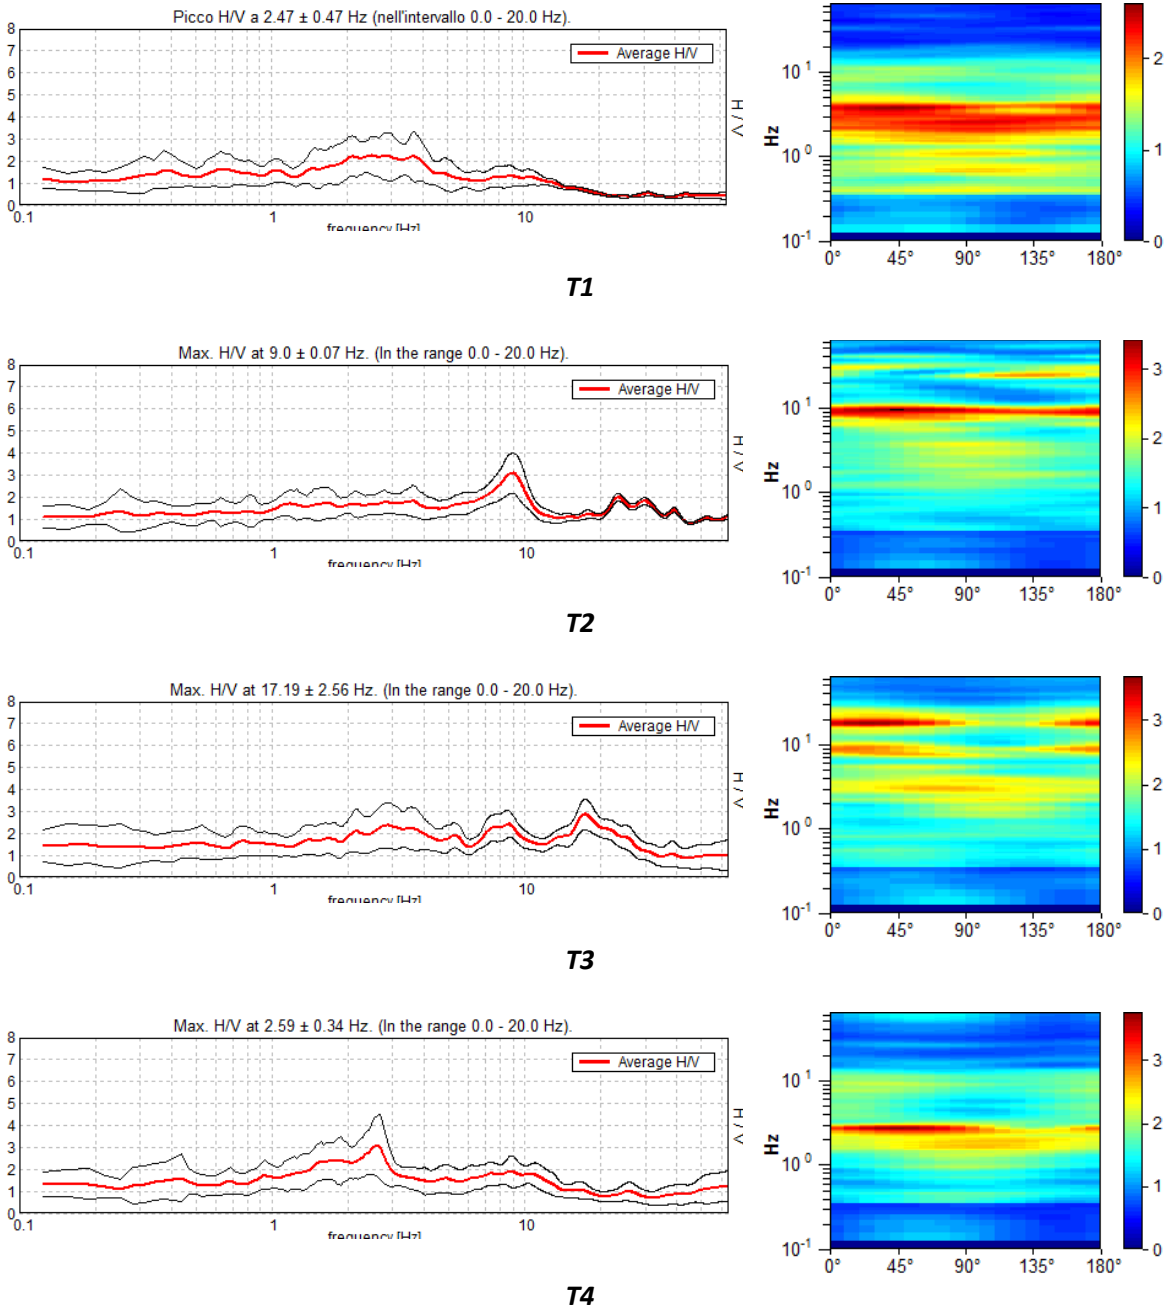
Figure 5.32. Noise measurements results in terms of H/V spectral ratio (on the left column) and H/V polar plots (on the right).

In Pescara del Tronto, the GEER team collected 4 noise measurements (Figure 5.31) using a three-component Tromino® tromograph. The methodology used for these measurements is the same as that described for Arquata del Tronto. Both H/V and polar H/V are reported in Figure 5.32. No significant H/V peaks can be observed in the measurements, which suggests a lack of stiffness contrast between slope debris-detrital covers and the underlying Flysch bedrock, at least in the investigated area. However, the complex subsoil in the most damaged southern portion of the village (in which measurements could not be carried out) may differ and be capable of producing stratigraphic and topographic site effects. As noted previously, the major damage in this area was accompanied by significant mass movements and permanent ground deformations to rock and soil deposits.

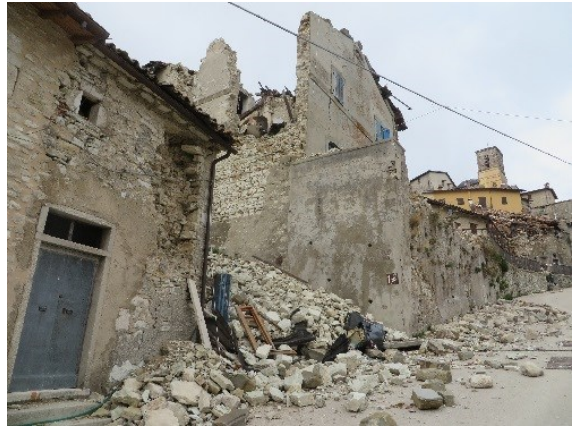
Picture	DATUM	Location		Damage Level	Notes
		Lat.	Log.		
P01	WGS-84	42.829358	13.205331	D4	
P02	WGS-84	42.82886	13.206422	D4	
P03	WGS-84	42.828836	13.206584	D5	
P04	WGS-84	42.82846	13.207108	D4	
P05	WGS-84	42.828289	13.207392	D1

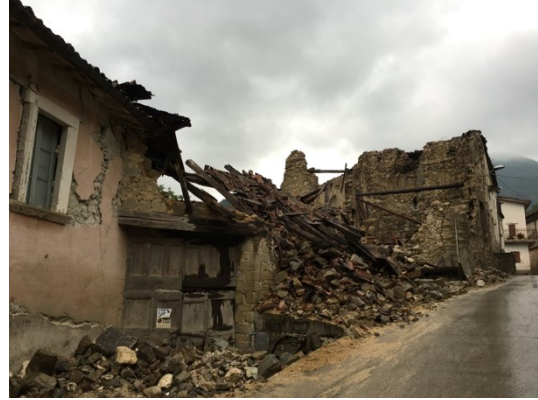
TAG	DATUM	Location		Damage level	Notes
		Lat.	Long.		
P1	WGS-84	42.7353°	13.2532°	D3	Diffused cracks
P2	WGS-84	42.7353°	13.2530°	D5	Collapse of the entire structure
P3	WGS-84	42.7354°	13.2528°	D2	Crack starting from the window corner
P4	WGS-84	42.7351°	13.2519°	D0	No damage
P5	WGS-84	42.7351°	13.2522°	D0	No damage
P6	WGS-84	42.735°	13.2522°	D4	Partial collapse of the structure

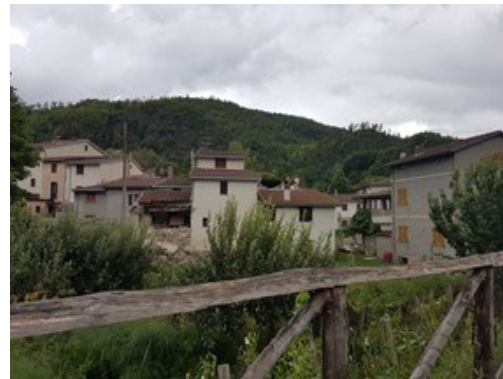
P02

Picture	DATUM	longitude	latitude	Damage level	Note
P01.jpg	WGS- 84	13.255	42.69528	D3	
P02.jpg	WGS- 84	13.255	42.69417	D4	View of several buildings
P03.jpg	WGS- 84	13.255	42.69528	D3	View of several buildings
P04.jpg	WGS- 84	13.255	42.69528	D3	
P05.jpg				D3	Downloaded from http://www.fontedelcampo.it/foto/foto-terremoto/
P06.jpg				D5	Downloaded from http://www.fontedelcampo.it/foto/foto-terremoto/
P07.jpg				D3	Downloaded from http://www.fontedelcampo.it/foto/foto-terremoto/

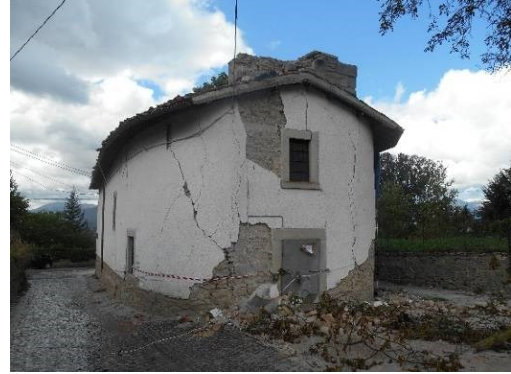
Picture	DATUM	longitude	latitude	Damage level	Note
P01	WGS- 84	13.324171	42.634639	D3	Old chapel, façade and absidal walls very deformed and x-cracked
P02	WGS- 84	13.324385	42.634543	D0	Almost undamaged new building in front of the chapel
P03	WGS- 84	13.324870	42.634559	D3	Intensely cracked building with a singular breach at the toe
P04	WGS- 84	13.325142	42.634781	D2 - D3	Small houses unevenly damaged
P05	WGS- 84	13.325969	42.634808	D3	Court house with dominating inter-openings cracks
P06	WGS- 84	13.325967	42.634803	D3-D4	Poor brickwork cracked (left) and breached (right)
P07	WGS- 84	13.325984	42.634731	D0	Undamaged restored building nearby
P08	WGS- 84	13.326309	42.634897	D0 – D1	Undamaged houses, one recently reinforced (see bottom picture, dated 2011) with tie rods with elliptical plates
P09	WGS- 84	13.326246	42.634884	D0	Recent low constructions uphill, almost undamaged
P10	WGS- 84	13.324369	42.634103	D3 - D4	Upper walls often breached

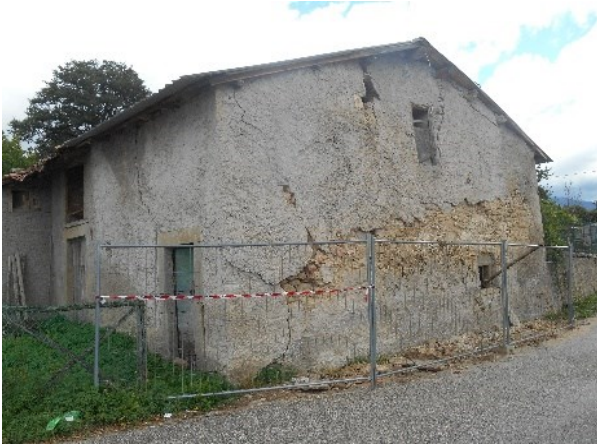
P11	WGS- 84	13.324422	42.633758	D3	Recent brickwork cracked and displaced
P12	WGS- 84	13.324433	42.633853	D3	Bulged and cracked poor masonry wall
P13	WGS- 84	13.324433	42.634000	D2	Partial damage even with tie rods

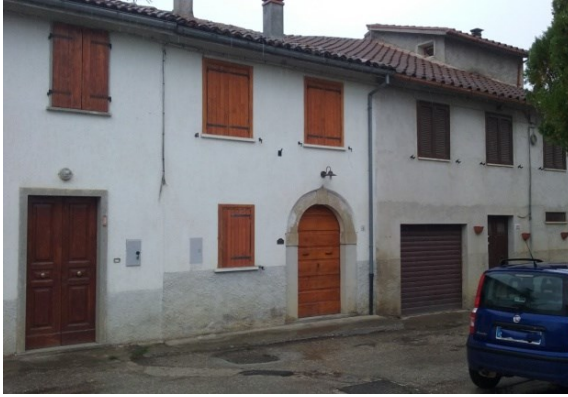
Picture	DATUM	Location		Damage Level	Notes
		Lat.	Long.		
P01	WGS-84	42.622807°	13.279402°	D0-D1	
P02	WGS-84	42.623130°	13.279552°	D1-D2	
P03	WGS-84	42.623654°	13.279299°	D2-D3	
P04	WGS-84	42.623777°	13.279313°	D4	<i>Partial collapse of the roof</i>

Noise measurements were obtained during the survey close to buildings shown in picture P01 (Figure 5.60). A portable Tromino tomograph was employed. The methodology used for these measurements is the same as that described in Section 5.3.3. Both H/V and polar H/V are reported in Figure 5.61. No significant H/V peaks can be observed in the measurements, roughly supporting that the village is located on seismic bedrock (Flysch) and often no significant amplification effects are expected. This apparent lack of site effect may have contributed to the low to moderate levels of damage.

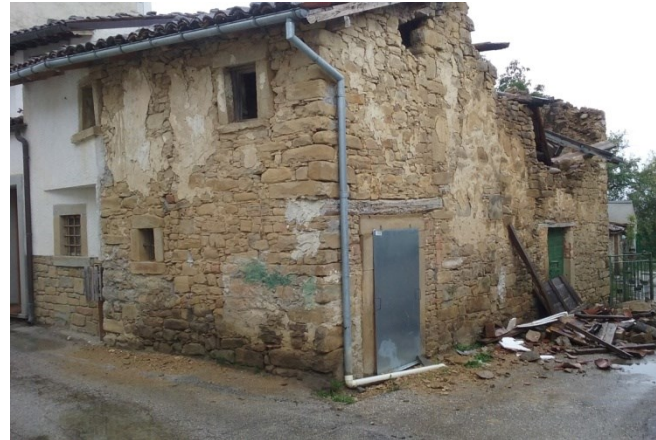
P04

Photos of representative structures inspected in Mosicchio are shown in Figure 5.60, with further details provided in Table 5.15 (WGS-84 coordinates, damage level of buildings, other notes). The hamlet consists mainly of unreinforced masonry structures, 2-3 stories in height. The damage was quite low, on average classified as D2. Only one case of partial collapse (D4) was observed in a poorly constructed, unreinforced masonry building (see P4).

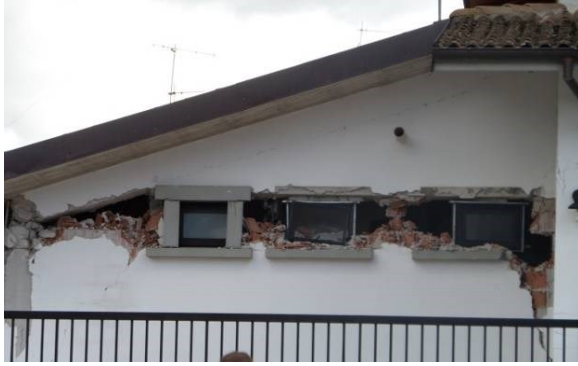
Picture	DATUM	Location		Damage Level	Notes
		Lat.	Long.		
P01	WBG-84	42.642058	13.304934	D2	
P02	WBG-84	42.641640	13.305167	D4	
P03	WBG-84	42.641709	13.305461	D5	
P04	WBG-84	42.641251	13.306553	D1-D2	
P05	WBG-84	42.641172	13.306394	D3	
P06	WBG-84	42.641388	13.306857	D3	
P07	WBG-84	42.641438	13.307067	D3-D4

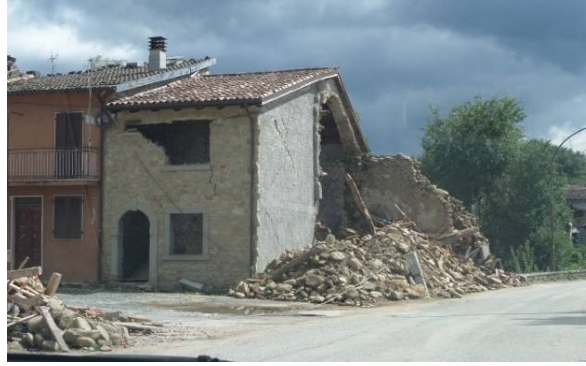
P02

Only a small part of the village was accessible in the days of the reconnaissance, which was surveyed as shown in Figure 5.69 and Table 5.18. The few buildings inspected (Figure 5.70) in some cases were partially or totally collapsed (P02, P03, P07), but most frequently had diffuse cracking (P04, P05, P06). Sommati had an average damage level in the order of D3-D4 with a local IMCS = 9 (Galli et al. 2016).
