Engineering Reconnaissance of the 24 August 2016 Central Italy Earthquake. Version 2

Geotechnical Extreme Events Reconnaissance Association

Report No. GEER-050B

22 November 2016

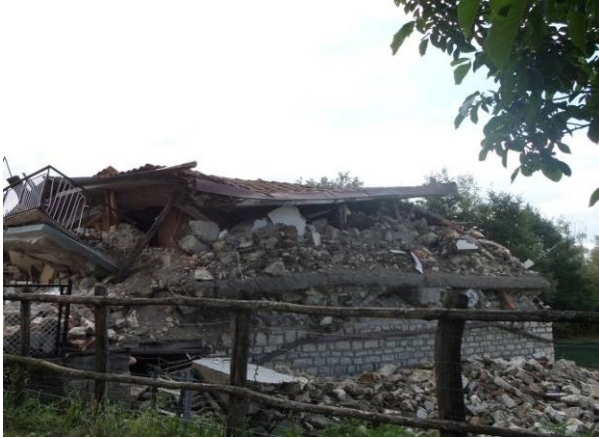
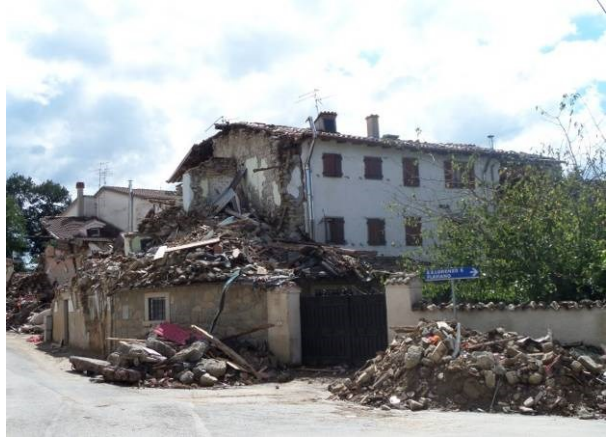
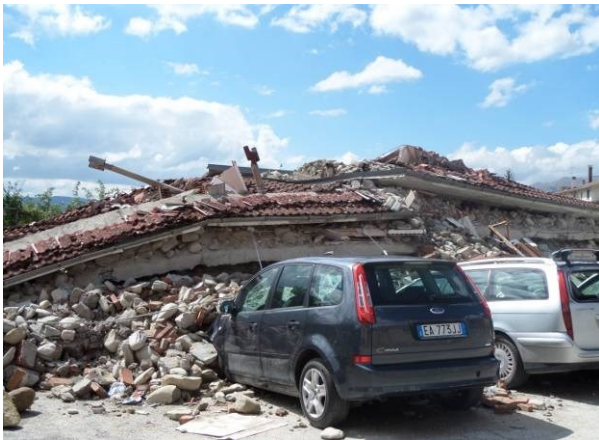
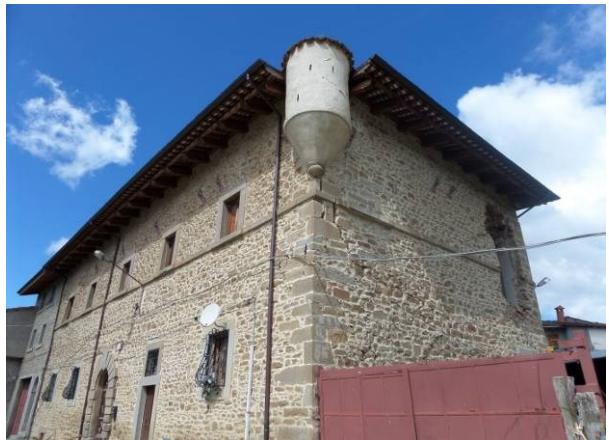
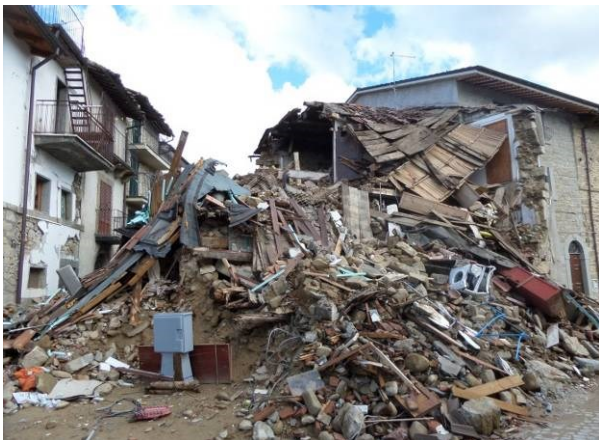
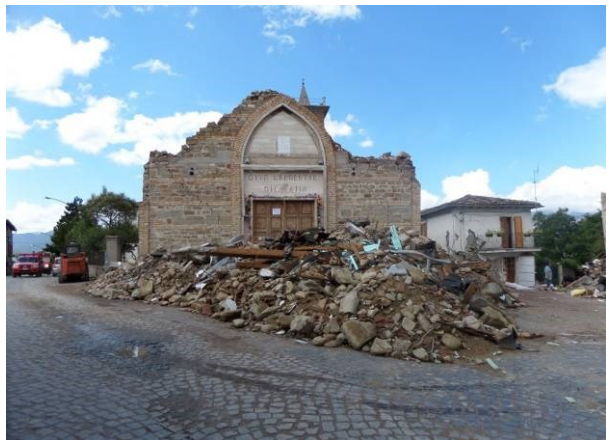
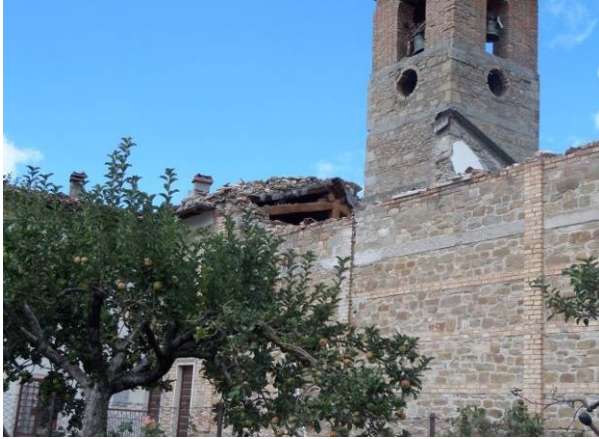
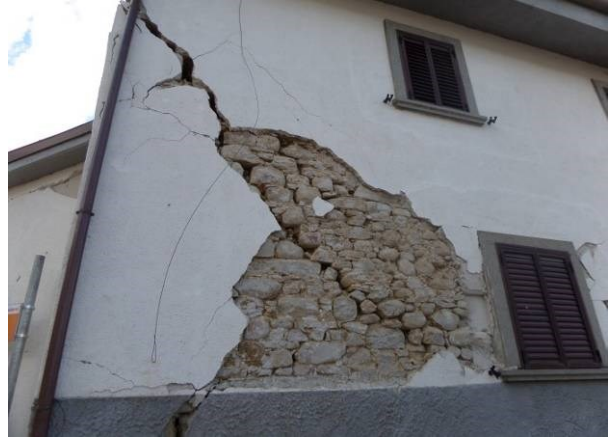
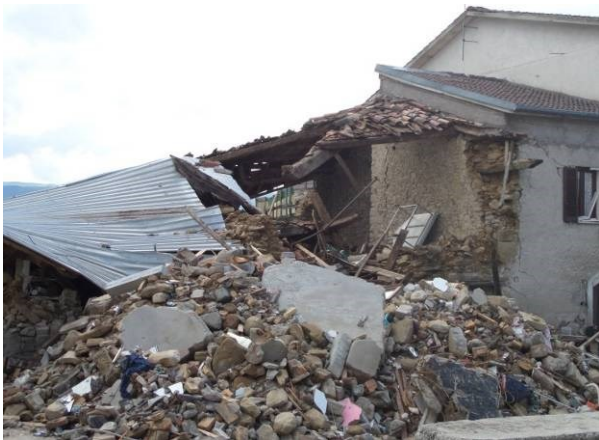
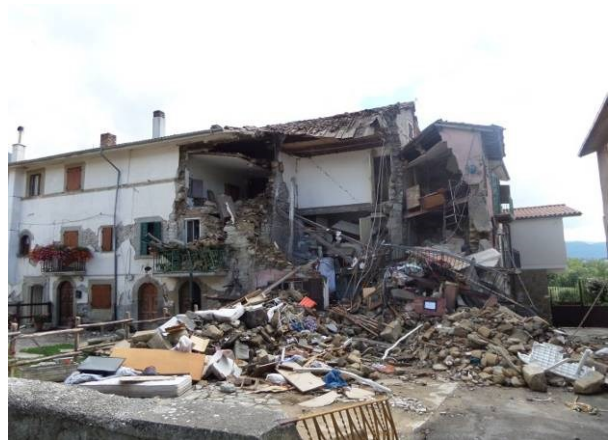
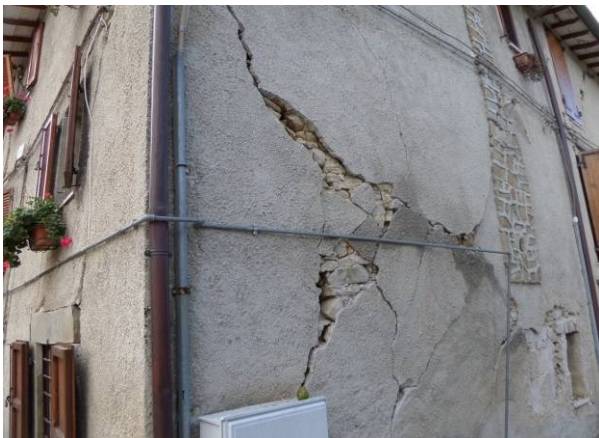
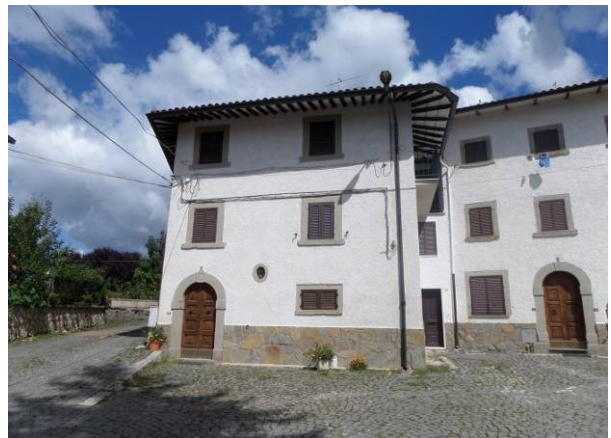
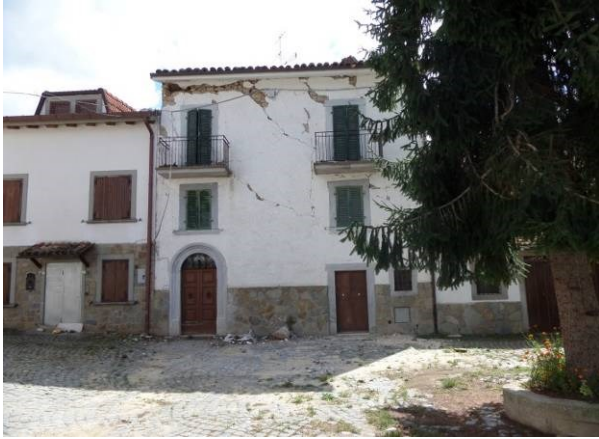
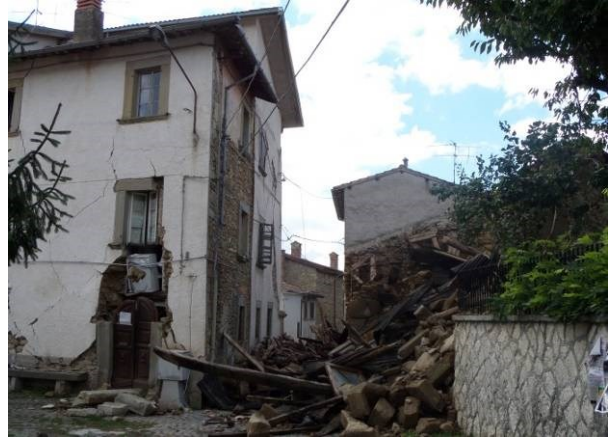
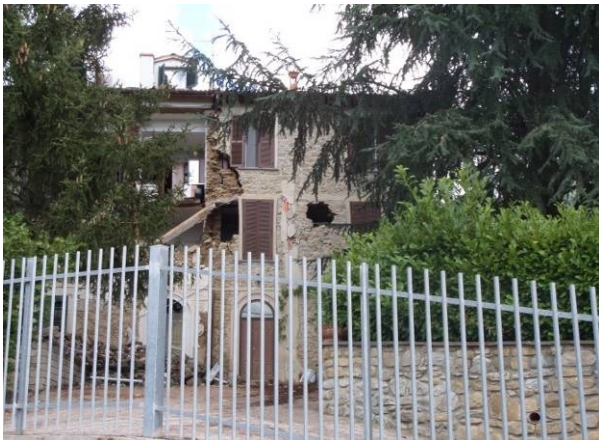
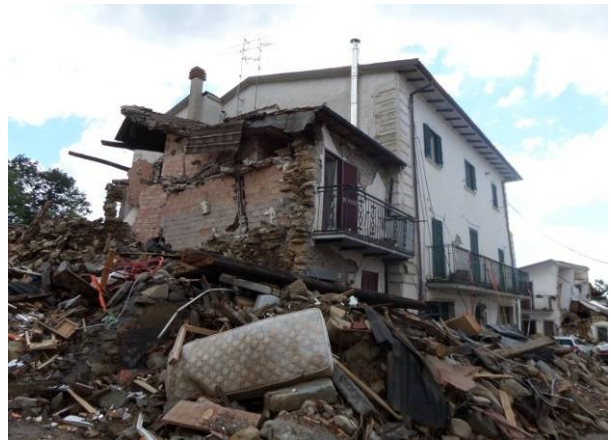
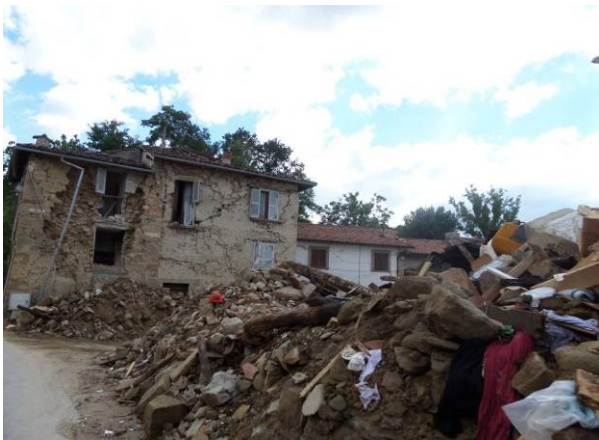
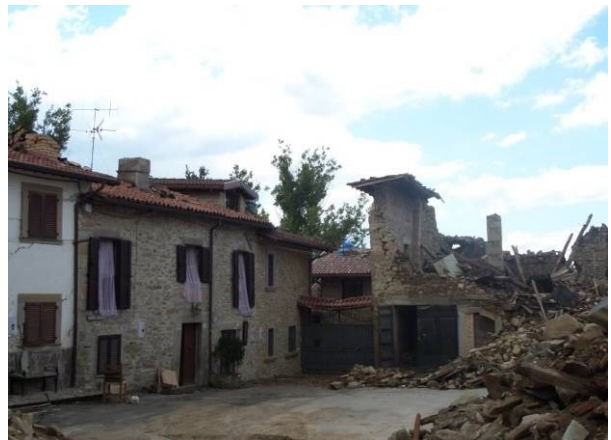
Figure 5.73. Representative pictures taken at San Lorenzo e Flaviano (see Table 5.19 for details).

Picture	DATUM	Location		Damage Level	Notes
		Lat.	Long.		
P01	WBG-84	42.665401	13.288931	D5	
P02	WBG-84	42.664418	13.289463	D4	
P03	WBG-84	42.664803	13.287449	D5	
P04	WBG-84	42.664831	13.287356	D3	
P05	WBG-84	42.664912	13.286910	D5	
P06	WBG-84	42.664897	13.286813	D4	
P07	WBG-84	42.664794	13.286675	D4	
P08	WBG-84	42.664897	13.286813	D3	
P09	WBG-84	42.664738	13.286589	D4	
P10	WBG-84	42.664724	13.286543	D4	
P11	WBG-84	42.664555	13.286144	D3	
P12	WBG-84	42.664167	13.285836	D0	
P13	WBG-84	42.664167	13.285836	D3	
P14	WBG-84	42.664066	13.285641	D5	
P15	WBG-84	42.664259	13.285575	D4	
P16	WBG-84	42.663913	13.289765	D4	
P17	WBG-84	42.664034	13.289765	D4	
P18	WBG-84	42.663913	13.289765	D5

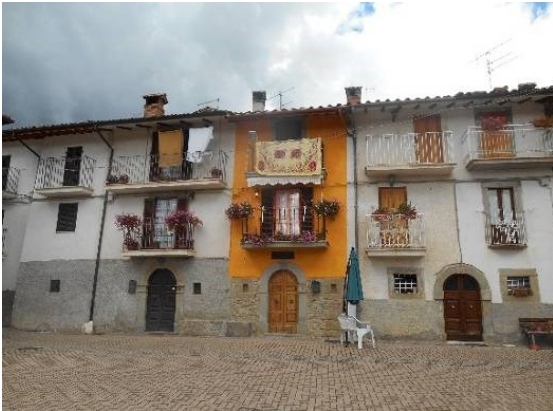
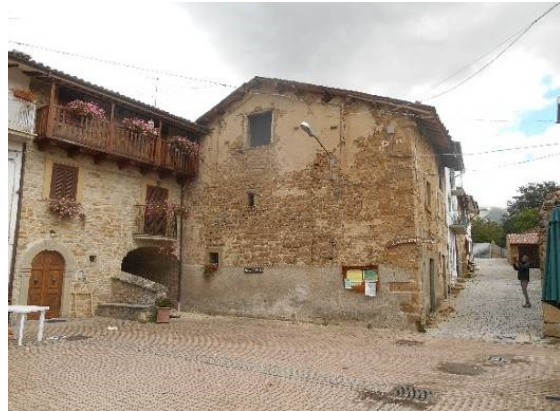
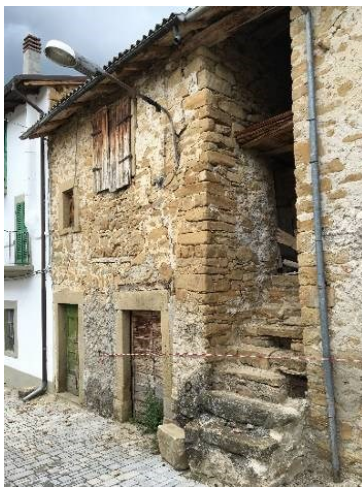
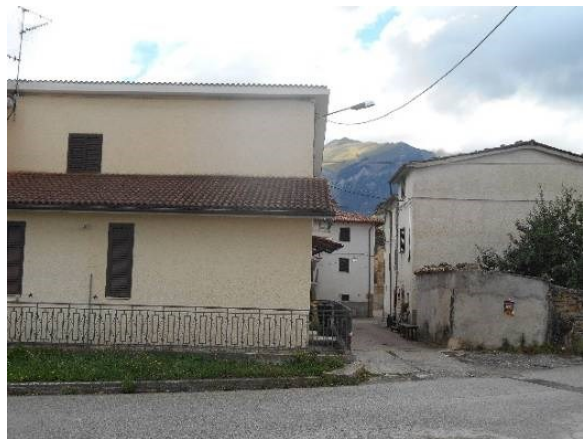
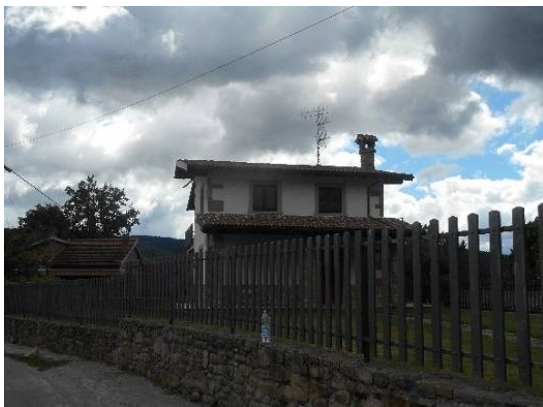
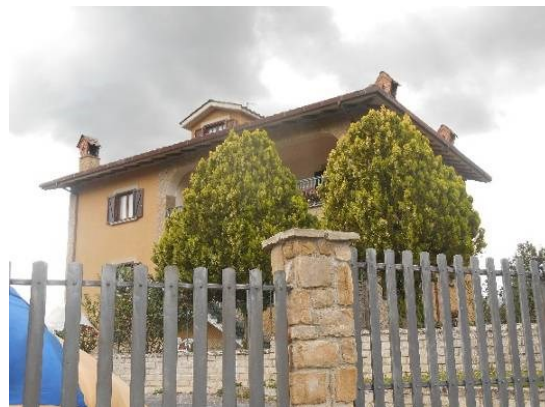
Figure 5.75. Representative pictures taken at Collocreta (see Table 5.20 for details).

Picture	DATUM	longitude	latitude	Damage level	Note
P01	WGS- 84	13.324494	42.630019	D0	Traditional buildings facing the small square, all undamaged
P02	WGS- 84	13.324644	42.629939	D1	Only slight cracking visible
P03	WGS- 84	13.324978	42.629897	D1	Maybe the most ‘damaged’ building
P04	WGS- 84	13.323975	42.630127	D0	New houses close to the main road, totally undamaged
P05	WGS- 84	13.323884	42.629816	D0	
P06	WGS- 84	13.323549	42.630106	D0

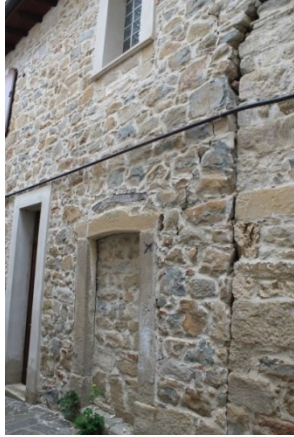
P01 (Colle)

Picture	Hamlet	DATUM	Position		Damage Level
			Lat.	Long.	
P01	Colle	WBG-84	42.843548°	13.307100°	D2-D3
P02	Colle	WBG-84	42.843584°	13.306980°	D2-D3
P03	Colle	WBG-84	42.843645°	13.307208°	D2-D3
P04	Pistrino	WBG-84	42.853423°	13.331786°	D2
P05	Pistrino	WBG-84	42.853335°	13.331713°	D2
P06	Pistrino	WBG-84	42.853186°	13.331661°	D2
P07	Pistrino	WBG-84	42.855579°	13.332642°	D0-D1
P08	Pistrino	WBG-84	42.855579°	13.332649°	D0-D1
P09	Pistrino	WBG-84	42.855579°	13.332649°	D0-D1
P10	Piano	WBG-84	42.854116°	13.339129°	D0
P11	Piano	WBG-84	42.853984°	13.339126°	D1
P12	Propezzano	WBG-84	42.860406°	13.378996°	D1-D2
P13	Astorara	WBG-84	42.837436°	13.31119°	D0-D1
P14	Astorara	WBG-84	42.838135°	13.307323°	D0-D1
P15	Castro	WBG-84	42.846221°	13.325959°	D4
P16	Castro	WBG-84	42.846416°	13.326965°	D4
P17	Castro	WBG-84	42.846416°	13.326965°	D3
P18	Castro	WBG-84	42.846416°	13.326965°	D3
P19	Collefratte	WBG-84	42.839388°	13.319004°	D3

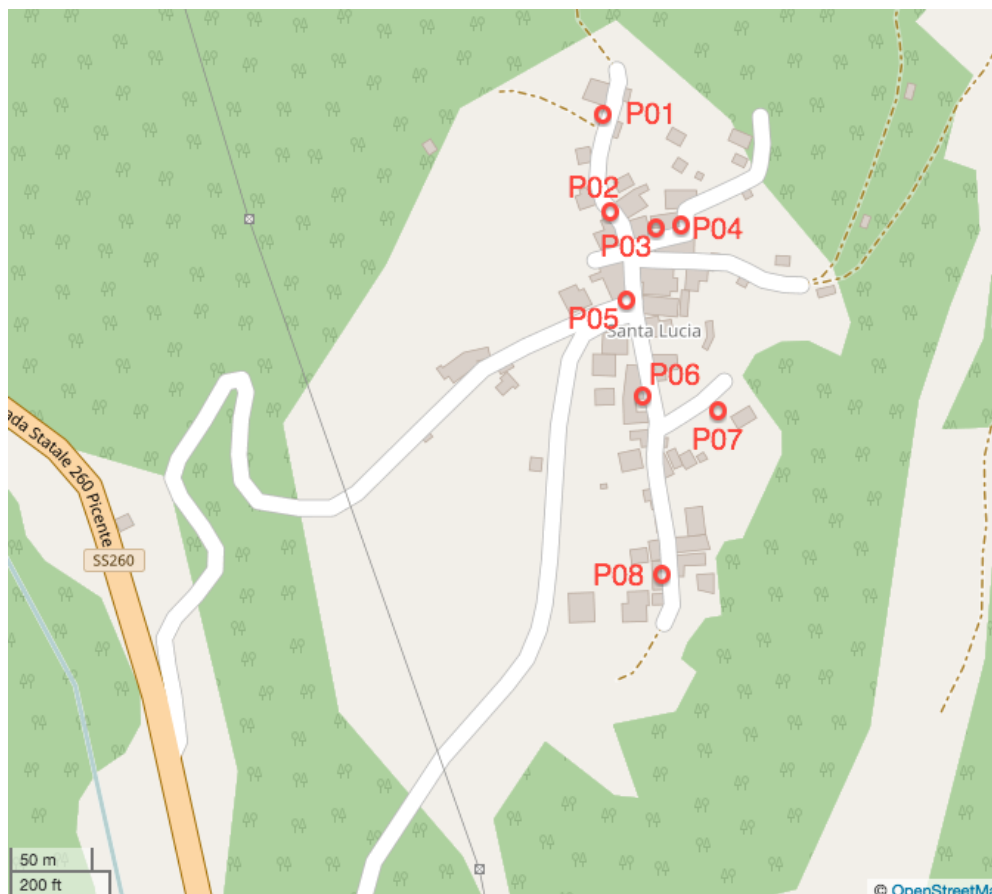
Figure 5.88. Locations of representative structures inspected in Santa Lucia (see Table 5.24 for details).

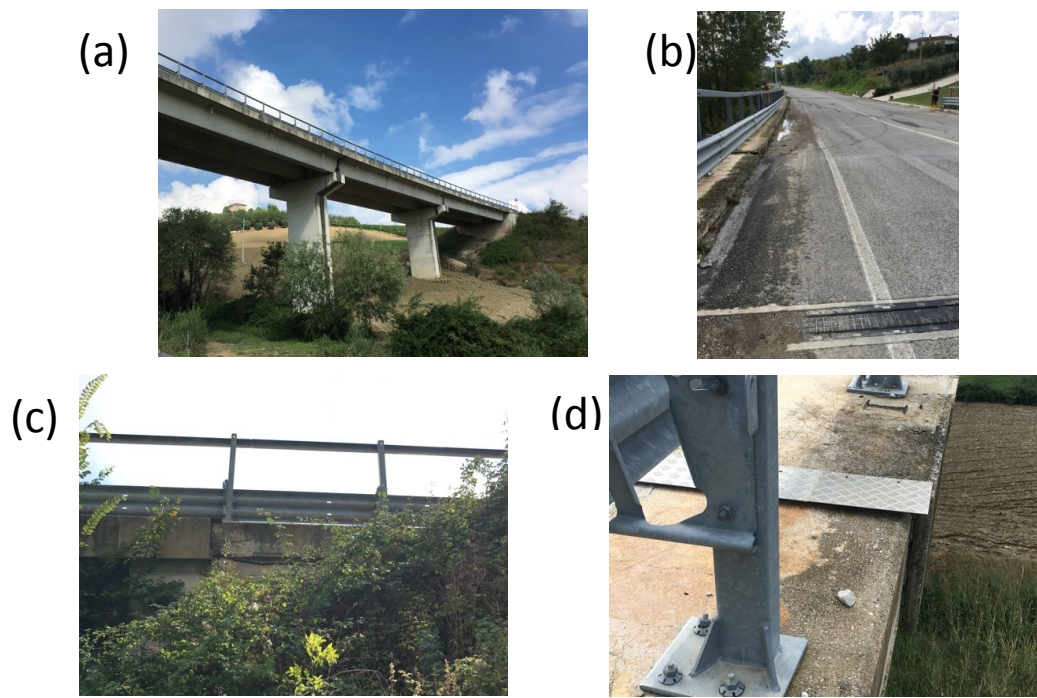
Figure 6.6. RC bridge along the SP173 in Offida (42.941687 deg, 13.702294 deg): overview of the bridge (a), settlement of the road (b) crack (c) and relative displacement of the abutment (d).

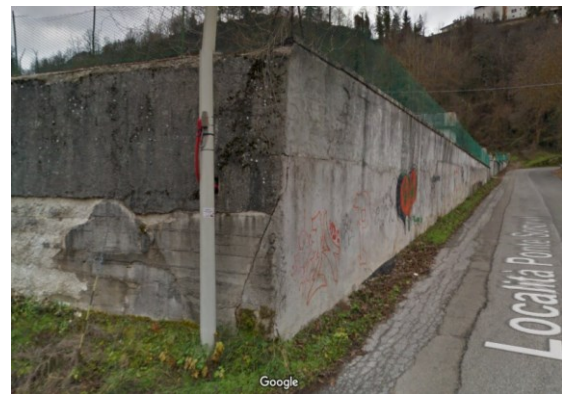
Figure 7.3a shows a collapsed retaining wall supporting a parking lot in the hamlet called “Ponte Sommati”, near Amatrice. The lower part of the wall was made of poorly reinforced concrete and the upper part was built with concrete blocks. The images in Figure 7.3b-c indicate the poor quality of the wall, including poor connections between the upper and lower parts.

Figure 7.3. Retaining wall at Ponte Sommati, in the surroundings of Amatrice (42.630662N, 13.291511E): (a) global view of the collapsed wall, (b) side of the wall not collapsed during the earthquake, (c) pre-earthquake image of the retaining structure (Google Earth, July 2011).

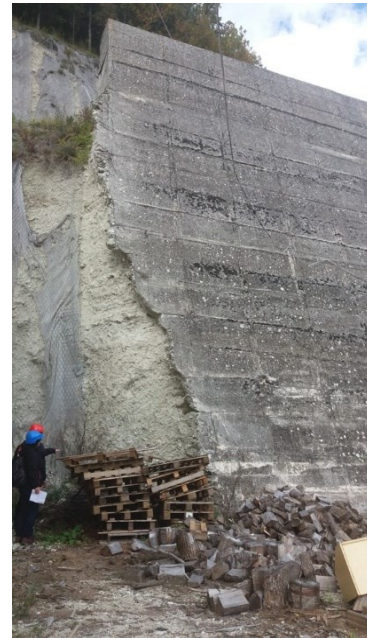
Figure 7.5 shows three cases of retaining walls damaged in Pescara del Tronto. In each case, the observed damage may be attributed in part to the poor quality of the retaining structures. Figures 7.5a-b show the collapse of two relatively low masonry walls. The wall in Figure 7.5a is made of concrete blocks connected by mortar, with no evidence of drainage measures having

been installed in the backfill. The wall in Figure 7.5b was erected with a typical dry-stone masonry technique (no mortar between stones) with no foundation. Figure 7.5c-d illustrate the damage to a fence drapery breached by calcarenite rock blocks falling from a slope as high as 8m. No significant damage was observed in the adjacent high concrete wall.

Figure 7.5. Retaining walls in Pescara del Tronto: (a) collapse of a concrete block masonry wall (42.751705N, 13.270562E), (b) collapse of a dry-stone masonry wall (42.751141N, 13.270889), (c) fence drapery breached by calcarenite rock blocks, (d) performance of the adjacent concrete wall (42.752331, 13.270207E).

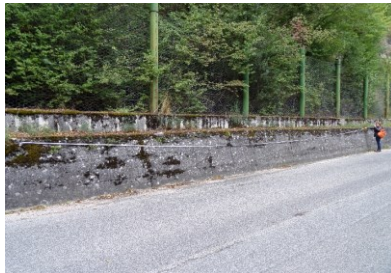
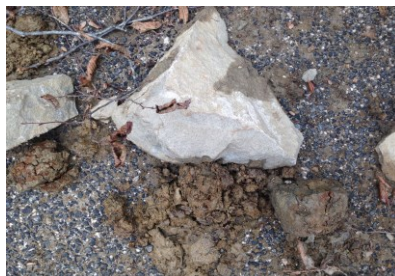
Figure 7.6a shows damage to a rockfall barrier along the SS260 road branch that connects Amatrice to the main road SS4 (Salaria). At the time of the reconnaissance, a protection embankment was placed at the toe of the slope (Figure 7.6b). The slope behind the barrier is covered with a hexagonal mesh, which along the failed slope is simply draped with no evidence of reinforcement (Figure 7.6c), while along the stable slope it appears connected to the arenaceous flysch formation by ropes and nails (Figure 7.6d).

Figure 7.6. Damage to a rockfall protection system along the SS260 road (42.648203N, 13.274285E) in Amatrice municipality: (a) collapsed zone; (b) failed (left) and stable (right) parts of the slope with protection embankment in the foreground; bottom view of the failed (c) vs. stable (d) slope and barrier; concrete wall supporting the barrier (e) and previous crack (f) denoting the absence of reinforcement; (g) arenaceous block with silty matrix and (h) maximum size of the rock blocks fallen.

The rockfall barrier is comprised of a fence with steel horizontal cables connected to vertical cantilever tubular piles anchored to a concrete beam placed upon a 1.4 m tall retaining wall (Figure 7.6e). The concrete wall appears to be unreinforced (Figure 7.6f).

Collapse of the system may be attributed to several factors, among which the lack of anchorage of the mesh panels to the slope and between adjacent panels too, inadequacy of the rockfall barrier with reference to the foundation of the tubular elements, the absence of any retaining cable on the top of the barrier, and the limited strength of both the fence and the horizontal cables. The rockfall barrier was not able to intercept arenaceous blocks up to approximately 30-40 cm in size (Figure 7.6f-g), sliding or falling from a maximum height of about 12 m.

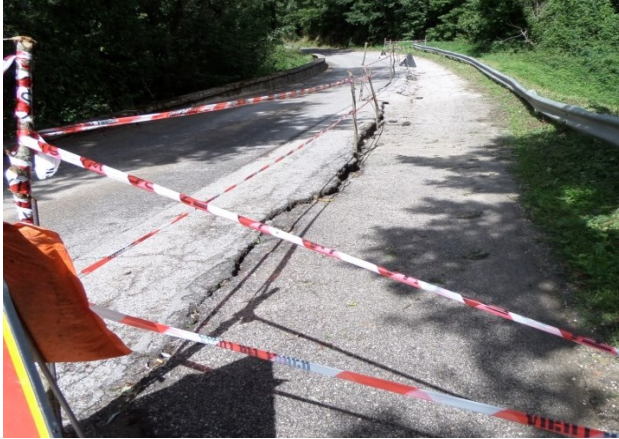
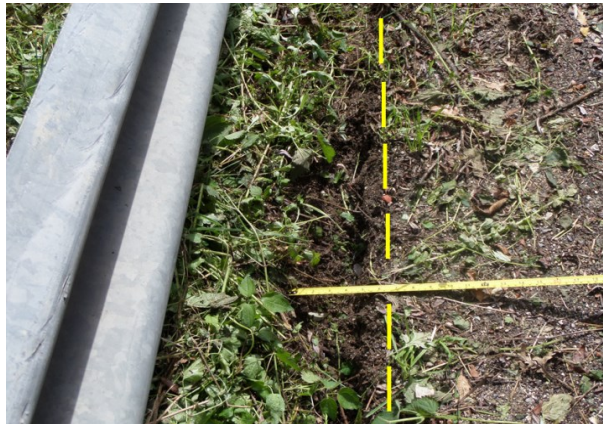
Traces of differential settlements along the road surface were evident before the earthquake as shown in Figure 7.7f (photo dated July 2011; Google Earth image for reference site 42.660061N - 13.293697E). The earthquake appears to have caused seismic compression of the road embankment fill, exacerbating prior settlements, presumably from hydro-compression or similar.

Figure 7.7. Embankment instability along the SP20 road between the villages of San Lorenzo e Flaviano and Sommati (42.660061N, 13.293697E): (a) longitudinal crack along the road surface after the earthquake;(b) downstream view of the crossing section; (c) view of the Armco tube underneath the embankment; (d) maximum vertical settlement at the bridge-embankment connection; (e) longitudinal crack at the border of the pavement surface; (f) previous conditions of the road branch before the earthquake (Google image dated July 2011).

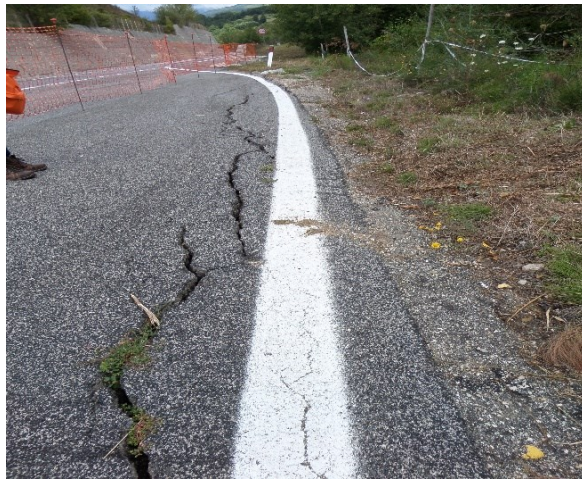
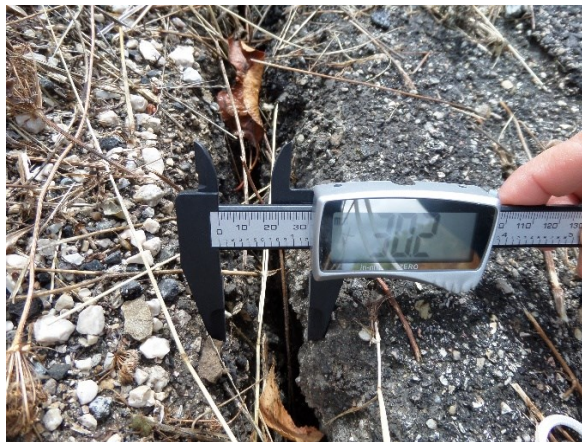
We observed longitudinal cracks (Figure 7.8a-b) at km 133 of main road SS4 (Salaria). Maximum crack widths in the asphalt surface are around 3 cm (Figure 7.8c) and cracking was also observed at the edge of the road pavement (Figure 7.8d). Adjacent to this section of road is a nearly vertical cut. Nearby areas with gentler slopes had no pavement cracking.

Figure 7.8. Embankment instability along the SS4 road at km 133 (42.650533N - 13.270442E): (a) longitudinal cracks along the whole rest area, (b) identification of the site location by road sign, (c) maximum horizontal opening of the longitudinal crack, (d) disconnection between the lateral slope and the road surface.

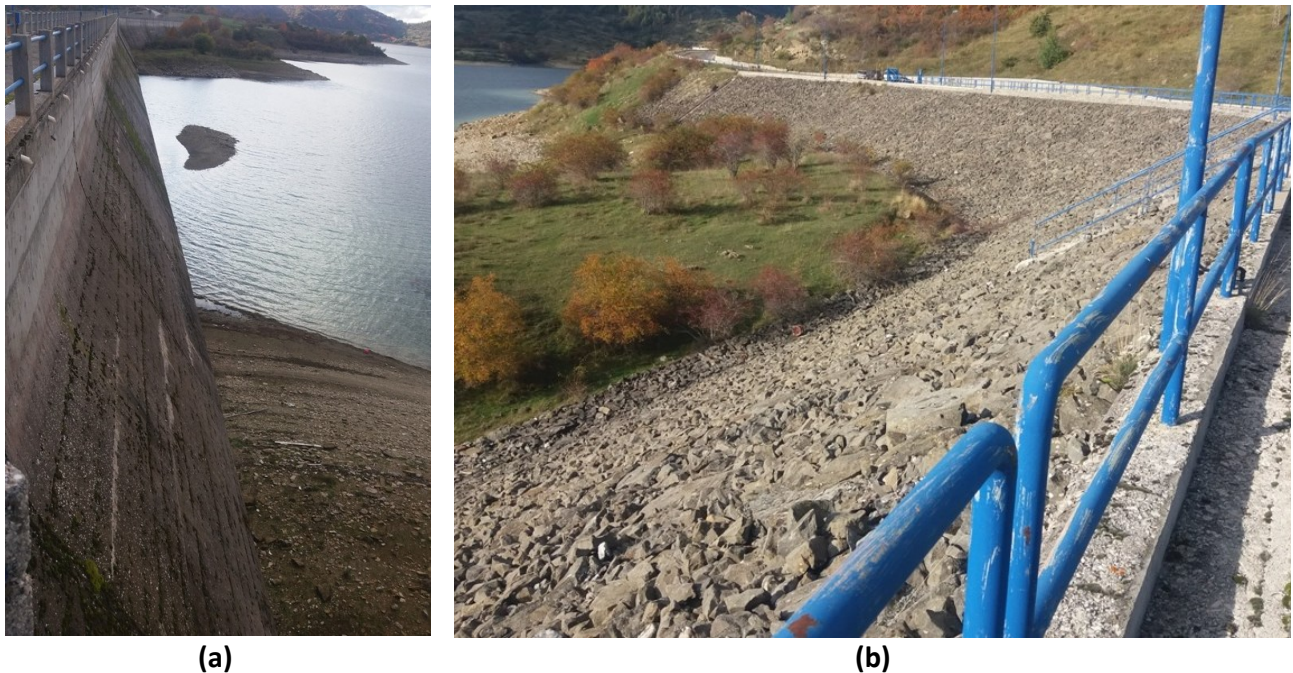
Sella Pedicate is a concrete gravity dam along most of its length but with a zoned embankment dam (with a clayey central core and a concrete foundation diaphragm) on the left abutment. The dam was built from 1965 to 1971; it is 20.75m tall and 750m long. Figure 7.18a shows the upstream face of the concrete dam, which is very steep (about 5 horizontal to 1 vertical), while the downstream face has a much milder inclination. The upstream face of the embankment dam is shown in Figure 7.18b, while the cross-section and the material properties are reported in Figure 7.16b and Figure 7.16c, respectively.

Figure 7.18. Photos taken on October 19, 2016 of the upstream face of Sella Pedicate concrete dam (a) and of one of its extremities (b), which is an embankment dam (42.514468°N, 13.370155°E).
