FAILURE OF TAPO CANYON TAILINGS DAM

By Leslie F. Harder Jr.,¹ Member, ASCE, and
Jonathan P. Stewart,² Student Member, ASCE

ABSTRACT: The failure of the Tapo Canyon tailings dam was one of the most striking failures of an earth structure to result from the January 17, 1994 Northridge, California earthquake. The failure involved a 60-m-wide breach of a tailings dam with a maximum height of 24 m, and 60 and 90 m downstream displacements of two sections of the dam. The failure resulted from liquefaction of the impounded tailings and possibly of the embankment materials. A significant volume of liquefied tailings passed through the breach in flows which extended hundreds of meters downstream within a natural drainage channel. The tailings dam failure, which occurred in a largely undeveloped area, caused no deaths or injuries, but did result in considerable economic losses for the owners of the tailings dam and a downstream water-treatment facility affected by the tailings flow slide. In this paper the writers will outline the construction history and geologic conditions at the site, and describe the strong influence of these factors on the characteristics of the embankment failure.

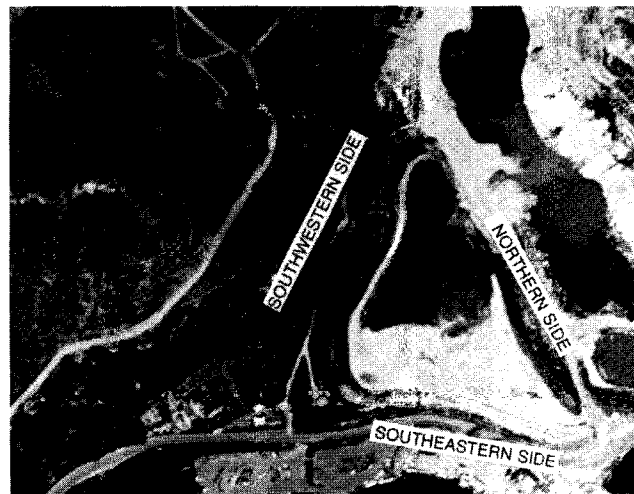
FIG. 2. Aerial Photograph of Pond No. 6 in Tapo Canyon before Northridge Earthquake (Photo by I.K. Curtis, Inc., April 1993)

but it may have been due to leakage from conveyance ditches and ponds located immediately to the north. Fig. 2 is an aerial photograph of the completed pond taken in April 1993. This photograph clearly shows ponded water in the western half of the facility.
