Liquefaction effects in the 2020 Mw 6.4 Petrinja, Croatia, earthquake

Liquefaction effects in the 2020 M_w 6.4 Petrinja, Croatia, earthquake

Zorana Mijic^{a,*}, Sonja Zlatović^b, Jack Montgomery^c, Katerina Ziotopoulou^d, Verica Gjetvaj^e

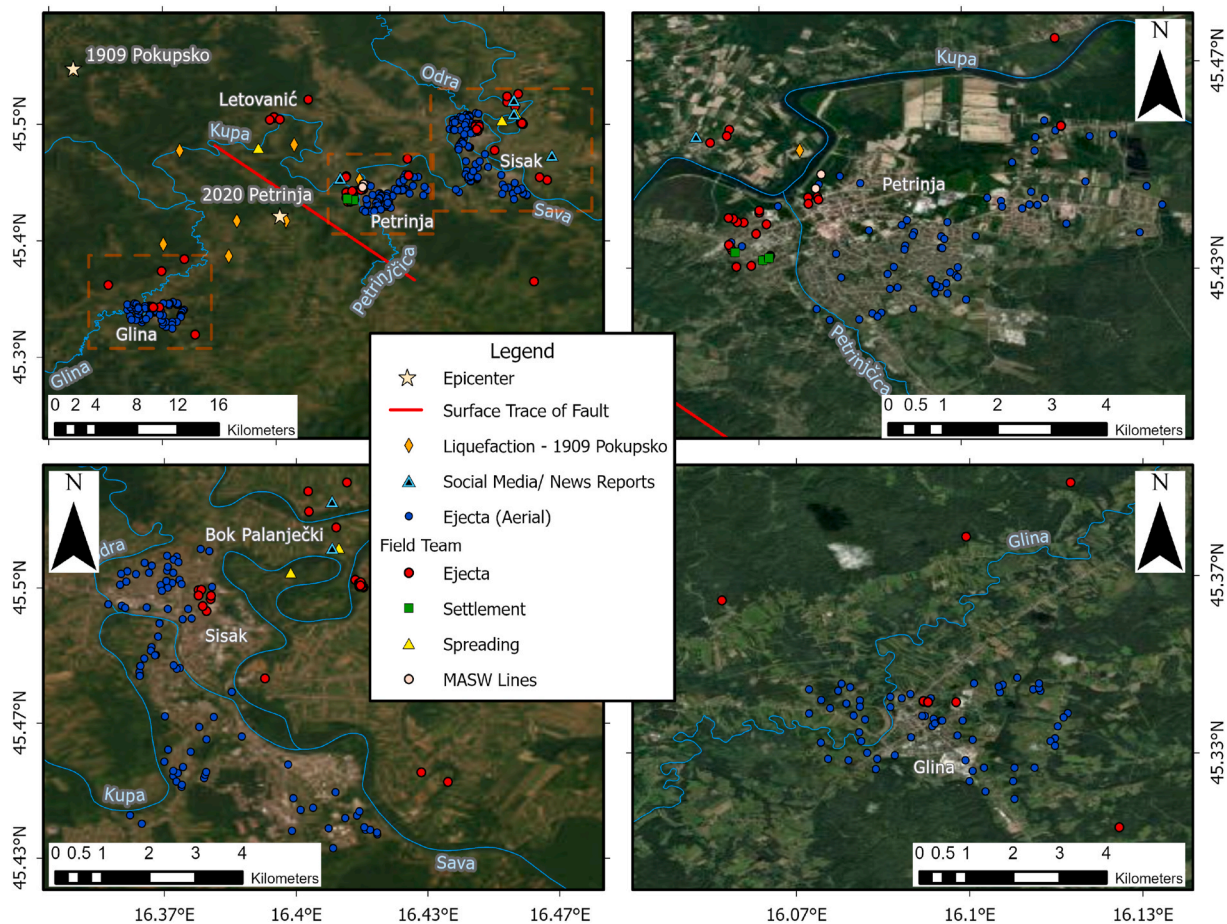
Fig. 1. Satellite map of Petrinja, Sisak, and Glina with locations of documented liquefaction sites in the 2020 Petrinja earthquake. The epicenter and inferred surface trace of the causative Petrinja fault [2], locations of the 1909 Pokupsko liquefaction [25], and sites with multichannel analysis of surface waves (MASW) lines (A. Salkovic and I. Salkovic, personal communication, Nov 2023 and Aug 2024) are also shown.

Liquefaction manifestations were documented using a combination of field visits, aerial and satellite image analysis, reports from residents, and social media posts (Fig. 1). Direct observations of liquefaction ejecta were made during field reconnaissance efforts at over 70 locations along the Kupa, Glina, and Sava rivers (red circles in Fig. 1). Post-earthquake digital orthophotographs for Drencina, Glina, Moscenica, Petrinja, and Sisak were developed by the Faculty of Geodesy at the University of

are shown as purple circles in Fig. 1. An example of a site where ejecta were mapped is presented in Fig. 2a. The absence of ejecta away from Drencina, Glina, Moscenica, Petrinja, and Sisak and near the Kupa, Sava, and Odra rivers is not necessarily due to mitigating factors but rather the limited coverage of aerial photographs. Similarly, the presence of vegetation, structures, and other features in the aerial photographs had the potential to obscure ejecta. There is also some uncertainty associated with the interpretation of ejecta in the aerial photographs due to their limited resolution. The locations of ejecta marked by the cyan triangles in Fig. 1 are approximate as they are based on news and social media posts [26–30].

Lateral spreading was observed in the villages of Bok Palanjecki (northeast of Sisak) and Stari Brod (northwest of Petrinja), as shown in Fig. 1. In Bok Palanjecki, lateral cracks were observed on both banks of the meandering Sava River. While no structural damage was noted, a private driveway was offset horizontally by up to 10 cm and vertically by up to 30 cm. In Stari Brod, approximately 2 km from the fault rupture, lateral spreading and ejecta were identified for several residential properties along the Kupa River. Ejecta were observed around the houses and in the open areas of the properties at 83, 94, 97, 98, 99, 110, and 110A Izisce St (Fig. 8a). Liquefied soil was also ejected through water wells. At 97 Izisce St, sandy ejecta were found both outside the well and 6 m below ground surface inside the well. Lateral spreading affected the properties at 94, 97, 98, and 99 Izisce St. Fig. 8a shows two major sets of cracks: one across the level ground farther away from the river, roughly along the northwestern facade of the houses (Fig. 8b), and another closer to the Kupa River, along the transition zone between the level and sloping ground (Fig. 8c). These cracks indicate this portion of the ground moved laterally toward the Kupa River due to liquefaction of underlying sandy layers.

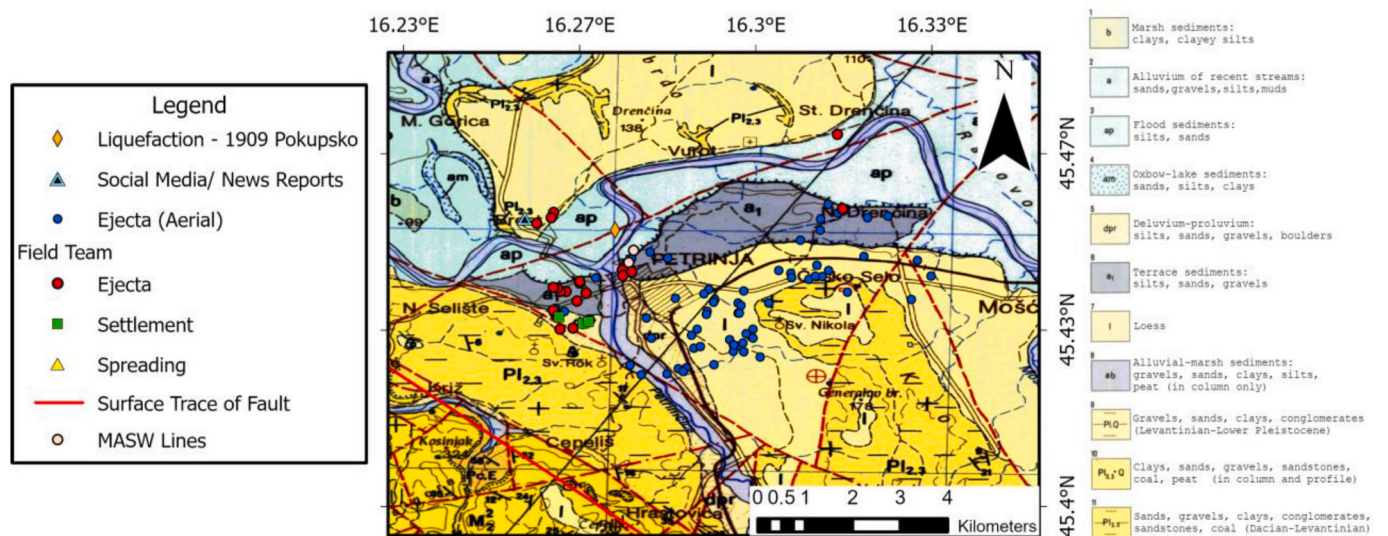
Fig. 3. Geologic map of the Petrinja region [31] showing locations of documented liquefaction case histories. The map legend on the right has been translated from Croatian.

geologic map by Pikija [31]. Fig. 3 illustrates the locations of liquefaction manifestation superimposed on the geologic map for Petrinja. The primary geologic units in the affected areas are Holocene flood (ap) and terrace deposits (a1) near the active river channels, Holocene deluvium-proluvium (dpr), and Pleistocene loess deposits (l). Flood deposits are formed by sedimentation of predominantly fine material that remained in suspension after flooding [31]. They are comprised primarily of clayey and sandy silt (5–12 % clay and up to 20 % sand) and fine sand to a lower extent. Terrace deposits tend to be characterized primarily by sandy silt but can also contain fine gravel. Deluvium-proluvium consists of weathered bedrock products (silt, sand, gravel, and boulders) carried down a slope in a gradual, relatively continuous manner as well as by torrential flows. Loess represents sediment of aeolian origin comprised of silt with typically 7–10 % sand and 4–14 % clay [31].
