Impacts of 2020 Beirut Explosion on Port Infrastructure and Nearby Buildings

Natural Hazards Review, 23(2)

Salah Sadek¹, M. ASCE, Mayssa Dabaghi¹, A.M. ASCE, Timothy M. O'Donnell², S.M. ASCE, Paolo Zimmaro^{2,3}, M. ASCE, Youssef M.A. Hashash⁴, F. ASCE, and Jonathan P. Stewart², F. ASCE

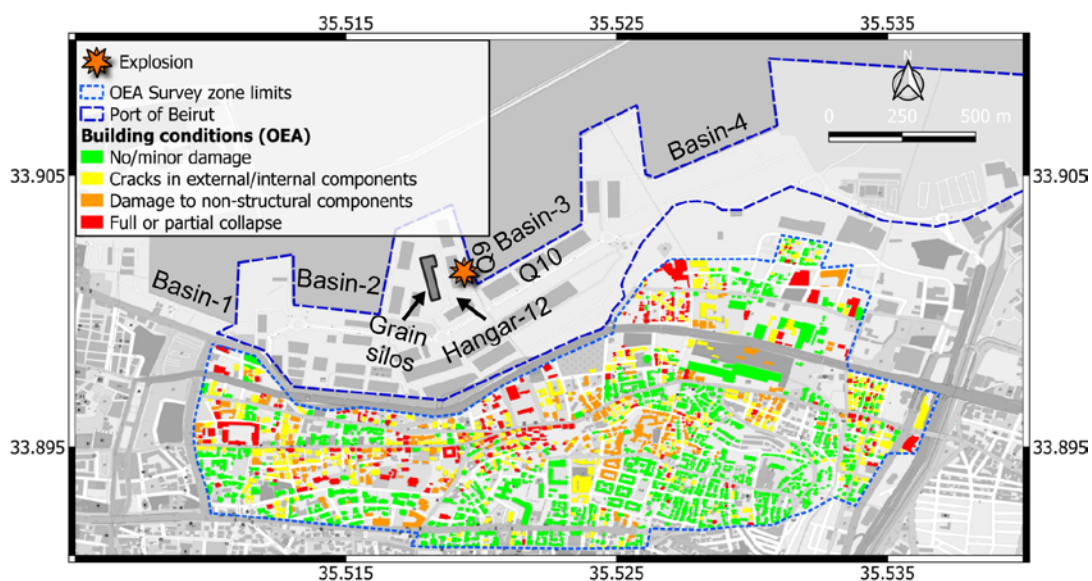
35
36 **Figure 1:** Map of Beirut showing the location of the explosion, Port of Beirut, and condition of the
37 buildings surveyed by the Order of Engineers and Architects (OEA, 2020). Within the Port of Beirut, basin
38 and quay wall numbers are provided.

86 The OEA documented the condition of the buildings they surveyed and provided building-specific
87 recommendations of evacuation, closure, or strengthening (full or partial, immediately or during
88 repair works) to the most damaged buildings. As shown in Figure 1, the damage was classified as
89 follows: no damage, cracks in building components, damage to non-structural components, and
90 risk of full/partial collapse. Relative to the blast site, the OEA inspections occurred up to 1 km
91 west, 1 km south, and 1.5 km east, in the districts of Minet El-Hosn, Zokak El Blat, Port, Saifi,
92 Rmeil, and Medawar. At the southern limit of the inspection areas, damage levels of “no/minor
93 damage” were recorded, whereas appreciable damage was observed at the western and eastern
94 margins of the surveyed area, suggesting that damage locations may extend beyond the limits of
95 the OEA surveys. The OEA damage assessments shown in Figure 1 were obtained from their

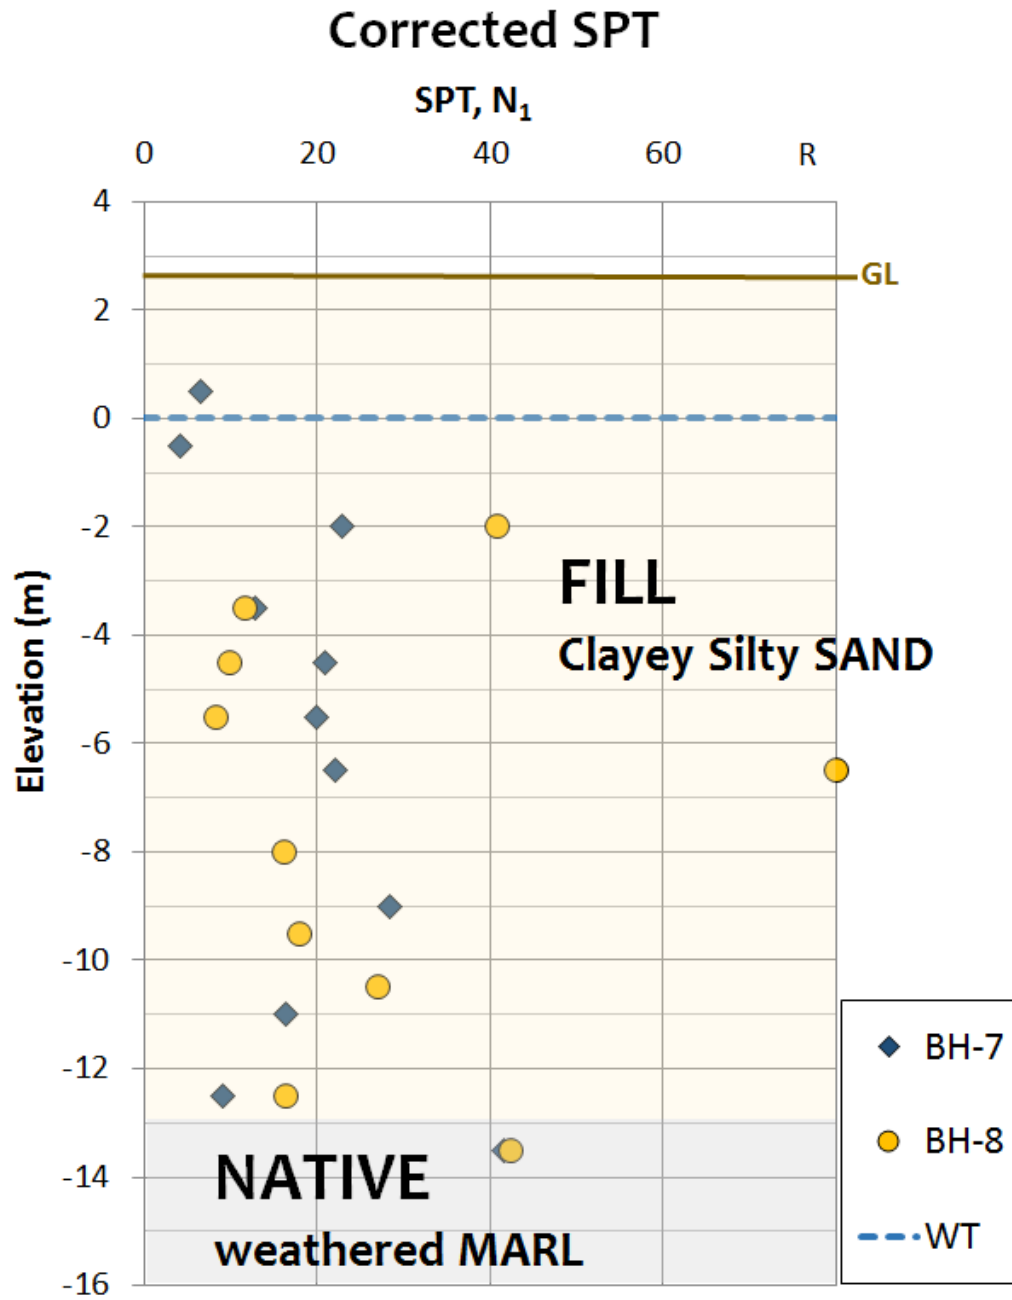
182 Overburden-corrected Standard Penetration Test (SPT) data is shown for the approximately 13
183 m deep fill layer at this location. The average value of $N_1 = 20$ blow/ft; the energy level is unknown
184 but is estimated as 45-60%.

194 **Figure 5:** Subsurface profile. The data was taken from boreholes located below the footprint of silos
 195 executed in Phase-1 (source-courtesy: *Forex sarl*, geotechnical site exploration co.)

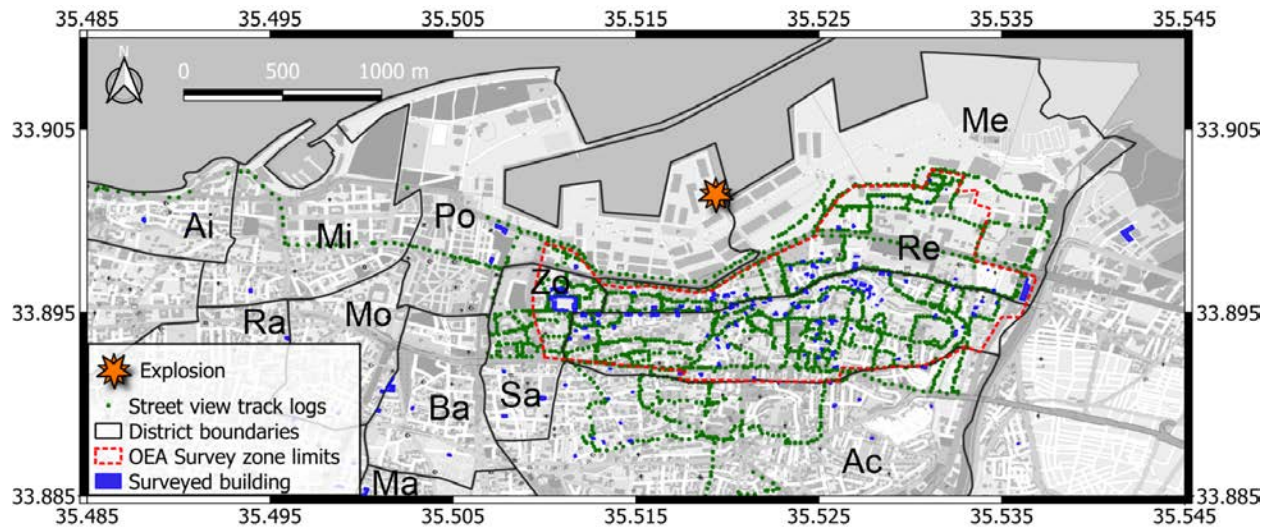
320 Figure 12 shows the locations of 172 buildings inspected during this effort, most of which are
321 located within 2 km of the blast.

322
323 **Figure 12.** Locations of buildings with in-person inspections and tracks of 360-degree photo surveys from
324 the GEER reconnaissance.

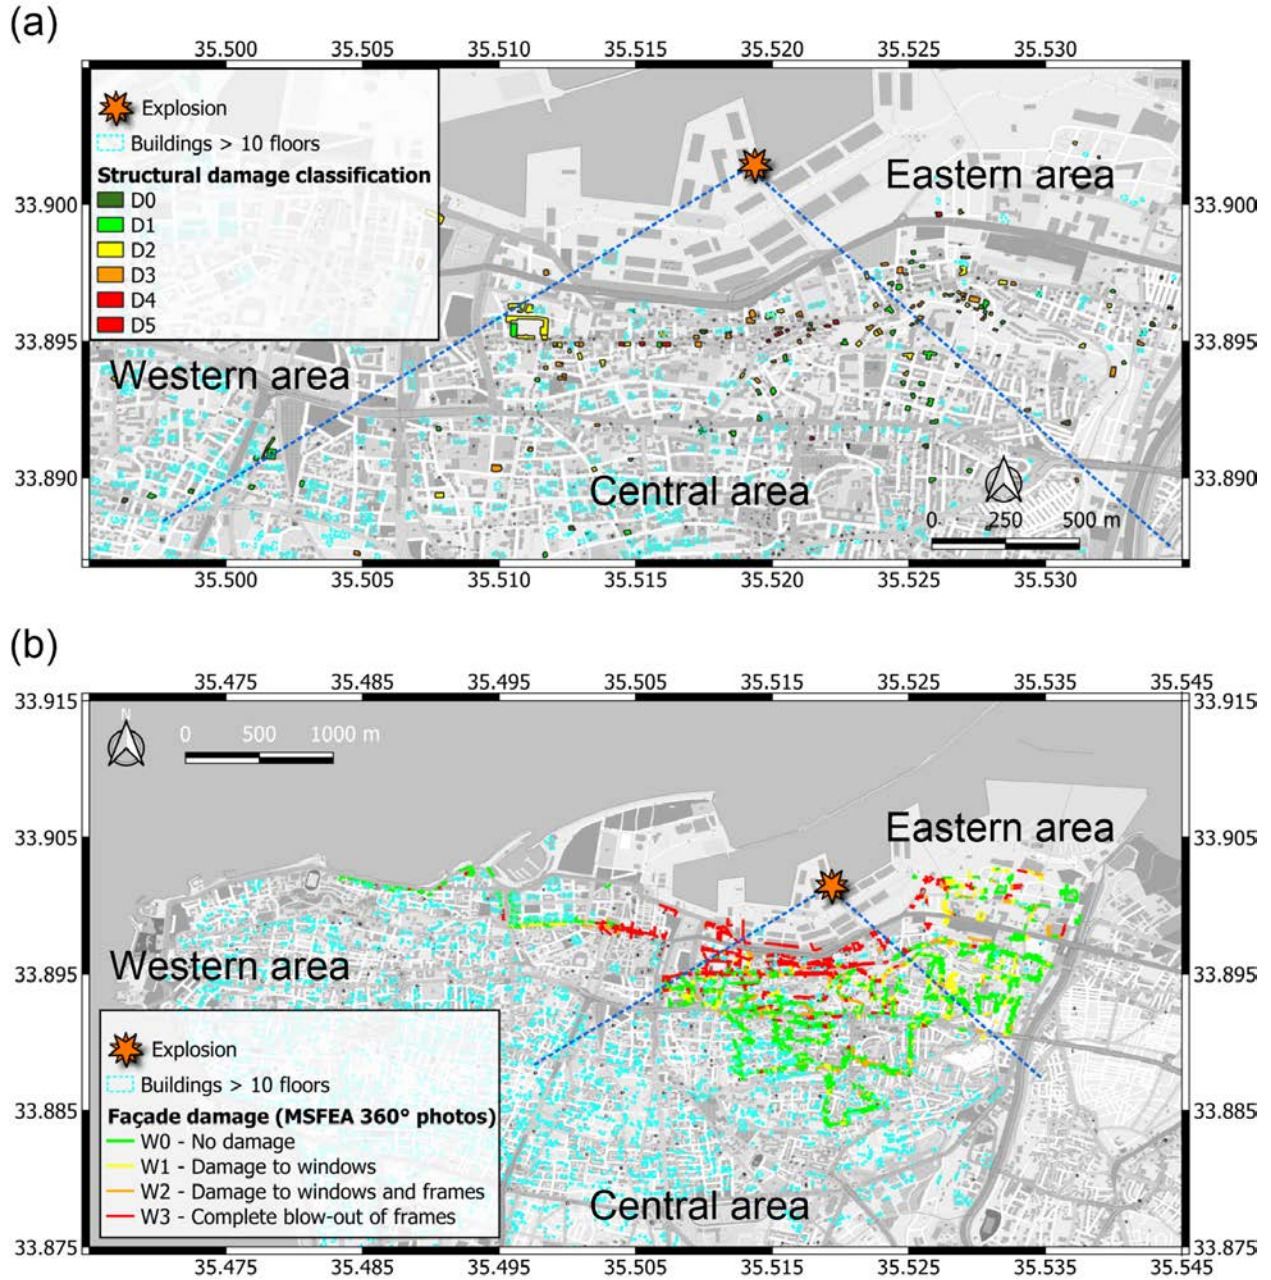
413 Figure 15 shows maps of the spatial distributions of structural and façade damage. The damage
 414 is mapped by coloring buildings with classified damage (per Tables 2 or 3). Uncolored buildings
 415 are in the AUB-UL database, but lack post-event damage classifications. As shown in Figure 15,

416 the city was also radially divided into three sub-areas, herein denoted the Western, Central and
417 Eastern areas, to examine possible azimuthal differences in the damage distribution.

421 Because the structural damage data is relatively sparse, damage patterns can be more easily seen
422 in the façade data (Figure 15b). Of the analyzed façades, 5388 of them were classified as Wxx-0,
423 1158 as Wxx-1, 759 as Wxx-2, and 1920 as Wxx-3. Figure 15b shows that there is a clear fringe
424 area that separates undamaged zones (Wxx-0) from zones with some damage (Wxx > 1). This
425 fringe zone is located at a variable distance from the explosion. It is located at a distance of ~1.5
426 km from the explosion in the Western area. This distance becomes ~0.7 km-0.9 km in the central
427 area and becomes ~1.2 km in the Eastern area. This analysis suggests that there is a non-
428 symmetric façade damage spatial distribution. It is possible that this pattern is related to the
429 damping effect of tall buildings/structures and/or the different levels of structural vulnerability
430 in different districts of the city.

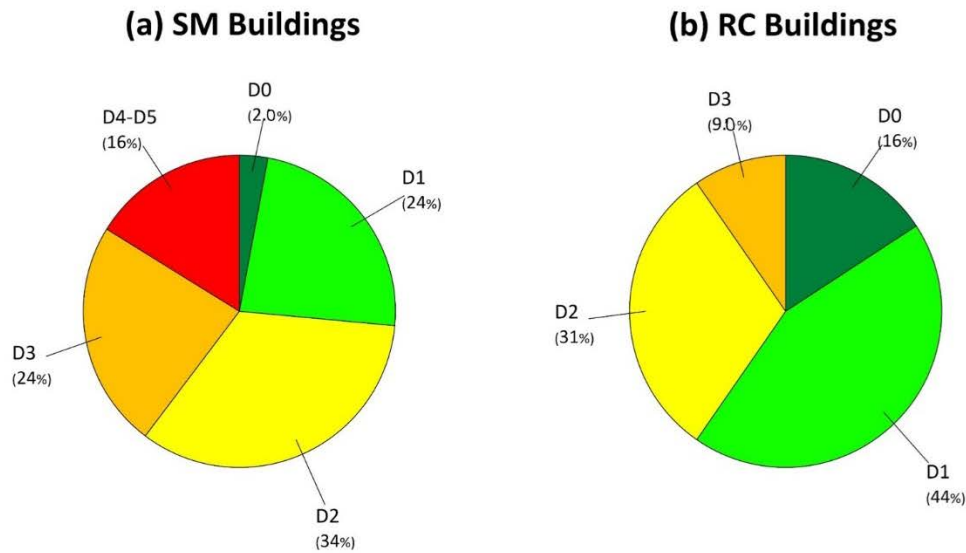
431 As described in the introduction of the *Building Impacts* section, Beirut buildings are
432 predominantly of SM and RC construction. The structures most damaged by the blast (D3, D4
433 and D5) were sandstone bearing-wall structures and older (gravity load designed) RC buildings.
434 Modern RC structures located close to the blast suffered damage mostly to non-structural
435 elements. Figure 16 illustrates the distribution of damage classes D0 to D5 for SM and RC
436 structures based on the in-person survey data only. The data show that the SM buildings
437 generally suffered more damage than RC buildings.

440 **Figure 16.** Distribution of damage classes in (a) Stone Masonry (68) and (b) Reinforced Concrete (114)
 441 buildings.

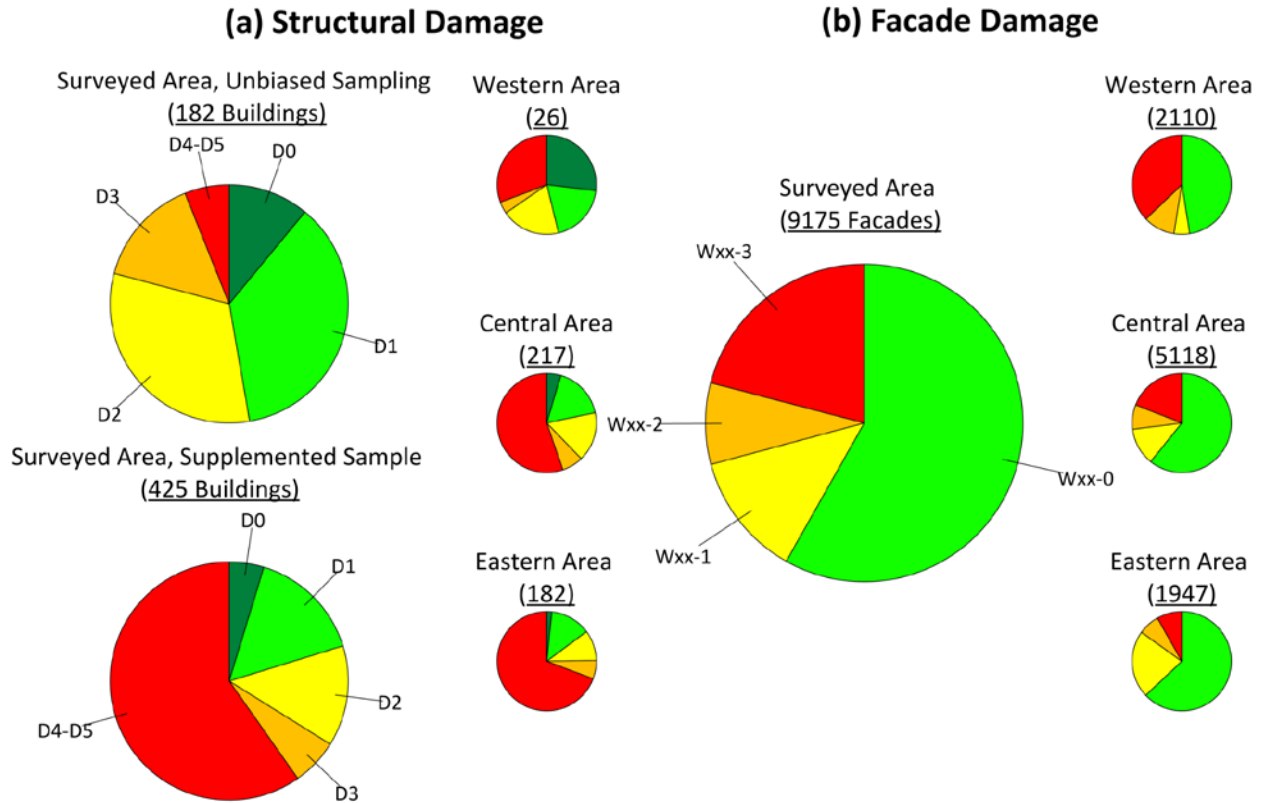
442 Figure 17 shows the distribution of damage classes amongst the assessed structures and facades
 443 for the entire city as well as the three sub-areas shown in Figure 15. Figure 17(a) focuses on
 444 structural damage, and considers two data populations. The “unbiased” structural sample
 445 consists of the 182 structures with in-person and 360° photos inspection (as described in
 446 *Structural Damage Assessment*). The second population (“supplemented sample”) adds 243
 447 collapsed or partially collapsed buildings (D4-D5) identified by OEA (2020). Those collapsed
 448 structures are a subset of those colored in red in Figure 1, after removing “collapses” that
 449 involved only balconies and not primary load-bearing systems, based on information in OEA
 450 (2020). These additional D4-D5 buildings bias the data set towards higher average damage
 451 ratings, in that it does not representatively sample structures across all performance levels. The

452 charts in Figure 17(a) indicate that the most severe structural damage effects are in the central

453 and eastern sub-areas. The apparently severe damage in the eastern sub-area is likely influenced
454 by most of the OEA evaluations having been performed in that part of the city.

455 Figure 17(b) shows the façade damage distributions. Contrary to the structural damage
456 information, these data indicate that the western sub-area experienced the most relative impact.
457 Because of the much larger sample size in the façade dataset and the aforementioned biased
458 sampling of structural damage, trends in the façade dataset are considered to more accurately
459 represent the spatial distribution of blast impacts in the city. The apparently greater facade
460 damage in the western sub-area of the city may result from a concentration of office buildings in
461 that region, which were slower to be repaired than residential structures that predominate in
462 other sub-areas. It is also possible that directional patterns in damage may be associated with
463 shielding from tall buildings, although such effects can only be speculated upon at the present
464 time and are not discussed further here.

Figure 17 (a) Structural and (b) façade damage distributions by all surveyed areas and sub-areas.

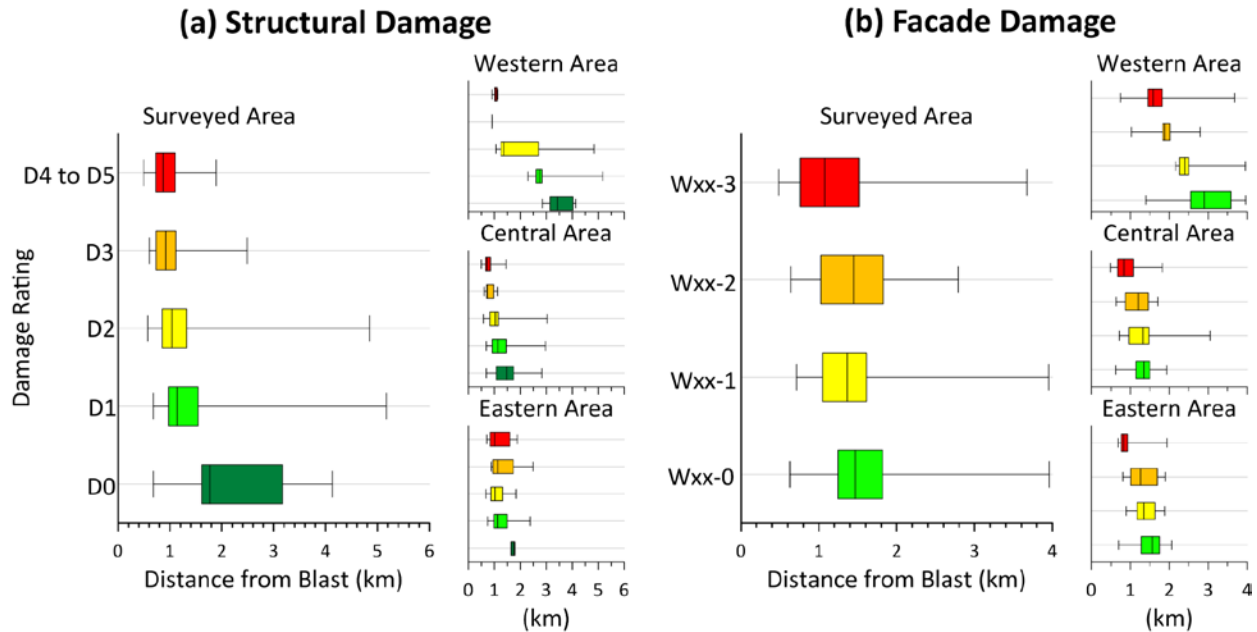
façades that were assessed in this area are along the coastline with a direct line-of-sight to the

477 explosion. As a consequence, there are fewer complicating factors (shielding, etc.) that might
478 impede the natural attenuation of damage with distance.

480 **Figure 18** (a) Structural and (b) façade damage variations with distance for all surveyed areas and sub-
481 areas

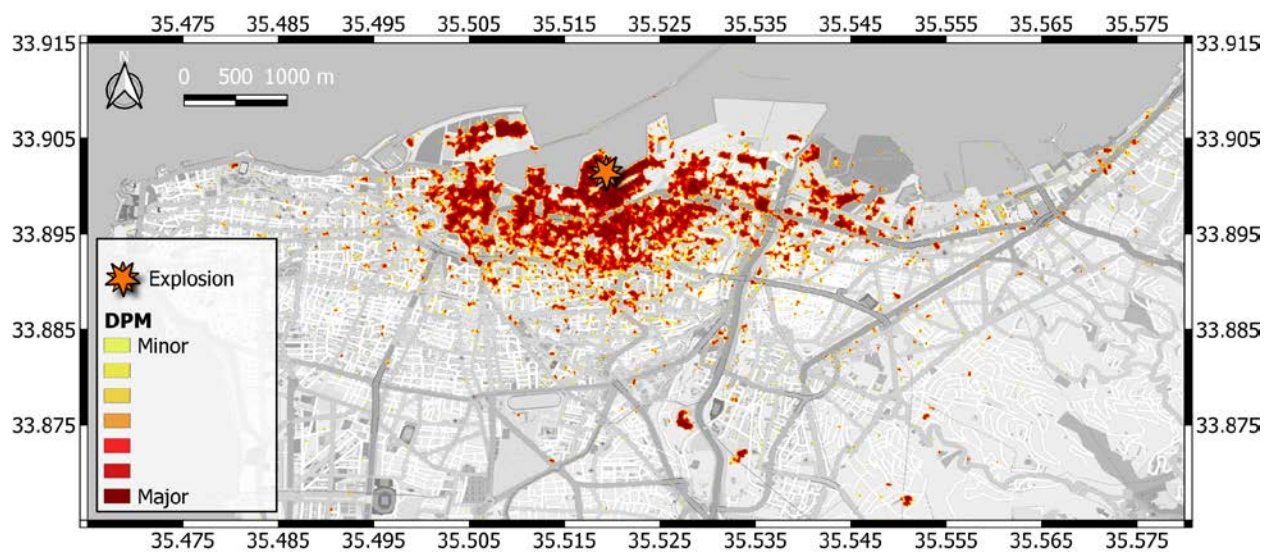
489 Following the August 4, 2020 Beirut explosion, a DPM was produced using SAR radar data from
490 the Copernicus Sentinel-1 satellites. This DPM was generated by comparing pre- and post-
491 explosion SAR scenes acquired from four different tracks. The satellite tracks view Beirut from

492 the west (two) and the east (two), with look-angles from vertical ranging between 31°-44°. The
493 map used 12 pre-event and two post-event SAR scenes between May 1, 2020 and September 1,
494 2020. The map covers an area of 13 by 16 km (Figure 19). Each pixel size is about 10 by 10 m.
495 Colored pixels represent zones where there was significant change in radar wave scattering at
496 the reflectors (i.e., ground surface or buildings), which may indicate damage from the stressing
497 event.

498
499 **Figure 19:** DPM produced following the 4 August, 2020 blast explosion (data source: NASA-JPL)

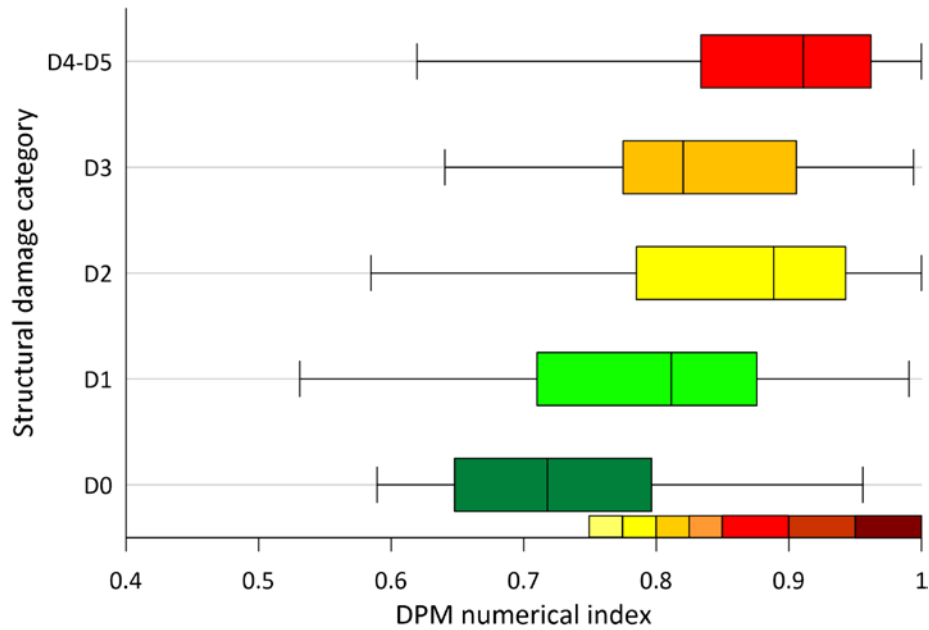
500
501 Figure 20 shows a box and whisker plot highlighting how DPM correlates with structural damage;
502 DPM in this plot has been converted to a numerical index between 0 and 1.0. This index
503 corresponds to the colors on maps over the index range of 0.75-1.0, as shown in the plot (the
504 index range of 0-0.75 produces no map coloration). The undamaged structures consistently occur
505 at index values < 0.75, and the damaged structures occur at index values > 0.75. Among
506 structures with damage (classes D1 to D5), DPM index is highest for structures with full or partial

507 collapse (D4-D5) (median > 0.9) and is approximately the same (median of about 0.8) for
 508 structures with lower damage states D1 to D3. This indicates an ability of the DPM index to
 509 distinguish among damage levels at a high level (no damage, damage, collapse), but not to
 510 distinguish among damage levels short of collapse.

511 **Figure 20:** Relationship between numerical index of DPM (0-1) and structural damage categories
 512

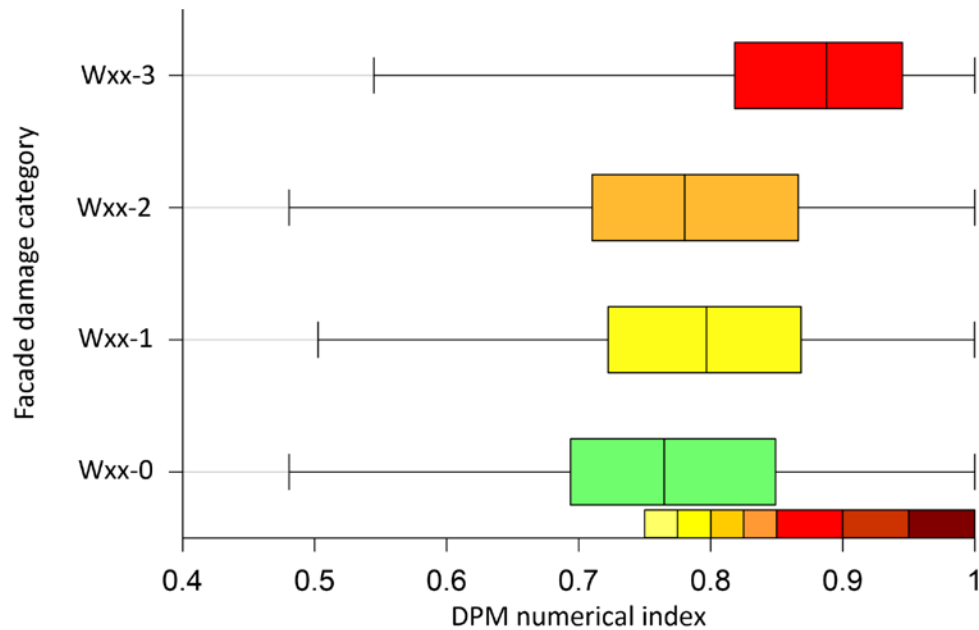
513 Figure 21 shows a box and whisker plot highlighting how DPM correlates with façade damage.
 514 The undamaged state (Wxx-0) has a median DPM index near the lower limit of shading (about
 515 0.75). Among structures with façade damage, DPM index cannot distinguish between damage
 516 levels Wxx-1 and Wxx-2 (median DPM index of about 0.8), whereas the strongest level of damage
 517 (Wxx-3) has a clearly higher median DPM index of 0.9.

519 **Figure 21:** Relationship between numerical index of DPM (0-1) and façade damage categories.
520
