Collapse of a concrete wall building in the 2010 Chile Earthquake

Report No.
UCB/SEMM-2014/02

Ahmet Can Tanyeri, and Jack P. Moehle

March 2014

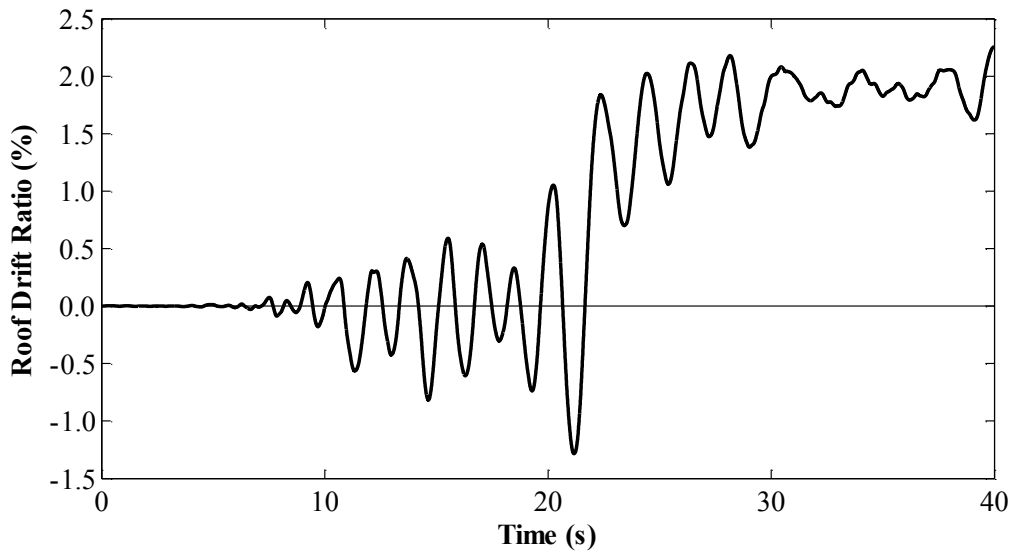
Calculated moment-drift relations and displacement response histories of the SDOF model subjected to the Concepción motion are plotted in Figures 20 and 21. It is worth noting that after a deformation cycle as large as 1.3% roof drift ratio in the west direction, the SDOF model collapses to the east (collapse) direction at around 22 seconds of the excitation. The final result of the dynamic SDOF analysis is consistent with the observed damage and collapse of the building.

Fig. 20 - Moment–drift ratio response of the SDOF model under the Concepción ground motion (Note: 1 kN.m = 0.7375 kip.ft)
