Monitoring channel change at the Sausal Creek Restoration Project, Oakland, California

MONITORING CHANNEL CHANGE AT THE SAUSAL CREEK  
RESTORATION PROJECT, OAKLAND, CALIFORNIA

University of California  
Landscape Architecture 222  
Professor G. Mathias Kondolf  
Spring 2006

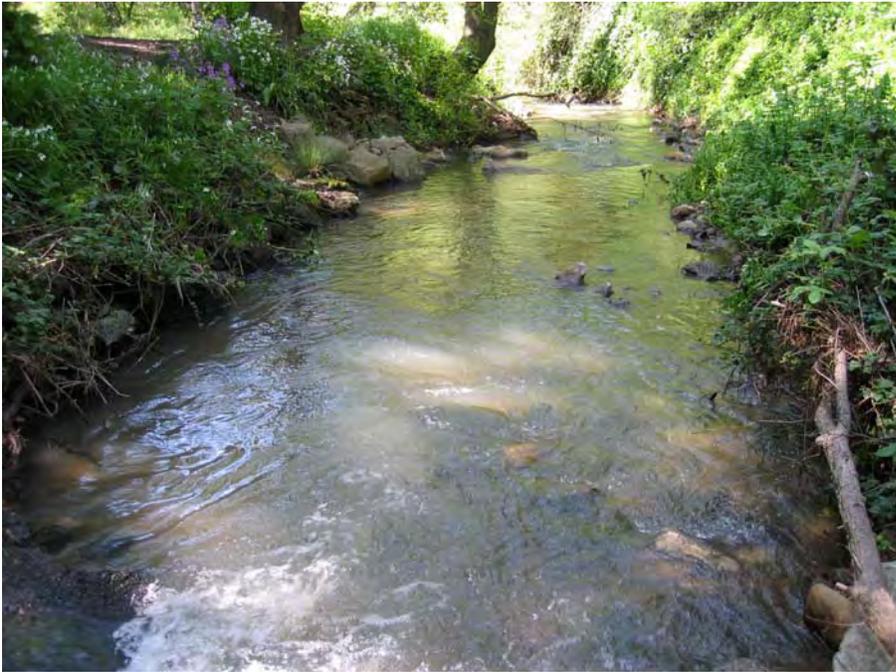
**Figure 3. Post-Project, Current Conditions of Sausal Creek**

Steep, vegetated banks and cobble streambed within typical channel section of upper reach of Sausal Creek.  
Photo: Kate Tollefson (KT), 4/26/06

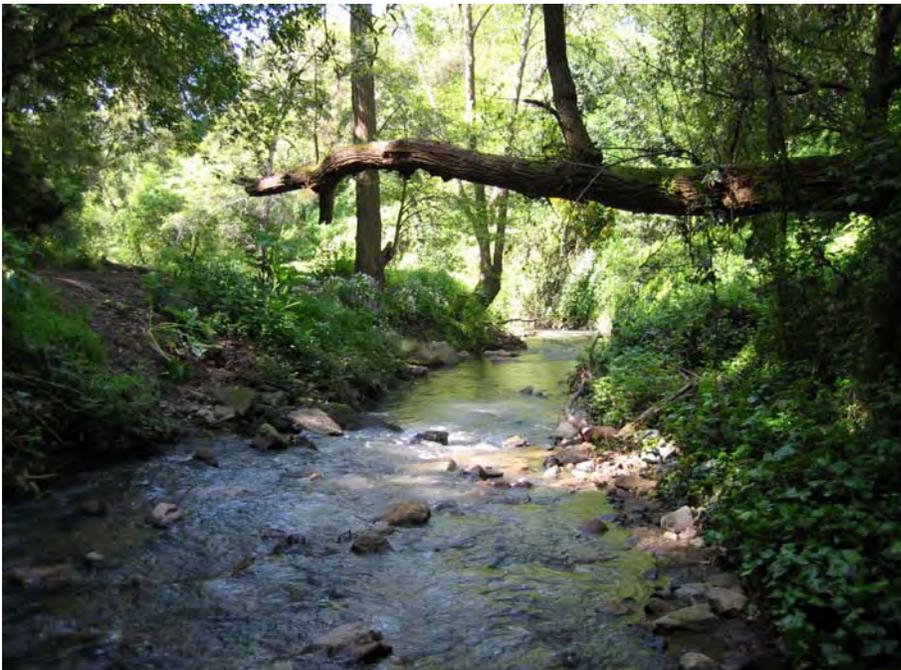
**Figure 4. Post-Project, Current Conditions of Sausal Creek**

Dense riparian vegetation and shaded streambed within typical channel section of upper Sausal Creek.  
Photo: KT, 4/20/06

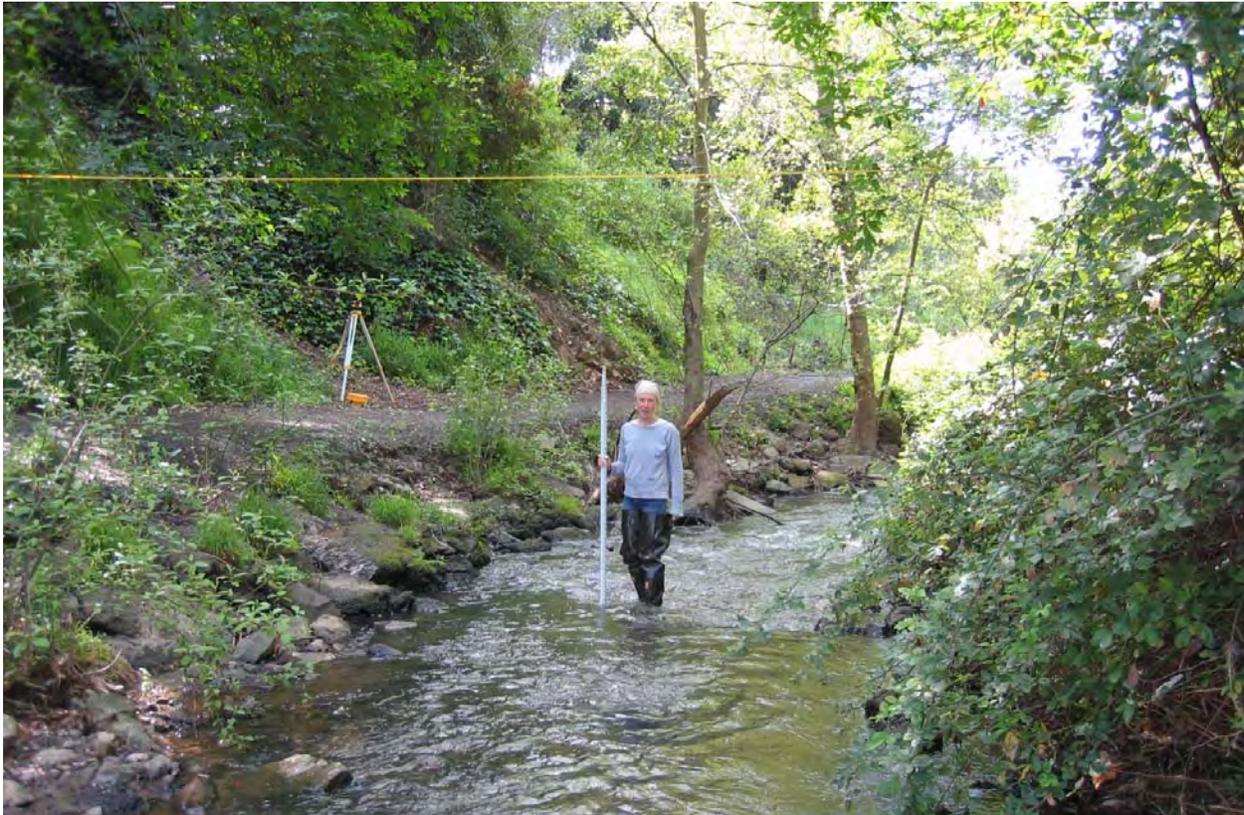
**Figure 14. Cross Section A Channel Conditions**

Channel survey at cross-section A, facing downstream at lower portion of restoration reach. Photo: TG, 4/20/06

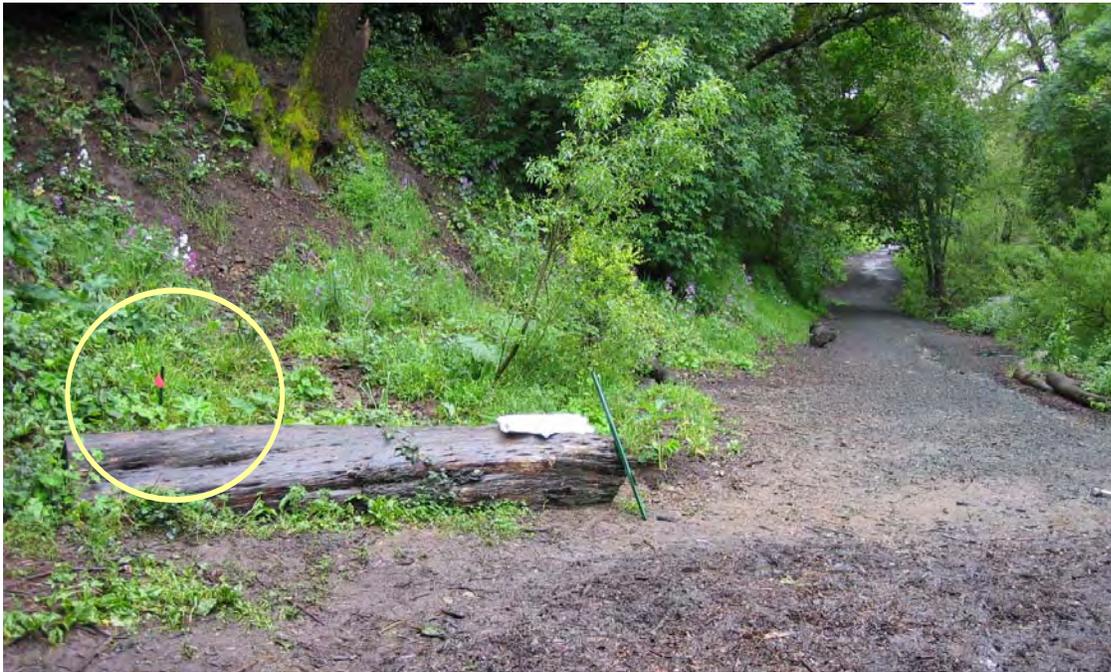
Figure 19. Cross Section C Marker

Cross-section C marker located behind log, at downstream end of wide terrace along trail.  
Photo: KT, 4/12/06

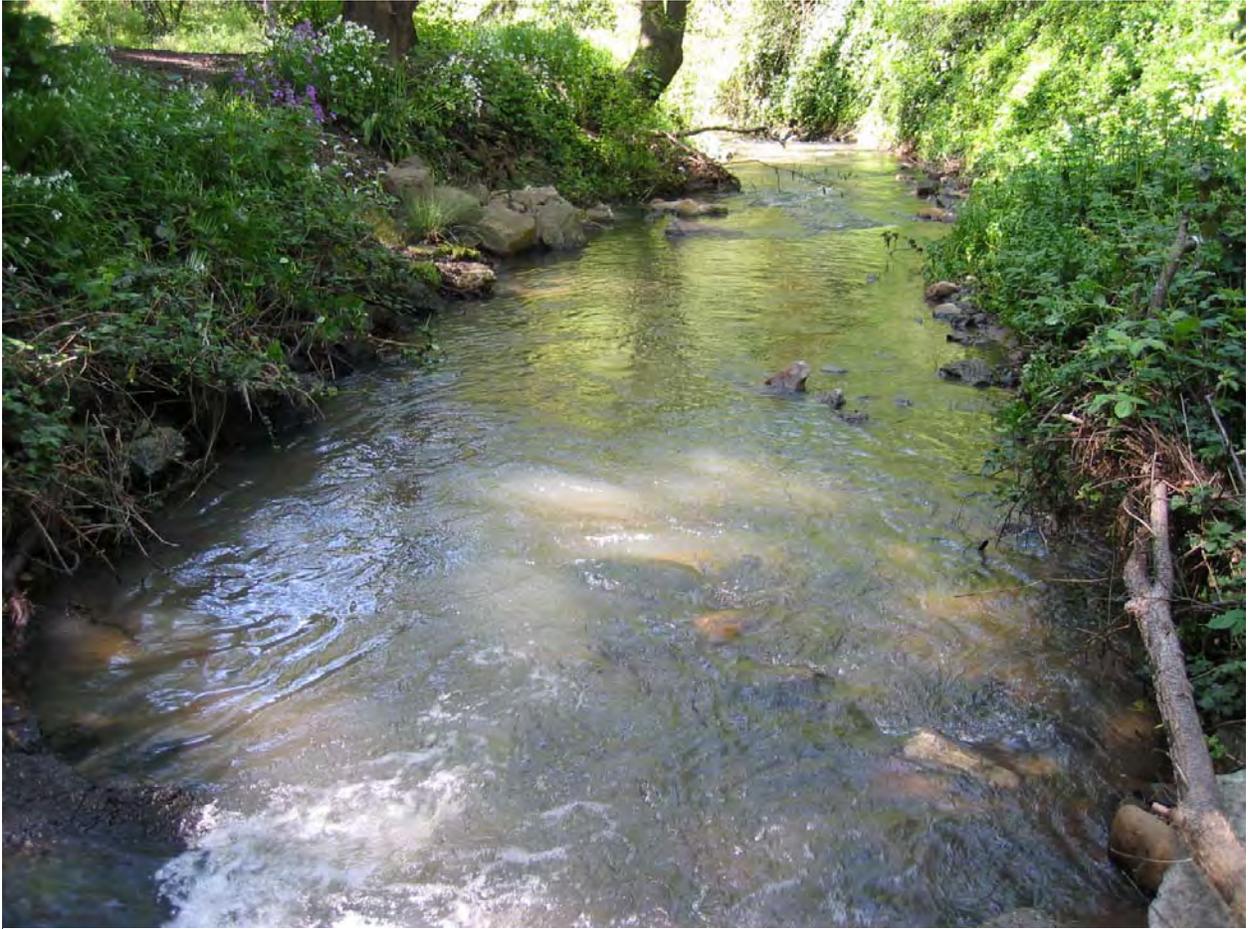
**Figure 24. Cross Section D Channel Conditions**

Stream channel at cross-section D. Photo facing downstream: KT, 4/20/06

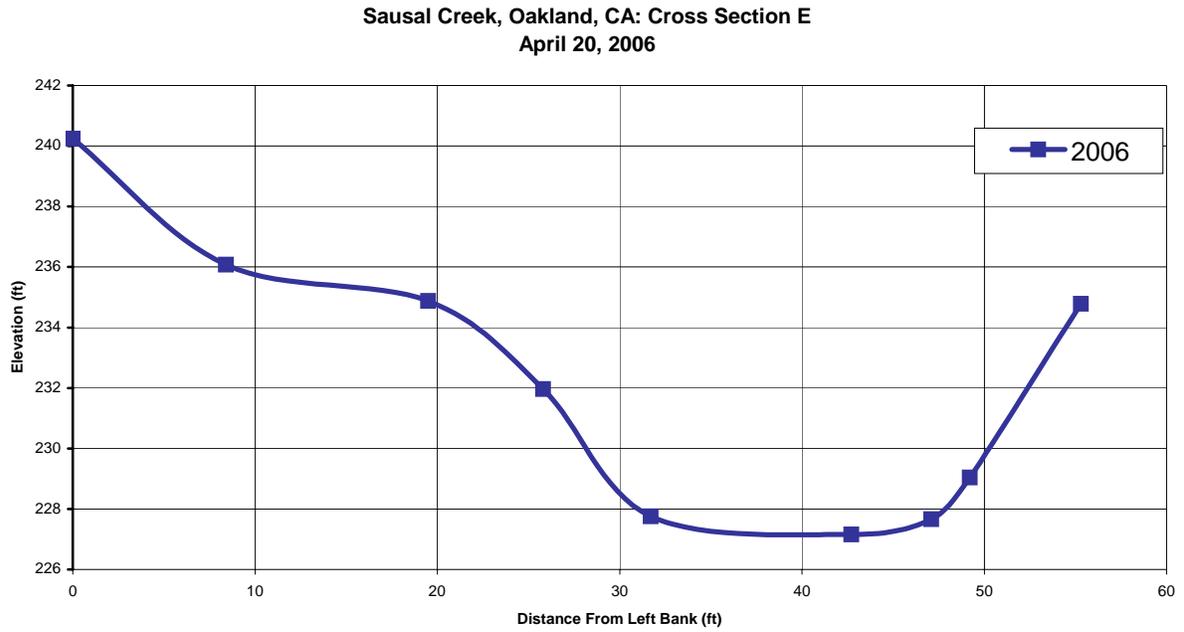
Figure 25. Cross Section E Survey

We did not locate the rebar for cross-section E and the 2005 survey was conducted in an unreferenced location. The 2006 survey establishes baseline conditions (Figure 25). A post marker was placed 200 feet from Cross Section D, along the trail in the upstream direction. The post marker is located immediately down slope from a large (3.5-foot dbh) two-trunk buckeye tree (Figure 26). The cross section is aligned with a rock weir in the stream (Figure 27). On the north bank of the stream, in alignment with the cross section, large limbs from a bay tree extend over the banks and stream (Figure 28). A portion of a concrete wall is exposed on the north side of the trail, roughly at the same elevation of the trail surface, and the top of the stream bank slope.

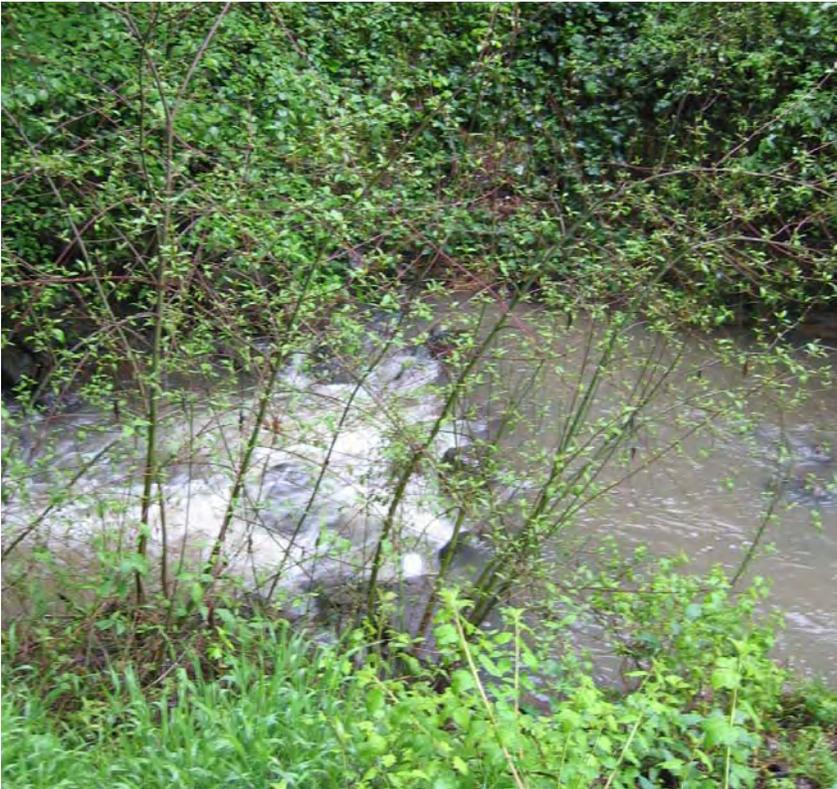
**Figure 27. Weir near Cross Section E**

Rock weir near cross-section E installed as part of restoration project. Photo: TG, 4/12/06

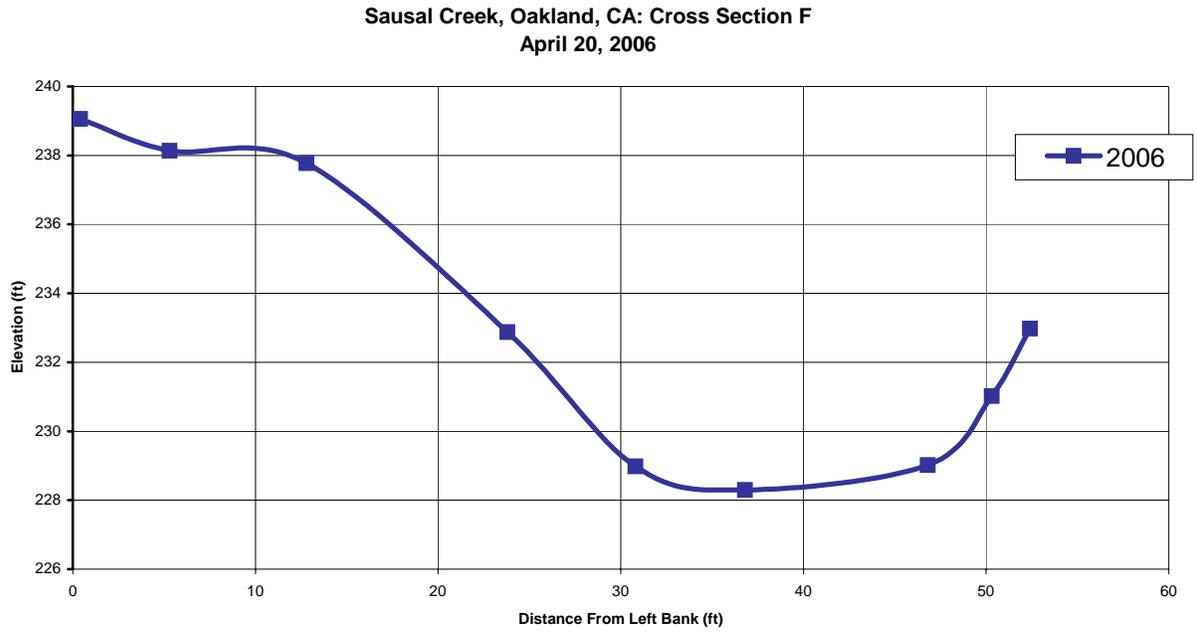
**Figure 29. Cross Section F Survey**

Therefore, the cross-section location survey establishes baseline conditions (Figure 29). The new post marker is located along the trail, 62 feet past Cross Section E. The post is located at the toe of a steep slope, before the trail bends sharply to the south (Figure 30). Herbaceous vegetation surrounding the post marker includes poison oak (*Toxicodendron diversilobum*). A bay tree (1-foot dbh) is growing on the slope, approximately 20 feet above the post marker. A rock weir is located approximately 4-feet downstream of the cross section alignment. The bank between the trail and stream is vegetated with dense willows (*Salix* spp.). Several mature oak trees occur on the upper slopes of the opposite (northern) side of the stream.

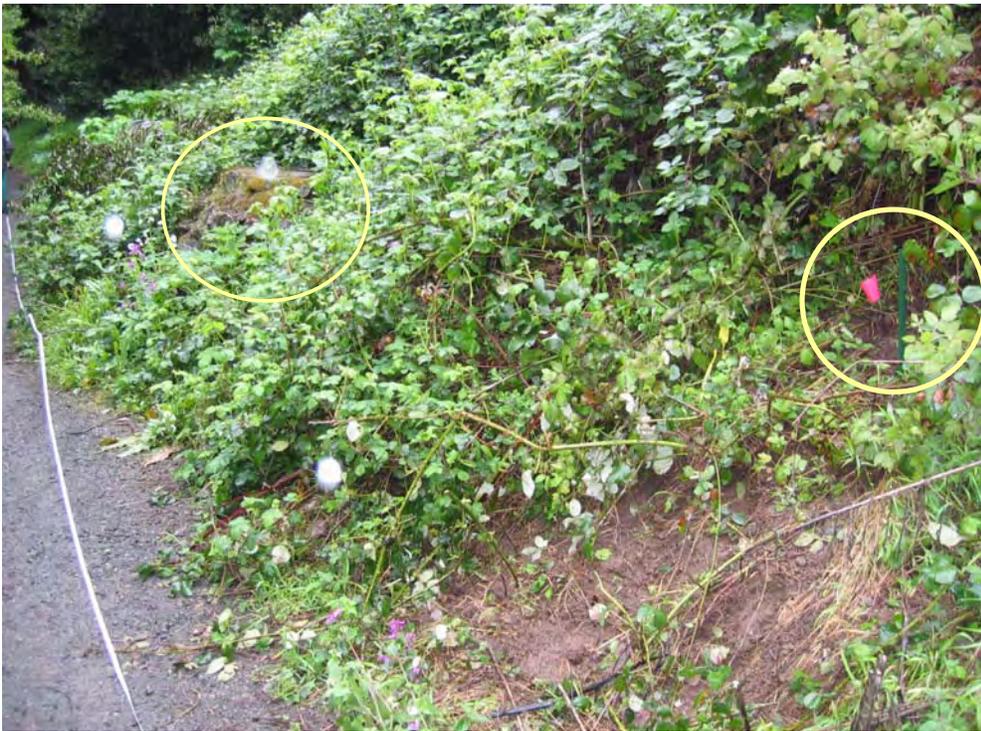
Figure 34. Cross Section H Marker

Cross Section H occurs 126 feet along the trail past Cross Section G. A sewer manhole (56-000-65) is located on the side of the trail, 19 feet (on-center) past the post marker for Cross Section H (Figure 34). The post marker is approximately 4-feet from trail edge, on a slope densely vegetated with blackberry (*Rubus* sp.) and other shrub species.

Cross-section H marker in circle on right and manhole (56-000-65) in circle on left. Photo: KT, 4/12/06

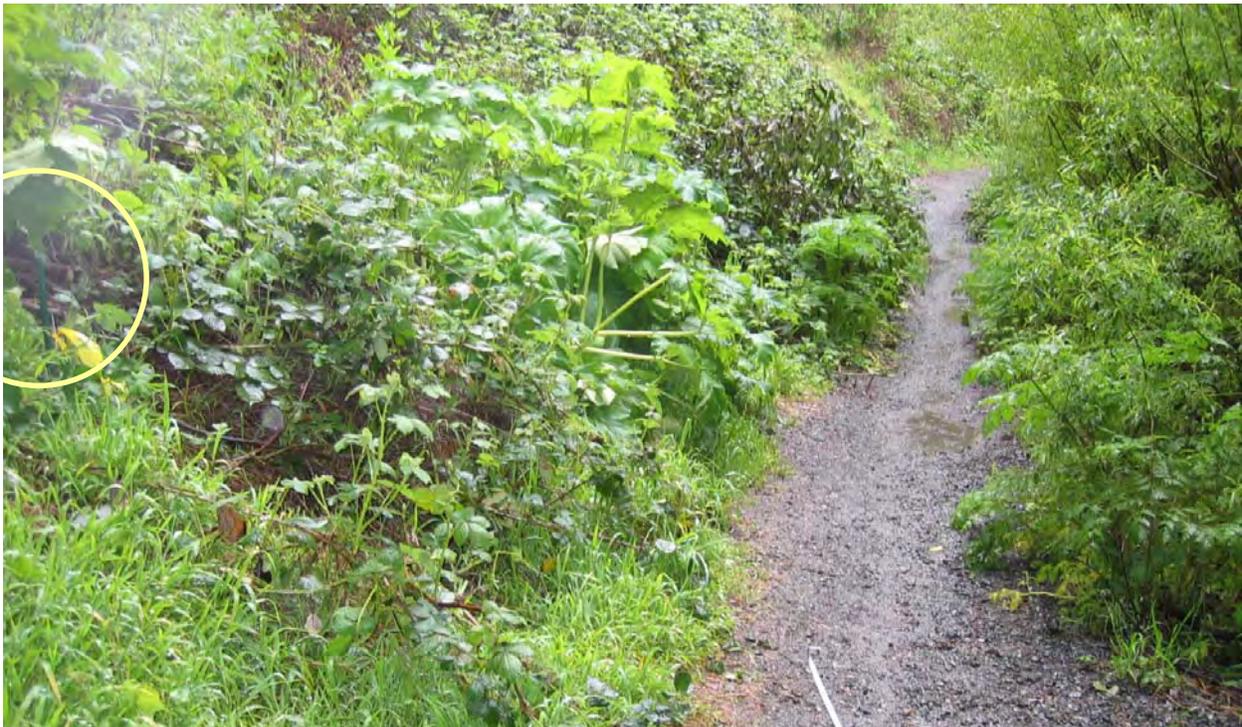
Figure 36. Cross Section I Marker

The post occurs on a moderately steep slope, densely vegetated with herbaceous and shrub species (Figure 36). No distinctive trees occur in the immediate vicinity of the post, although a multi-trunk bay tree is located on the trail bank, approximately 40-feet away in the upstream direction. At the time of the 2006 survey, a large bay tree had fallen in the stream channel, across the cross-section alignment (Figure 37).

Post marker for cross-section I, looking in downstream direction along trail. Photo: TG, 4/12/06.

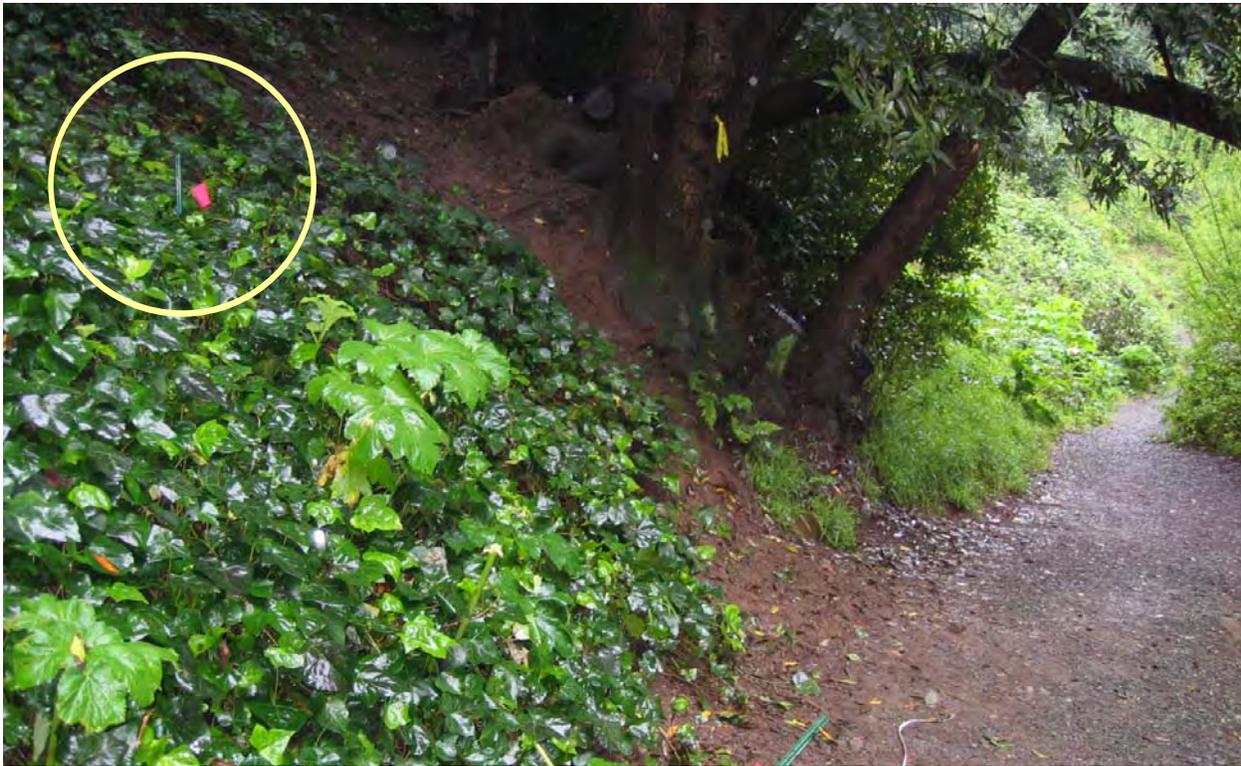
Figure 39. Cross Section J Marker

We installed a new post marker for cross section J, located 50 feet past Cross Section I, approximately 10 feet past the multi-trunk bay tree (1-foot average dbh). The post marker is located on a moderate slope covered by English ivy (*Hedera helix*) (Figure 39). A rock weir is located approximately 5 feet downstream of the Cross Section J alignment (Figure 40).

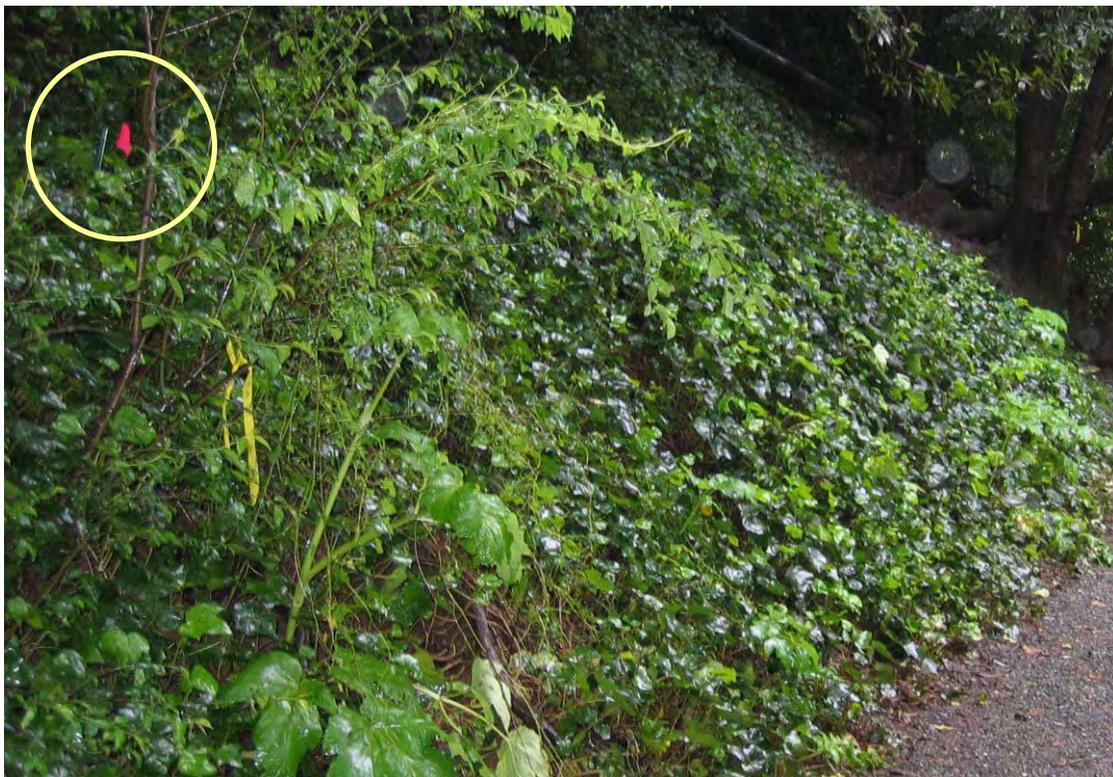
**Figure 43. Cross Section K Marker**

The cross section marker is located 41 feet along the trail past Cross Section J (in the upstream direction). The post marker is located on a slope covered by English ivy (Figure 43). The stream channel at the cross-section location is densely vegetated with willow trees and a rock weir occurs approximately 5 feet downstream of the cross-section alignment (Figure 44).

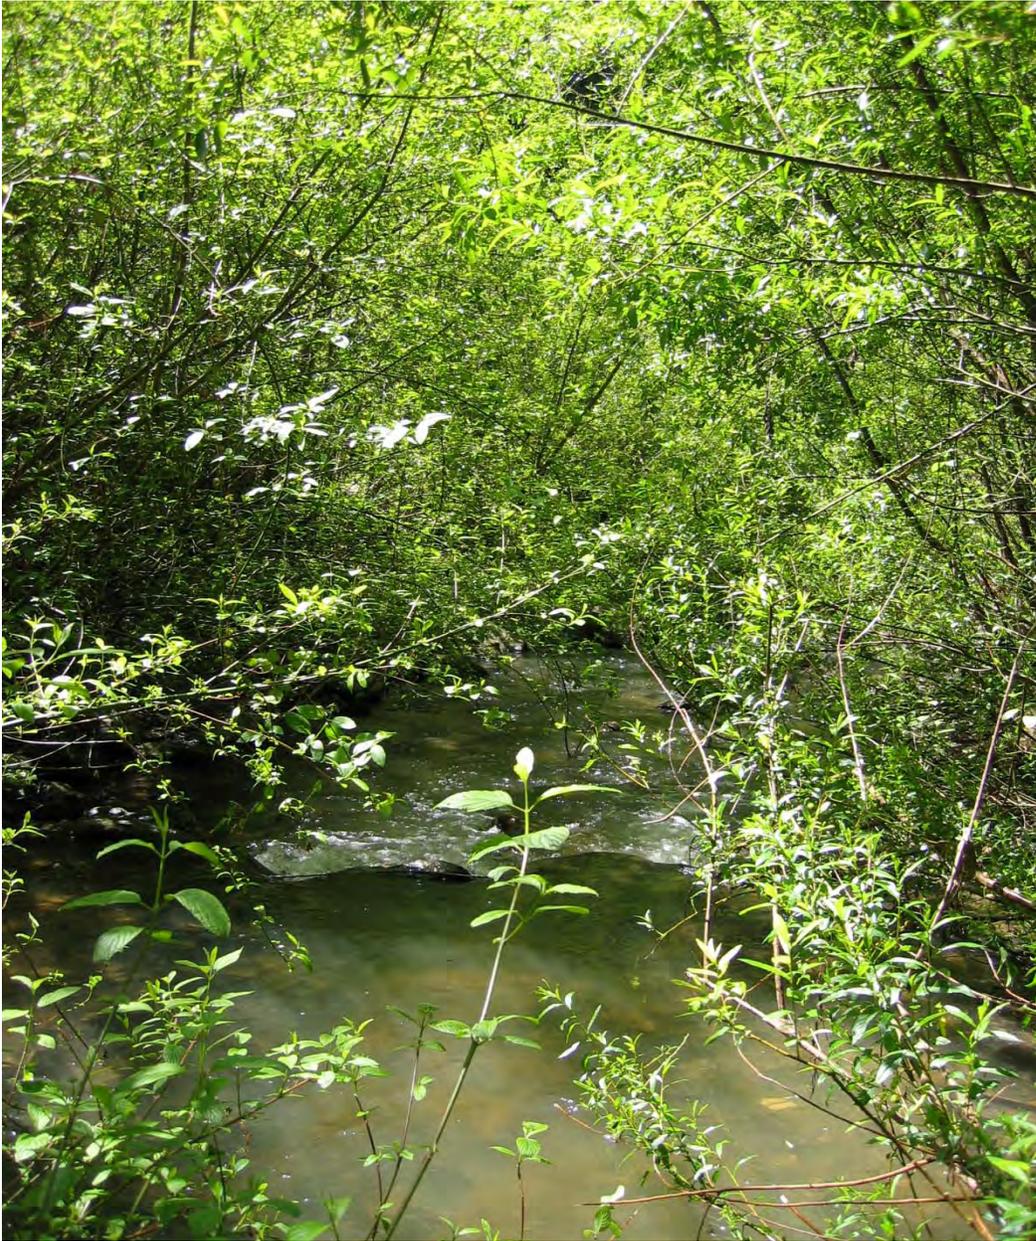
**Figure 44. Cross Section K Channel Conditions**

Dense riparian vegetation and rock weir downstream of cross-section K alignment.  
Photo: KT, 4/20/06
