Post-Project Assessment of the 2003 Cerrito Creek Restoration and Recommendations for Additional Stormwater Management

Michelle Adlong, Michael Cook, Matthew Kennedy

December 14, 2011 - LAEP 227

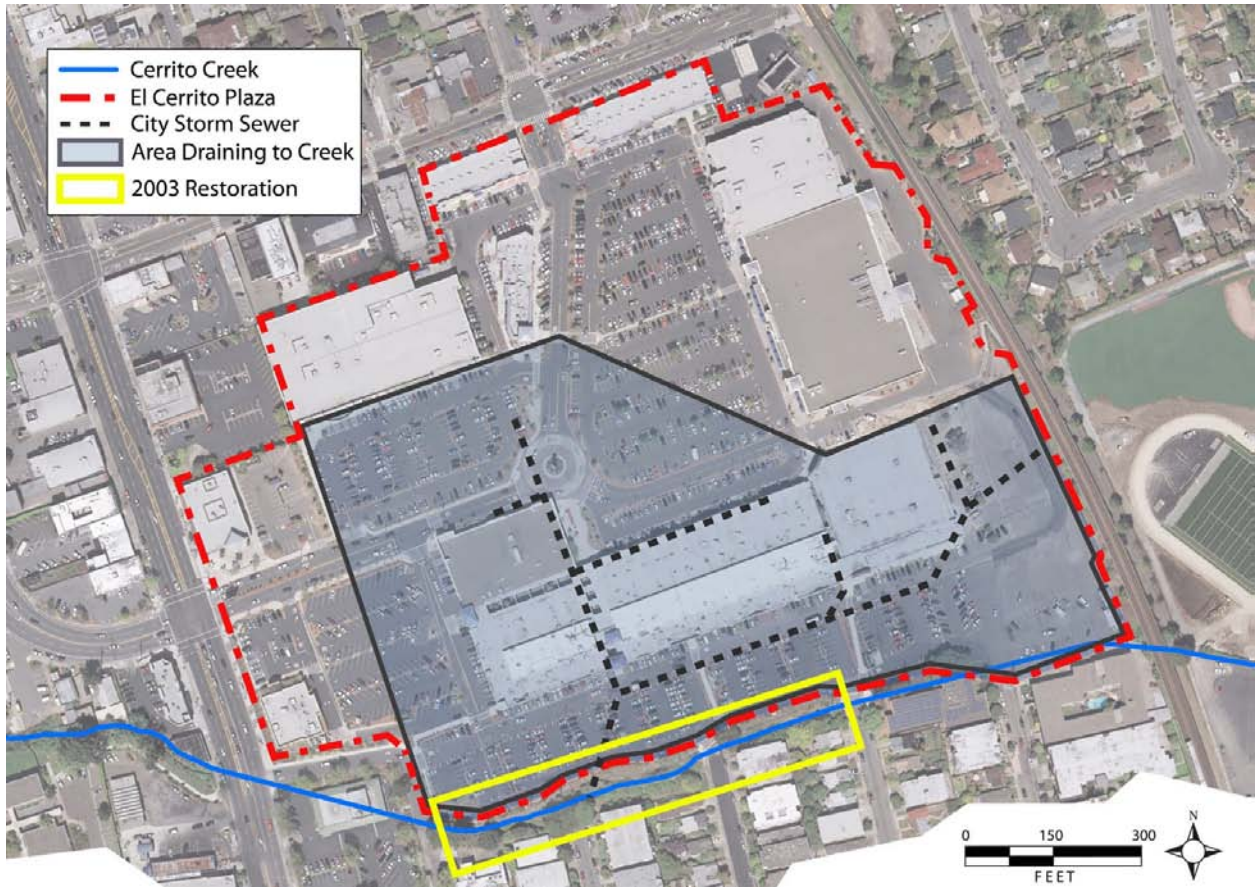
Figure 3: Map of Cerrito Plaza and Cerrito Creek showing area of impervious surface discharging directly to reach of restoration project.

This study focuses on a 700-foot reach of the creek along the shopping center's southern border between Kains and Talbot Avenues. The reach receives 60% of the stormwater runoff from Cerrito Plaza (Figure 3). The reach underwent a restoration project in 2003 concurrently with a major renovation of the shopping center and parking areas. The restoration project removed concrete and asphalt from the channel's banks, widened the creek corridor by roughly 20 feet, re-contoured the creek, and re-planted the corridor with native riparian vegetation. The restoration project goals were the creation of a natural meandering channel, reduction of flooding and bank erosion, removal of invasive species, re-vegetation of slopes with native plants,

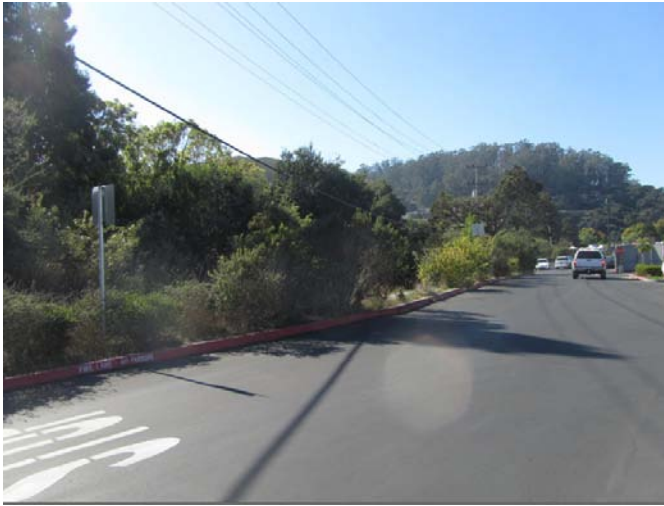
Figure B1: Edge of Cerrito Plaza parking lot and Cerrito Creek riparian zone, looking west (downstream) from Talbot Avenue.
