Tassajara Creek restoration project: Continued riparian habitat monitoring

**Tassajara Creek Restoration Project:
Continued Riparian Habitat Monitoring**

**Michelle Trinh and Julie Percelay
University of California, Berkeley**

December 12, 2008

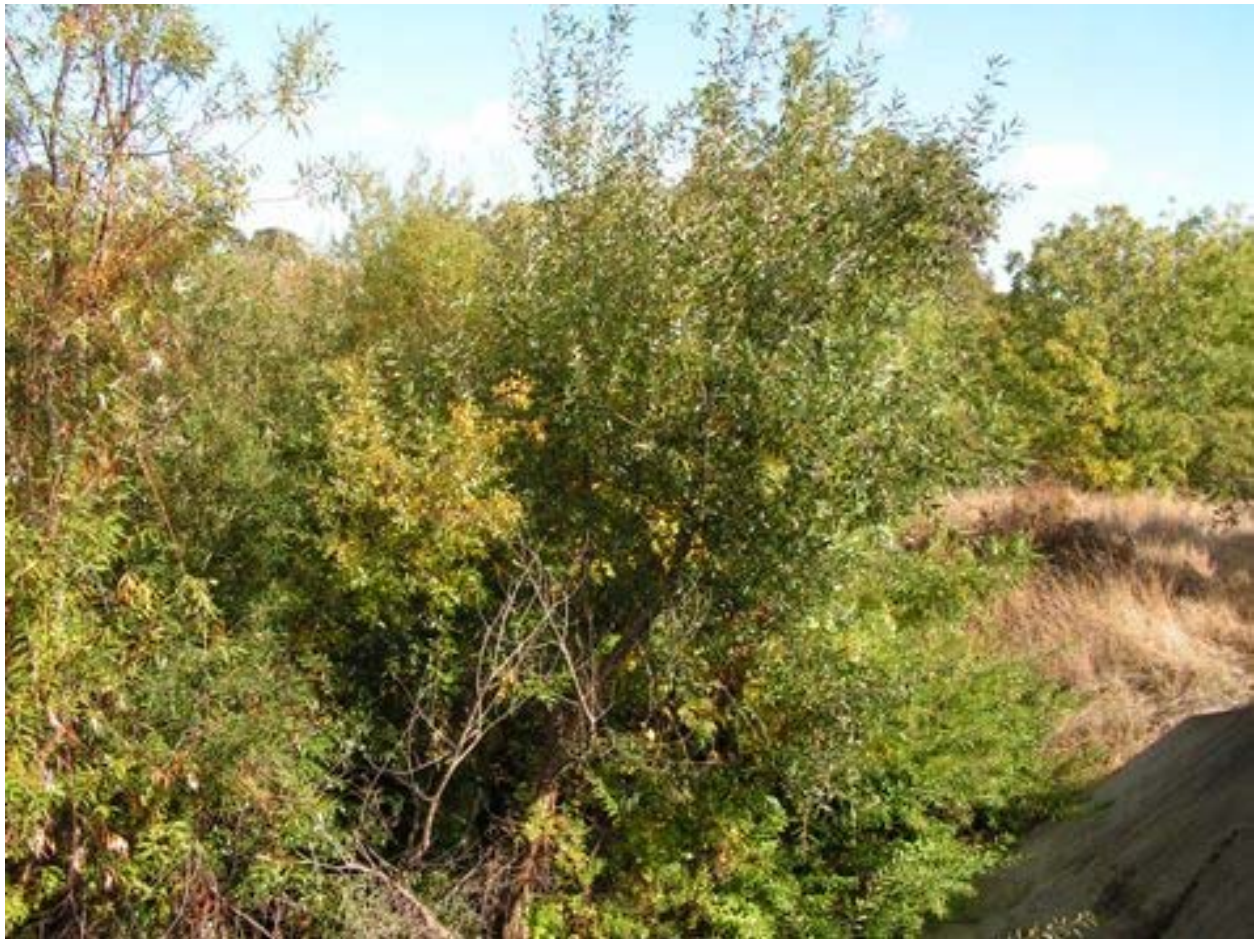
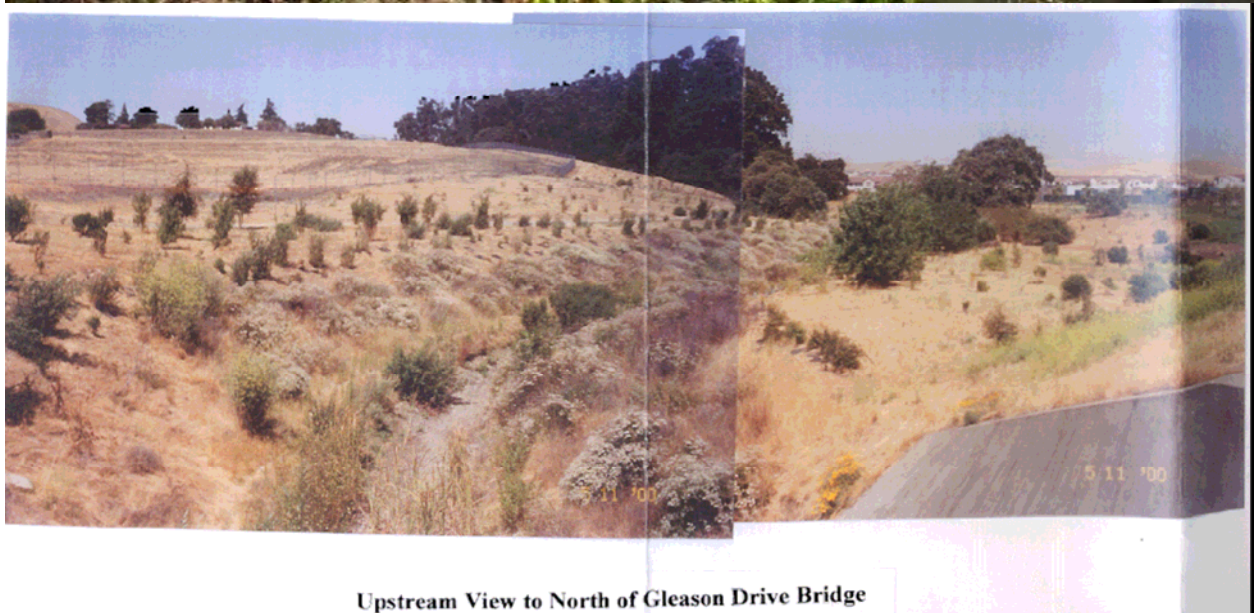
Upstream View to North of Gleason Drive Bridge

Figure 11: Upstream View of North of Gleason Drive Bridge (N 37 42.769' W 121 52.701'), top picture taken on November 4th 2008, bottom picture 2000 (Davis Environmental Consulting, 2001).

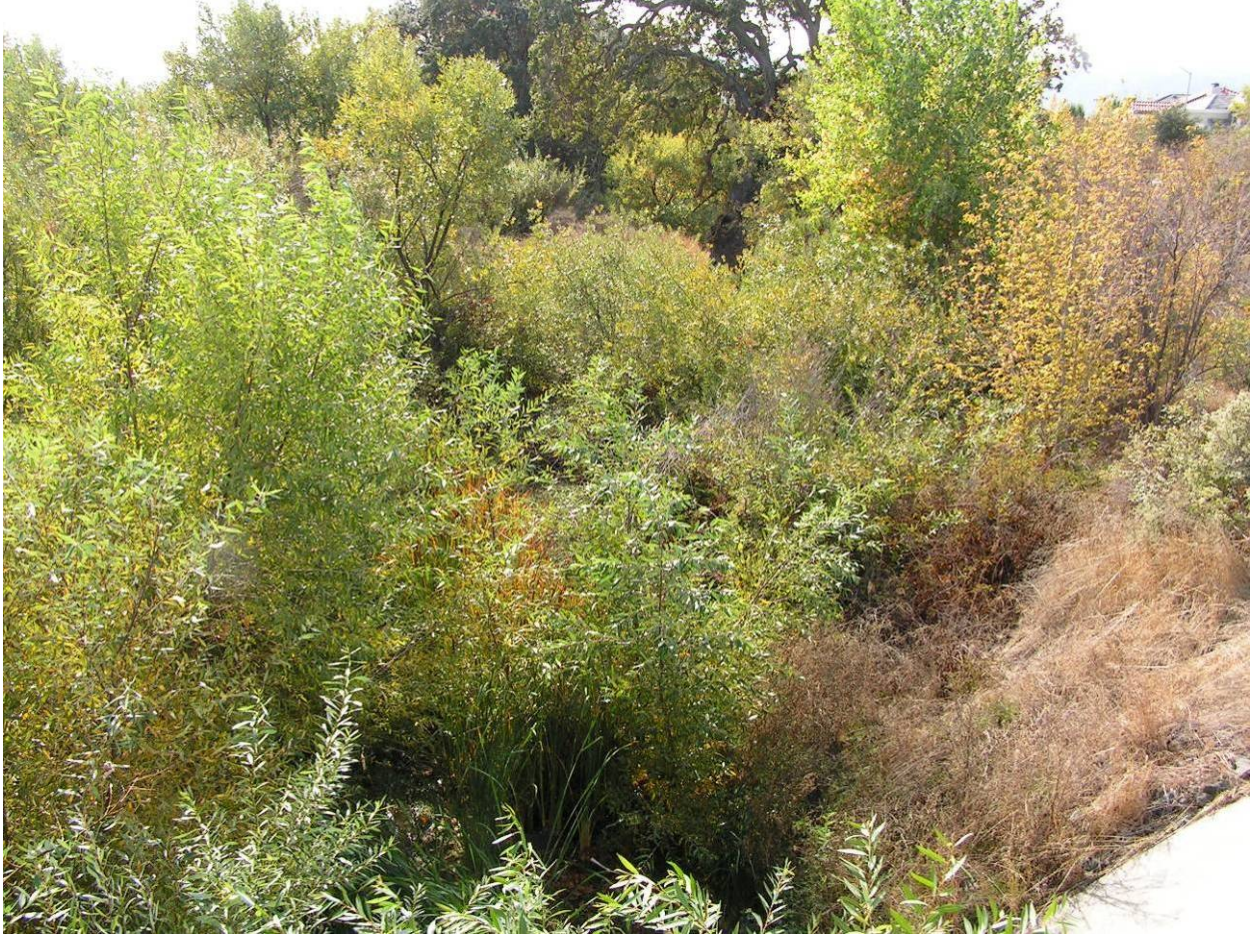
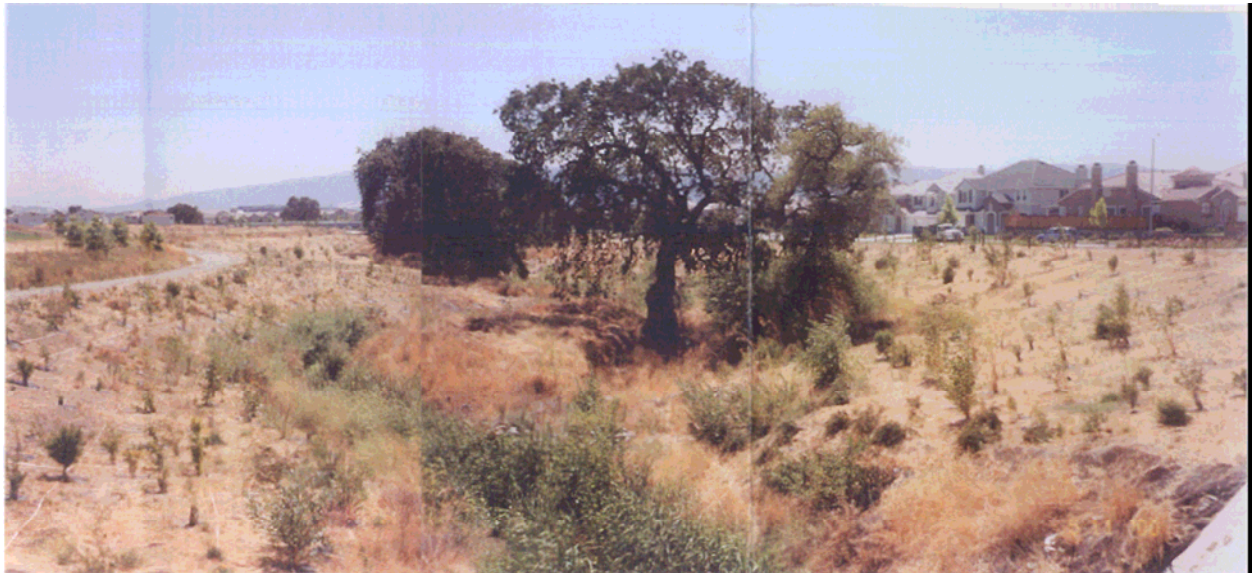
(Figures 14 and 16). The outer side of the floodplain and the river banks are typically fully vegetated (Figures 15, 17, 19, 20 and 21). Figure 12 shows the evolution in Reach 3. As in Reach 2, the river banks are fully vegetated and the floodplain has sparser wood riparian species coverage.

Figure 12: Downstream View to South of Gleason Drive Bridge (N 32 42.753' W 121 52.710'), top picture taken on November 4th 2008, bottom picture 2001 (Davis Environmental Consulting, 2001).

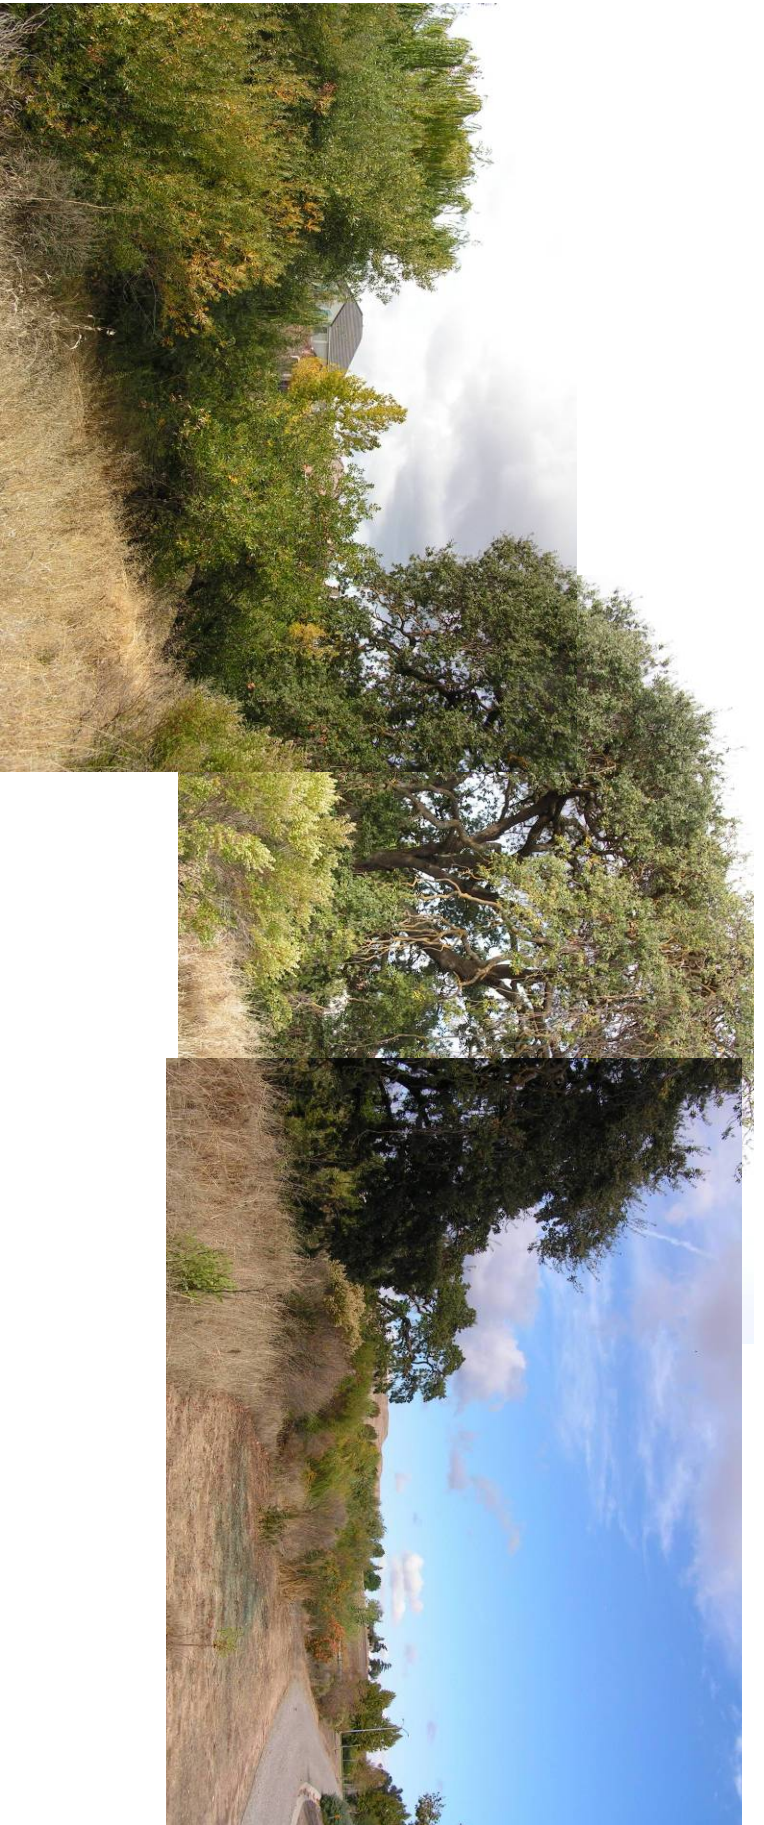
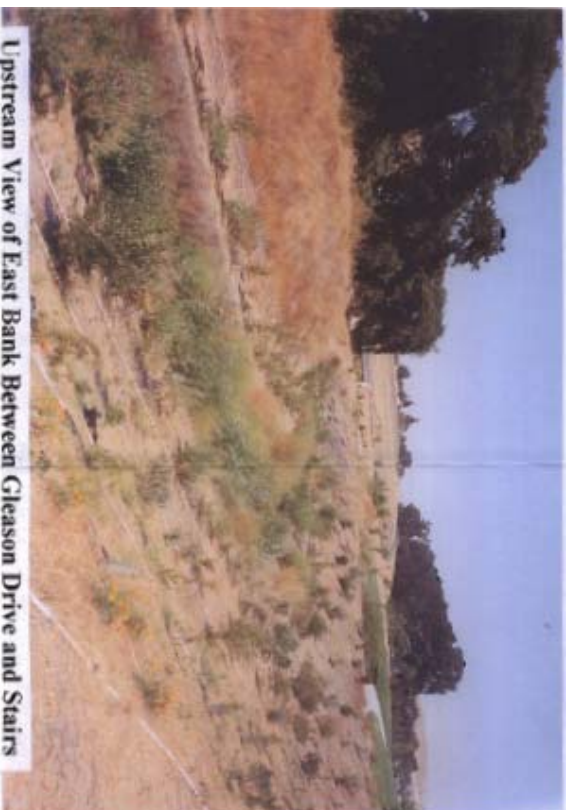
Upstream View of East Bank Between Gleason Drive and Stairs

Figure 13: Upstream View of East Bank Between Gleason Drive and Stairs, top picture taken on November 4th 2008, bottom picture taken in 2001 (Davis Environmental Consulting, 2001).

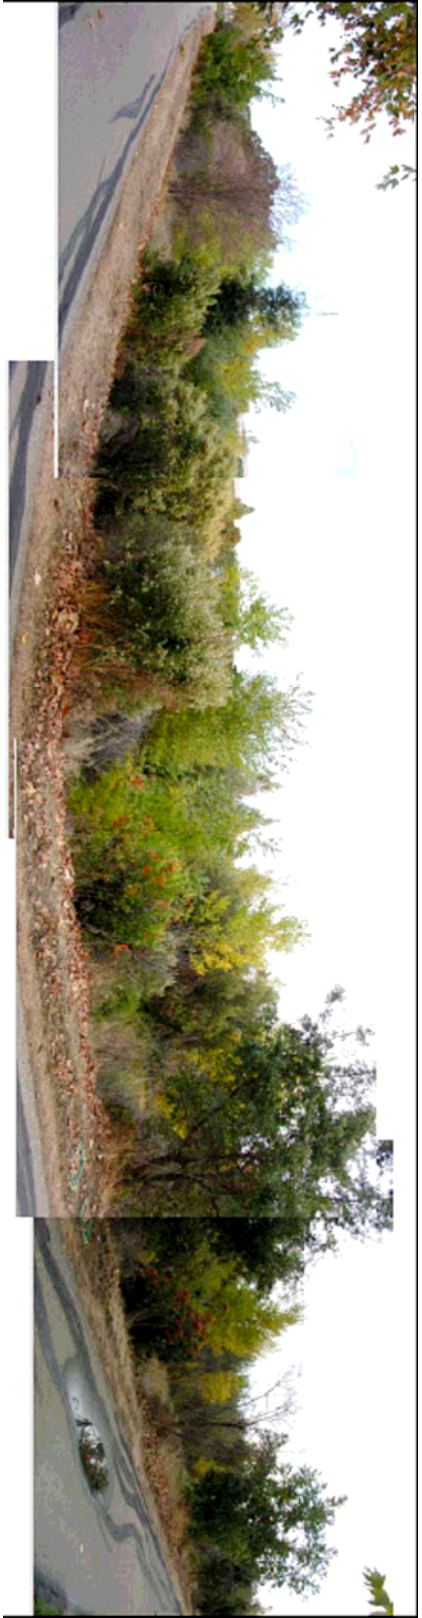
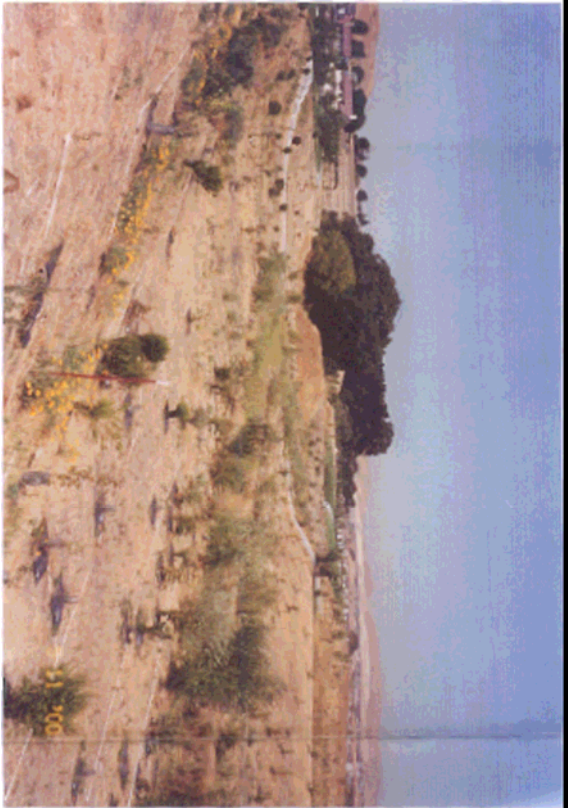
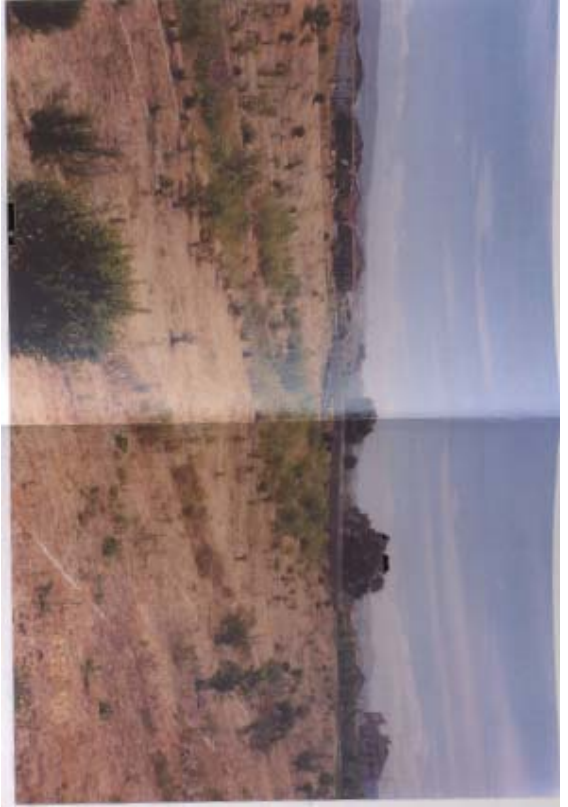
Figure 14: Panoramic Photo from West Bank Between Stairs and Central Parkway (N 37 42.604' W 121 52.805'), right picture taken on November 4th 2008, left picture taken in 2001 (Davis Environmental Consulting, 2001).

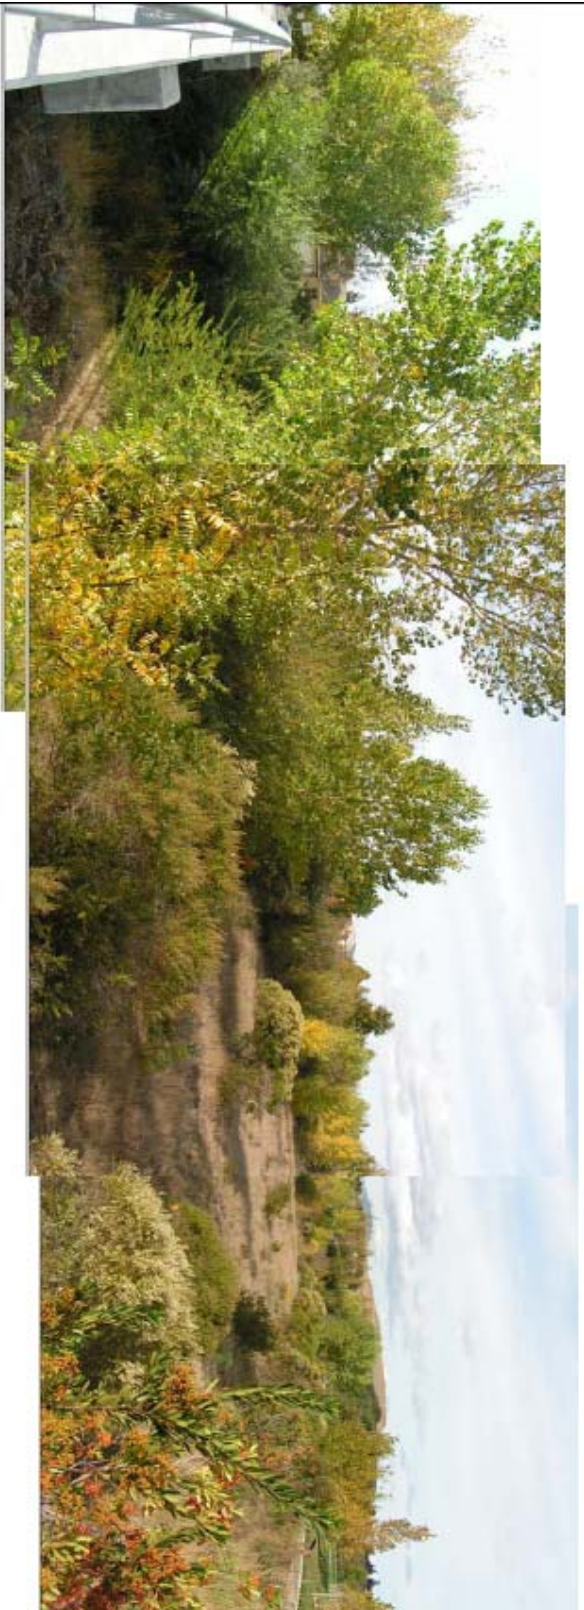
Figure 15: Upstream View to North Central Parkway Bridge, Left bank panoramic (N 37 42.529° W 121 52.763°)

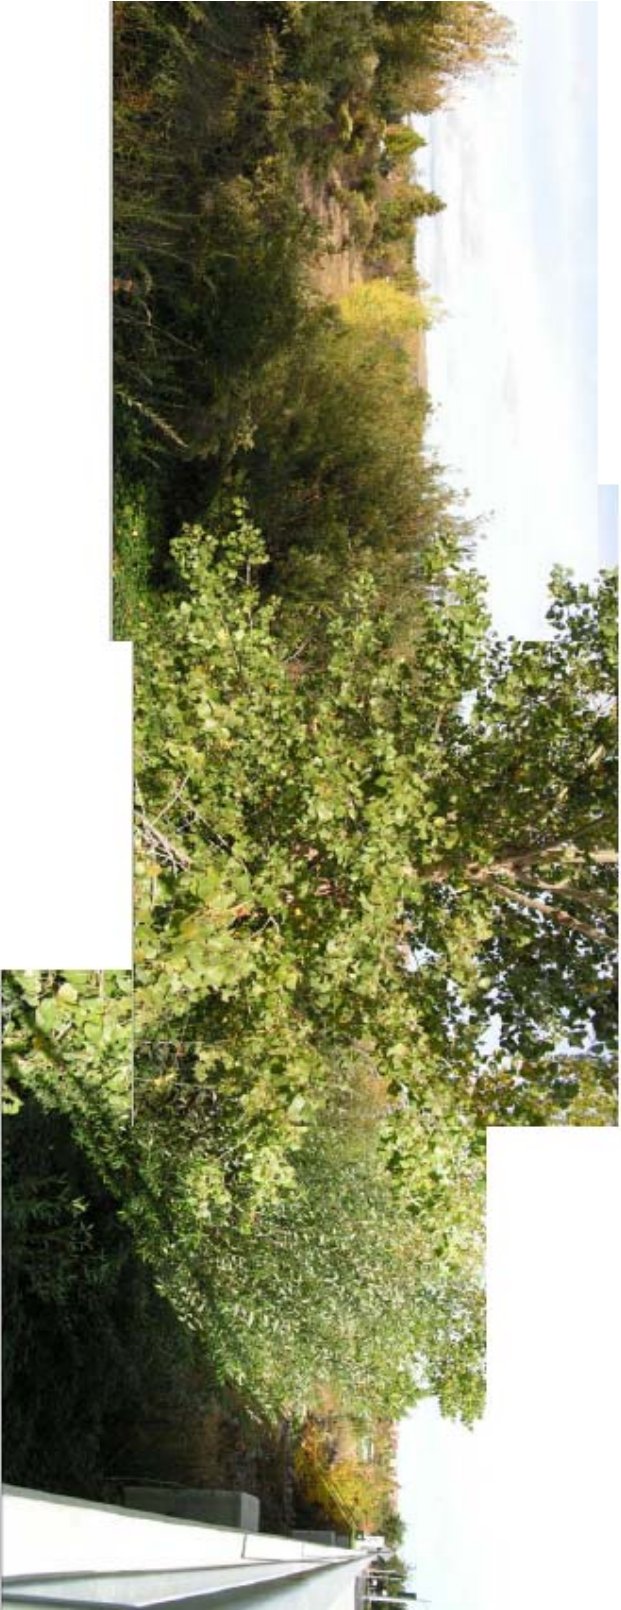
Figure 16: Upstream View to North of Central Parkway Bridge, Right Bank panoramic (N 37 42.527' W 121 52.791')

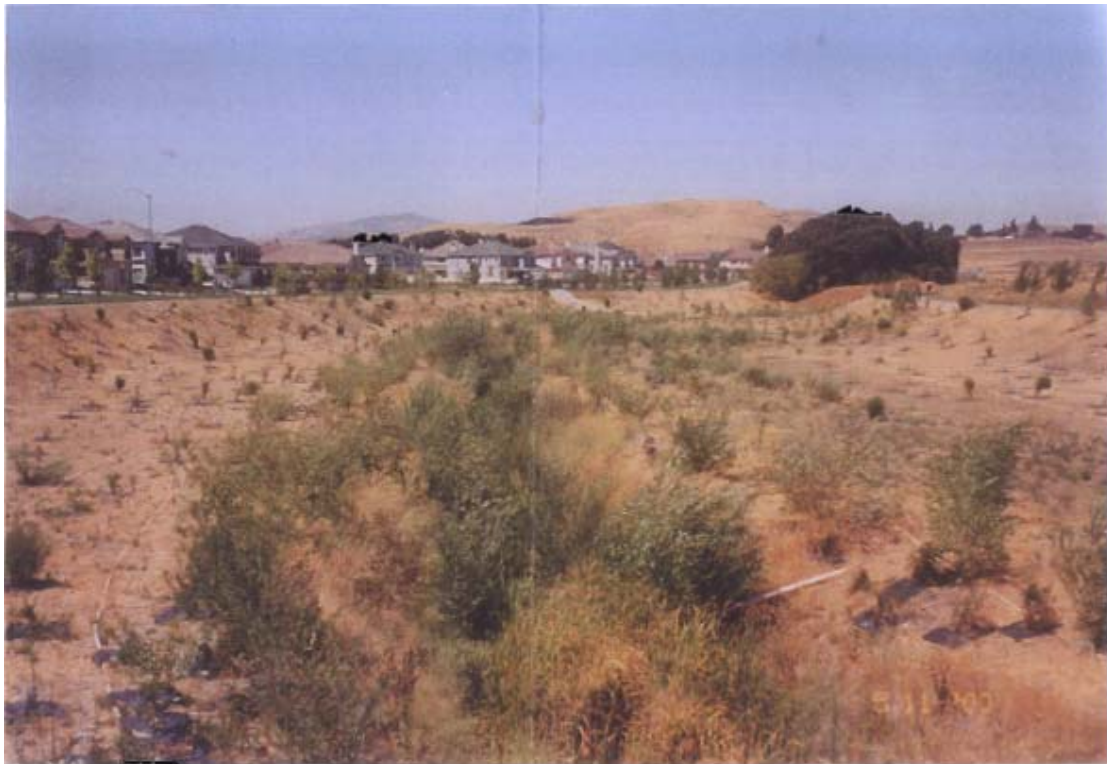
Upstream View to North of Central Parkway Bridge

Figure 17: Upstream View to North of Central Parkway Bridge, 2001 (Davis Environmental Consulting, 2001).

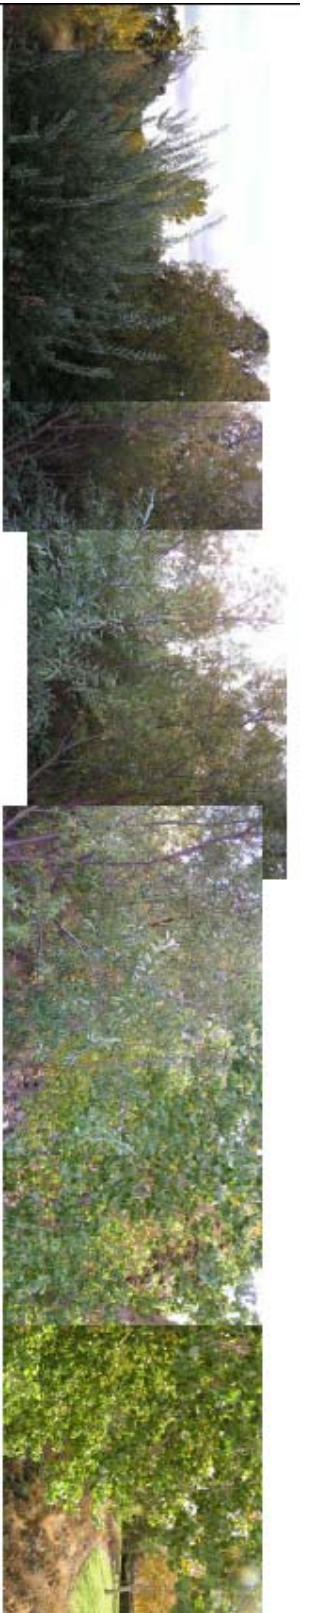
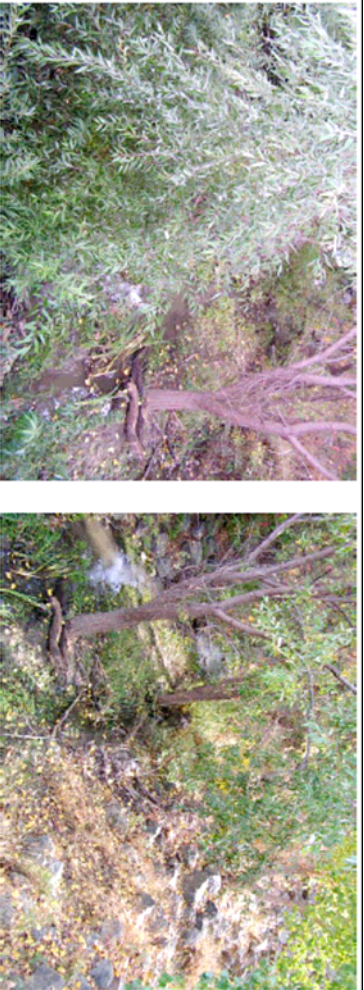
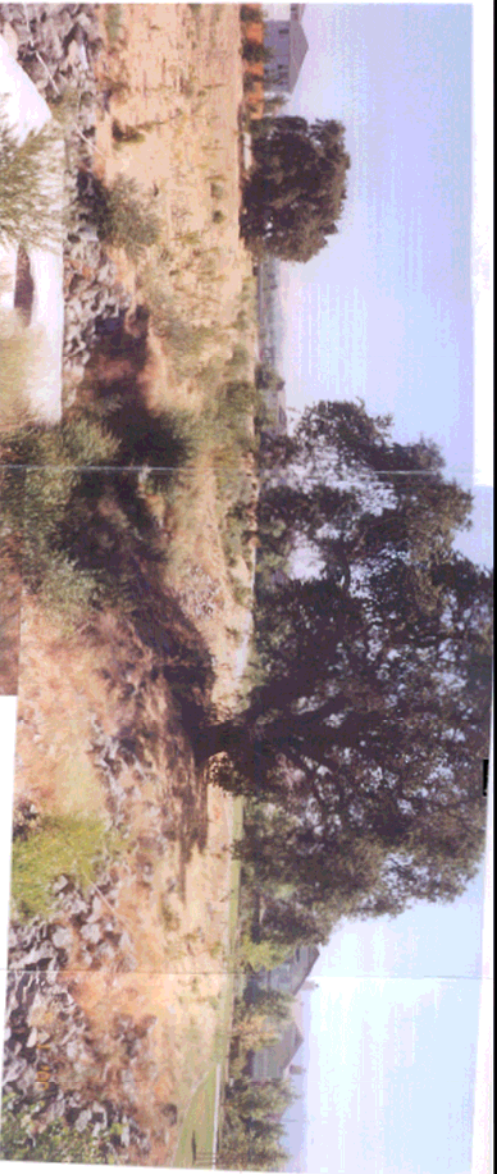
Downstream View to South of Central Parkway Bridge

Figure 18: Downstream View to South of Central Parkway (N 37 42.512' W 121 52.711' to N 37 42.510' W 121 52.784'), picture taken on November 4th 2008, bottom picture taken in 2001 (Davis Environmental Consulting, 2001).

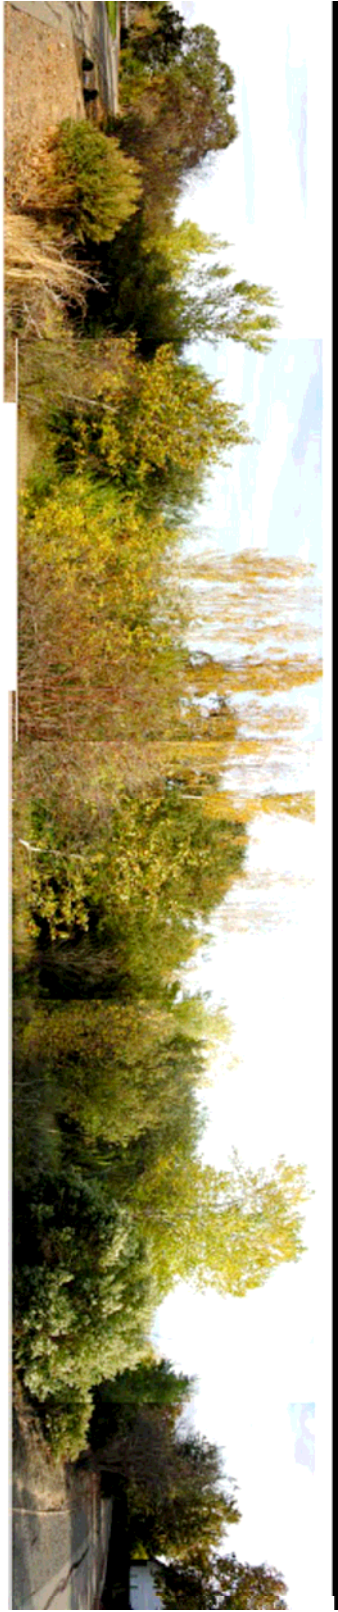
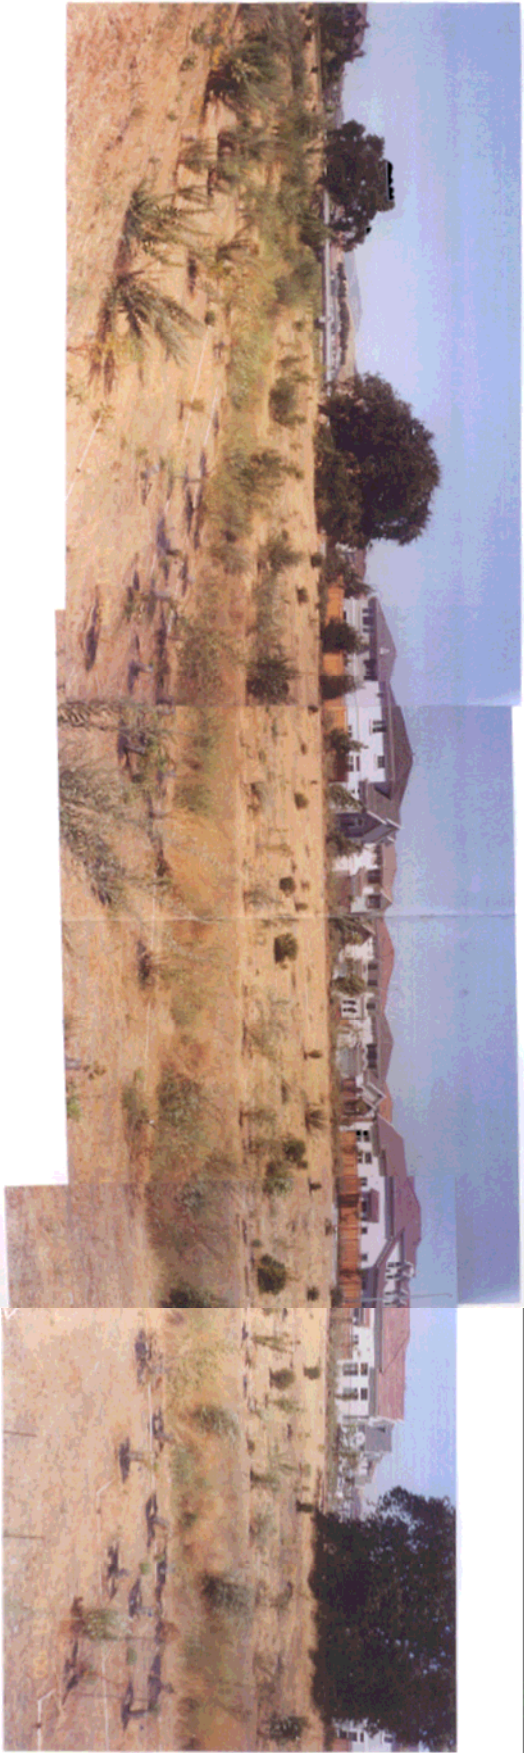
Figure 19: Panoramic Photo from West Bank South of Central Parkway (N 37 42.456' W 121 52.781'), bottom picture taken in 2001 (Davis Environmental Consulting, 2001).

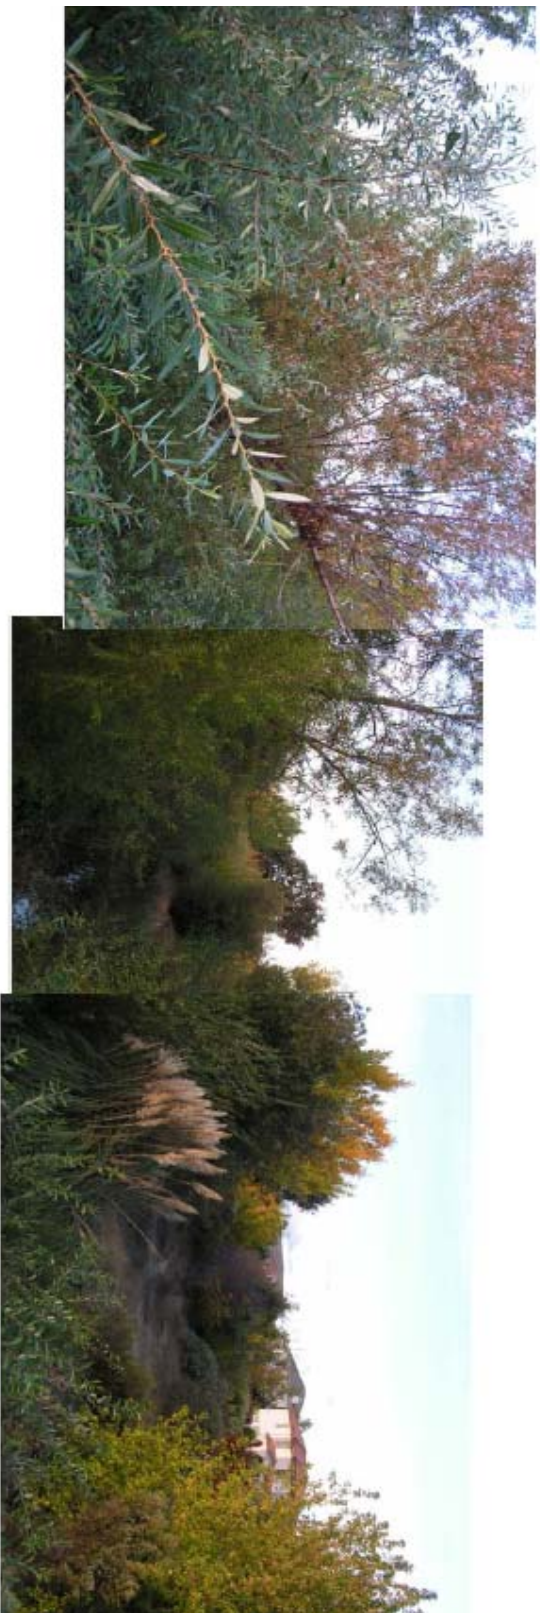
**Figure 21: Upstream View to North of
Dublin Boulevard Bridge**

**Upstream View to North of Dublin Boulevard Bridge
(note natural colonization of emergent vegetation in channel)**

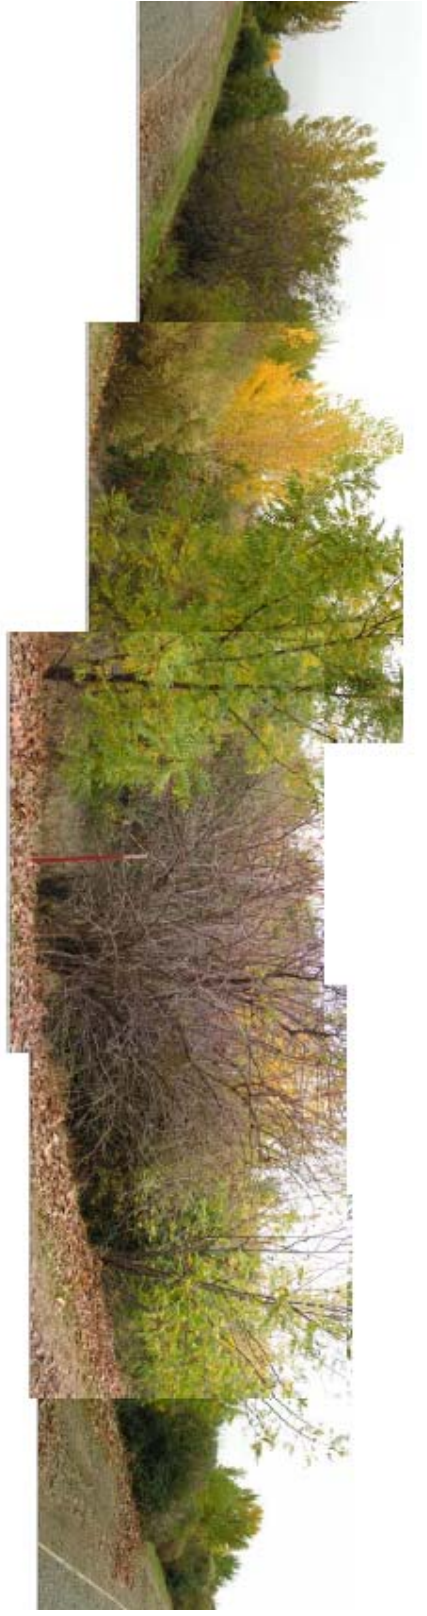
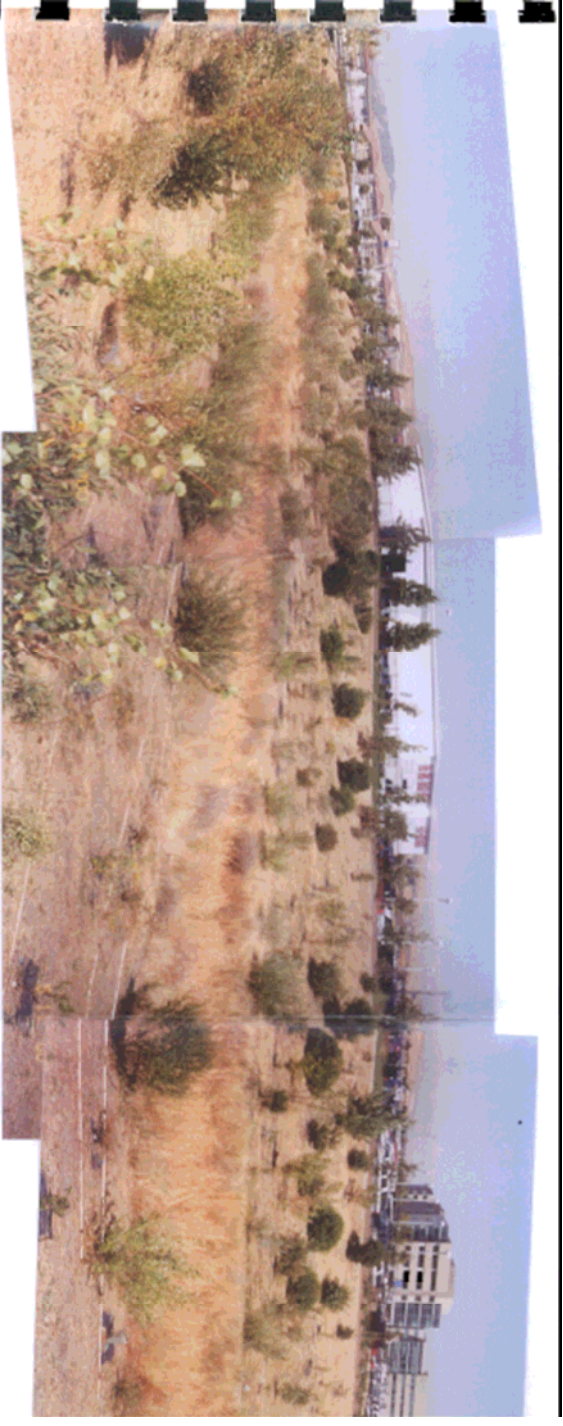
Figure 22: Panoramic Photo from West Bank South of Dublin Boulevard (N 37 42.288' W 121 52.719')

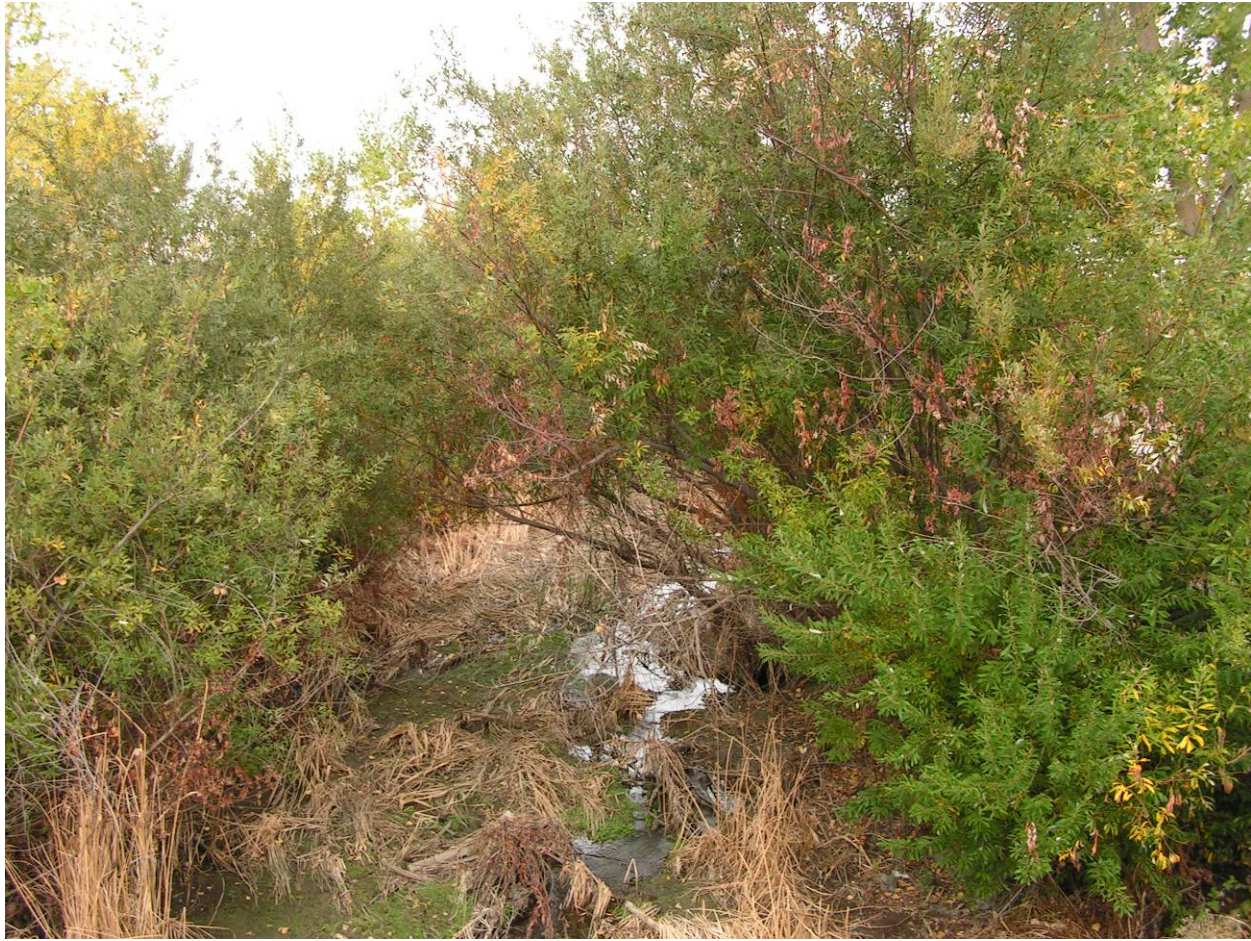
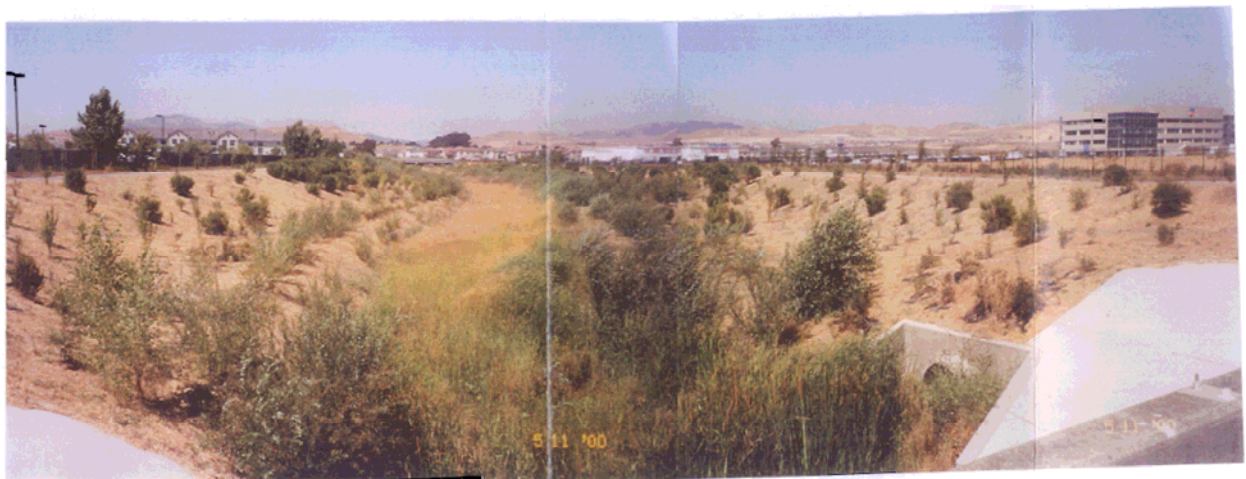
Upstream View to North From Highway 580 Bridge

Figures 23 and 24 show the vegetation progress in Reach 1. The vegetation is fully developed on the floodplain (Figure 23) and along the river bank (Figure 24). Figures 13 to 22 show the results for Reach 2. Some areas of the floodplain are meadows of dry grasses and do not contain woody riparian species

Figure 23: Upstream View to North from Highway 580 Bridge (N 37 42.120' W 121 52.739'), top picture taken on November 11th 2008, bottom picture taken in 2001 (Davis Environmental Consulting, 2001).
