Looking forward, looking back : monitoring the Tassajara Creek Restoration Project

Looking Forward, Looking Back: Monitoring the Tassajara Creek Restoration Project

Chad Krofta
Michael Novotney
Department of Civil and Environmental Engineering
University of California, Berkeley

Final Draft
December 3, 2003

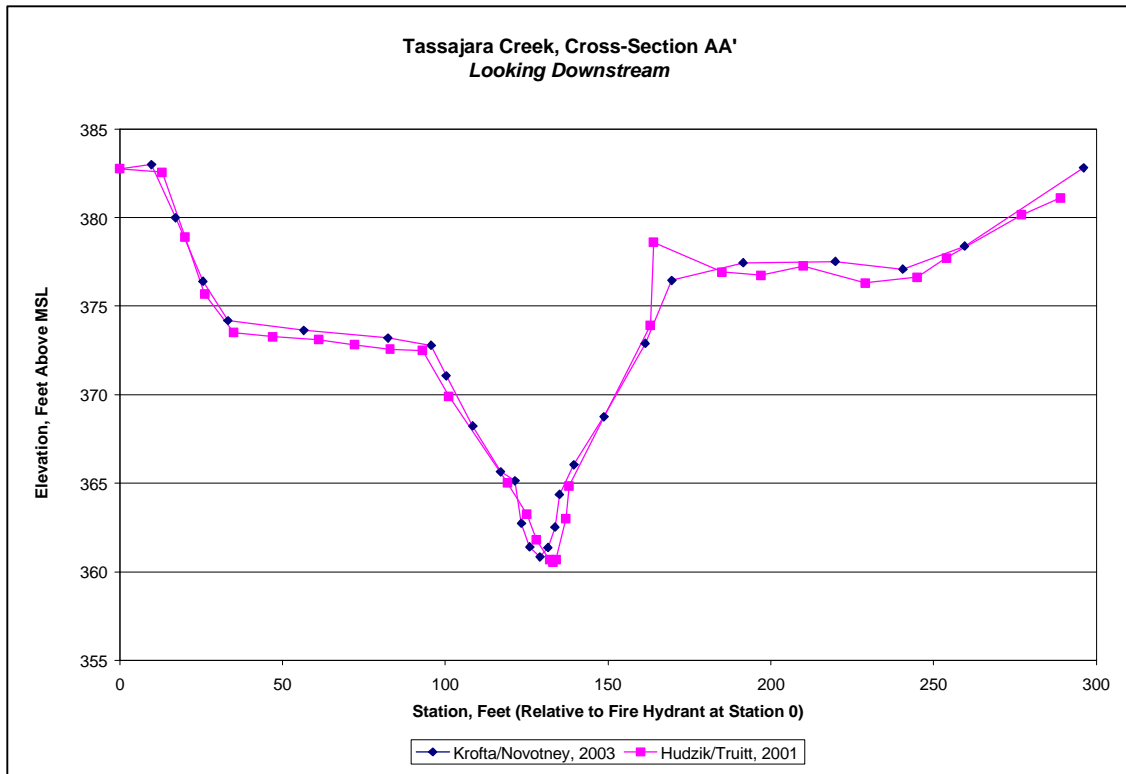
Figure 8.

The plots of the cross-sections illustrate how the channel geometry of Tassajara Creek has changed since the restoration project was completed in 1999 (Figures 8-15). It should be noted that design cross-sections were only available for the six-downstream most transects. Therefore, the plots for cross-sections AA' and BB' contain no design data. Additionally, there is a significant alignment error in the plot of cross-section HH' (Figures 15). The 2003 cross-section in this plot does not correspond well with the pre-existing cross-sections, as both elevations and stationing are noticeably different. Because this data was collected by Rebecca Lave, it is difficult to speculate on the source of this discrepancy, although it is likely the result of survey error. As for the cross-sections that do align well, comparison of the 2003 cross-sections to the 2001 cross-sections shows that very little has changed at the transects in the past two years (Figures 8-15). The elevation differences seen in the figures are most readily explained by the fact that we were not able to occupy and survey the exact same cross-sections that Hudzik and Truitt did in 2001.
