Post-Project Appraisal for the Winter Creek Restoration Redwood Grove, UC Botanical Gardens at Berkeley

LA 227 River Restoration
Term Project Paper – Final Draft
December 11, 2010

Abstract

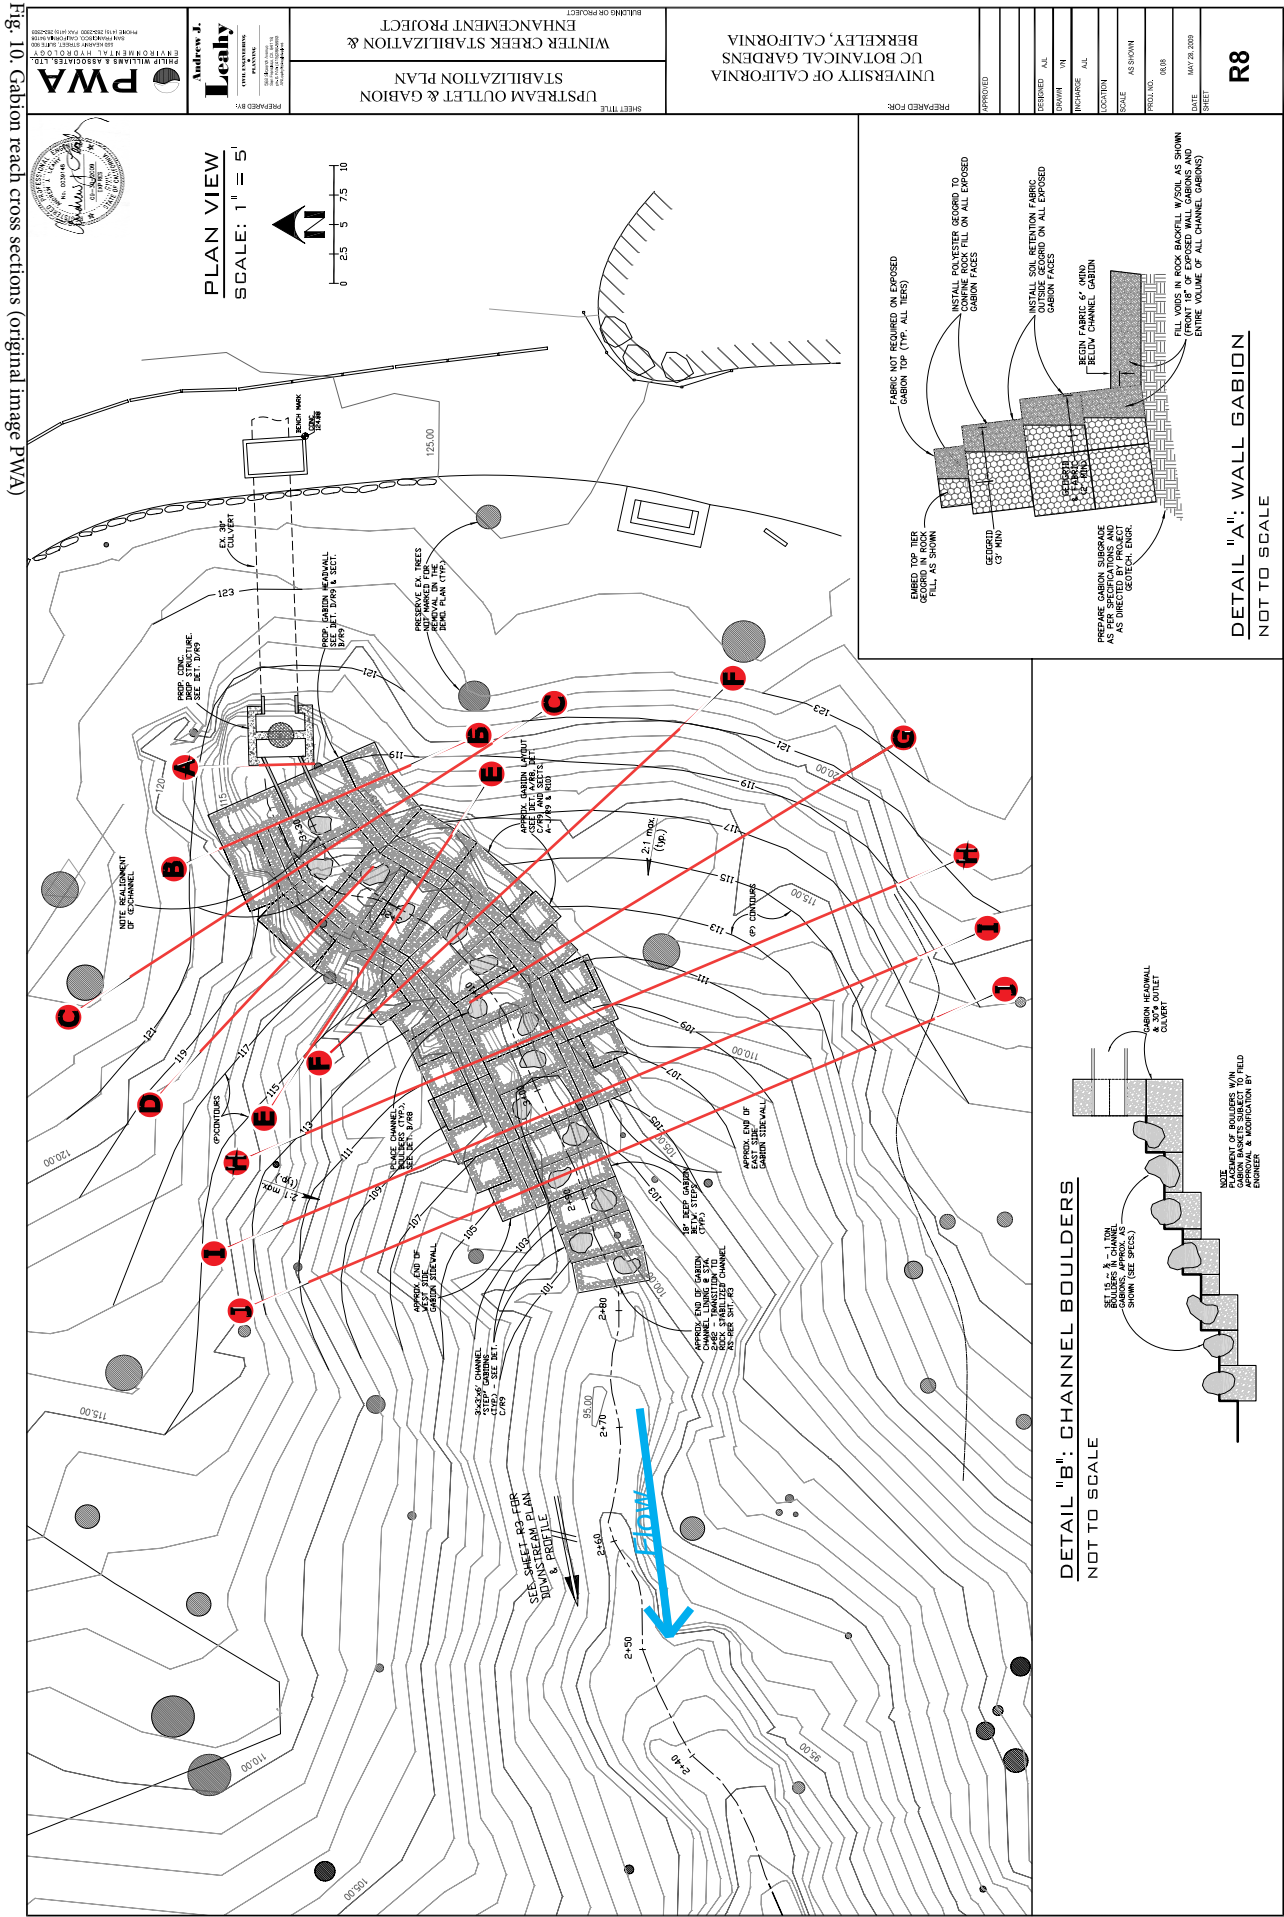
Fig. 10. Gabion reach cross sections (original image PWA)

It appears the designed bank cuts were not constructed as applied to the slope than originally designed for in the following cross sections in the gabion reach: cross section D, high on the right bank (Fig. 13), cross section G, beyond the highest gabion on the left bank (Fig. 14), cross sections H and I beyond the highest gabion on the left bank and cross section J, high on the right bank (Fig. 15). It can be observed on the plan drawing (Fig. 10) that at least one large redwood tree (designated by the dark circles) remains near each of these cross sections. In order to maintain the trees, the contractors may not have been able to apply the cuts proscribed by the design documents. As the slopes in these areas are steeper than the design slopes they may experience erosion in the future if not monitored.

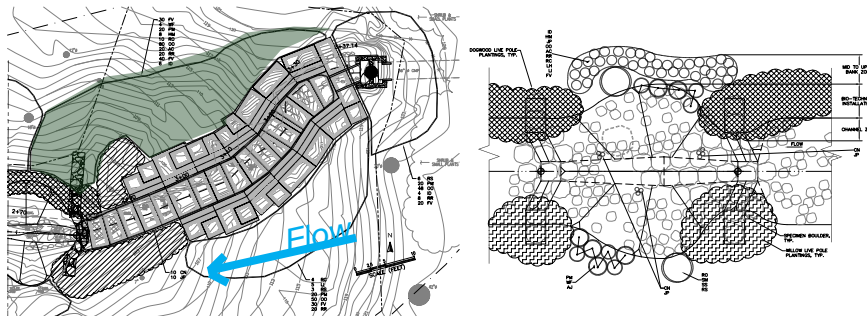
Figure 21. Planting plan for the Gabion reach (sampled area highlighted in green)

Botanical Name	Common Name	Number in plan	Number found in field
<i>Fragaria vesca</i>	Woodland strawberry	30	30
<i>Woodwardia fimbriata</i>	Giant chain fern	4	3
<i>Polystichum munitum</i>	Western swordfern	20	20
<i>Heuchera micrantha</i>	Alum root	8	N/A
<i>Rhododendron occidentale</i>	California azalea	10	8
<i>Oxalis occidentalis</i>	Redwood sorrel	80	80
<i>Asarum caudatum</i>	Wild ginger	20	N/A
<i>Rubus spp.</i>	California blackberry	20	10
<i>Iris douglasiana</i>	Douglas iris	6	6

Compromises between restoration and education goals have impacted the success of the planting plan and potentially will also compromise the banks stability in the long run. Overall, the non-live pole plantings had good survivorship. In the instances where it was found that survivorship was poor as shown in Fig. 21, it would be of interest to note if the medium they are planted in, the water availability, or the elevations at which they were planted differs from the more successful plantings or whether they were installed incorrectly or mishandled. These are some questions we did not have time to investigate in more depth and might be of use in informing similar projects. However, it is evident that the shading caused by the redwoods on the right bank has significantly hindered the survivorship of the live pole plantings. The purpose of these plantings is to provide bank stabilization therefore the right bank is now more susceptible to failure than the left bank where, unshaded, the live pole plantings have been very successful. This demonstrates how important it is to select restoration measures that are compatible with the surrounding environment. It is recommended that the project partners continue to monitor the project so that any problems that may arise from what we have observed can be identified and dealt with quickly to insure the stability of the banks.

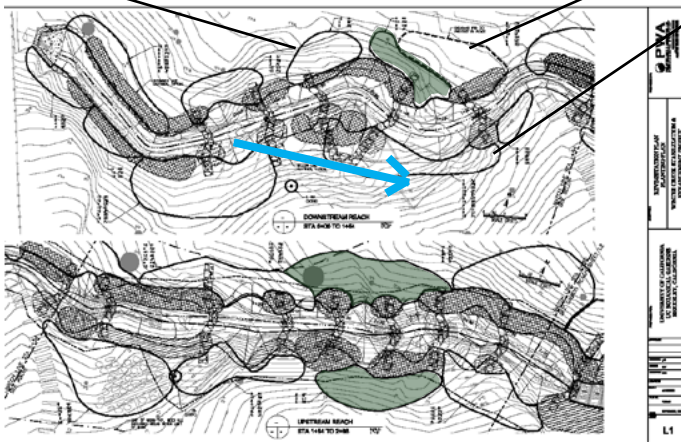
Figure 23. Planting plan for Upstream and Downstream reaches (sampled area highlighted in green).

Botanical Name	Common Name	Number listed in plan	Number found in field
<i>Polystichum munitum</i>	Western swordfern	12	8
<i>Heuchera micrantha</i>	Alum root	8	N/A
<i>Rhododendron occidentale</i>	California azalea	6	2
<i>Juncus patens</i>	Common rush	8	8

Botanical Name	Common Name	Number listed in plan	Number found in field
<i>Polystichum munitum</i>	Western swordfern	14	5
<i>Oxalis occidentalis</i>	Redwood sorrel	40	40
<i>Asarum caudatum</i>	California azalea	12	N/A
<i>Carex nudata</i>	Torrent sedge	10	2
<i>Woodwardia fimbriata</i>	Giant chain fern	6	1
<i>Juncus patens</i>	Common rush	16	8

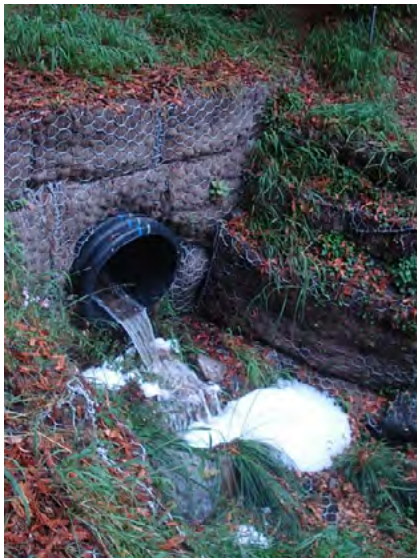
Upstream of our site, Winter Creek drains an area of approximately 160 acres. We estimated lag time to peak flow at approximately 8 minutes, which was confirmed by our observations on October 23, when it began to rain while we were surveying at the site. Runoff appeared at the culvert at the upstream end of the project site approximately 10 minutes after it began to rain. This runoff also carried trash into the project site and foam began to collect at the drop under the pipe culvert and in the pools downstream (Fig. 38-39).

Figure 38. Foam in project site during precipitation, October 23, 2010.

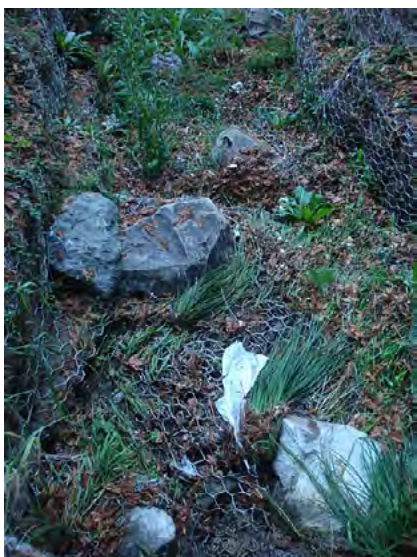
Figure 39. Trash in project site following precipitation, October 31, 2010.
