Understanding the water, understanding the canyon: establishing a baseline study of the Redwood Canyon reach of Cerrito Creek in Blake Garden

Understanding the Water, Understanding the Canyon

ESTABLISHING A BASELINE STUDY OF THE REDWOOD CANYON REACH
OF CERRITO CREEK IN BLAKE GARDEN

CAMILLE THOMA & DULCE RIVAS

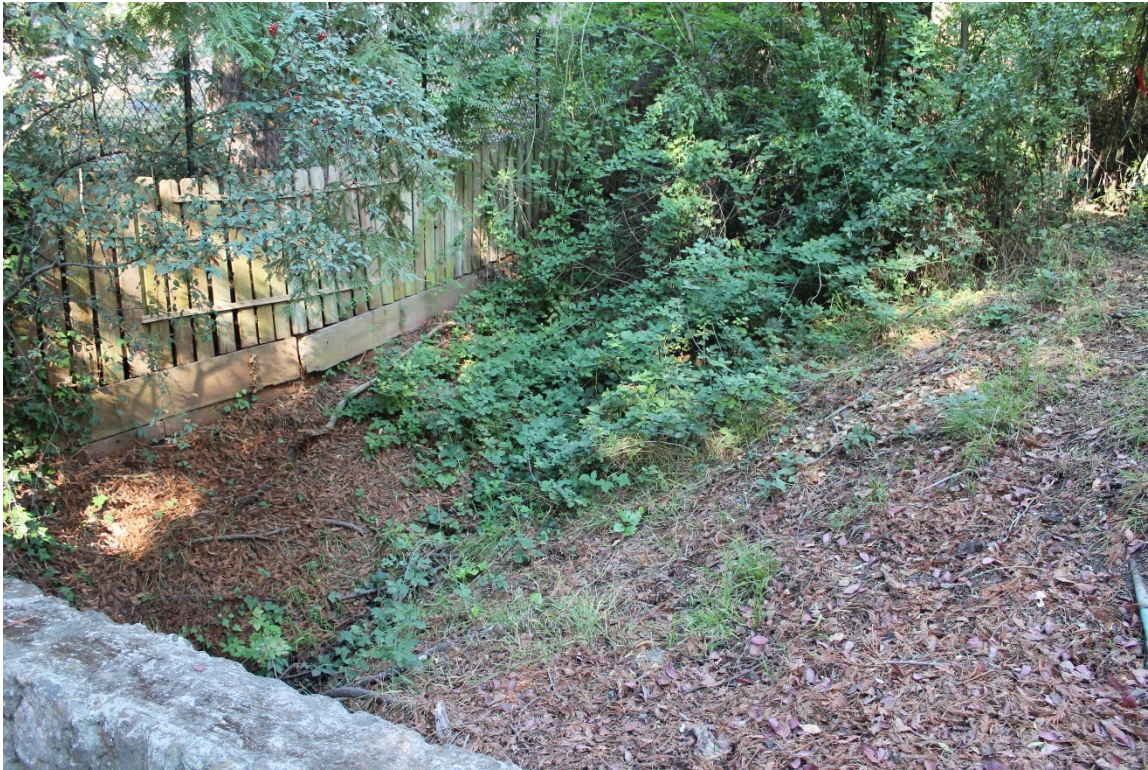
Figure E1 Area above driveway to Carmelite Monastery and site of spring that feeds the Redwood Canyon Reach of the Cerrito Creek.
