The George H. Scripps Memorial Marine Biological Laboratory of the Scripps Institution of Oceanography, University of California, San Diego

Historic Structure Report to the California Office of Historic Preservation

SIO Reference 79-26

October 1979

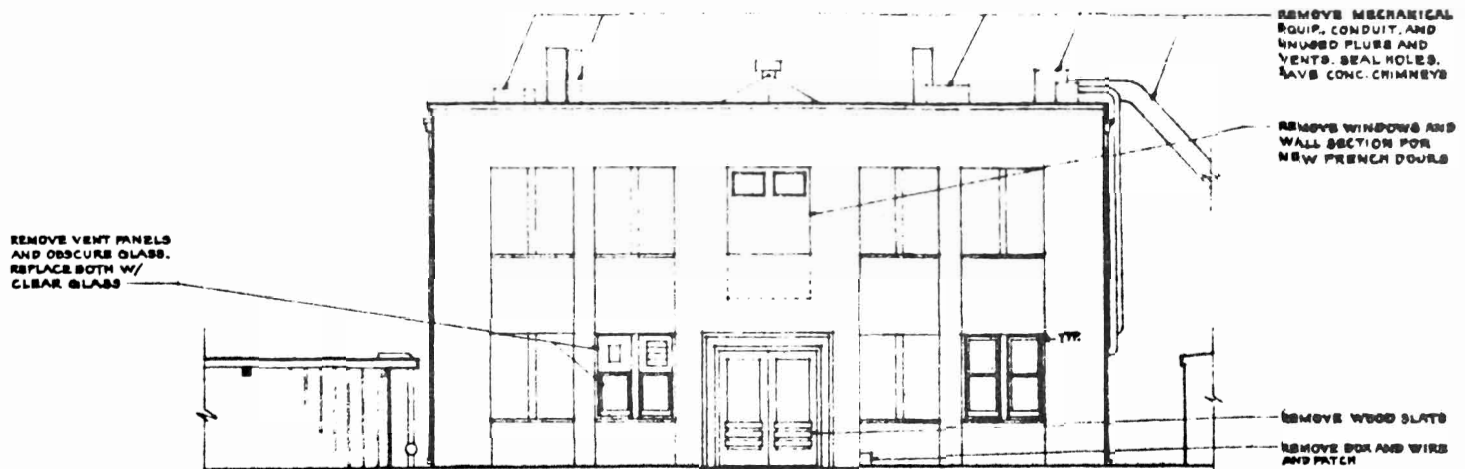
EAST ELEVATION - EXISTING

The exterior of Scripps Laboratory (figures 7-8) is much as it appeared after the 1932 remodelling, changed from its original appearance only by the change in window style. The dividers between lights of the original steel-frame windows tended to disappear from sight; in the wood-framed windows they are apparent. The windows are in pairs throughout the building (except at the southeast corner of the first floor on the south wall, where one is missing). Windows are of only two sizes: pairs of wide windows between columns on the north and south walls, and pairs of narrow windows on the east and west walls. Six window lights have been removed and replaced by air intakes and exhausts; two large vent pipes rise along the north wall. The exterior is painted uniformly with a buff paint, including all window frames, trim, and doors. Originally, at the completion of construction, it was plain concrete, with varnished woodwork on the doors.
