Sausal Creek Restoration at Dimond Park: Vegetation and Geomorphology Post-Project Appraisal

Final Draft: Sausal Creek Restoration at Dimond Park: Vegetation and Geomorphology Post-Project Appraisal

Carl Bello, Rex Chen, Taylor Lithgow, and Emily Meyers

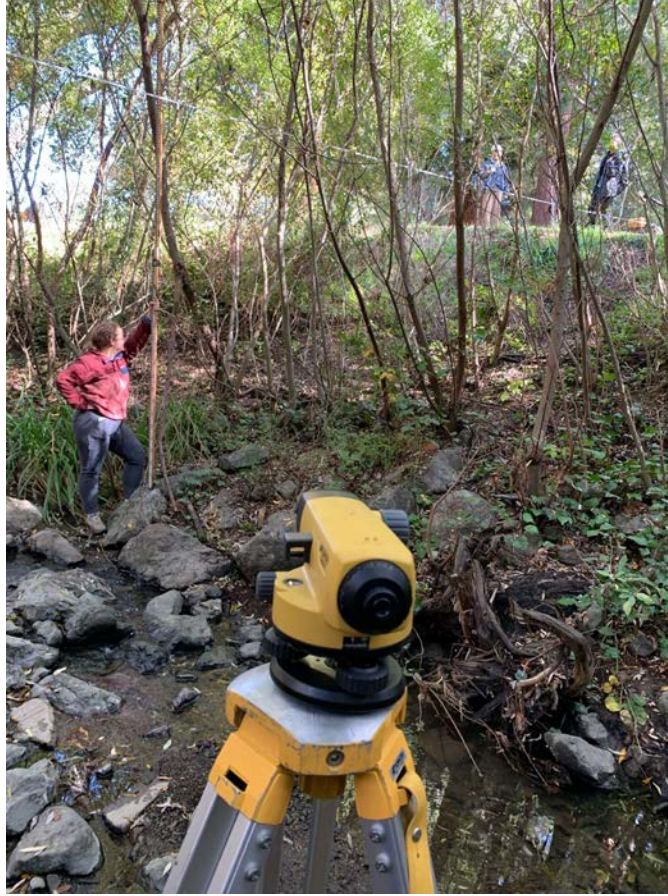
Photo 9. Right bank looking upstream (left bank in Figures 1, 2, 4, 5, and 6) while surveying at T3. Instrument is at second TP position.
