Local site effects and incremental damage of buildings during the 2016 Central Italy earthquake sequence

ABSTRACT

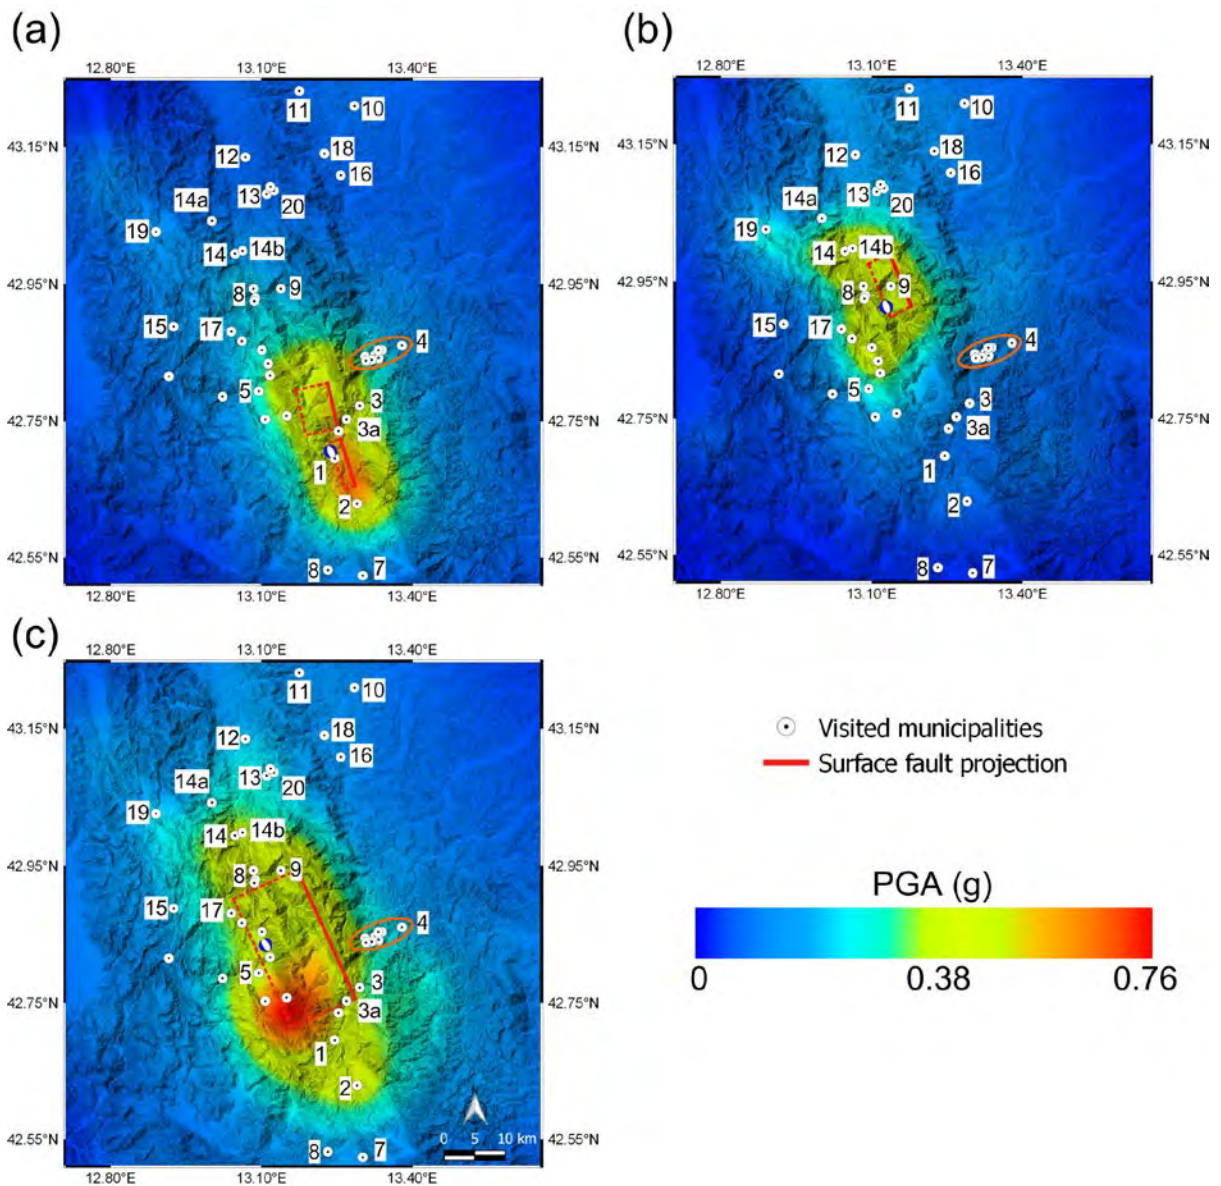
169 Figure 2 shows the spatial distribution of peak ground acceleration (PGA) for the three
170 main shocks. In Table S1, a summary of PGA values for visited locations along with a
171 detailed analysis of site-specific geological conditions is also provided. Main municipalities
172 and hamlets covered in this paper are labeled in Figure 2, with a sequence number consistent
173 with those reported in Table S1. It is important to note that the contour map showing spatial
174 distribution of PGA shown in Figure 2 and the PGA values at selected locations summarized
175 in Table S1, do not properly account for local effects since uniform generic site conditions
176 were assumed for the entire area. Furthermore, each damage level value in Table S1
177 represents an average damage level in the villages, while intra-village damage patterns are
178 discussed in a subsequent section.

201 **Figure 2.** Location of visited municipalities and hamlets, epicenter locations (moment tensors), and
 202 spatial distribution of PGA for the: (a) 24 August M6.1, (b) 26 October M5.9, and (c) 30 October
 203 M6.5 earthquakes. Numbers in Figure 2 are those presented in Table S1.
