Post-project evaluation of Tule Ponds in Fremont, California : Integration of stormwater treatment and wetland restoration

Post-project evaluation of Tule Ponds in Fremont, California: Integration of stormwater treatment and wetland restoration

A paper presented to Matt Kondolf for the course Hydrology for Planners: LA222

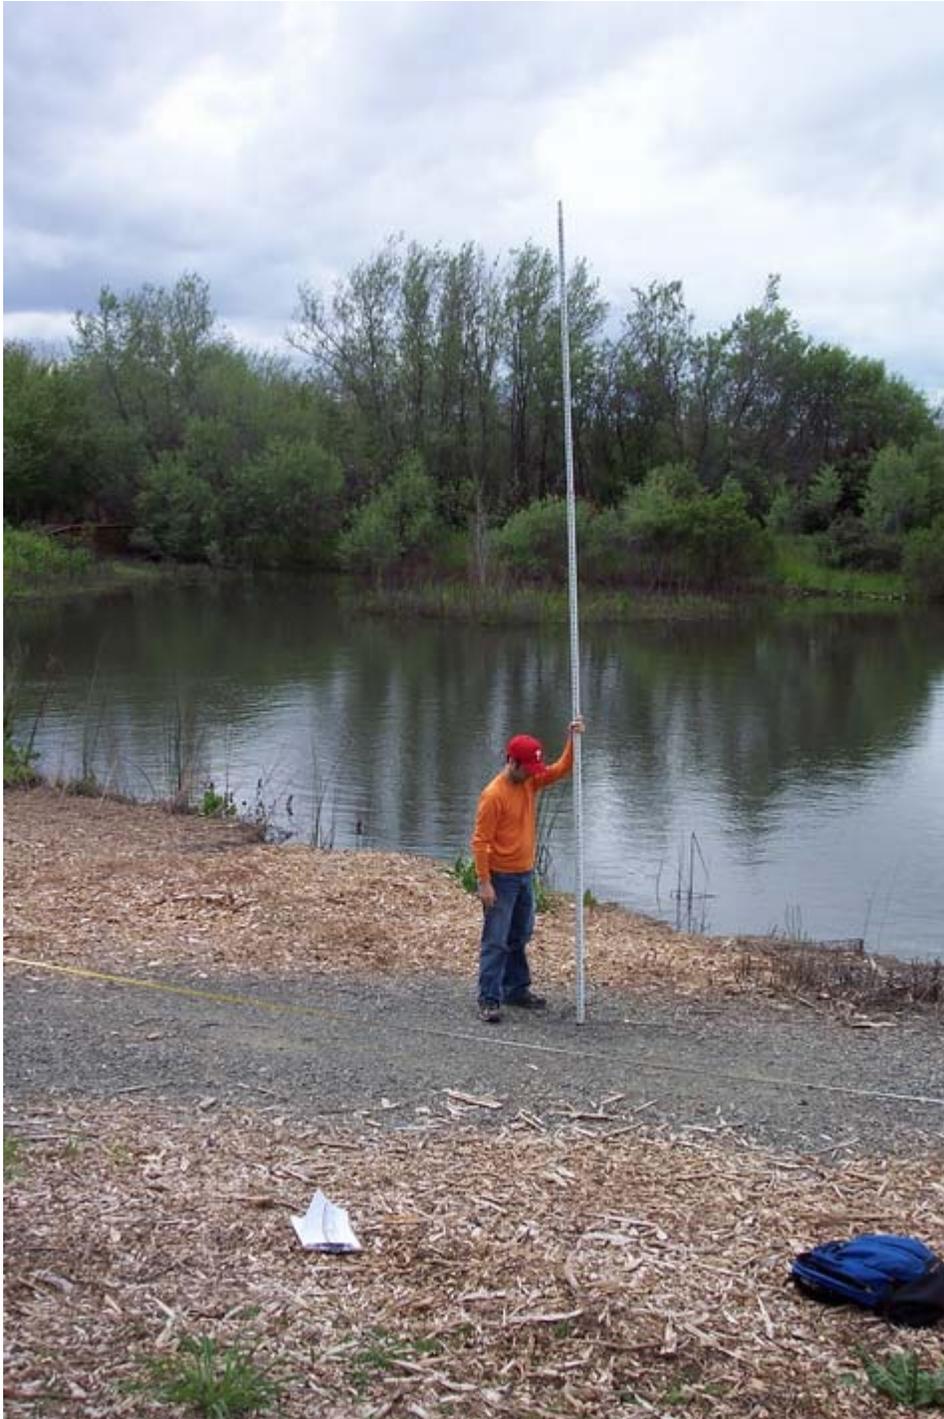
Photo 3. Typical land survey procedure measuring elevation of features such as the road. Pond C Island 2 in the background which is just below water level at the time of sampling.
