Redwood Creek, Marin County 2010 Monitoring Study of a Salmonid Habitat Stream Restoration Project: Seven--Year Post--Project Evaluation

Richard Crockett, Fiona Cundy, Colin Hanley
LA 227 | Stream and River Restoration
Term Project | December 2010

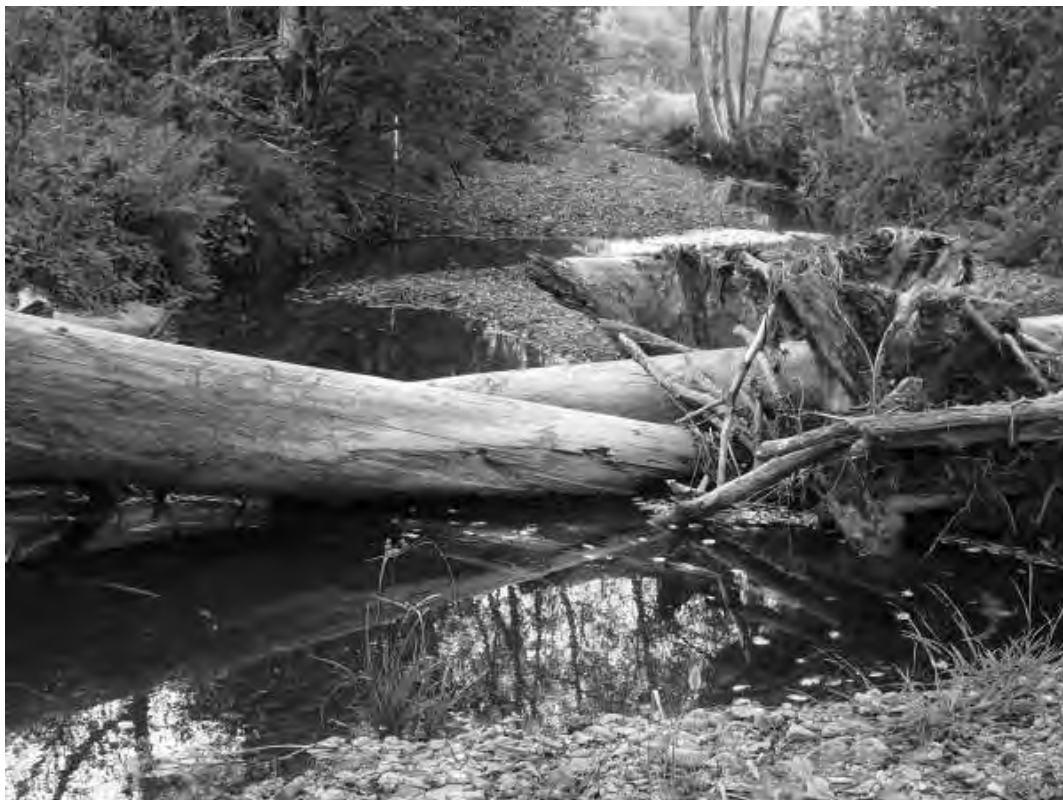
Figure 8
Photo of logjam 6-7-8 in 2006, post-restoration
Source: Mark Thompkins

Within the bowling alley reach, we recorded very large woody debris accumulation at logjam 6-7-8. We tried to observe where the large amounts of debris were coming from and why they had stacked up so high at this woody debris structure, and not any of the others. About 150-200 feet upstream of logjam 6-7-8, we observed a collection of about a dozen large, dead, leafless alder trees, and about half consisted of only 10-foot-high tree trunks and their upper portions toppled (Figure 16).

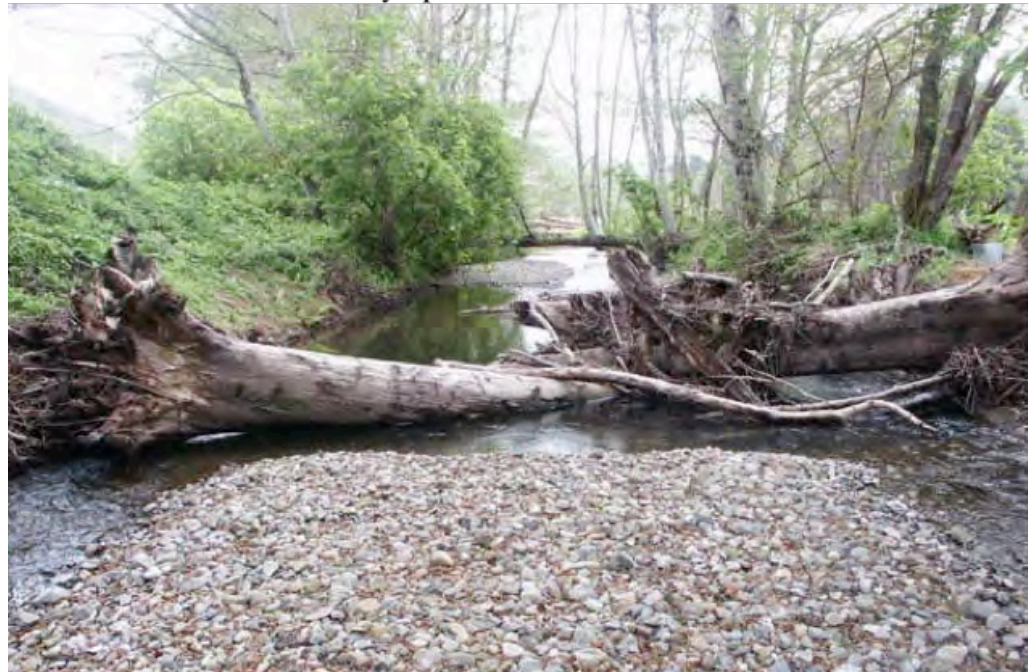
Figure 9B
2004
Source: Matz and
Purcell 2004

Figure 9C
2010
Willow and other
native vegetation types
have colonized along
the gravel bars. From
this view, entire large
tree trunks have added
to debris jam 6-7-8,
creating a solid woody
debris structure above
the water, ideal for coho
rearing habitat.

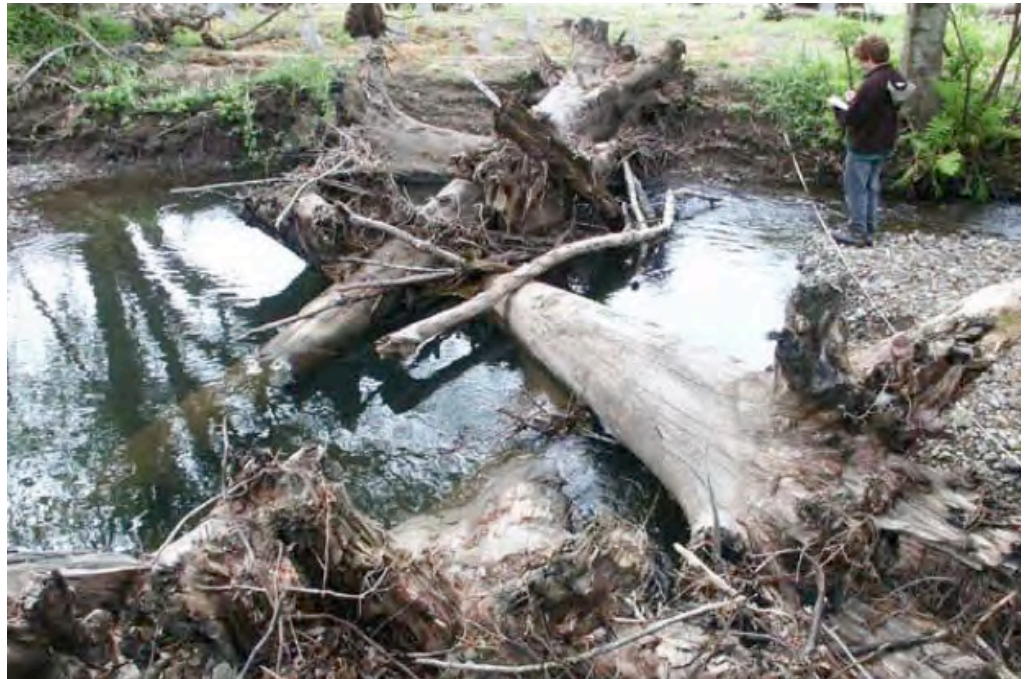
Figure 10B
2004
Source: Matz and
Purcell 2004

Figure 10C
2010
Logjam 6-7-8 has grown
nearly 4' above the
surface of the water ,
consisting mostly of the
dead red alder branches
washing down from
upstream of the
restoration project.

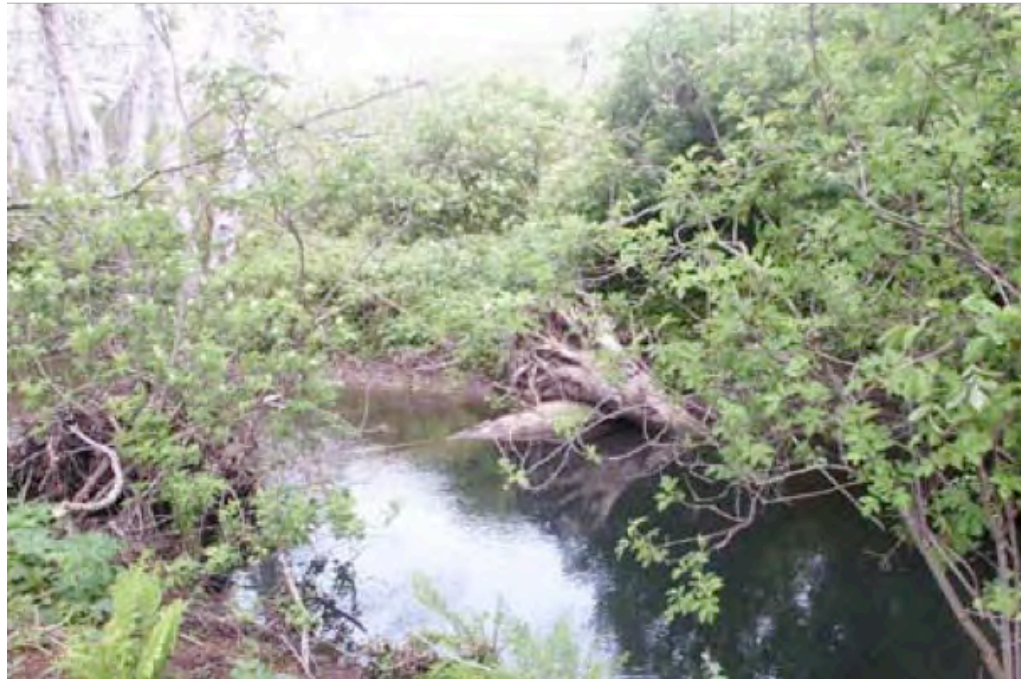
Figure 15B
2004

Seven years after restoration, the logjam structures have held their integrity. While the design of structure 6-7-8 has been the most successful in collecting additional woody debris, the other logjams, such as number 5 have not naturally accumulated additional woody debris collection as well.

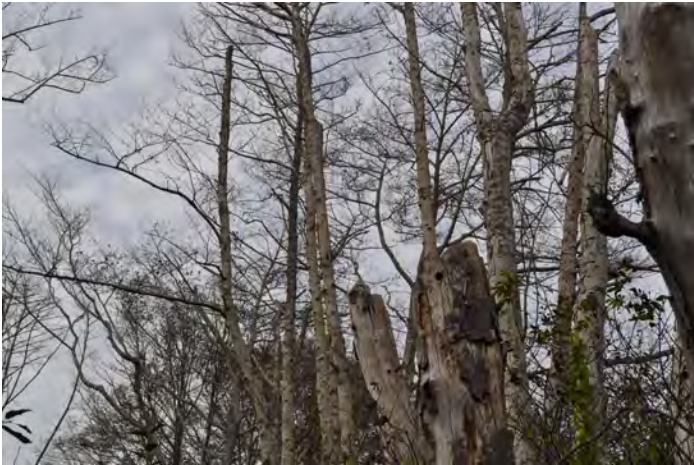
Figure 16

The lack of tall shade trees in this reach could cause an issue to the salmonid habitat that has been restored at the Banducci Site. However, the large amount of large wood debris entering the channel could cause more debris jams like the one at logjam 6-7-8. This large supply of wood entering the channel could be helpful in creating habitat for salmonids. It might be helpful for NPS to get an expert to the site and determine if it is better to cut down the dead and dying trees and remove them or if they can be left. The health of mature shade trees should be considered during the design and construction phases of restoration projects. Additionally, a plan to replace the canopy vegetation in this reach of Redwood creek would be helpful to creating good riparian habitat.

causes of the tree health decline, including construction disturbances, increased post-project inundation, and disease.

Additional site photos: Redwood Creek riparian alder tree canopy

Dead alder tree canopy just upstream from the 432-foot bowling alley reach.

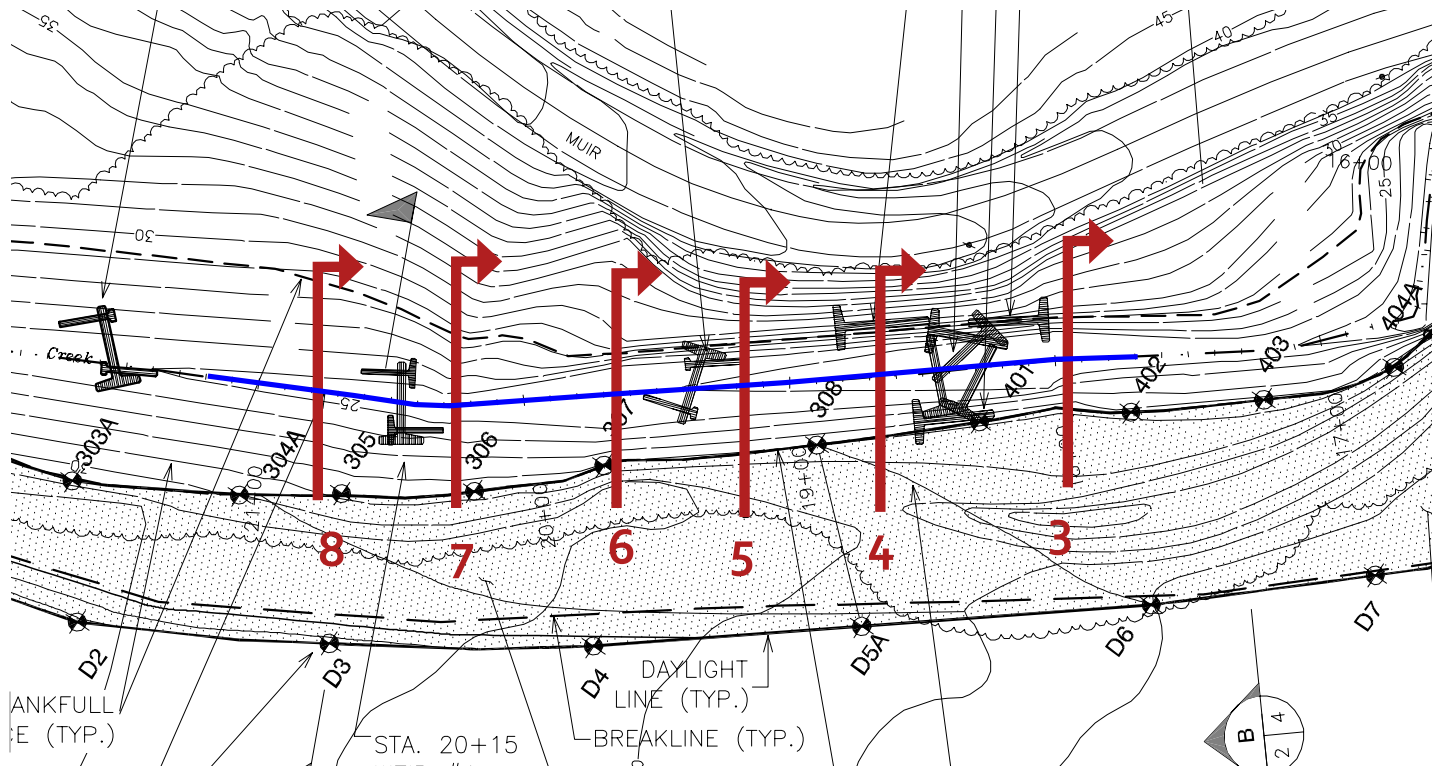
Figure 29
Map of cross section monitoring points throughout the 432-foot Bowling Alley reach

The pre-project channel profile (Figure 29) had a constant slope, with no variability. The distinguishing characteristic of the 2010 profile is the 2 to 4 feet deep pools near the large woody debris structures. Toby Minear, UC Berkeley graduate student, generously provided us with cross section and profile data from 2003 (immediately following placement of woody debris structures), 2005, and 2006. Each pool's depth, length, and relative location to the large woody debris structures has varied from year to year, but in each post-construction survey, the pools trend towards both deeper and longer with increased distance downstream. One potential reason for this is that the woody debris structures and thickening vegetation could be recruiting sediment towards the upstream reach, creating hungrier water and causing increasing pool scour with increasing distance downstream.

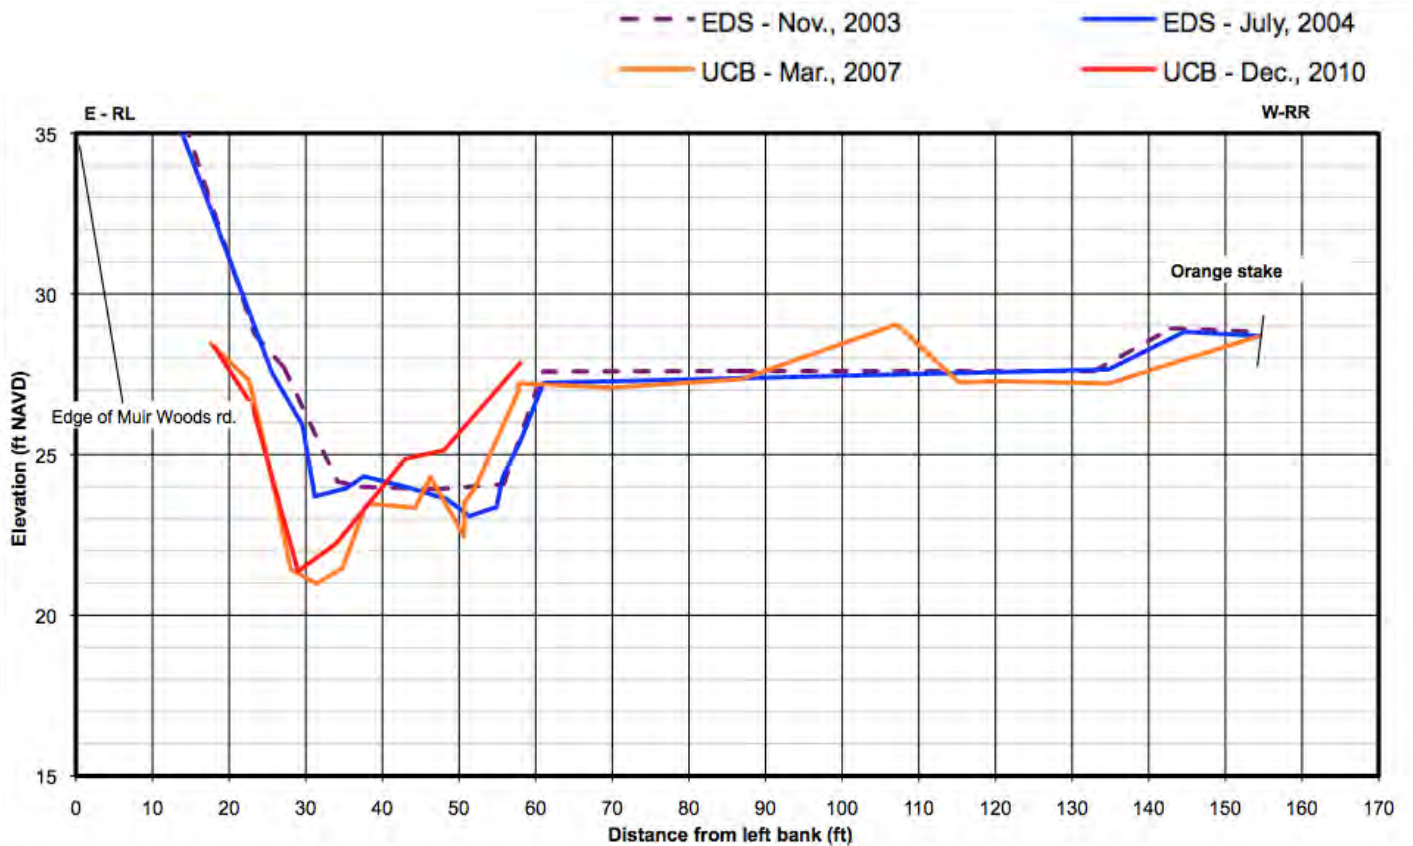
Figure 31
Redwood Creek Cross Section Survey XS PC 4

It's difficult to isolate the cause of geomorphic features on the profile and cross section with the variety of parameters contributing to channel scour and sediment transport. For example, upstream channel changes can have significant impact on sediment transport in the restoration reach. One parameter we can examine is the recent hydrology (Figure 28). The highest Redwood Creek flow event since 2003 construction was the 2006 New Years storm, which was about a 10-year event. We don't have data that closely brackets this event, but one feature that appears after this event was the left bank toe scour at section PC₄ mentioned above.
