Post-Project Appraisal of Arroyo Viejo Creek Improvement Project, Oakland, California

December 2005

LAEP 227: Restoration of Rivers and Streams

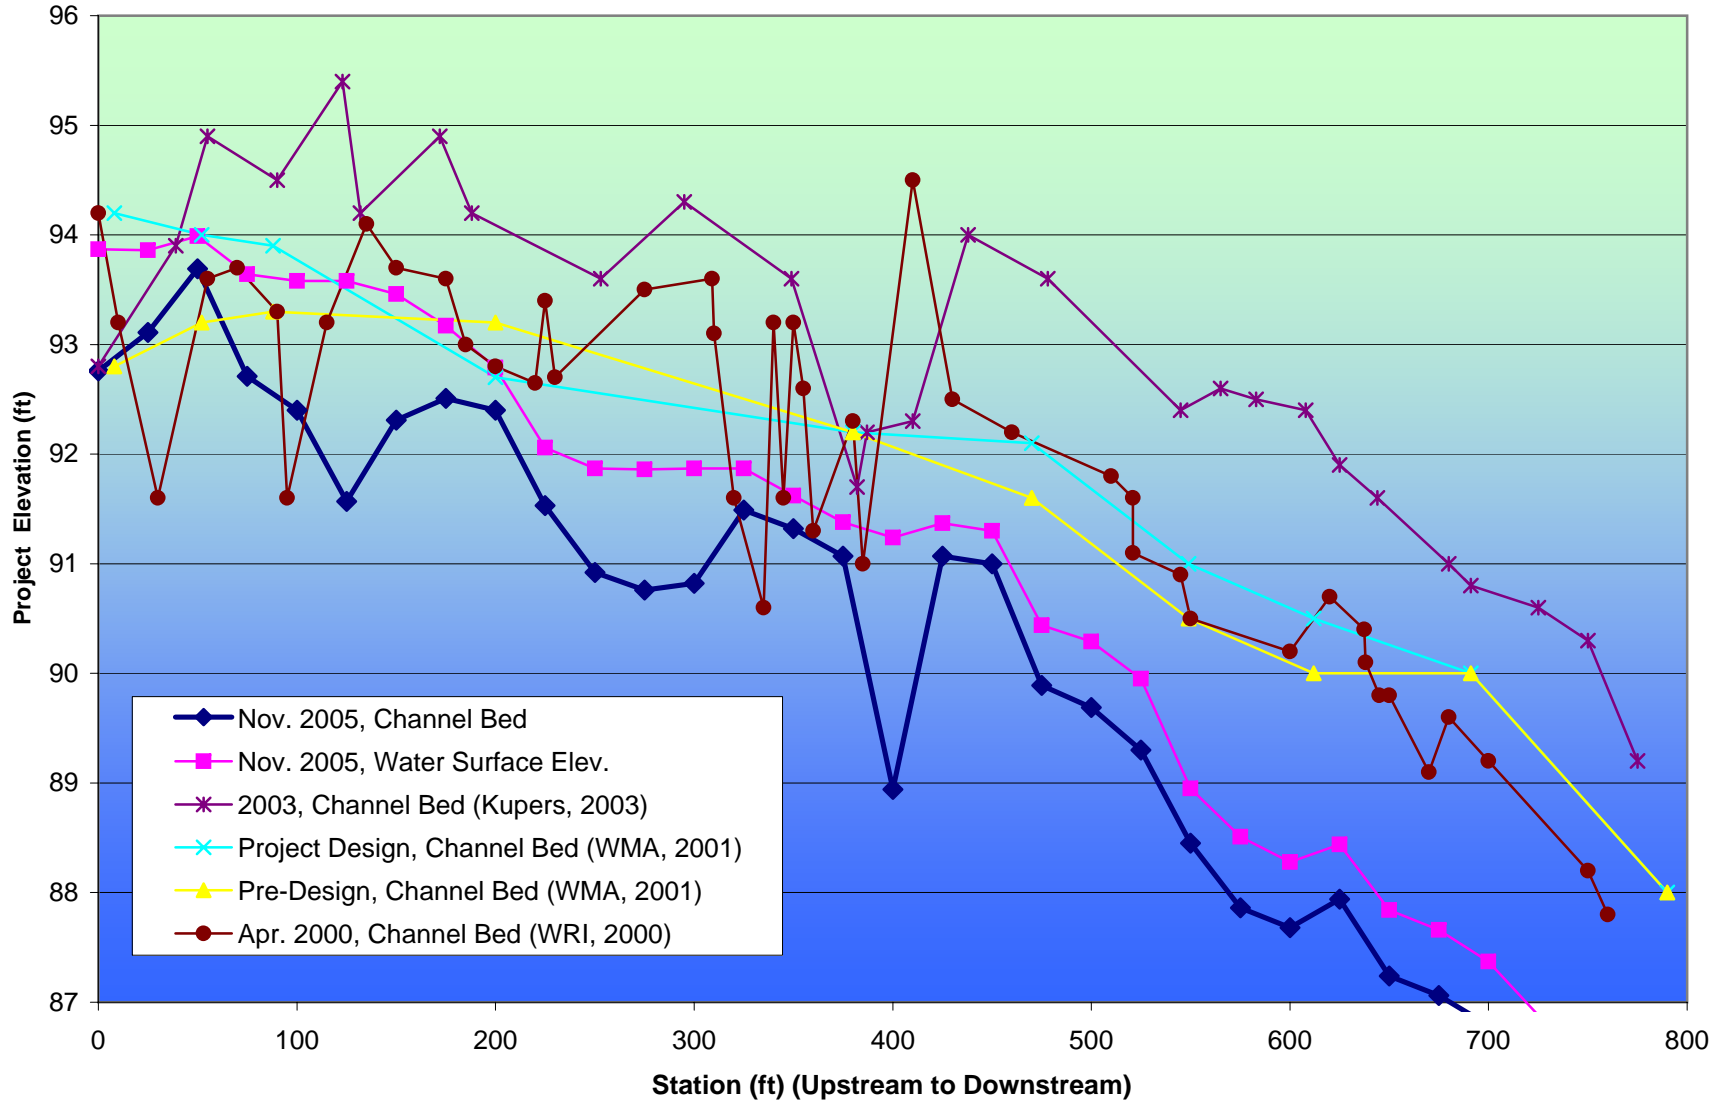
Figure 5a: Longitudinal Profile

The vertical scale shown in Figure 5a is exaggerated in relation to the horizontal scale, which overly emphasizes the elevation change of the creek along the alignment. The project creek elevations are constrained as a result of structural culverts at Krause Ave. and 78th Avenue. Thus, the overall creek gradient is unlikely to vary from pre-project conditions. When viewed at true scale (vertical scale equivalent to horizontal scale), the overall creek gradient was not modified, as shown in Figure 5b. Figure 5c highlights features along the long profile from the east end of the project area to the west end of the project area.

The long profile surveys shown for comparison in Figures 5a, 5b and 5c are based on a pre-project survey (WRI, 2000), the design drawings (WMA, 2001), and two post-project student surveys (Kupers, 2001, 2003). Due to the lack of reliable stationing information in the field, a direct comparison of all long profiles should be performed with caution, as differences in readings may have occurred as a result of misaligned stationing along the alignment of the creek and/or inconsistent measurement locations within the creek watercourse channel.

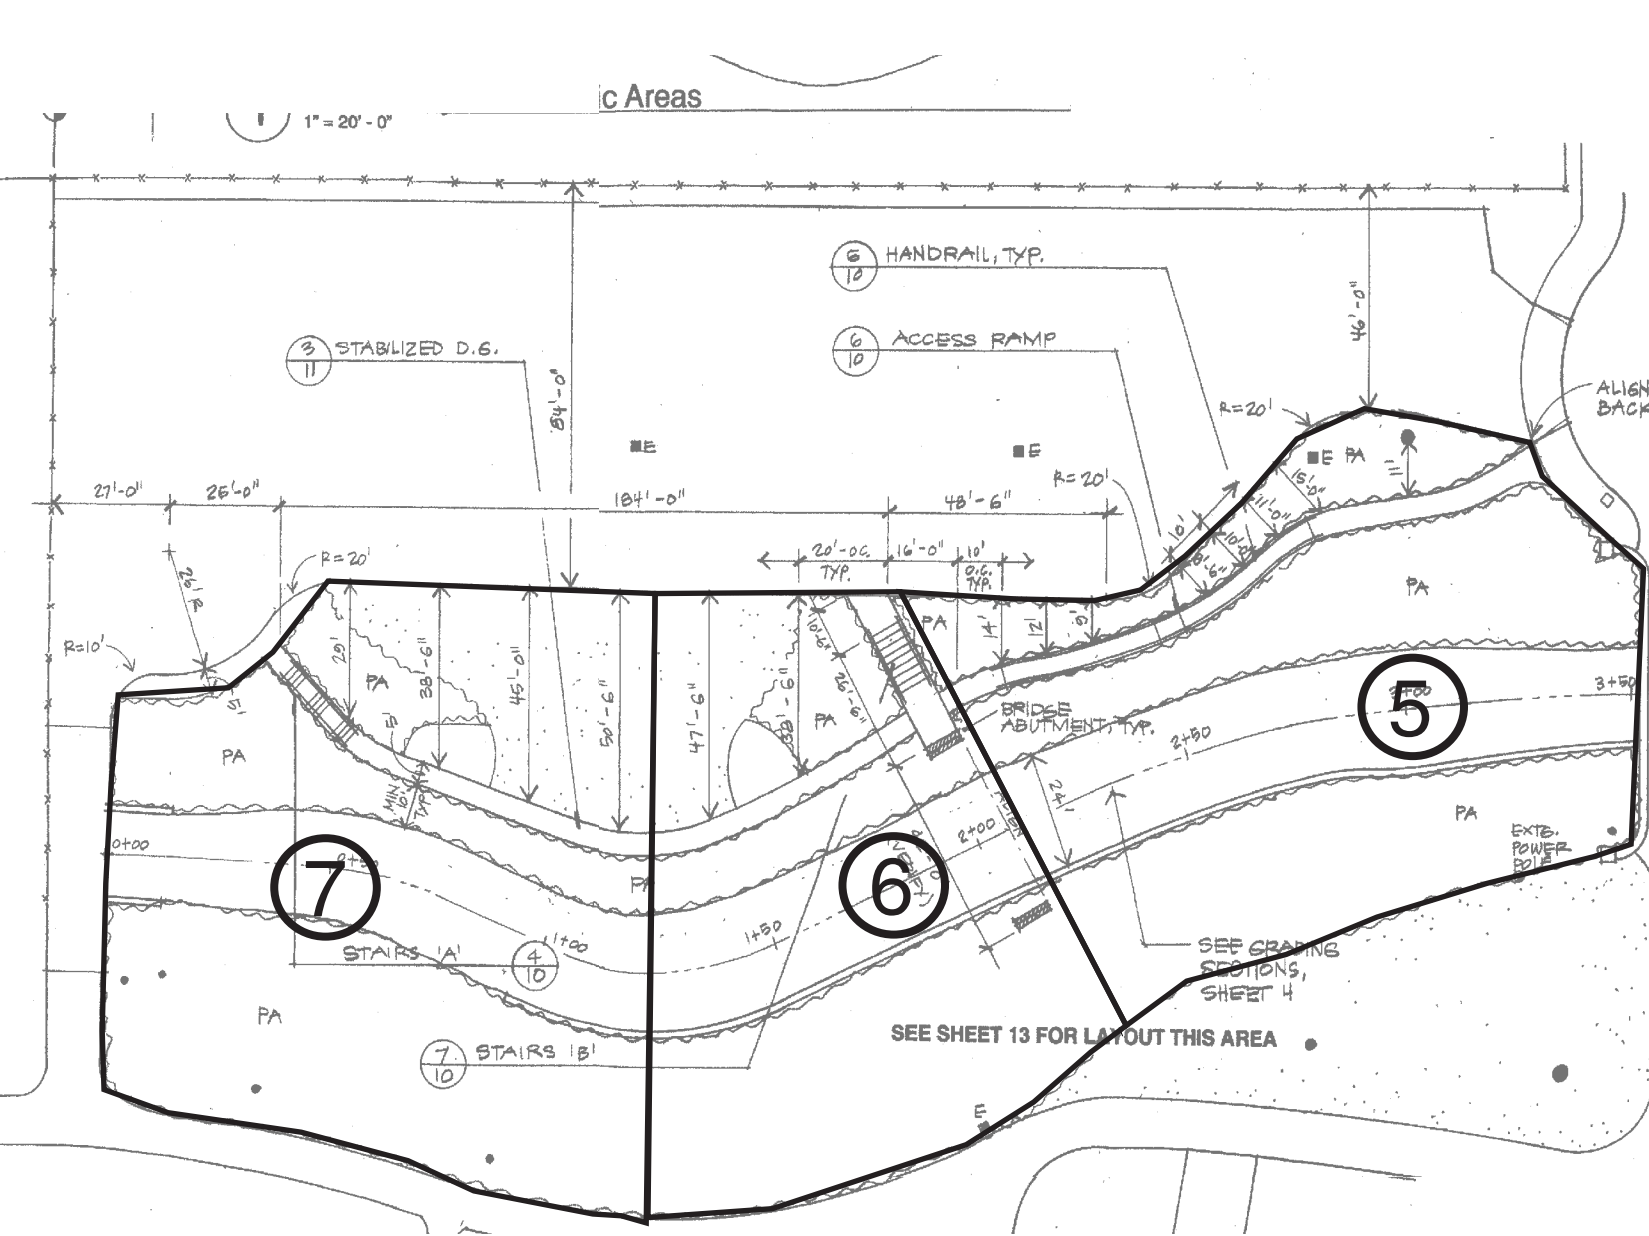
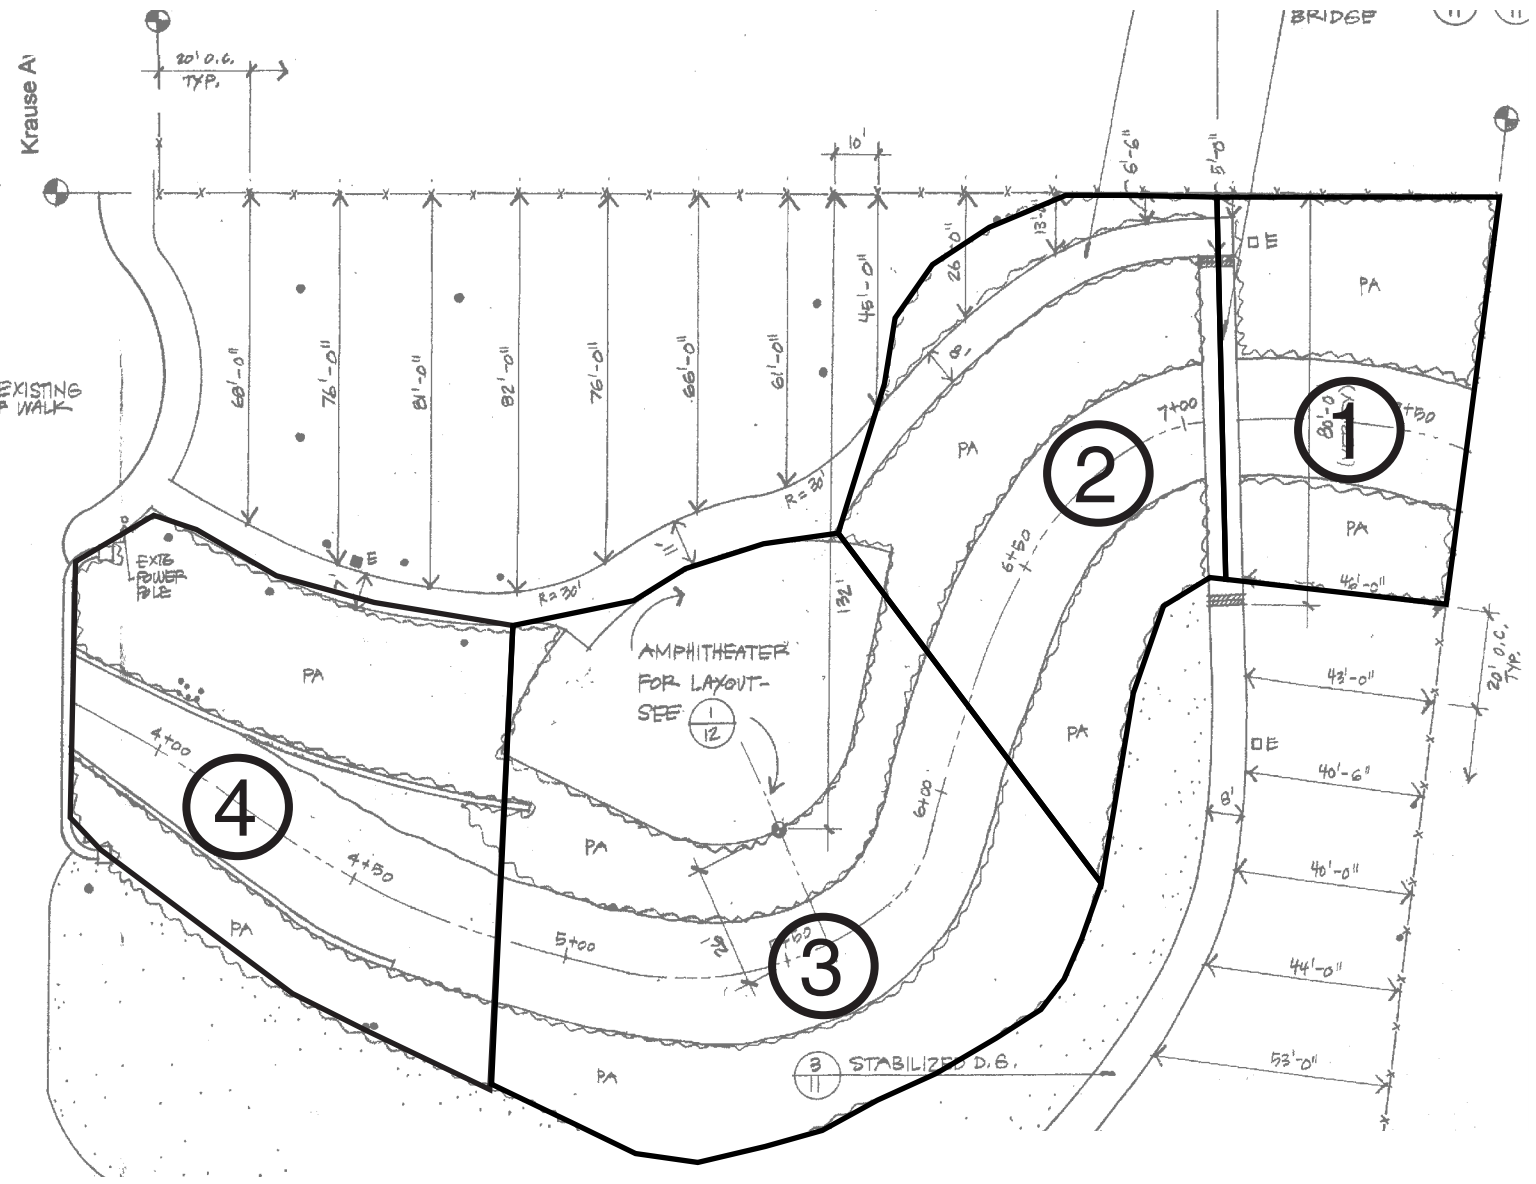
Figure 9
Vegetation Survey

Area #	Relative Area	% Native	% Non-Native
1	0.08	38%	62%
2	0.12	76%	24%
3	0.15	22%	78%
4	0.13	40%	60%
5	0.19	52%	48%
6	0.15	48%	52%
7	0.18	80%	20%
	Weighted Average:	52%	48%

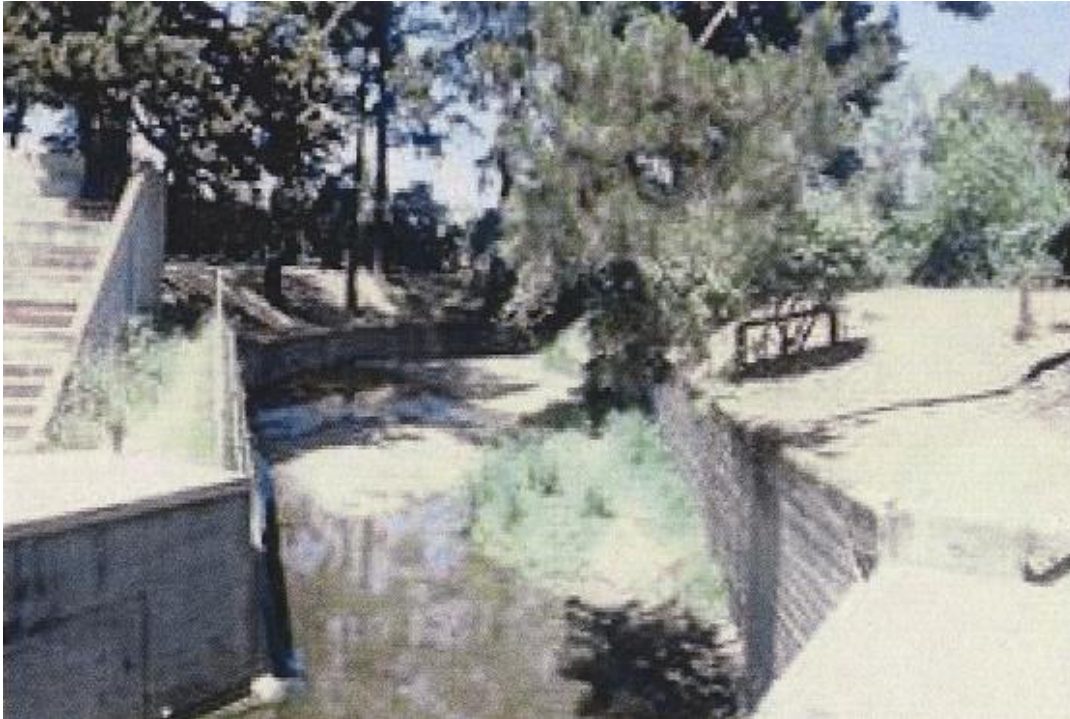
Photo 1. This pre-construction photo from Kupers (2001) shows the eastern stretch of the project reach, specifically the masonry and concrete channel walls that were targeted for removal. The view is upstream from the amphitheatre.

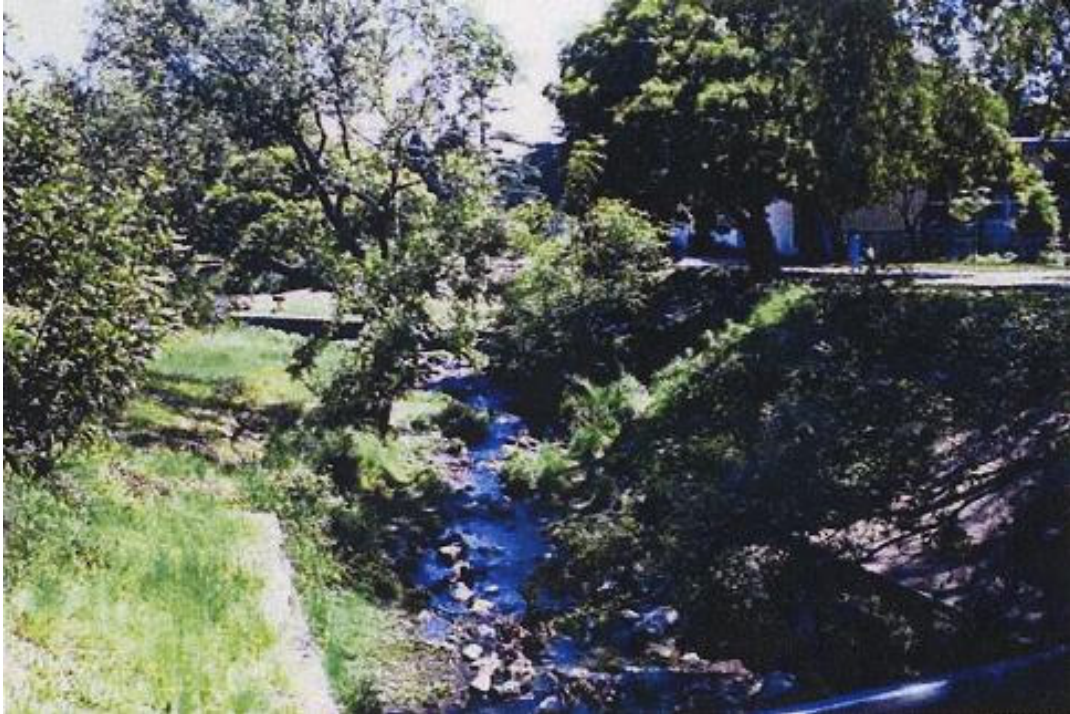
Photo 2. Another pre-construction photo from Kupers (2001) shows the western stretch, which was re-graded and re-planted during the restoration project. The view is upstream from the end of the project reach.

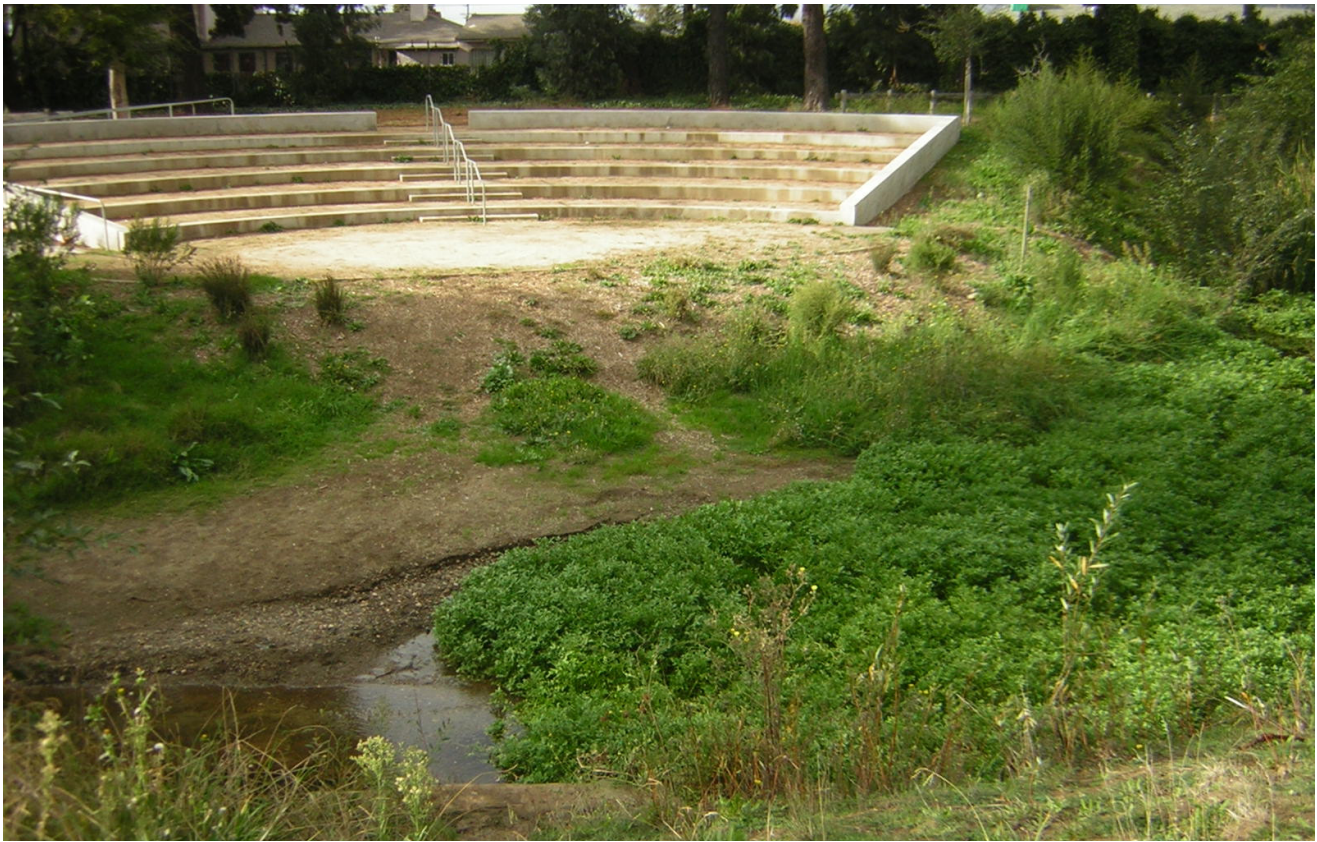
Photo 7. Reconstruction of the amphitheatre was one of the major components of the project. The amphitheatre, which formerly covered the creek with its stage, now transitions naturally into it, while providing a small floodplain for the creek.

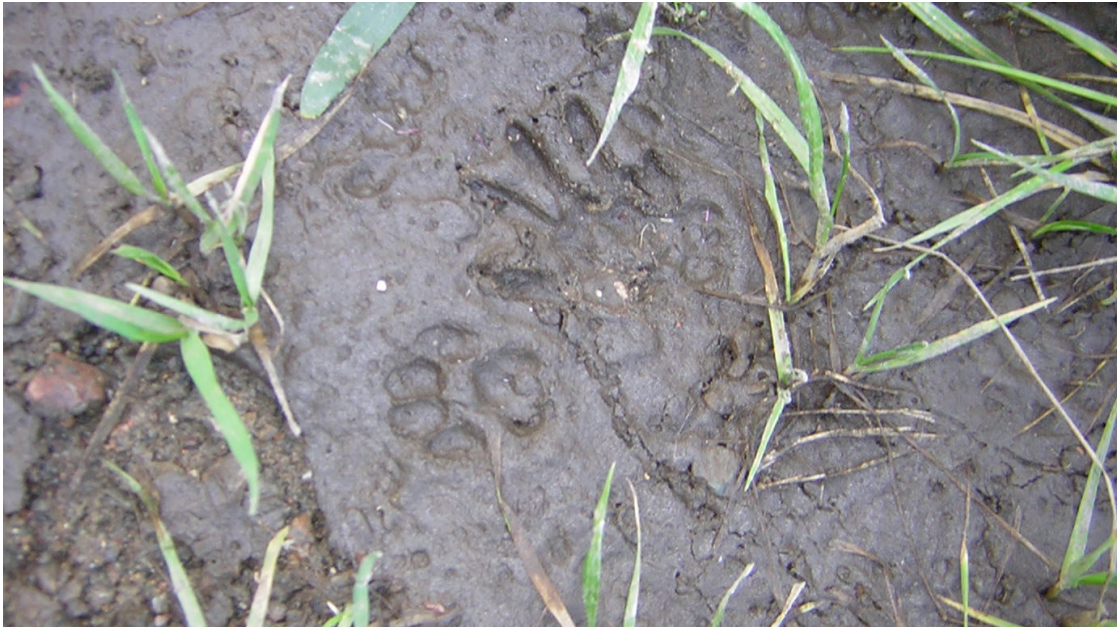
Photo 22: The site is used by both pets and wildlife, as indicated by these dog and raccoon prints.
