Assessment of Channel Changes Three Years after Implementation of the Salmon Habitat Enhancement, Phase 1 on Redwood Creek at Muir Woods

Kondolf, Landscape Architecture 227
University of California, Berkeley
Fall 2022

Mariolina Nicolina Papa, Sergio Jimenez,
and Ruby Telfer

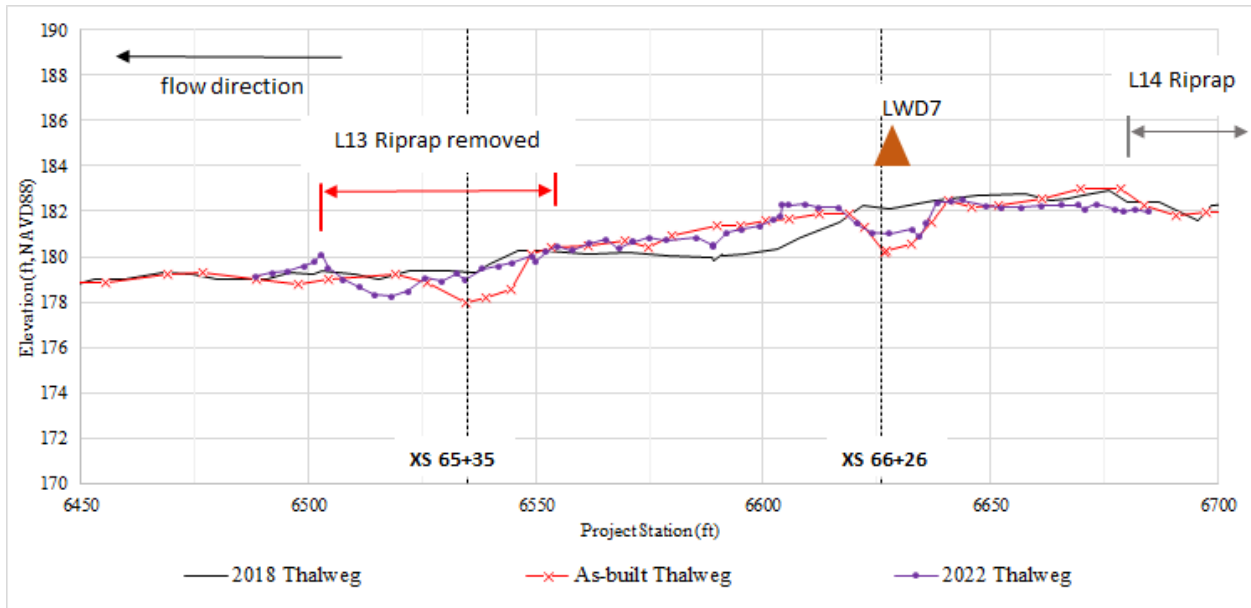
Figure 3. Thalweg profile through cross sections (XS) 65+35 and 66+26

The LWD7 (Figure 3) consists of placed large and small wood adjacent to the right bank. A pool excavated 2-feet deep in 2019 downstream of LWD7 has been partly filled by about one foot, as shown in XS 66+26. In the right side of XS 66+26 there is a deposit lens with maximum thickness of around 2 ft; we observed that this deposit is made up of very fine sandy sediments. Between project stations 6500-6550 ft, where riprap L13 was removed, a pool or lowered thalweg graded in 2019 is almost completely filled in, but a new pool has formed a little further downstream. Deposition has occurred on the right bank of XS 65+35 such that the channel bed on the right aggraded more than a foot compared to the pre-project condition (Figure 4). We observed at XS 65+35 that the wet channel is in contact with the left bank, which is undercut. Downstream there is a pool about 12 ft long and 7 ft wide, a little further downstream the wet channel is in contact with the right bank and has undercut the bank there as well (Figure 4). After riprap removal the wet channel tends to undercut the banks alternately in the right and left banks. This could be interpreted as a trend to recreate a more sinuous course over time.

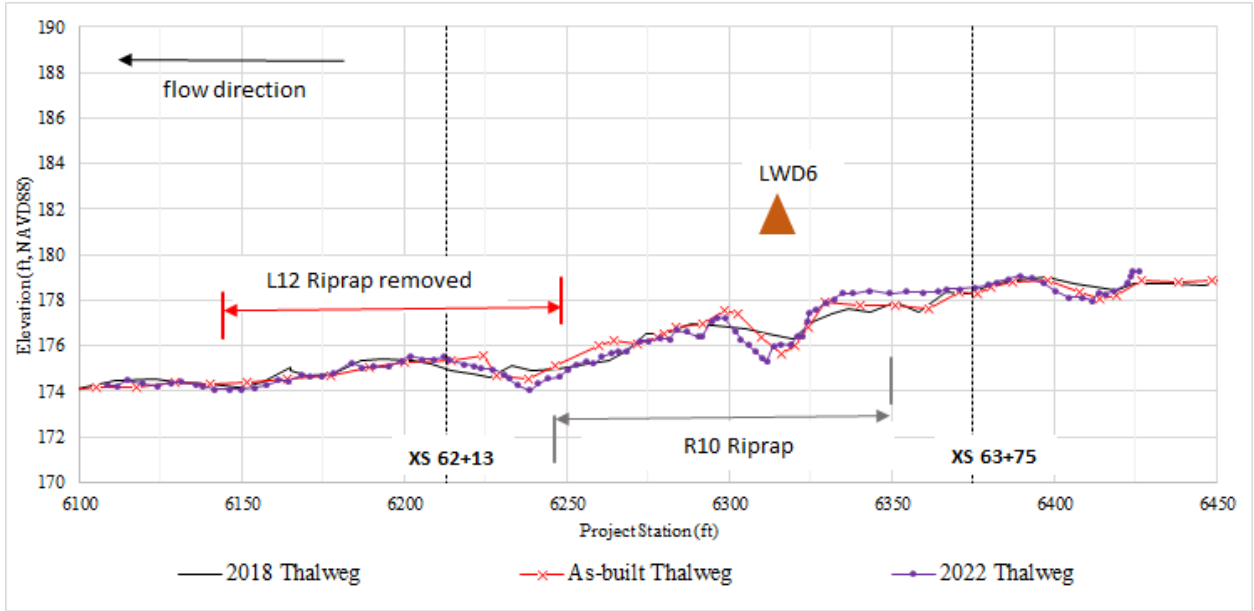
Figure 5. Thalweg profile through XS 62+13 and 63+75

The thalweg profile of project stations 6100-6450 ft (Figure 5) shows little change between the 2019 as-built channel bed elevations and the current condition. The left bank is undercut in the area of XS 63+75. Some of the logs of LWD6 are held in place by vertical pin logs. Sediment deposition occurred at project station 6350 ft, whereas the pool deepened and lengthened downstream LDW6 where there is also a tributary confluence with Fern Creek (Figure A4 in Appendix). The left bank eroded in this area since 2019. However, further downstream the left bank where the L12 riprap was removed is protected by an unaffected erosion control fabric. Interestingly, unlike the section where L13 was removed (Figure 3), the NPS did not excavate a pool or place LWD at L12 during the project work. In this case, the process of alternating right and left bank under-excavation did not occur.

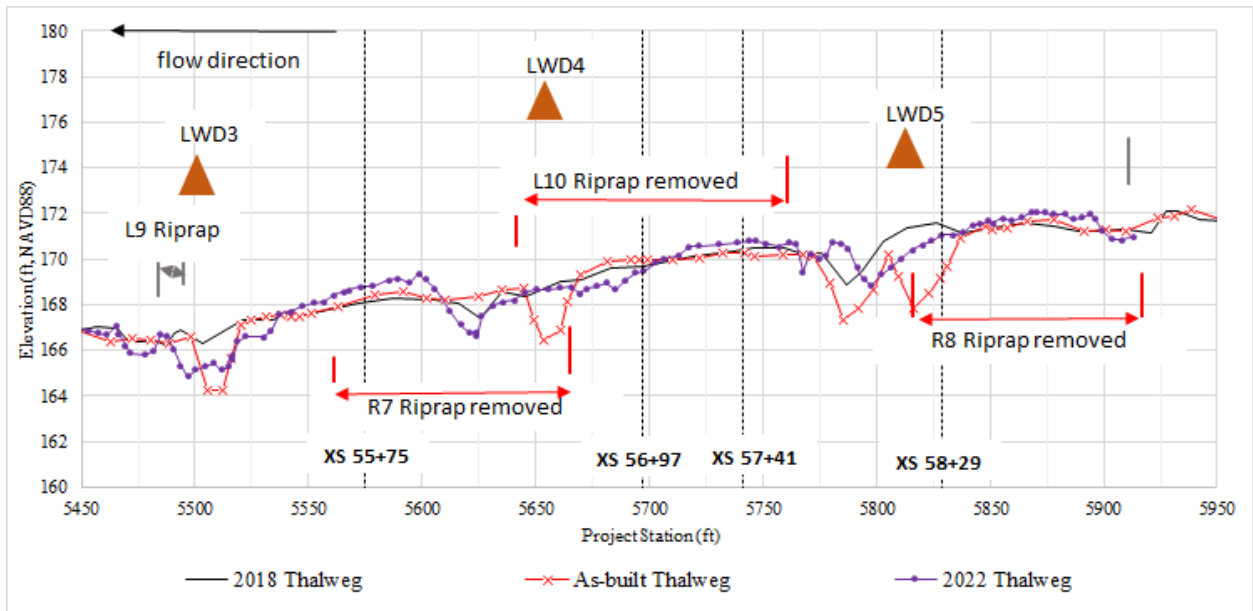
Figure 7. Thalweg profile through XS 55+75 and 58+29

In Figure 7, the right bank from which riprap R8 was removed (between stations 5900 and 5850 ft) has maintained the same shape since 2019, but it is now undercut. Only two of the four placed logs in the LWD5 constructed log jam remain. The two remaining logs are oriented in the flow direction and the cross section no longer has logs that span the channel (Figure A22 in Appendix A). The 2019 excavation at approximately station 5800 ft filled in and the bed of XS 58+29 regraded to 2018 elevations, except along the toe of the right bank, where a lateral pool occurs (Figure 8). With XS 57+41 showing deposition on the left and erosion of the upstream end of a constructed bar on the right, the bed at this location has returned to conditions similar to pre-intervention conditions. The left bank where the L10 riprap was removed is protected by the erosion control fabric, with a portion of the left bank cut at the toe (Figure A23). However, further downstream at XS 56+97, erosion of about 1 ft has occurred at the toe of the left bank where the erosion control fabric is also torn (Figure 9). The top of the bar (downstream of station 5700 ft) has also lowered by about 0.3 ft. The LWD4 is maintained in place by vertical pin logs. The longitudinal profile shows that the pool excavated in 2019 (station 5650 ft) at LWD4 filled up, but a new one has formed downstream (approx. station 5625 ft) along the toe of the left bank. This pool formed at the endpoint of the LWD4 logs and includes an undercut left bank (Figure 10).

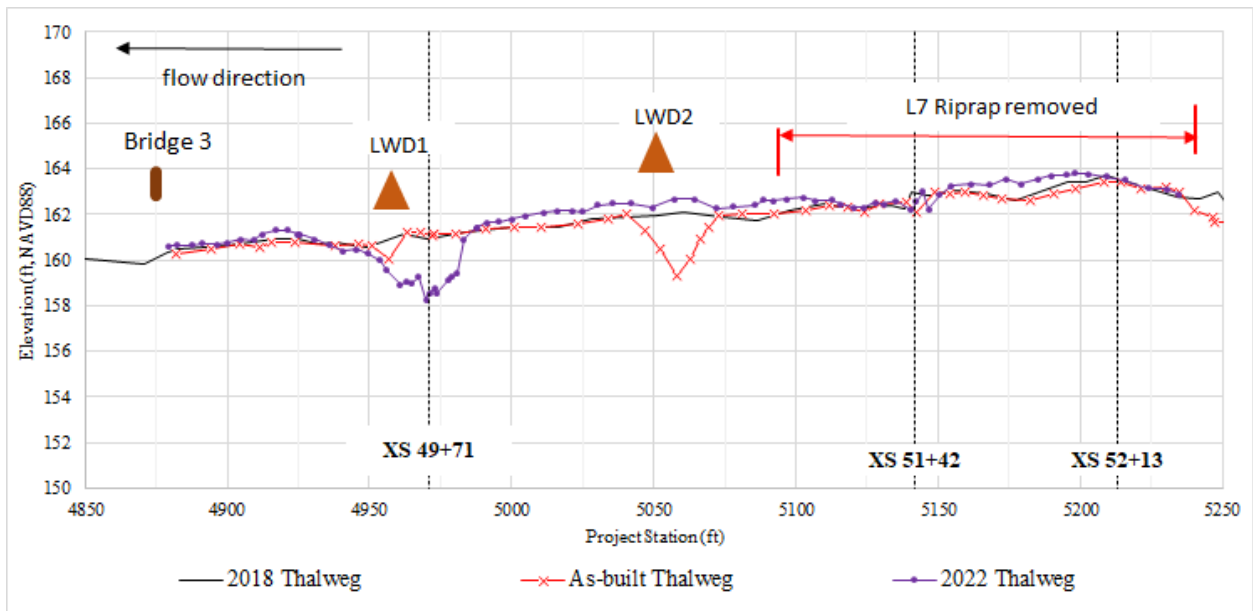
Figure 12. Thalweg profile through XS 49+71 and 52+13

In Figure 12, the section in the Cathedral Grove reach where the riprap L7 was removed (between project stations 5250 and 5100 ft) has slight bed aggradation. However, an area of minor bed scour is observed in the central part of XS 51+42. The logs in LWD2, which were not secured in place with pin logs, have either washed downstream or washed to the toe of the left bank. At station 5050 ft, a sediment deposit has filled the pool that was constructed under the logs of LWD2 in 2019. There is a little aggradation of the riverbed between stations 5050 and 5000 ft. The LWD1 log jam remained in place, due to a long redwood log that spans the channel. Its ability to trap wood had been augmented by some placed pieces under the spanner in 2019; many of those pieces moved but are still part of a log jam at that location. Some of the dislodged upstream logs accumulated in this section. This large log jam also retained many small branches (small woody debris). At approximately station 4975 upstream of LWD1, a small pool constructed in 2019 has deepened, widened and expanded laterally upstream. The XS

49+71 in Figure 14 shows erosion along the entire cross section with maximum depth of scour in the center of about 2.5 ft. (Pools would be deeper when water surface elevation is included). Downstream of the log jam, where no project actions were conducted, the riverbed retains the simplified channel bed of the pre-project conditions.

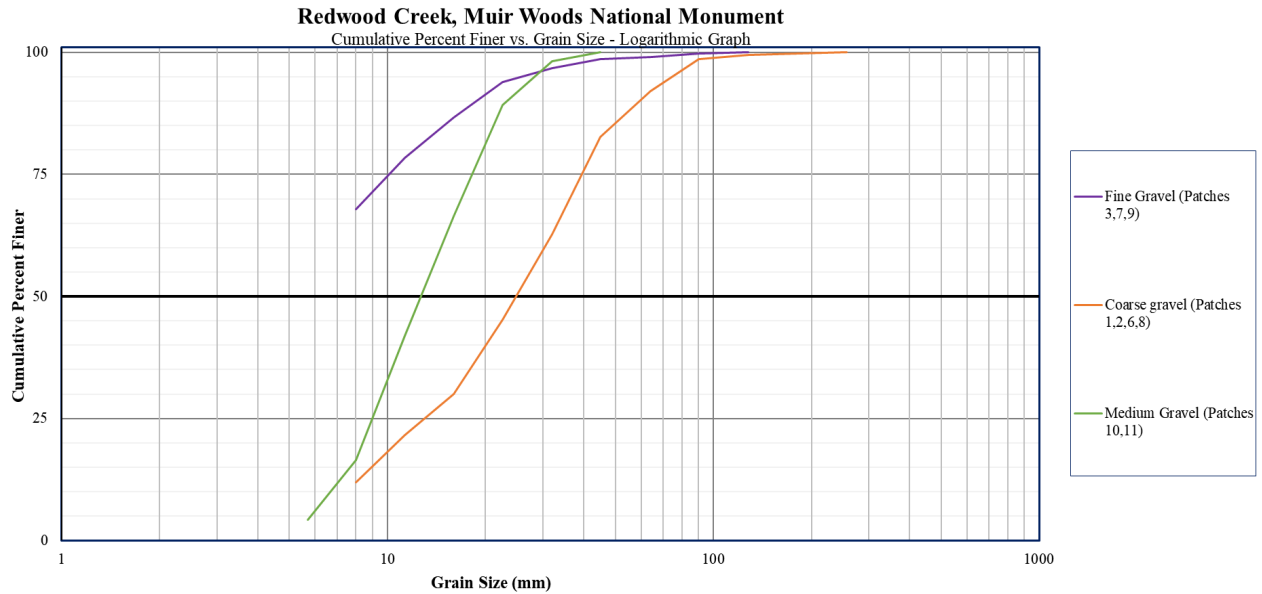
Figure 17. Sediment Size Distribution in 2022 subreach

On Figure 17, we report the grain size distribution curves obtained by pebble counts. We combined the patches with the same D_{50} classification and assumed they belonged to the same patch. Pebble counts conducted on all patches except for 10 and 11 do not measure sediments below 8 mm due to the limitations of our equipment. The orange line indicates that the D_{50} class corresponds to coarse gravel, the green lines indicate a D_{50} sediment class of medium gravel, and the purple lines indicate a D_{50} sediment class of fine gravel.

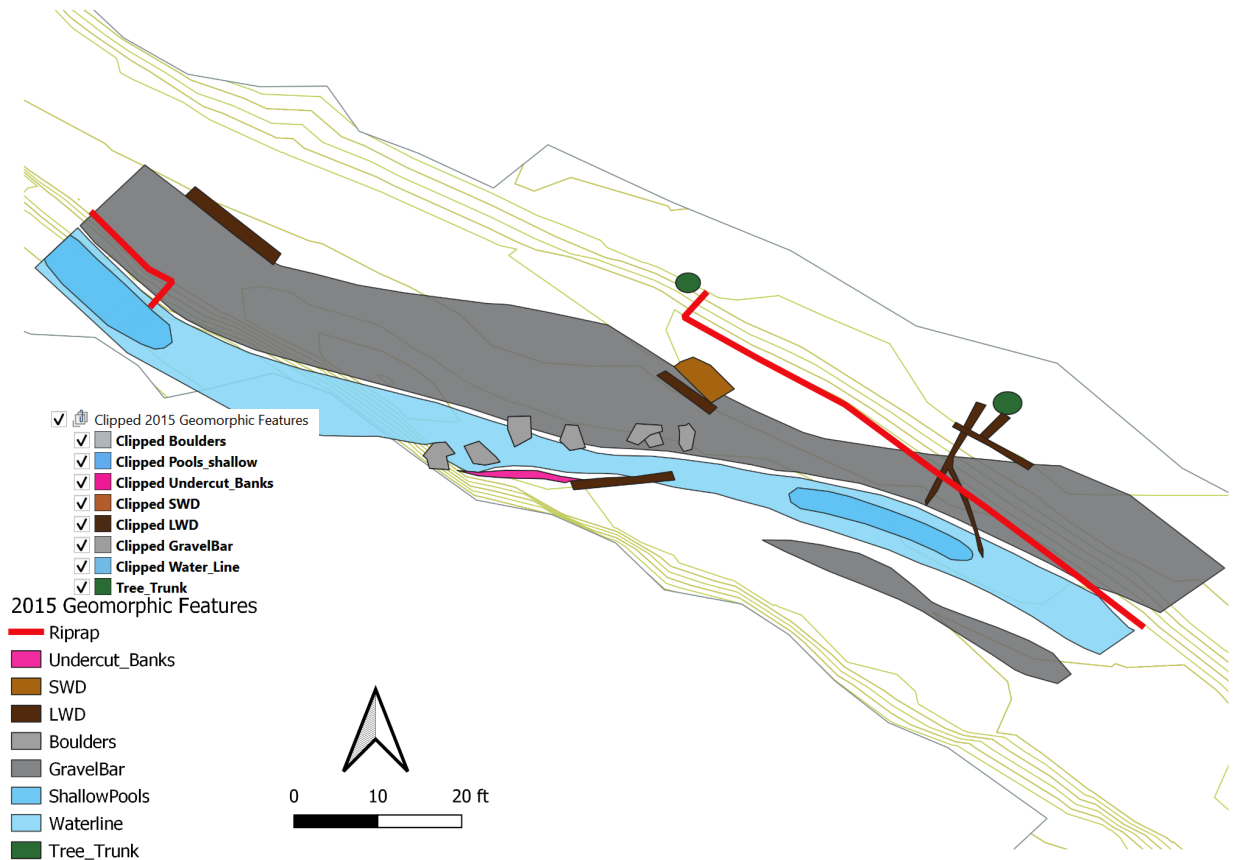
Figure 19. 2015 Geomorphic Features (Allison 2015)

The 2015 geomorphic map in Figure 19 contains two long shallow pools, some LWD, a small undercut bank on the right downstream side, smaller gravel beds, some small woody debris and a low flow channel hugging the right bank, without a meander.

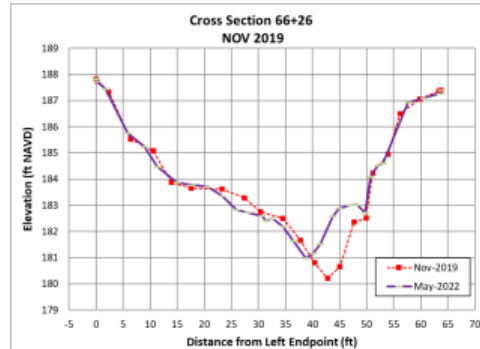
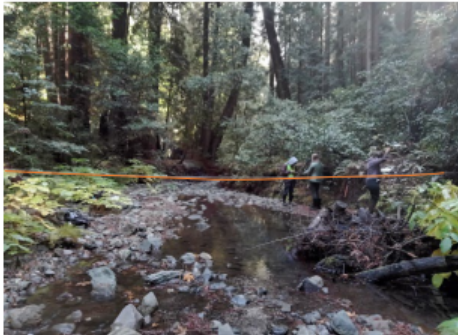
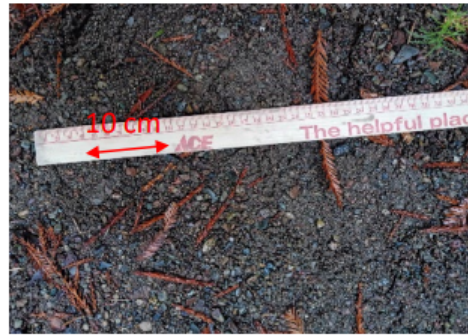
NOTES: there is a woody sediment stack in the hydraulic right immediately upstream of the section. Behind the stack is a lens of deposit with a maximum thickness of about 2 ft. The deposit has very fine sediments at the surface $D_{50} < 2$ mm (Figure A1.4). The sediments of the underlying layers (Fig. A1.5) show fine clay particles and decaying woody debris.

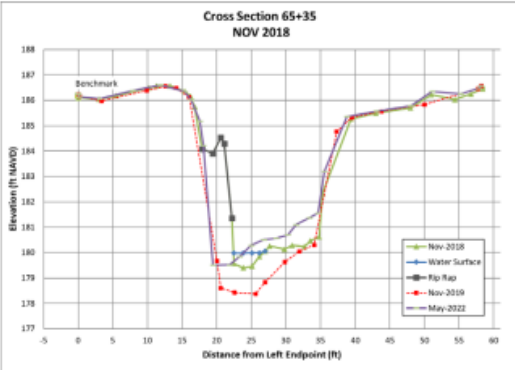
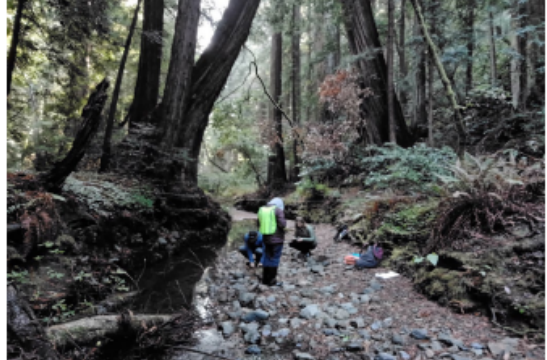
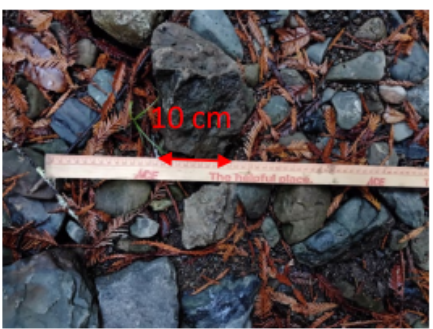
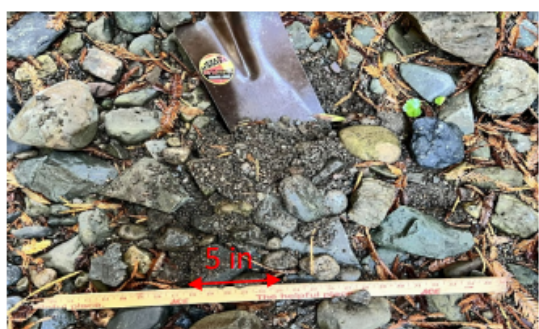
NOTES: Rip-rap has been removed on the left in this section. The profile of the banks has not changed. A deposit about 1 foot thick has formed. Just upstream of the section, on the left, there is a small pile of branches and logs. It can be seen from the longitudinal profile that further downstream the bed elevation has lowered. In that area, there is a pool about 12 feet long and 7 feet wide. At the pool, the bank is undercut.

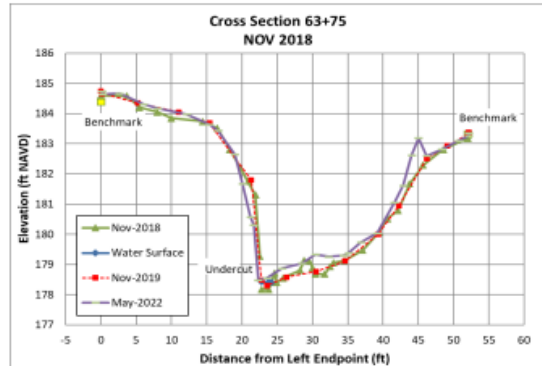
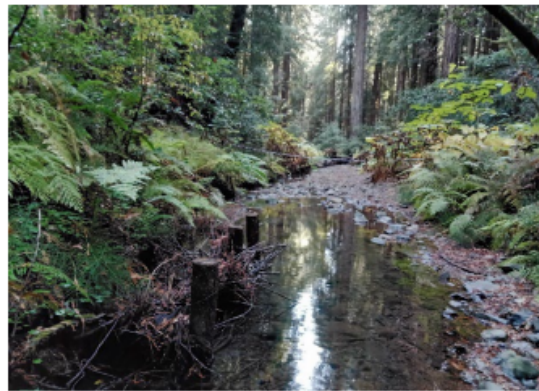
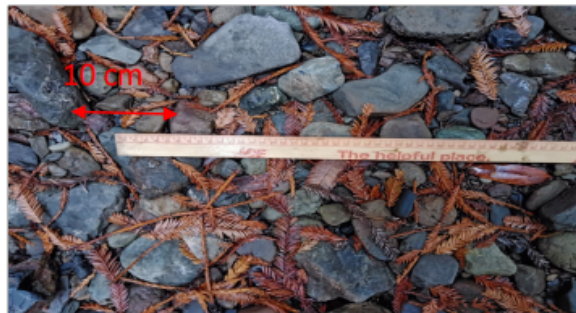
NOTES: About 30 ft upstream of the section, on the left, a structure was created in 2019 to retain branches. The structure is stuck in the riverbed. The left bank is undercut from the structure to the section (Fig. A3.2). About 50 ft downstream there is a log jam (Fig. A4.3). In the section, there is a thin deposit of about 0.3 ft.

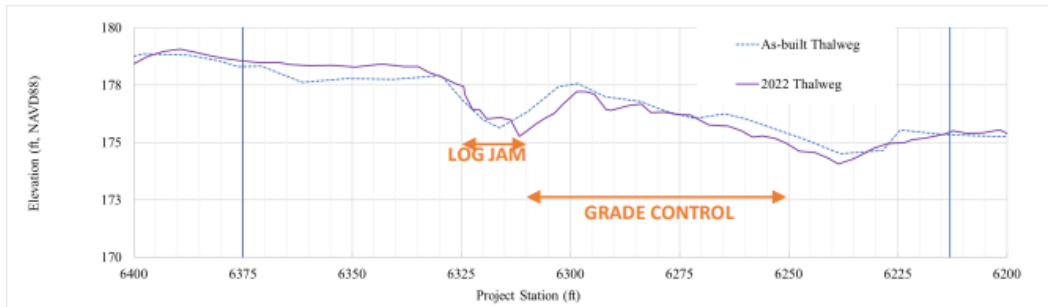
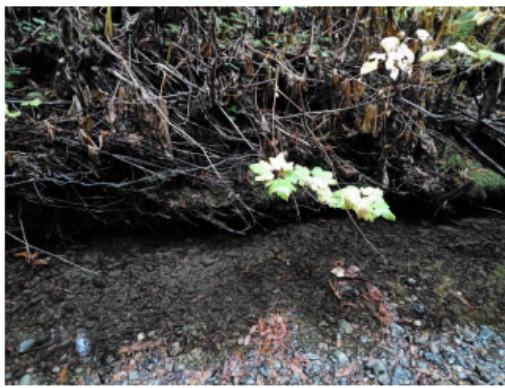
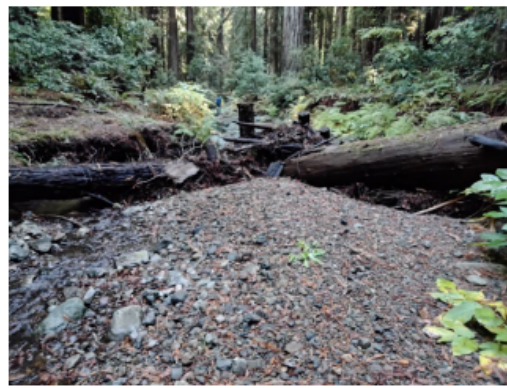
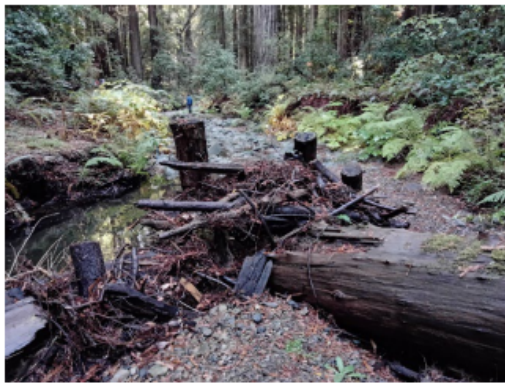
NOTES: At the log jam there is the junction of a tributary on the left. Immediately upstream of the log jam, there is a central bar with a lobe of sediment deposits (Fig A4.3). Of the three logs arranged in 2019, the middle one is missing. The logs are blocked by poles and retain branches. On the left downstream of the log there is bank erosion and a deep pool (Fig A4.4 and Fig. A4.5). Downstream there is a grade control structure at the end of which there is a large pool about 1.4 ft deep.

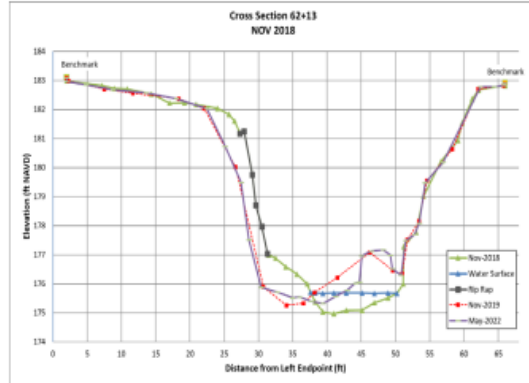
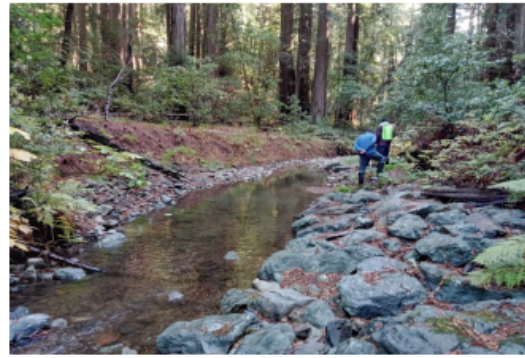
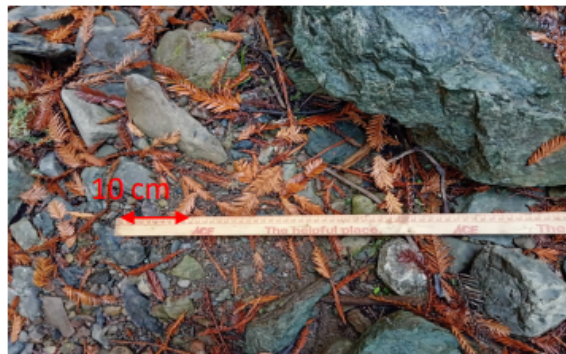
NOTES: Rip-rap has been removed on the left in this section. The bank has maintained its shape since 2019. The section has had erosion in the central part. The bar laterally to the right has widened. An incision remains in contact with the right bank.

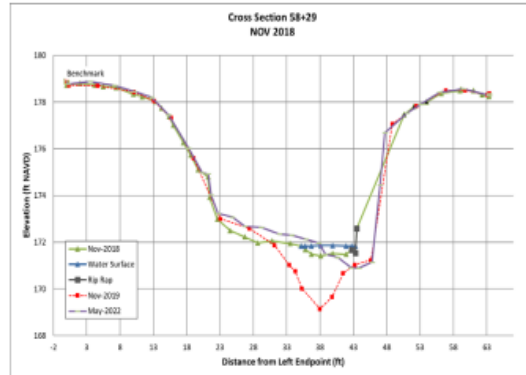
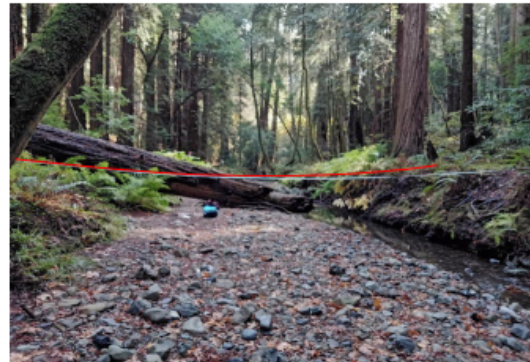
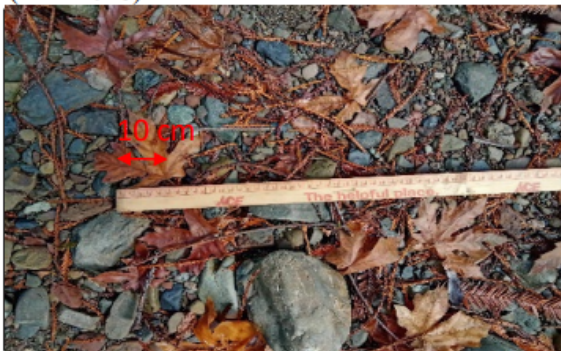
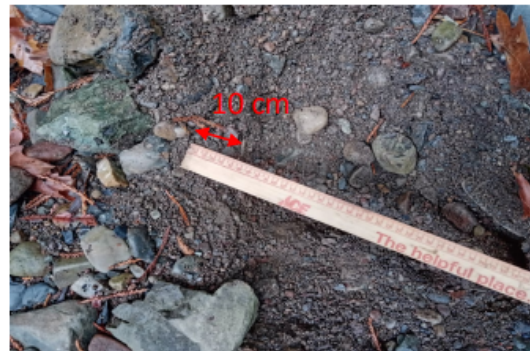
NOTES: The log jam arranged in 2019 was displaced, the remaining logs are oriented in the flow direction. The 2019 excavation was filled in and the section resumed shape like 2018 except for a lower elevation portion at the right bank. In the right the rip-rap was removed, and the bank has kept the shape given in 2019. The right bank is undercut.

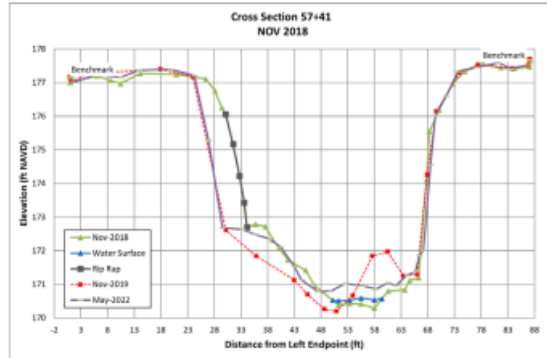
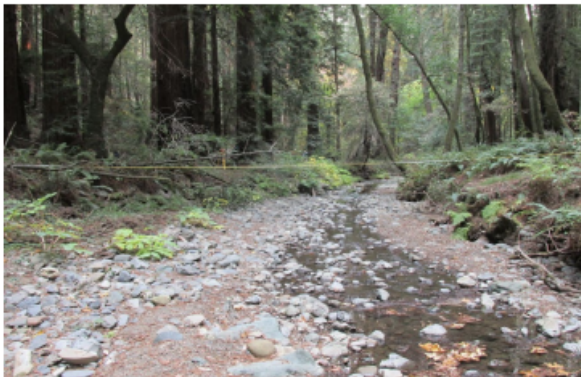
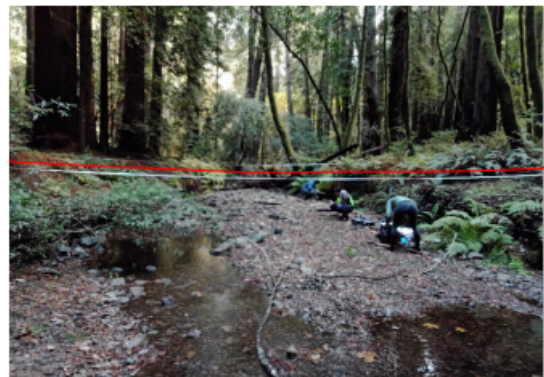
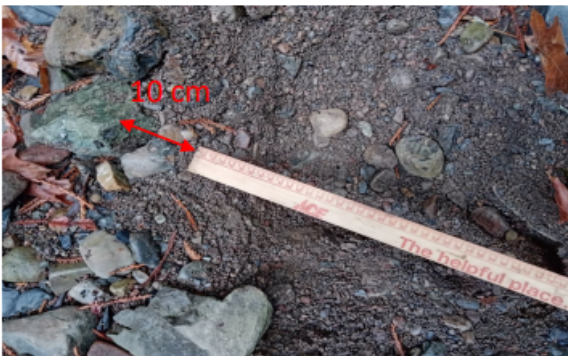
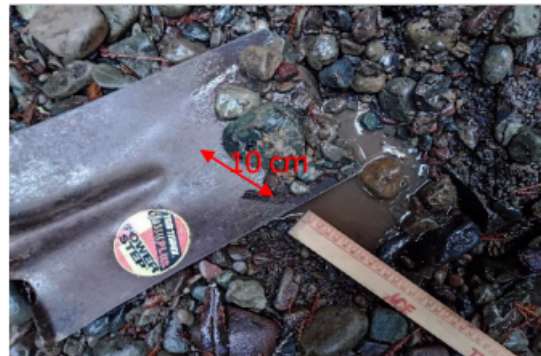
Fact sheet – cross section 57+41

NOTES: Rip-rap was removed on the left. The bank has the same shape given in 2009. On the riverbed there is deposition on the left and erosion on the right, it seems the shape has returned to something like the pre-intervention situation (2008, see Fig. A7.4). The deposit has finer sediments at the surface on the left and coarser sediments on the right.

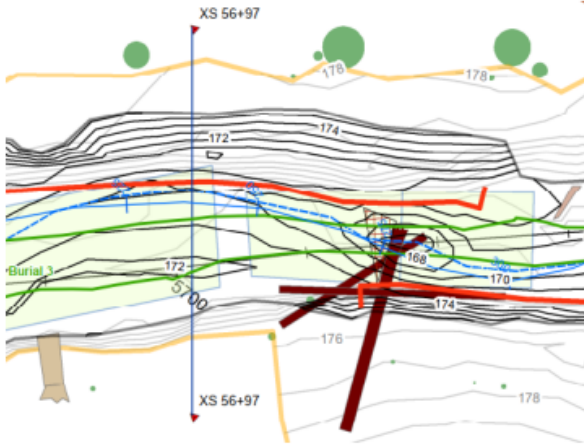
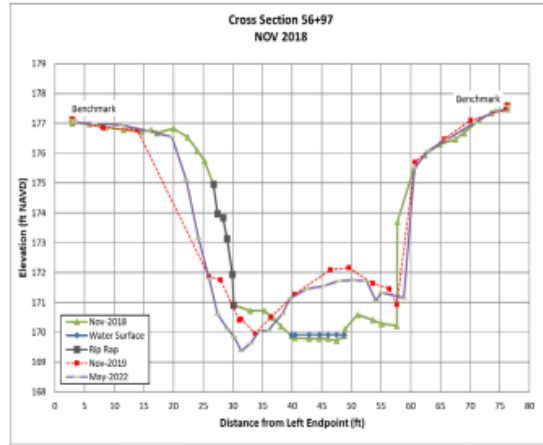
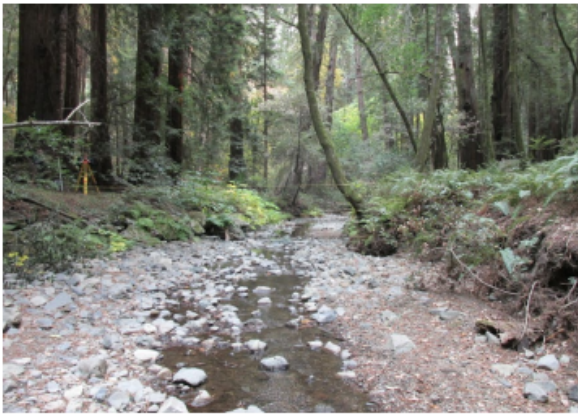
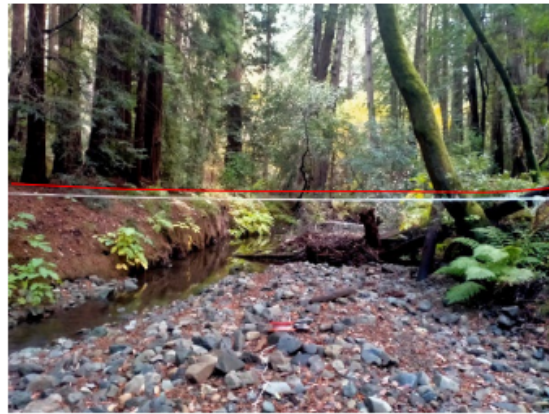
Fact sheet – cross section 56+97

NOTES: The rip-rap was removed on the left and the bank was reshaped. The 2019 and 2022 left bank profiles do not match, probably this is because fewer points were surveyed in 2019. Erosion of about 1 ft has occurred at the toe of the left bank, the erosion control fabric is cut. The top of the bar has also lowered by about 0.3 ft.

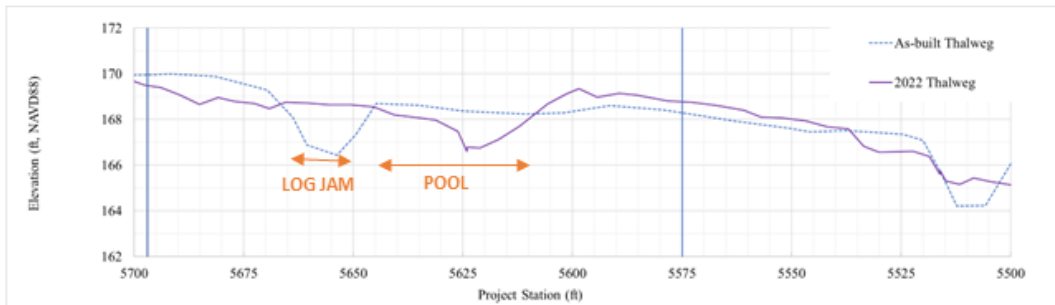
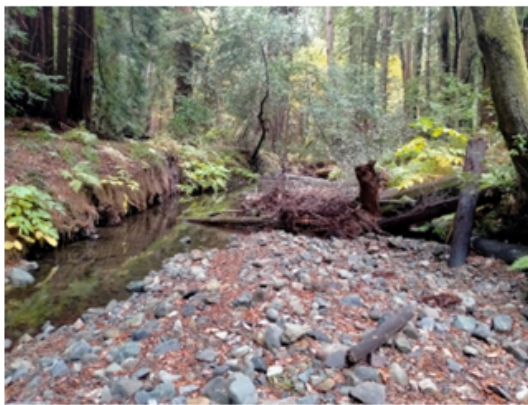
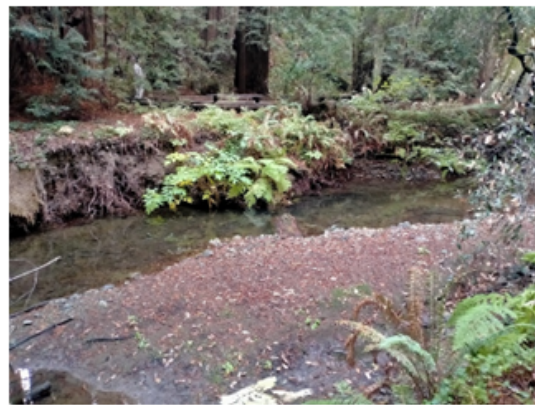
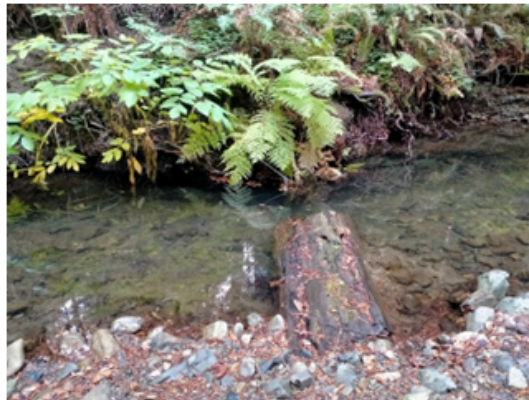
Reach between cross sections 56+97 and 55+75

NOTES: The log jam has been modified; some logs are absent. Branches have been retained. A pool occupies the left half of the riverbed for a length of about 30 ft. The maximum depth in the central part is about 2 ft.

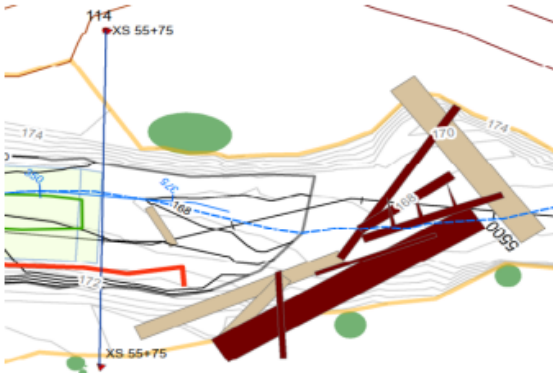
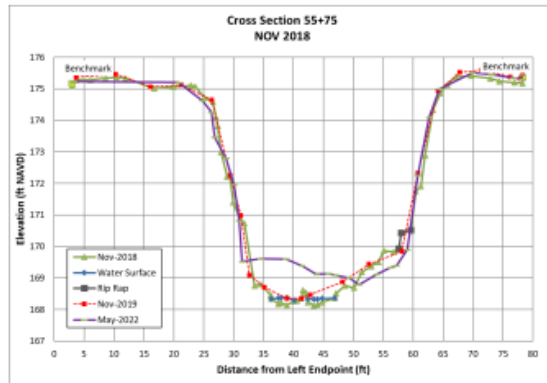
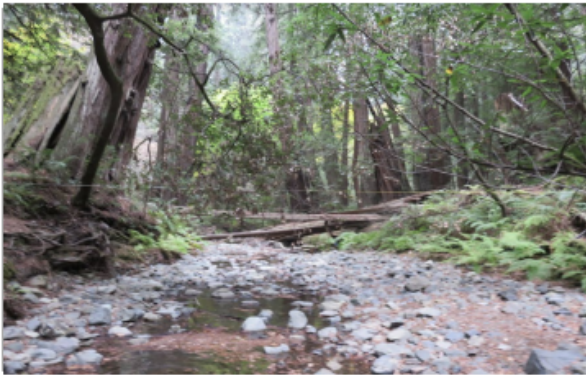
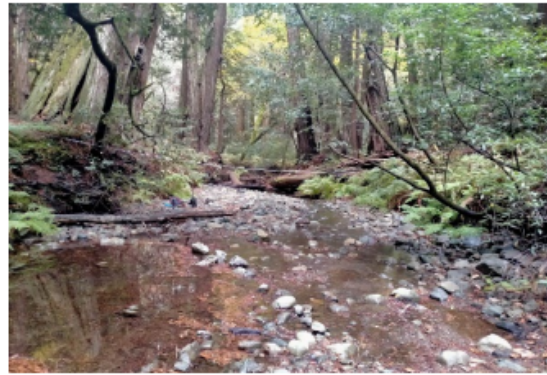
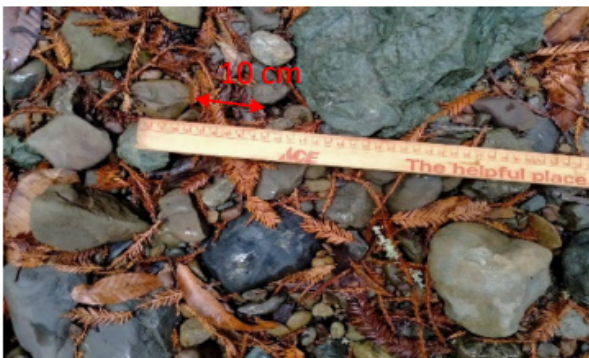
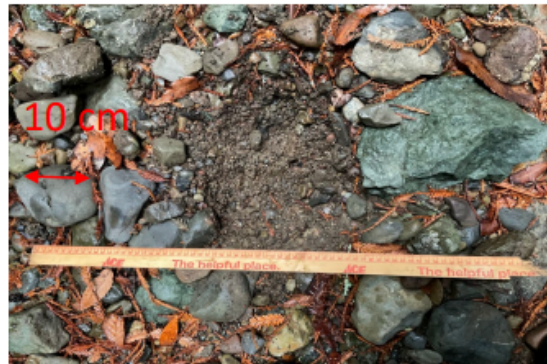
Fact sheet – cross section 55+75

NOTES: The cross-section has formed a deposit of about 1 ft. In the middle and left part of the section and erosion about 0.5 ft. at the foot of the right bank.

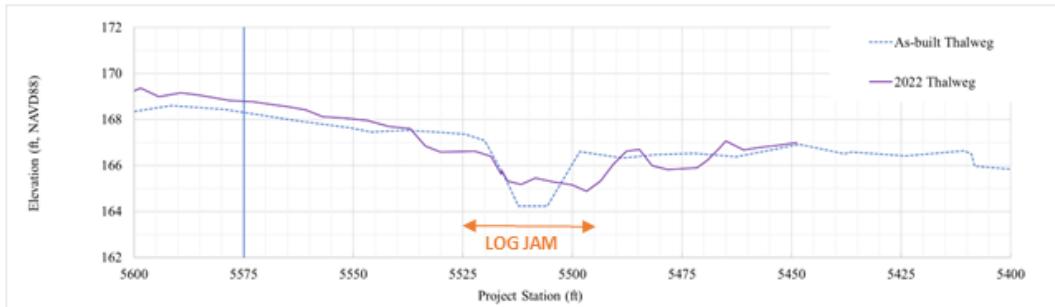
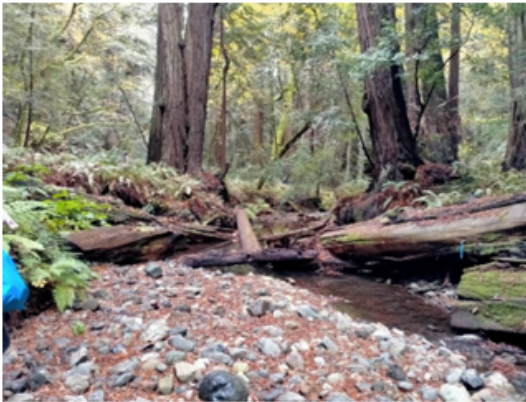
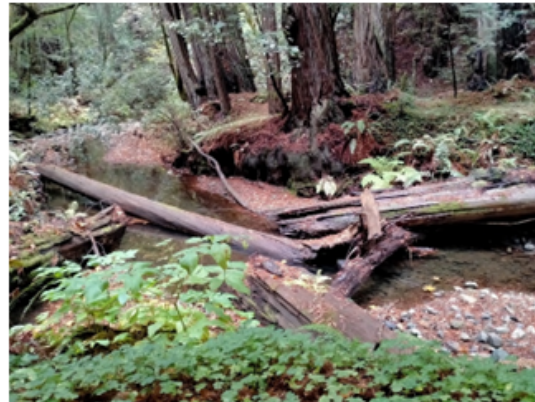
Reach between cross sections 55+75 and 52+13

NOTES: Logs have been moved and oriented in the direction of the flow. Some logs are missing. A pool has formed at the log jam and another further downstream. The right bank is undercut for a long stretch.

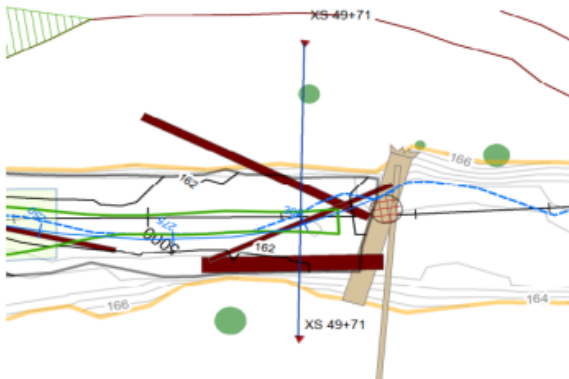
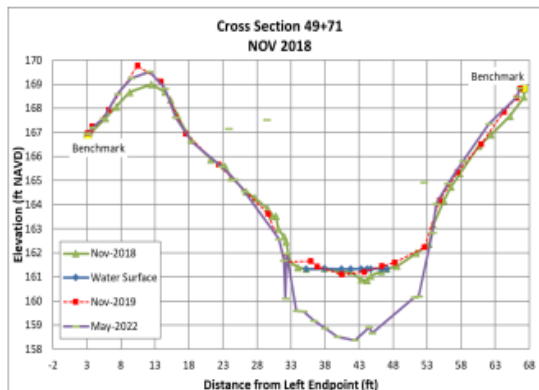
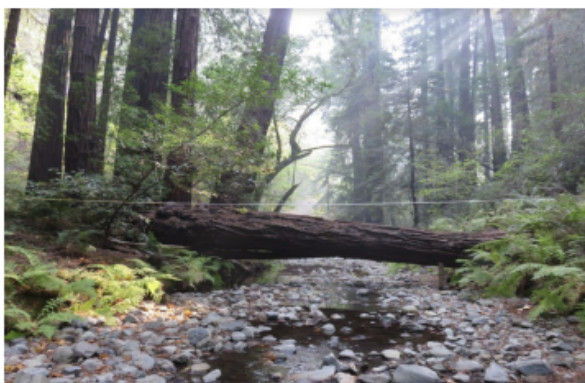
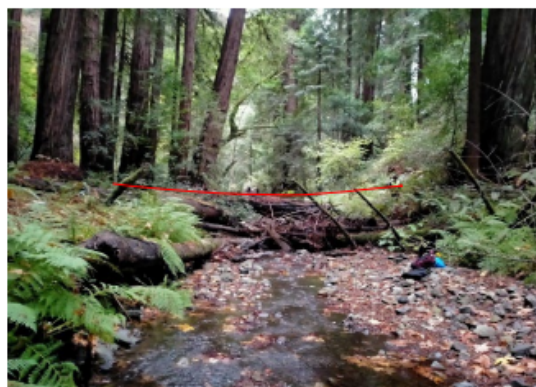
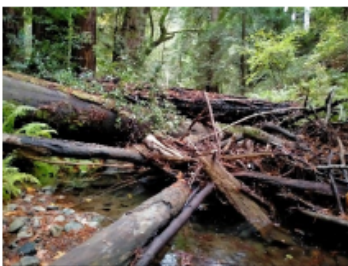
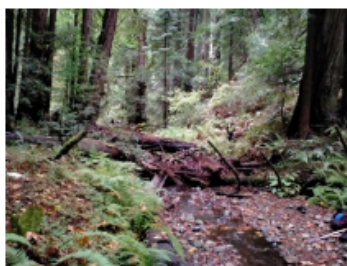
Fact sheet – cross section 49+71

NOTES: Some of the logs washed out from upstream have accumulated in this section. The log jam also retained many branches. There is erosion along the entire cross-section width with maximum thickness in the center being about 2.5 ft. Downstream of the log jam the riverbed has a simplified shape.
