Parallel passageways: An assessment of salmon migration in the San Gregorio watershed

**PARALLEL PASSAGEWAYS: AN ASSESSMENT OF SALMON MIGRATION
IN THE SAN GREGORIO WATERSHED
FINAL DRAFT**

Chris Alford

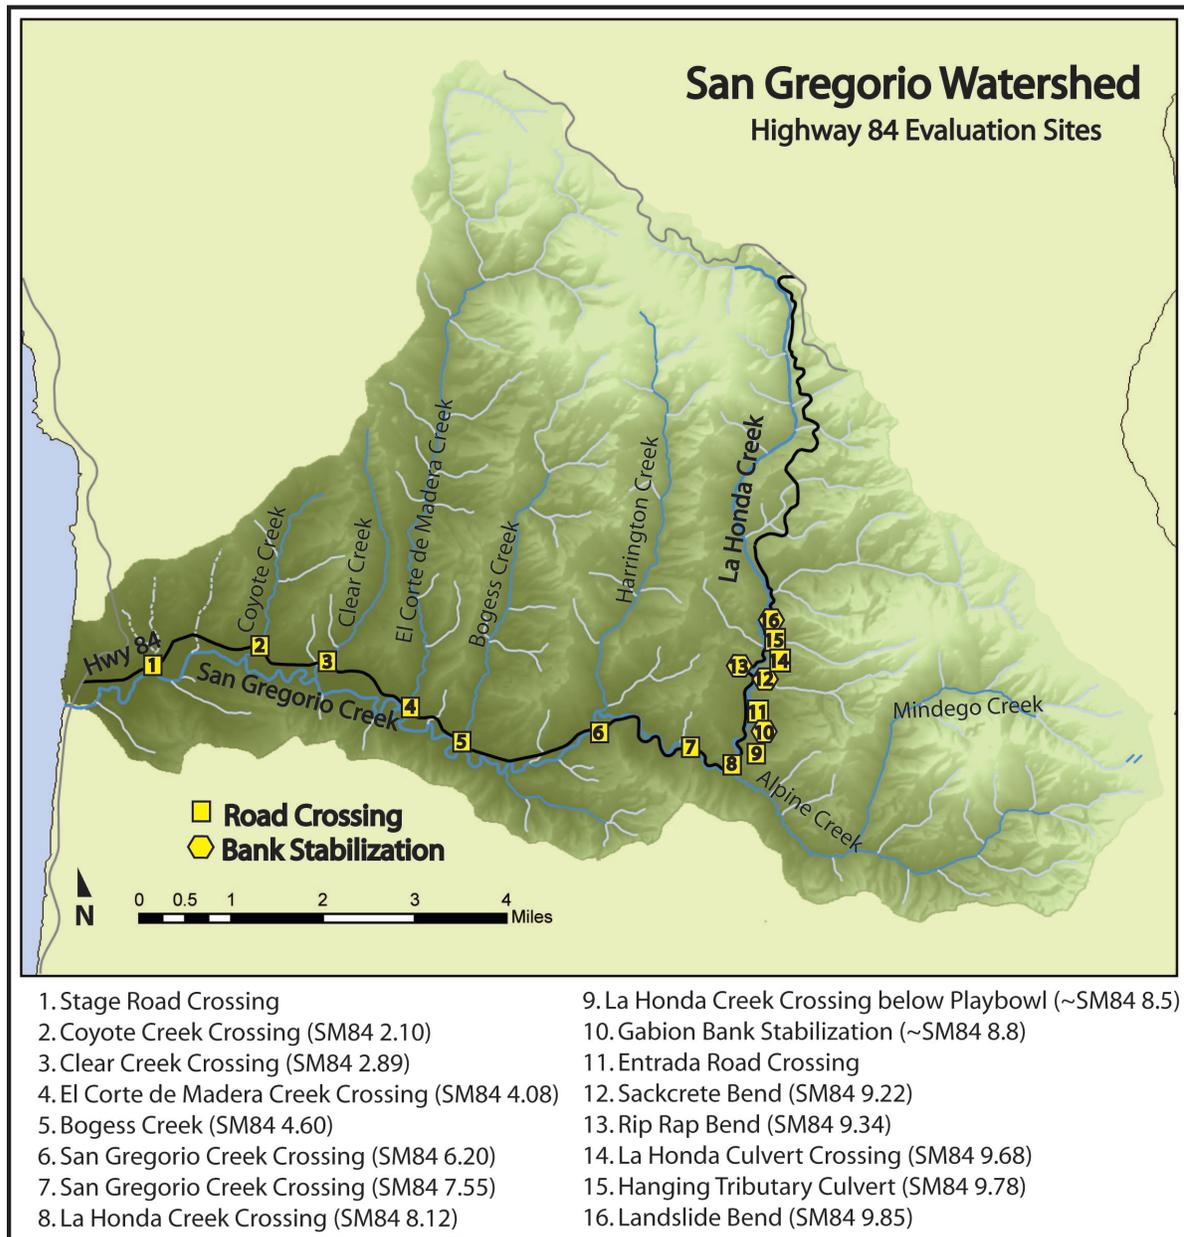
FIGURE 2: San Gregorio Watershed and evaluation site locations

I identified road crossing locations on USGS 7.5-minute Quadrangles and identified bank stabilization sites both on the Highway 84 Realignment Project As-Built Plans and through recommendations by individuals familiar with the watershed (Figure 2). The San Mateo County Public Works Department provided access to copies of the Highway 84 Realignment Project As-Built Plans. Sarah Pearce, a geomorphologist with extensive field experience in the upper reaches of the San Gregorio watershed, provided assistance in locating erosion control sites. David Yam, Caltrans District 4 Environmental Division Branch Chief, noted some erosion control sites along the Highway 84 transportation corridor and provided references to Caltrans standard specifications for erosion control and bank stabilization techniques. I conducted document searches at the Water Resources Archives and through the San Gregorio Watershed Information System and conducted interviews with two local landowners in an effort to locate information pertaining to the history of salmon populations in the watershed.
