Post Project Analysis of a Restored Reach of Redwood Creek

LA222 – Hydrology for Planner  
UC Berkeley – Spring 2012

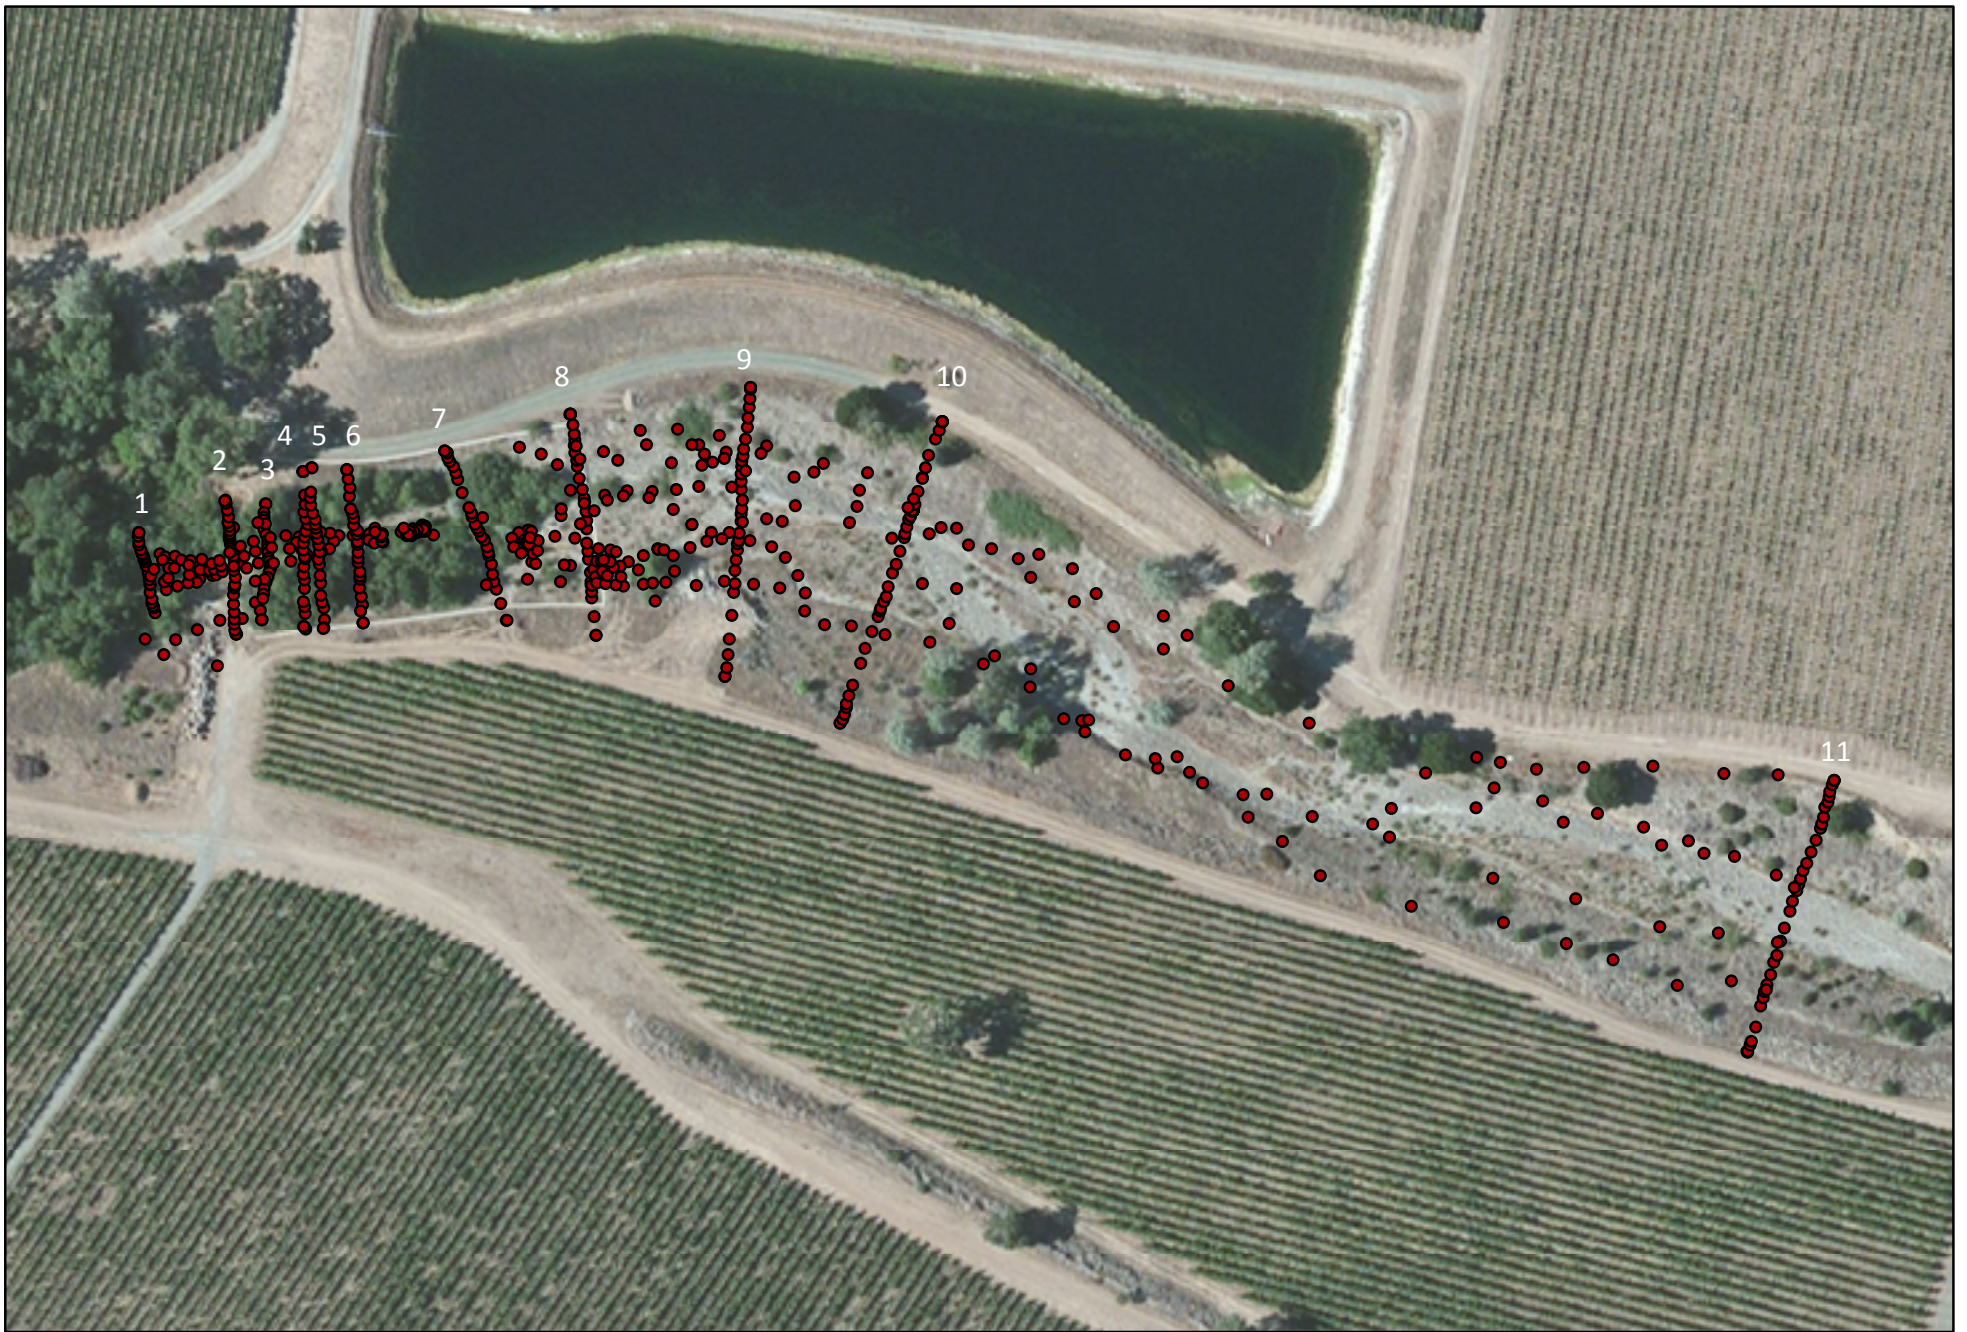
Figure 12. Cross Section Locations

We resurveyed 4 cross-sections using an auto-level, rod, and tape, in order to compare the results to the previous survey. Figure 12 shows the cross-section locations. We were unable to locate all the monuments associated with the historic data. We tied all elevations into the North American Vertical Datum of 1988 using benchmarks located at
