Tassajara Creek, Twenty Years Later: Long-term riparian vegetation restoration monitoring using field surveys and remote sensing

Skyler Lewis
LA254 Rivers & Cities
Spring 2021

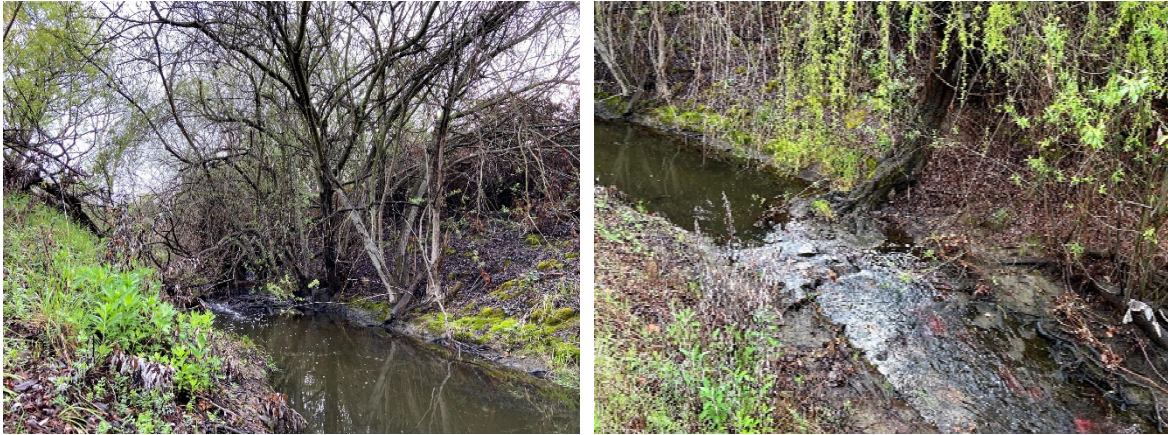
Pools and riffles on the main channel, north of the trail crossing looking upstream.

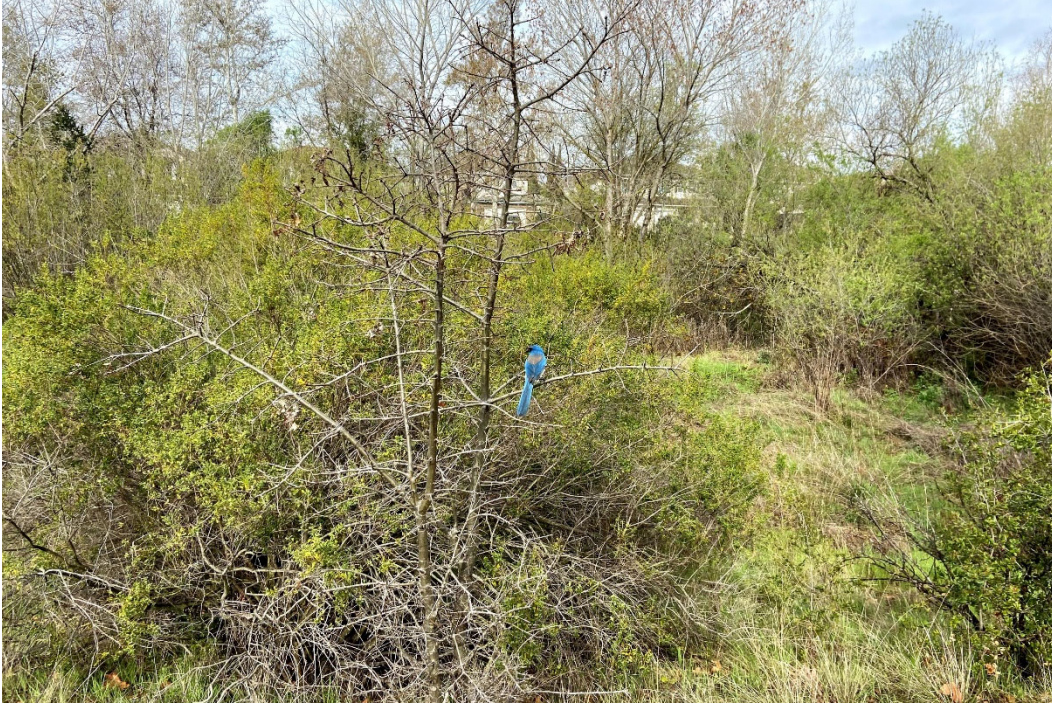
Exhibit 14. Photo observations, south of trail crossing to Central Pkwy
Dense terrace vegetation (e.g. *Baccharis*) looking west
