Pedestrian and Bicycle Safety Evaluation in a SMART Corridor

**California PATH Research Report  
UCB-ITS-PRR-2008-25**

Final Report for Task Order 5204

October 2008

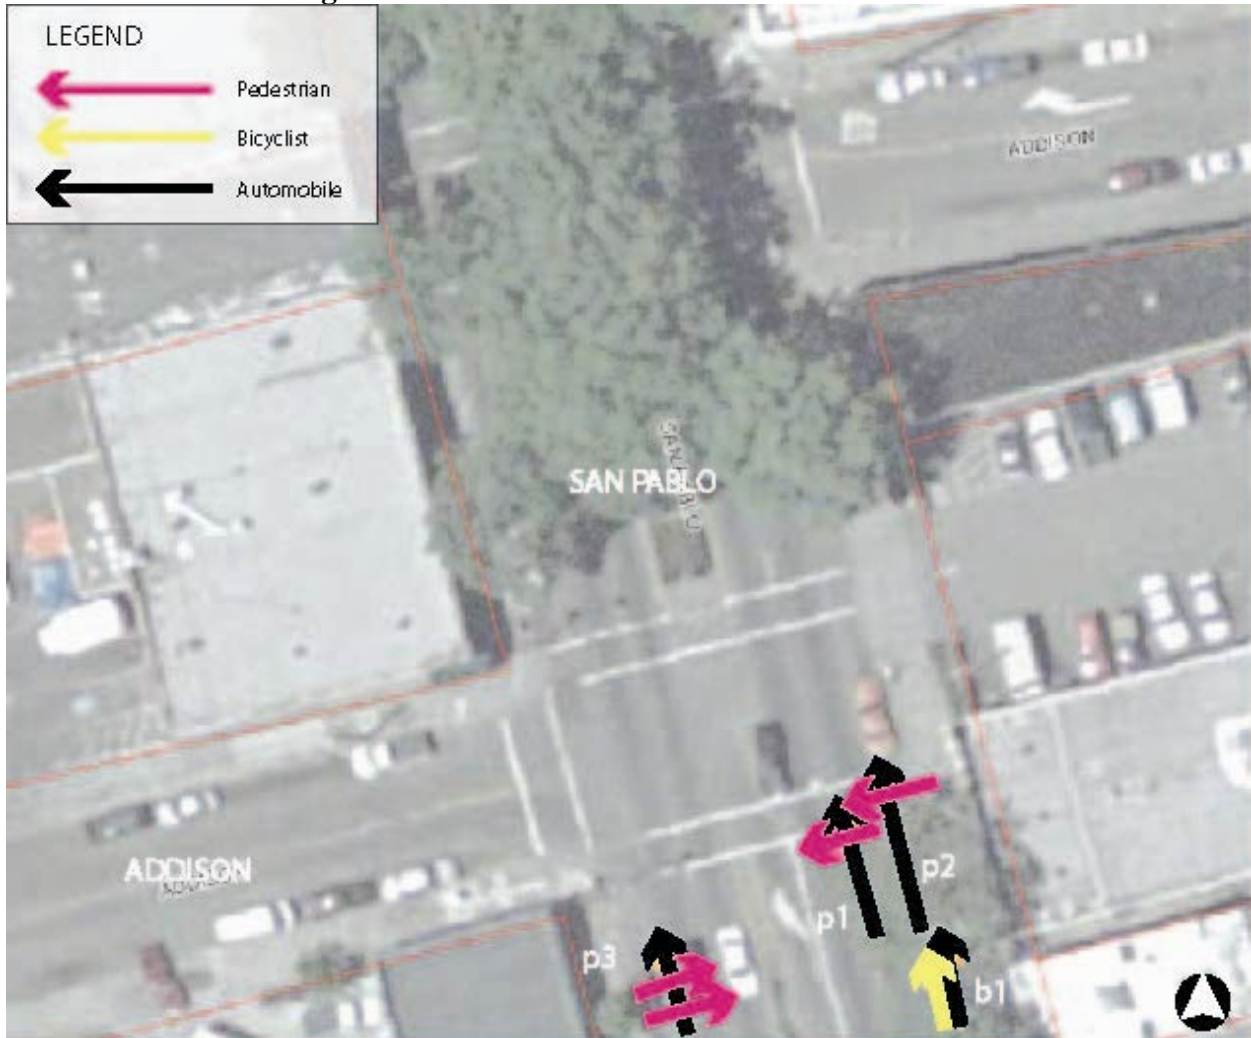
**Figure 5.9. San Pablo Avenue and Addison Street**

There were vehicle collisions with three pedestrians, and vehicle collisions with one bicyclist reported for this intersection in the past six years. The crashes appeared to be concentrated at the eastern side of the southern intersection and approach. It is not clear by the data provided whether the crashes occurred in the proximity of the northern or southern Addison crossing. The pedestrian crashes occurred in the intersection with vehicles stopping or proceeding straight, they occurred outside of the crosswalk between a vehicle backing up and two eastbound pedestrians. The bicycle crash occurred with a northbound vehicle entering traffic. The crash types and previous movements are illustrated in figure 5.9.

- Upgraded/extended median (pedestrian refuge island): reduce conflict, reduce number of trapped pedestrians, increase number of pedestrians using crosswalk.

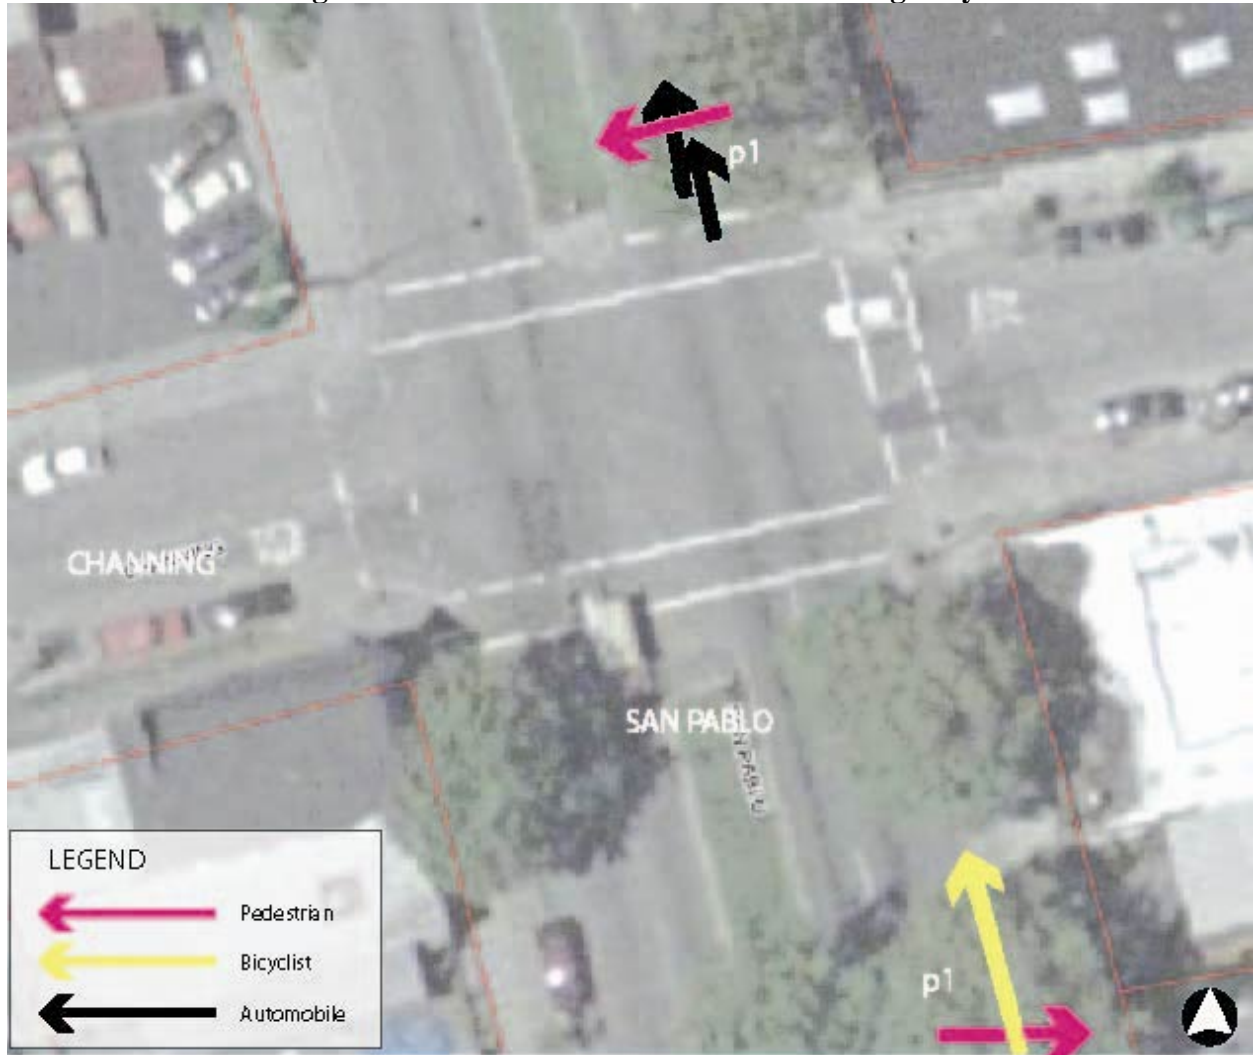
**Figure 5.12. San Pablo Avenue and Channing Way**

One vehicle collision with a pedestrian, and three vehicle collisions with bicycles were reported between 1998 and 2003. The pedestrian/vehicle crash occurred about 30 feet outside of the intersection on San Pablo Ave., with two northbound vehicles and a westbound pedestrian. The pedestrian/bicycle collision involved a westbound pedestrian and a northbound bicyclist on San Pablo over 100 feet from the intersection. The crash types and previous movements are illustrated in Figure 5.12.

- In-roadway knockdown signs, passive awareness: increases awareness, reduces conflict; however, may give pedestrian false sense of security.
- Speed trailers: discourages speeding, reduces conflict.
- Pedestrian activated flashing lights: reduces conflict, increases use of crosswalks; could reduce pedestrian awareness.
- Upgraded/extended median (pedestrian refuge island): reduce conflict, reduce number of trapped pedestrians, increase number of pedestrians using crosswalk.

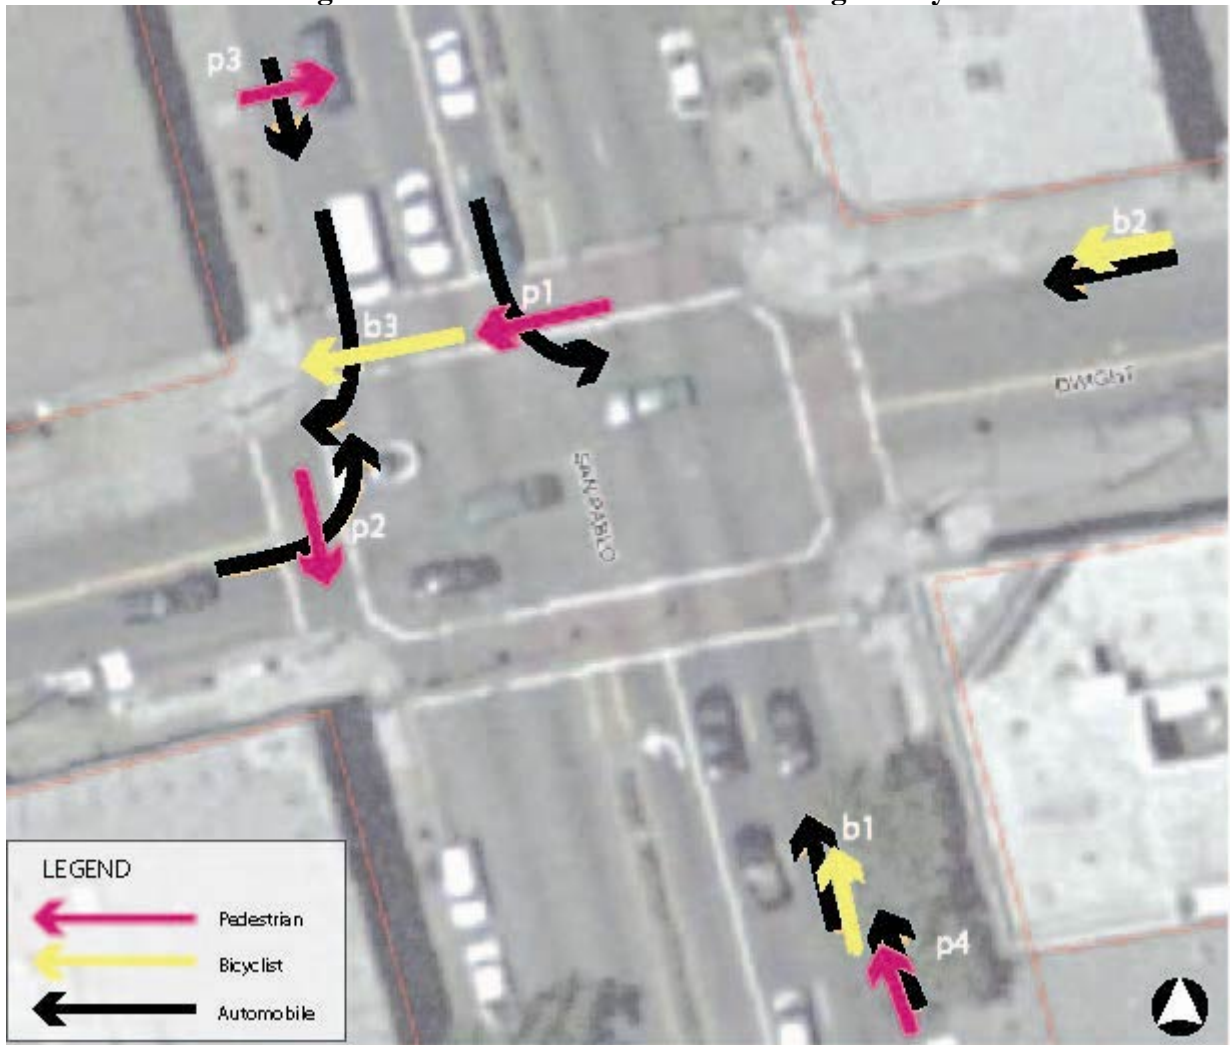
Figure 5.13. San Pablo Avenue and Dwight Way

Vehicle collisions with four pedestrians, and vehicle collisions with three bicyclists were reported between 1998 and 2003. The majority occurred in the northwest corner of the intersection and approach. Pedestrian crashes involved straight-moving and left-turning vehicles and included both driver and pedestrian violations. Two bicycle crashes involved a stopped or parked car with straight moving bicyclists, and one involved a right-turning vehicle into a bicycle traveling the wrong way against traffic. The crash types and previous movements are illustrated in figure 5.13.

- Upgraded/extended median (pedestrian refuge island): reduce conflict, reduce number of trapped pedestrians, increase number of pedestrians using crosswalk.
- Ample signage for bicyclists to guide them to alternative bicycle network, two blocks the west of this intersection.
- Signs encouraging motorist to “share the road” and warning of approaching bicycle boulevard intersection.
- Signs warning motorist parking on the street about “door zone vigilance.”

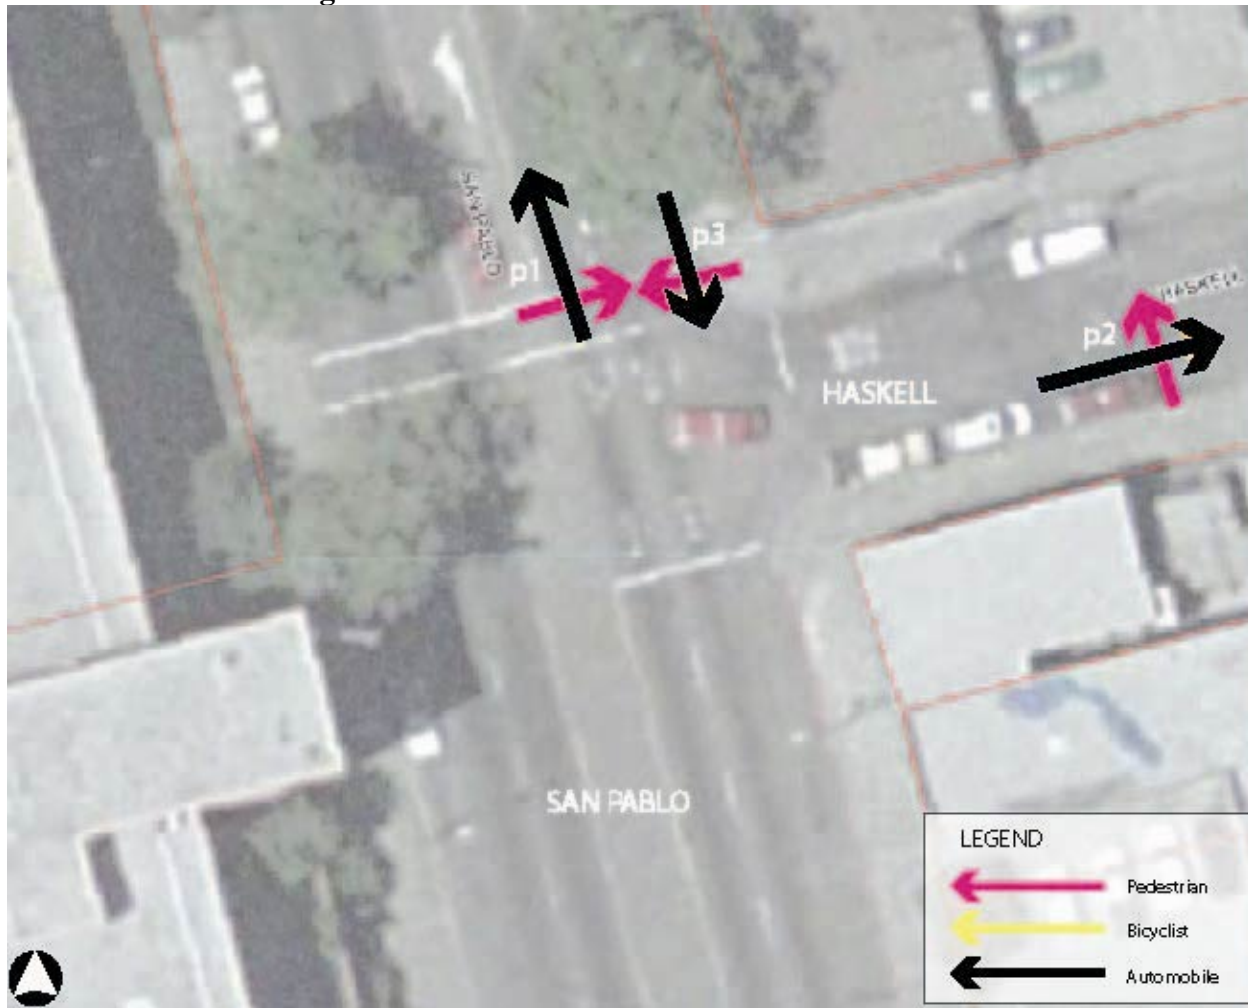
Figure 5.16. San Pablo Avenue and Haskell Street

There were vehicle collisions with three pedestrians reported for this intersection between 1998 and 2003. Two were determined to be the fault of the pedestrian. Pedestrian crashes involved vehicles backing up, a pedestrian jaywalking and an improper passing maneuver by a vehicle. The crash types and previous movements are illustrated in Figure 5.16 below.

- In-roadway knockdown signs (impactable yield), passive awareness: increases awareness, reduces conflict.
- Speed trailers: discourages speeding, reduces conflict.
- Pedestrian activated flashing beacons: reduces conflict, increases use of crosswalks; could reduce pedestrian awareness.
- Pedestrian activated flashing lights: reduces conflict, increases use of crosswalks; could reduce pedestrian awareness.

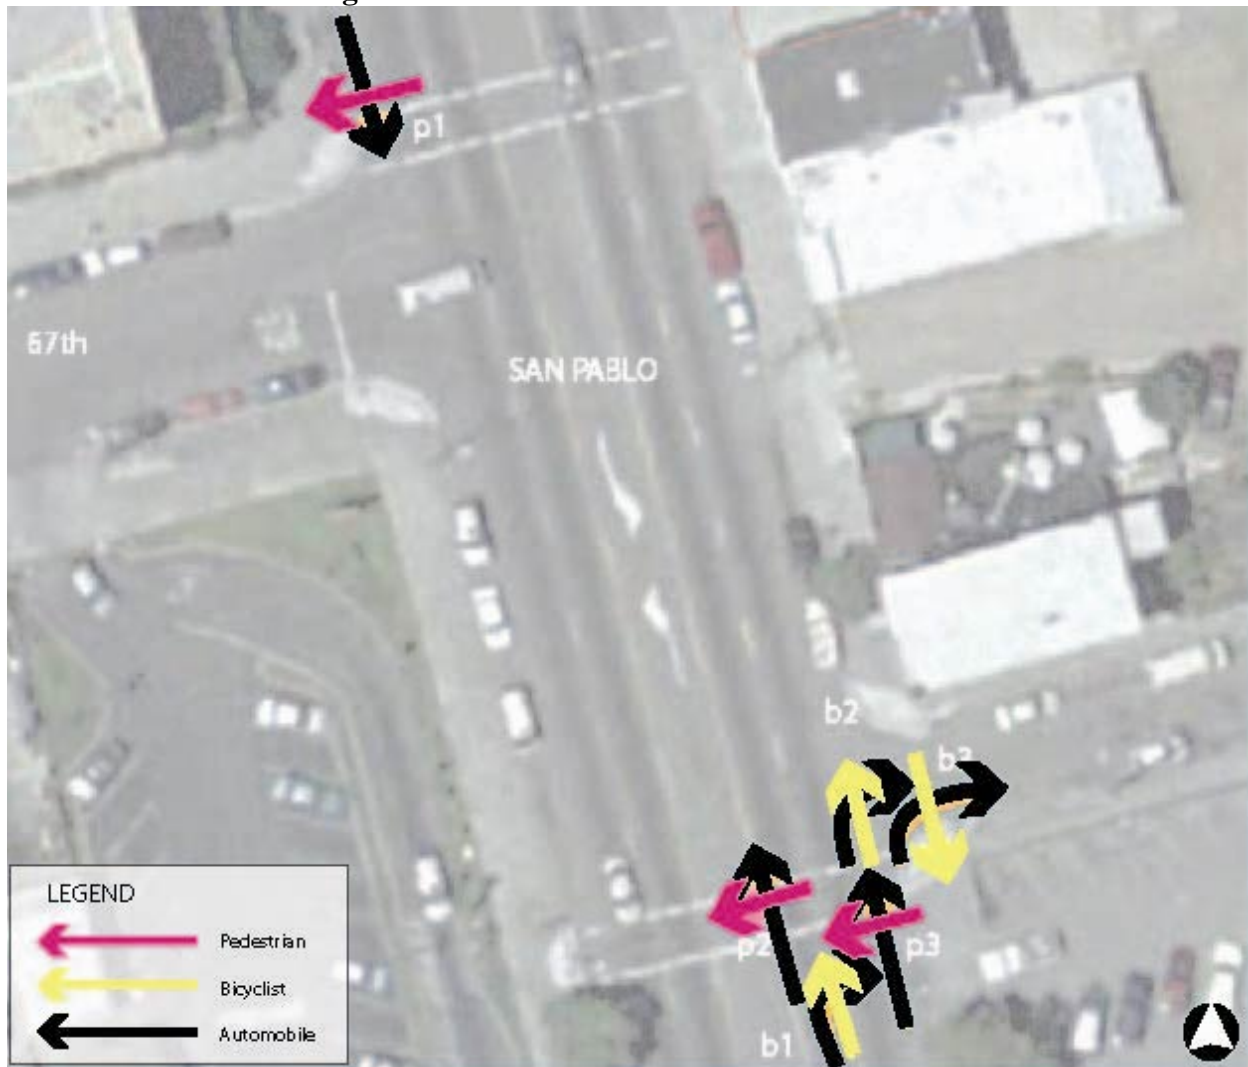
**Figure 5.17. San Pablo Avenue and 67th Street**

Vehicle collisions with three pedestrians, and vehicle collisions with three bicyclists were reported for this intersection between 1998 and 2003. Pedestrian crashes involved straight-moving vehicles and were at or within ten feet of the intersection. Bicycle crashes involved right-turning vehicles and were concentrated on the southeastern side of the intersection. The crash types and previous movements are illustrated in figure 5.17.

- Replace landscaping with higher canopy vegetation to improve crosswalk visibility.
- In-roadway knockdown signs, passive awareness: increases awareness, reduces conflict; however, may give pedestrian false sense of security.
- Speed trailers: discourages speeding, reduces conflict.
- Pedestrian activated flashing beacons: reduces conflict, increases use of crosswalks; could reduce pedestrian awareness.

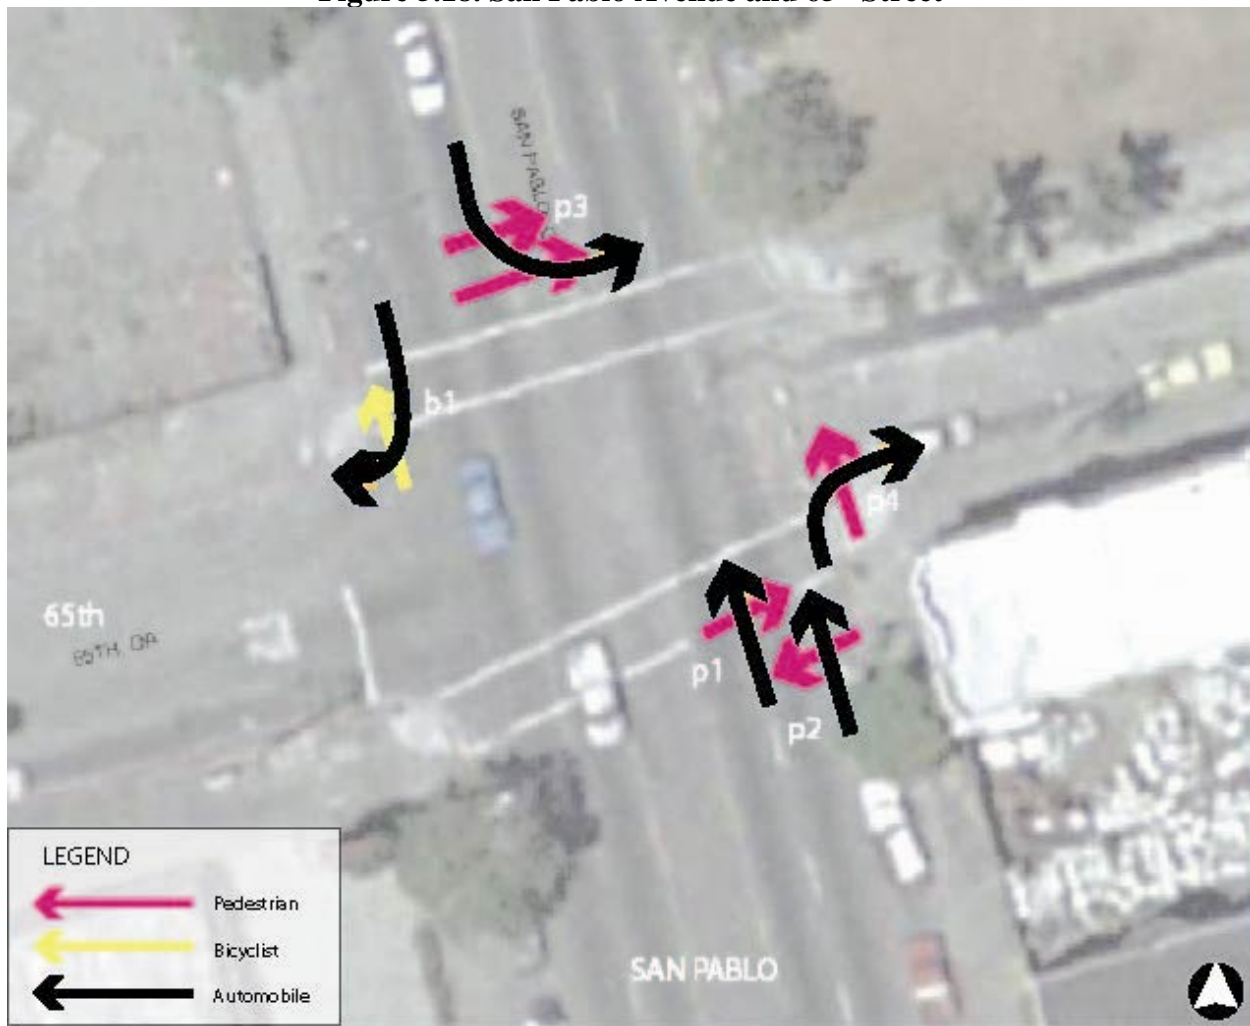
Figure 5.18. San Pablo Avenue and 65<sup>th</sup> Street

Vehicle collisions with four pedestrians, and vehicle collisions with one bicyclist were reported for this intersection between 1998 and 2003. Pedestrian crashes involved straight-moving, left-turning and right-turning vehicles. In all cases, the drivers were at fault. The bicycle crash involved a bicyclist traveling on the wrong side of the road with a right-turning vehicle. The crash types and previous movements are illustrated in figure 5.18.

- Median extensions to crosswalk (pedestrian refuge islands): reduce conflict, reduce number of trapped pedestrians, increase number of pedestrians using crosswalk.
- In-roadway knockdown signs (impactable yield), passive awareness: increases awareness, reduces conflict; may give pedestrian false sense of security.
- Speed trailers: discourages speeding, reduces conflict.
- Pedestrian activated flashing beacons: reduces conflict, increases use of crosswalks; could reduce pedestrian awareness.
