Cyclic Testing of Three Full-Scale Steel Beam-Column Connections

**REPORT NO.
UCB/SEMM-96/01**

**CYCLIC TESTING OF
THREE FULL-SCALE
STEEL BEAM-COLUMN
CONNECTIONS**

Report to ADP/Fluor Daniel

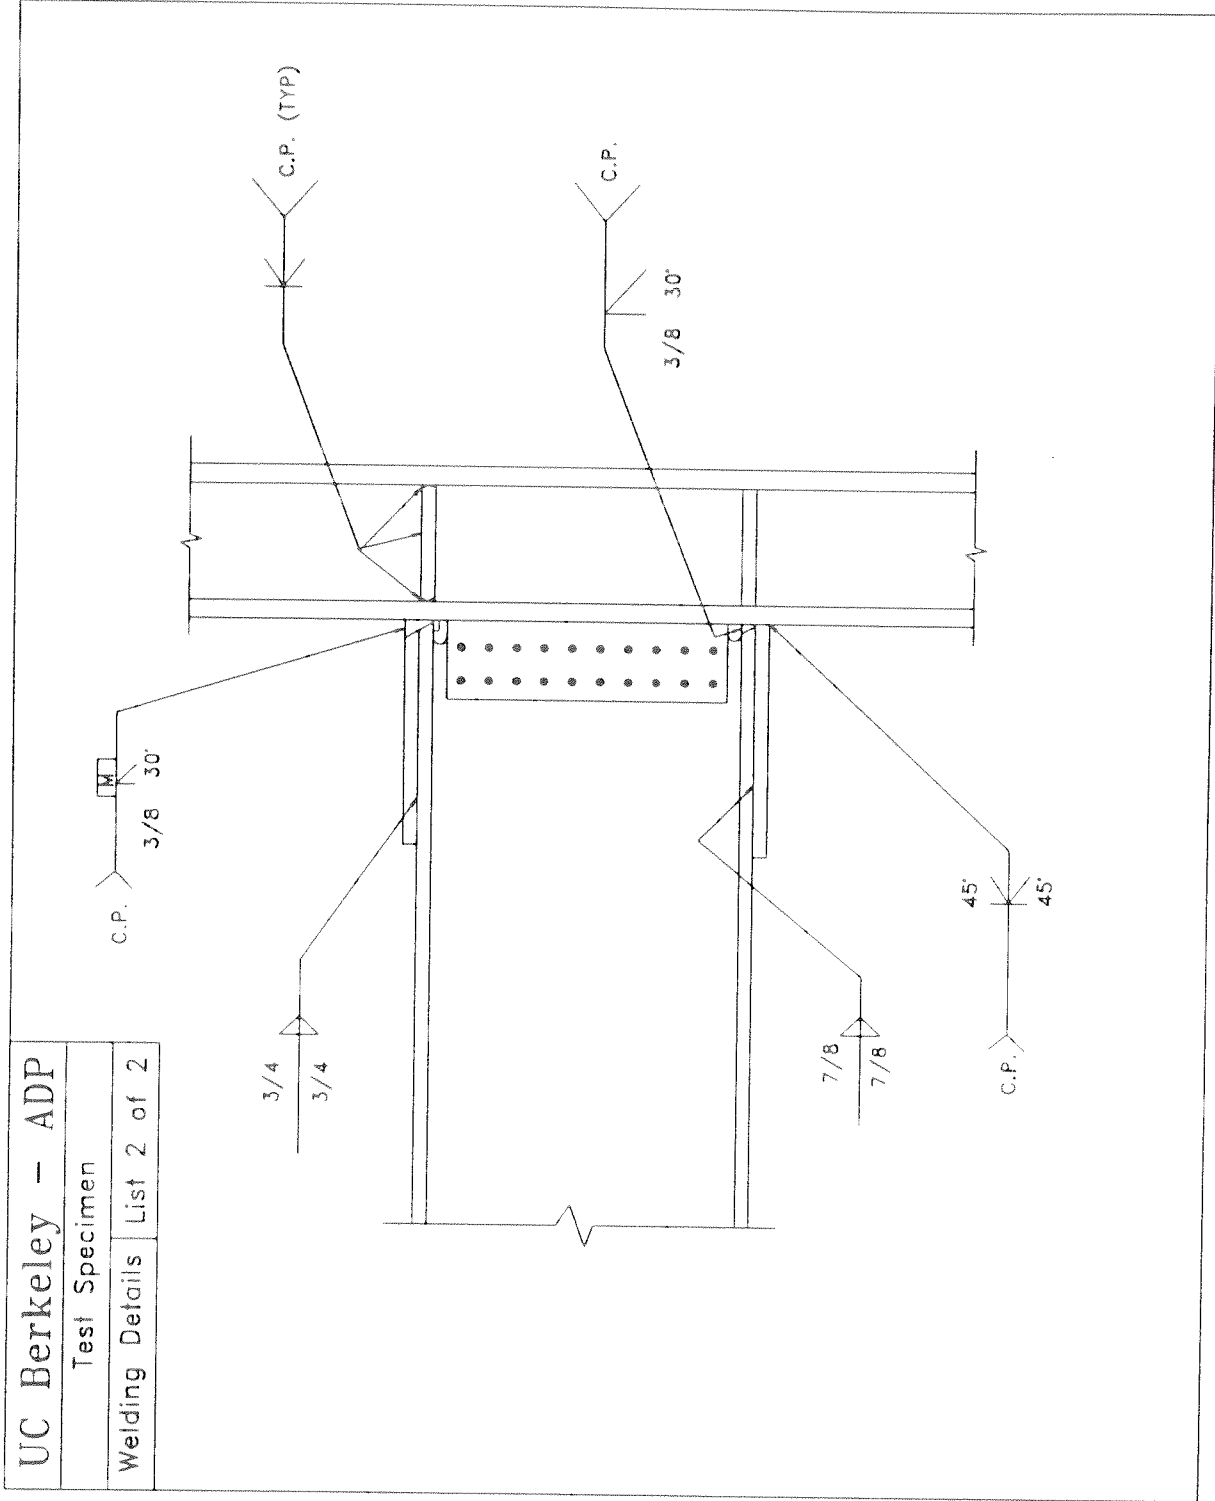
FIGURE 1B: WELDING DETAILS

Inspection of the damaged specimens after the tests seems to indicate that some of the specimens were not fabricated following the welding specifications shown in Figure 1b. This might explain the specimen behavior differences observed during the tests.

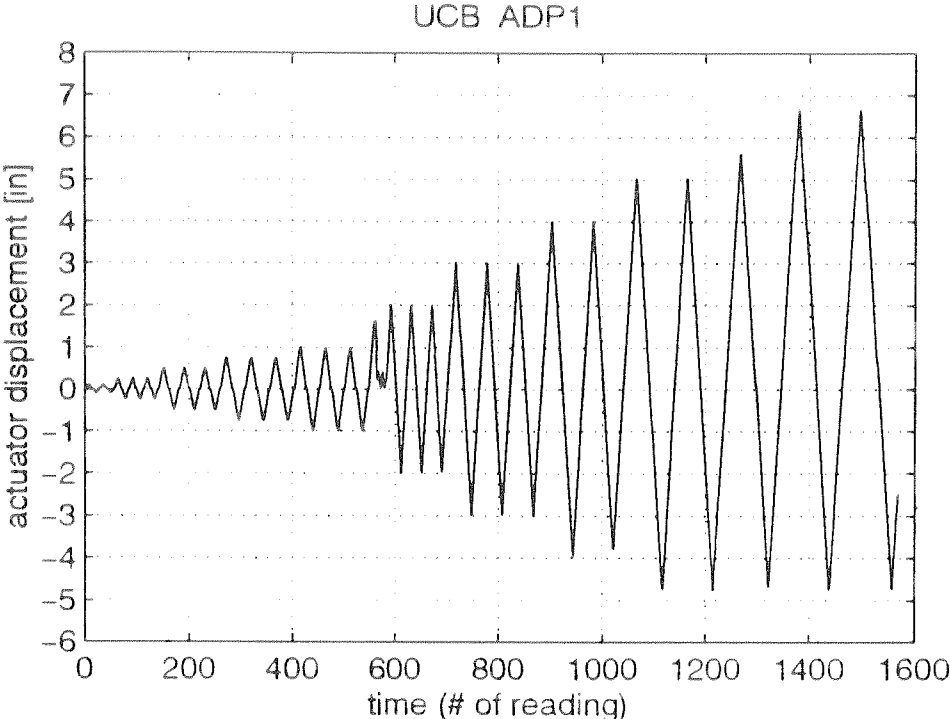
FIGURE 7: IMPOSED LOADING HISTORY -- ACTUATOR DISPLACEMENT

The imposed actuator displacement history is shown in Figure 7. The last cycles were asymmetrical due to some initial offset of the beam end (~ 1.5"). The specimen behaved elastically during the 1" actuator displacement cycles. First yielding was noticed during the first 2" cycle. Some tearing in the corner of bottom cover plate-beam flange weld was noted during the 3" cycles. Small buckling of both beam flanges occurred during 4" cycles. A tear in the corner of the top cover plate-beam flange weld appeared after the first 5" cycle.

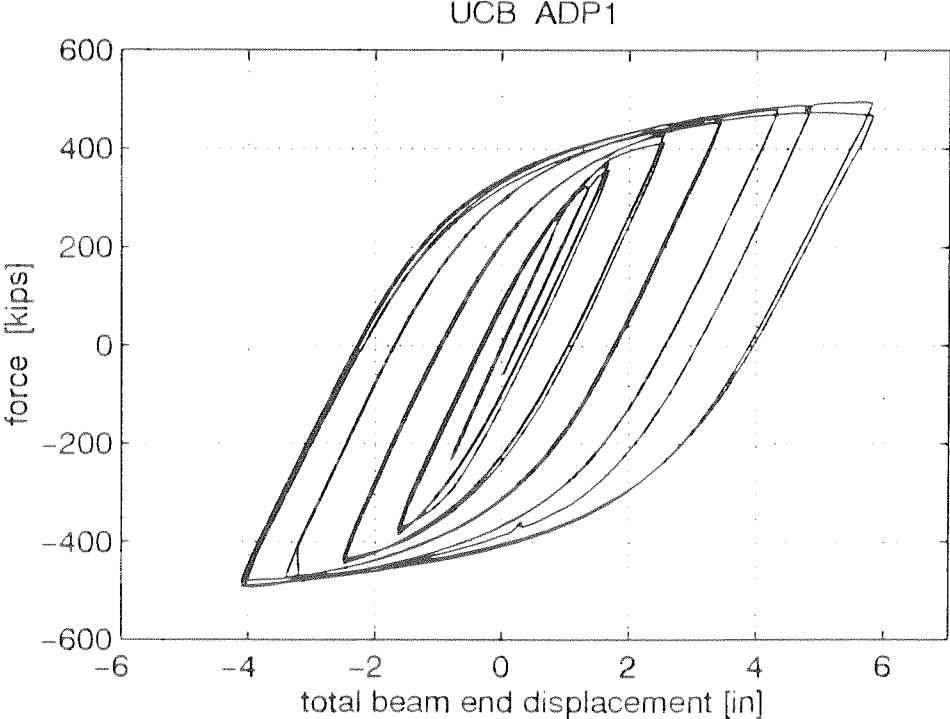
FIGURE 8: APPLIED LOAD / BEAM END DISPLACEMENT RESPONSE

Plots of applied load versus beam end displacement response and moment versus plastic rotation are presented in Figures 8 and 9, respectively. Moment and plastic rotation were calculated with respect to the bottom cover plate edge. A graph showing the energy dissipated by the specimen versus cumulative actuator displacement is presented in Figure 10. Panel zone shear deformation is shown in Figure 11. Beam deflection (total beam end displacement minus column and panel zone contributions) is shown in Figure 12. Plots of local strains in selected points (measured by strain gages) are presented in Figures 13 - 26. Photographs in Figures 27 - 32 show deformation of the beam flanges and weld cracks during the test. Key parameters characterizing the specimen performance are given in Table 2.

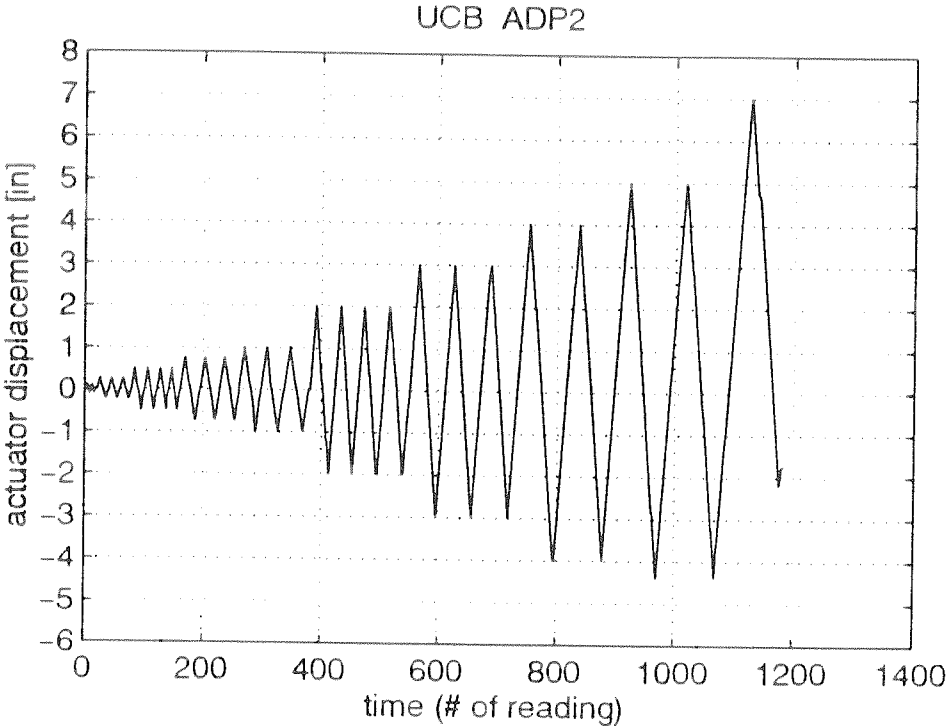
FIGURE 33: IMPOSED LOADING HISTORY -- ACTUATOR DISPLACEMENT

Testing was performed during three days (December 13, 14, and 17, 1995). The imposed actuator displacement history is shown in Figure 33. The cycles starting from 5" actuator displacement were asymmetrical due to some initial offset of the beam end (~ 1.5"). Plots of applied load versus beam end displacement response and moment versus plastic rotation are presented in Figures 34 and 35, respectively. A graph showing the energy dissipated by the specimen during this test versus cumulative actuator displacement is presented in Figure 36. Panel zone shear deformation is shown in Figure 37. Beam deflection is shown in Figure 38. Plots of local strains in selected points are presented in Figures 39 - 52.
