Post-Project Assessment of Step-Pool and Channel Morphology at Wildcat Creek, Tilden Golf Course

Post-Project Assessment of Step-Pool and Channel Morphology at Wildcat Creek, Tilden Golf Course (Final Draft)

Ashley Cao, Vermouth Li, Carina Swann

LA227 Restoration of Rivers and Streams

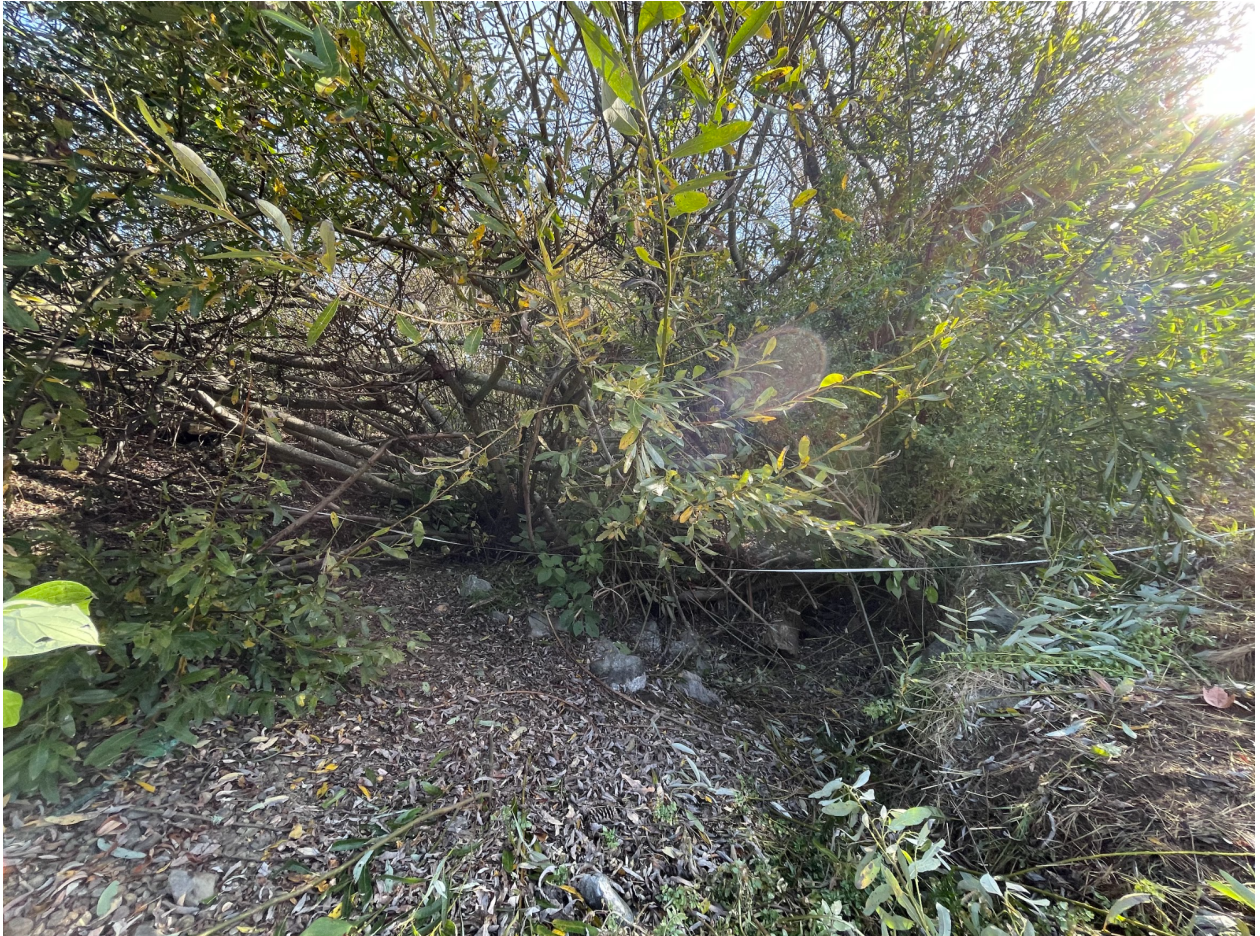
Figure 3: *Photograph of Cross Section 2 in Restoration Reach marked by white tape measure and surveyed in 2023. Wildcat Creek in Berkeley, CA.*

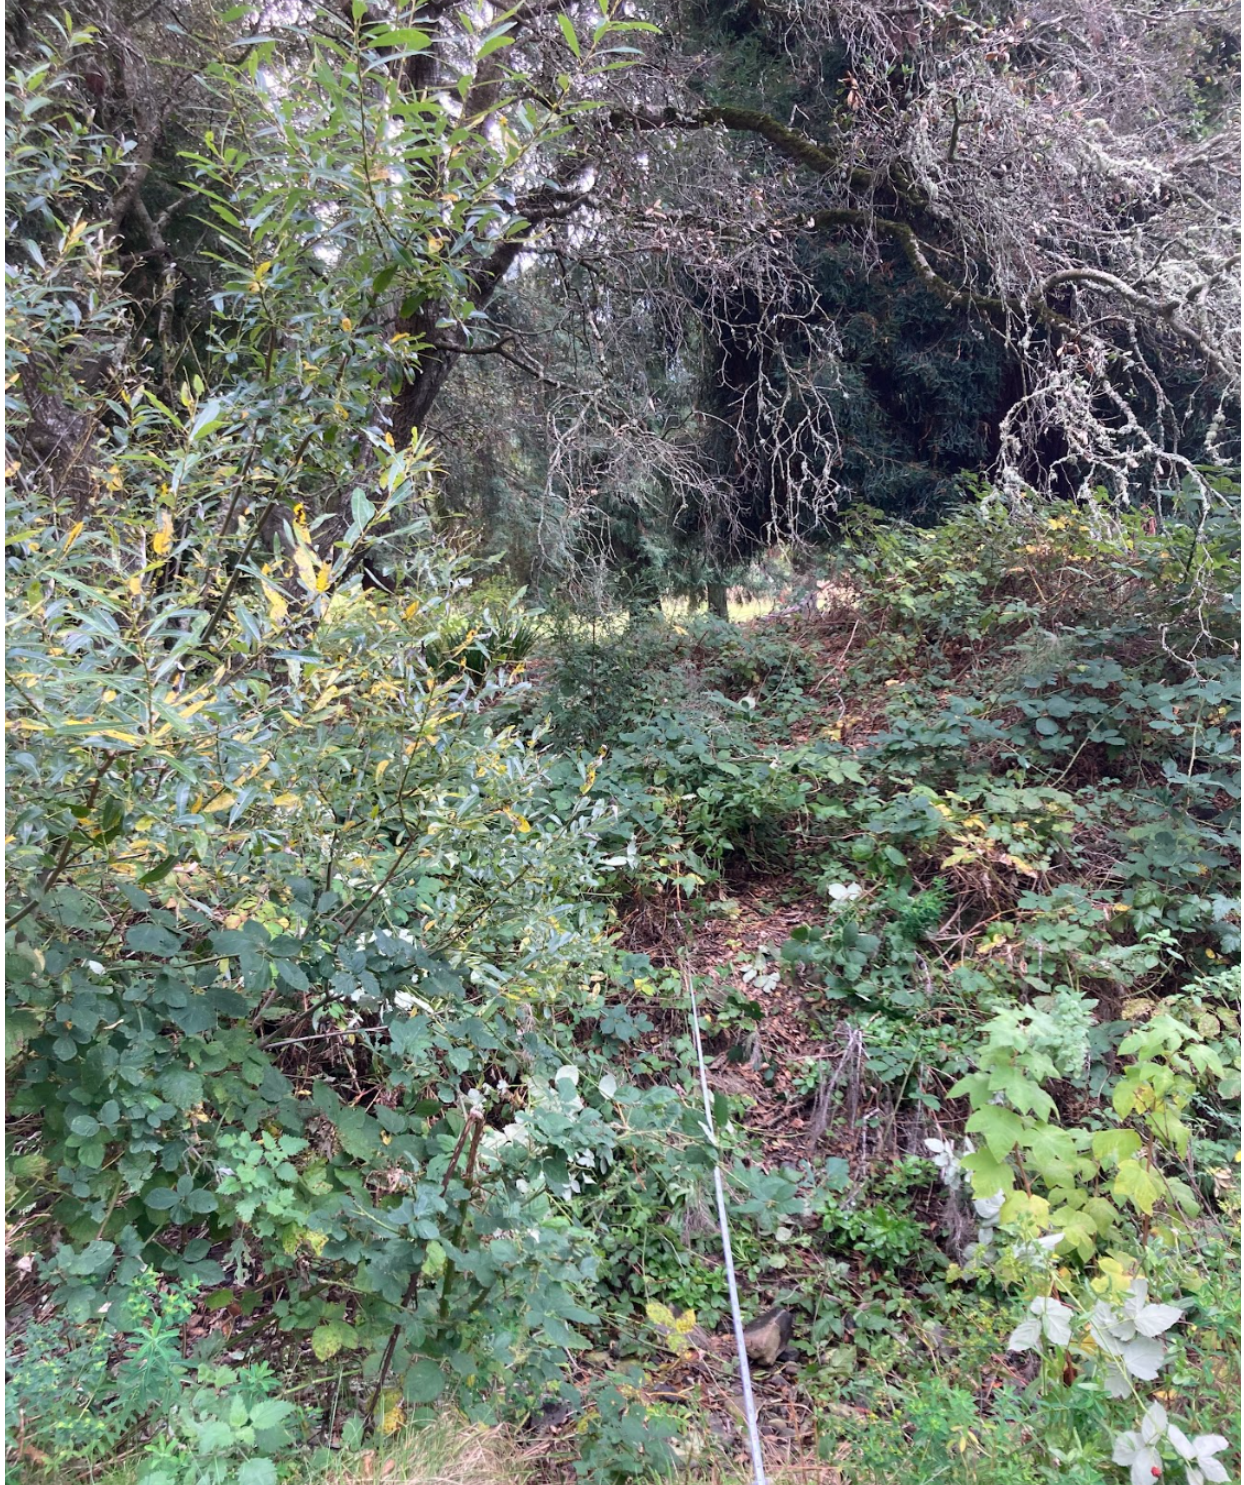
Figure 4: Photograph of Cross Section 4 in Experimental Reach marked by white tape measure and surveyed in 2023. Wildcat Creek in Berkeley, CA.

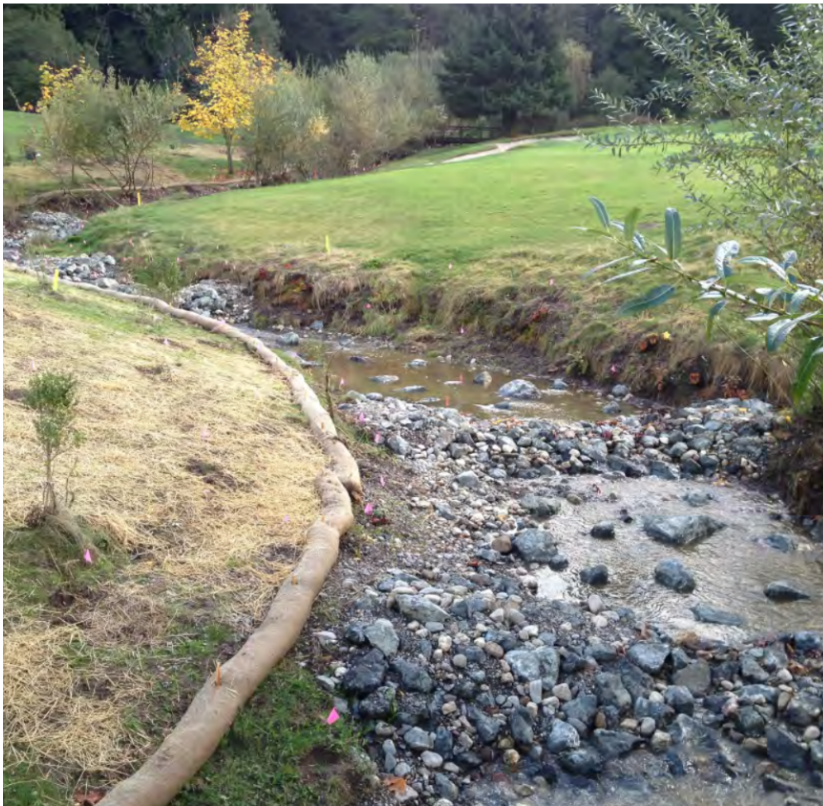
The Restoration Reach only has one large patch of riparian vegetation near Cross Section 2 (**Figure 6**). The major vegetative species found in this reach were arroyo willow (*Salix lasiolepis*) and red willow (*Salix laevigata*). Other identified species were coyote brush (*Baccharis pilularis*), horsetail

Figure 6a: Photo Point 2, taken immediately post-construction in 2012. Originally presented in RDG's 2022 Monitoring Report. Restoration Reach of Wildcat Creek in Berkeley, CA.

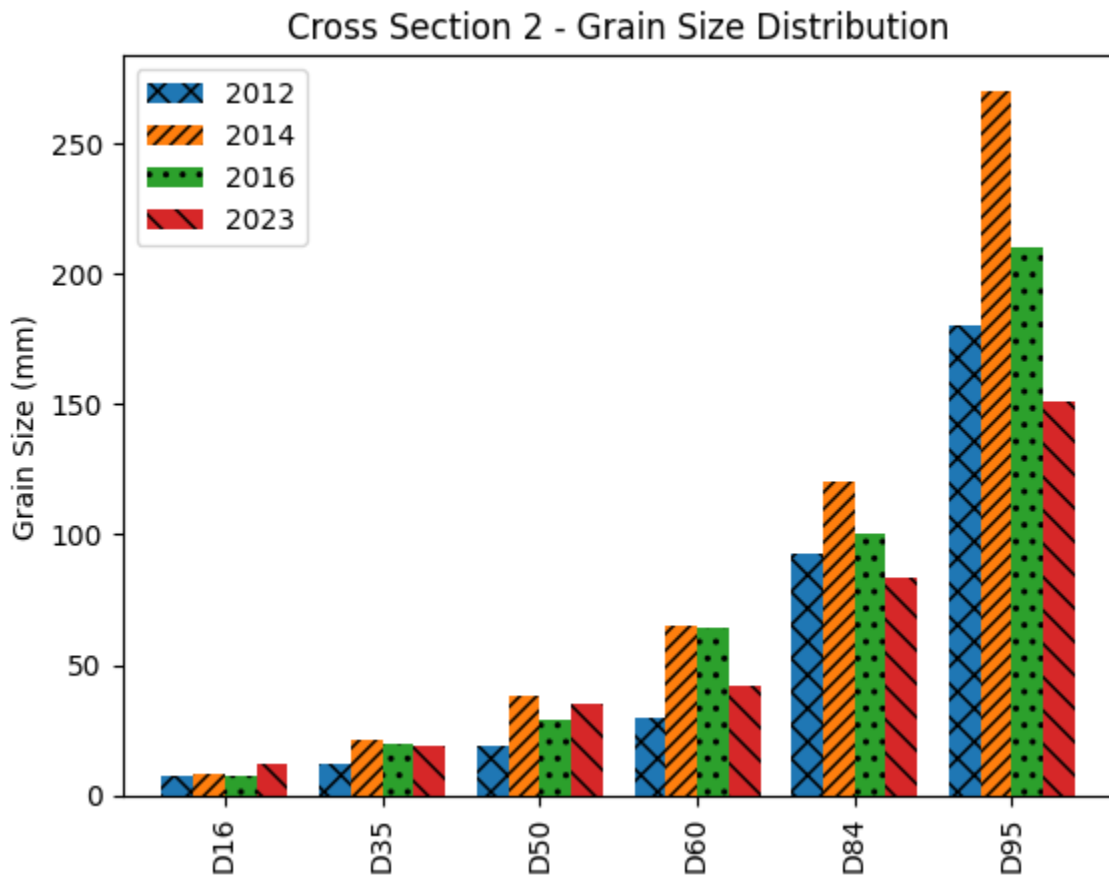
We observed an increase in grain size across all particle size distribution percentages in 2014 and a subsequent decrease in particle sizes larger than the D50 starting from 2016 and continuing to 2023 (**Table 1**). However, we note a lack of measurements between 2017 and 2022, so we don't know if this has been a steady trend towards fining or if the grain size has fluctuated in between. Despite this, it is apparent that 2016 marks the beginning of a transition towards a finer sediment composition (**Figure 10a & 10b**). Below, we further discuss potential causes of the fluctuation in grain size during 2016 when looking at the Experimental Reach.

Figure 10a: Compiled 2023 and historical grain size distribution at Cross Section 2 of Restoration Reach on Wildcat Creek in Berkeley, CA.

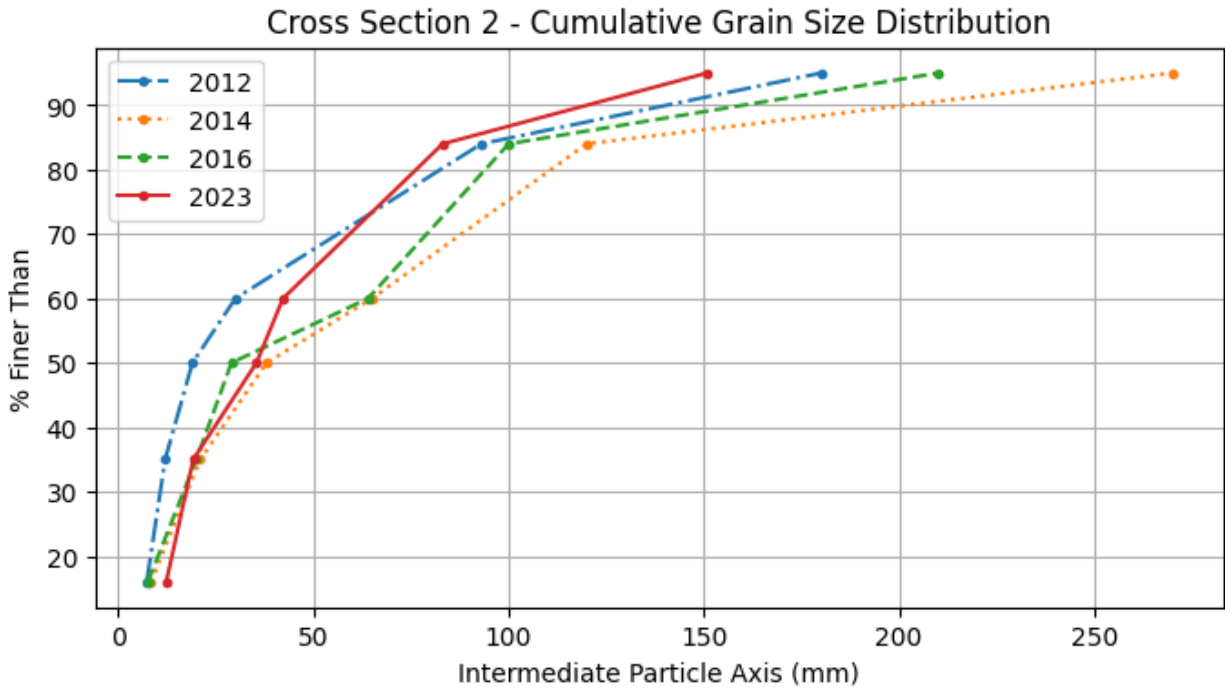
Figure 10b: Overlaid 2023 and historical cumulative grain size distribution at Cross Section 2 of Restoration Reach on Wildcat Creek in Berkeley, CA.

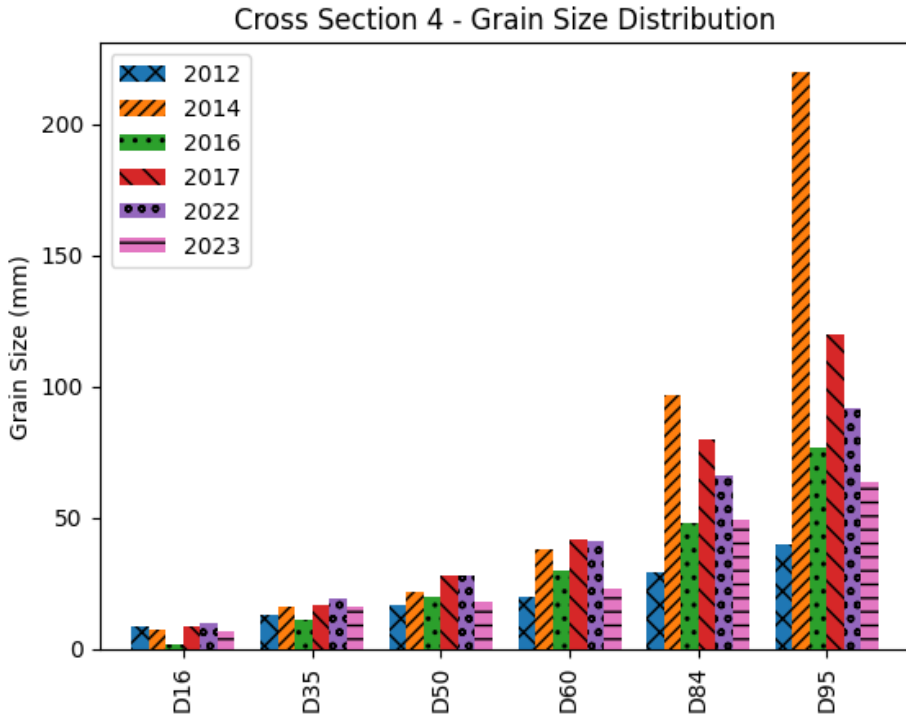
Table 2 and **Figure 11a** show similar trends in sediment composition between the Experimental Reach and Restoration Reach, with a notable increase in D50 in 2014 and a general decrease in subsequent years after 2016, potentially shifting towards the sediment composition observed in 2012 (**Figure 11b**). The 2012 grain size reflects the natural sediment supply of the creek without the coarse particles RDG manually added into the creek during construction. Because RDG collected the 2012 pebble count before rains were able to carry the manually added coarse particles downstream to Cross Section 4 where the pebble count was collected, we don't see a large D50 in the 2012 data (RDG, 2022). The 2014 data, however, does reflect RDG's 2012 manual addition of coarse clasts, as we see through the increase in D50 from 2012 to 2014. After heavy rainfall in water years 2016-2017 and 2022-2023 (Raguso, 2023), heavy flows likely flushed out these coarser sediments along with the finer sediments. But because the natural sediment supply is finer than the sediment supplied by RDG in 2012, we see a reduction in particle size in subsequent years after 2016 (**Appendix A**) (Chin, 2022).

Figure 11a: Compiled 2023 and historical grain size distribution at Cross Section 4 of Experimental Reach on Wildcat Creek in Berkeley, CA.

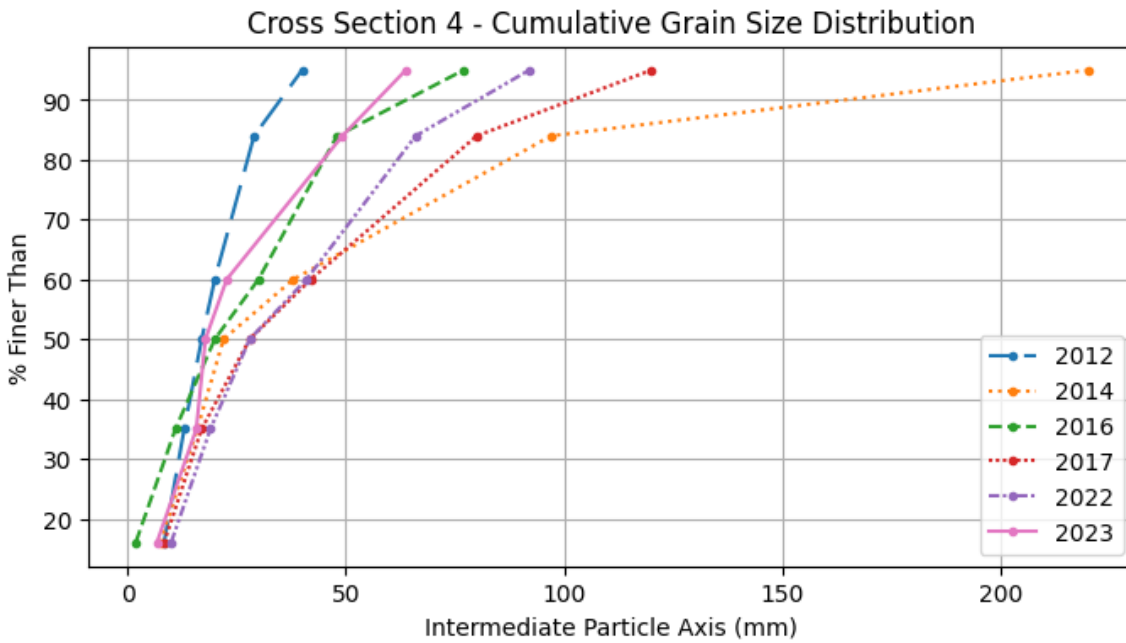
Figure 11b: Overlaid 2023 and historical cumulative grain size distribution at Cross Section 4 of Experimental Reach of Wildcat Creek in Berkeley, CA.

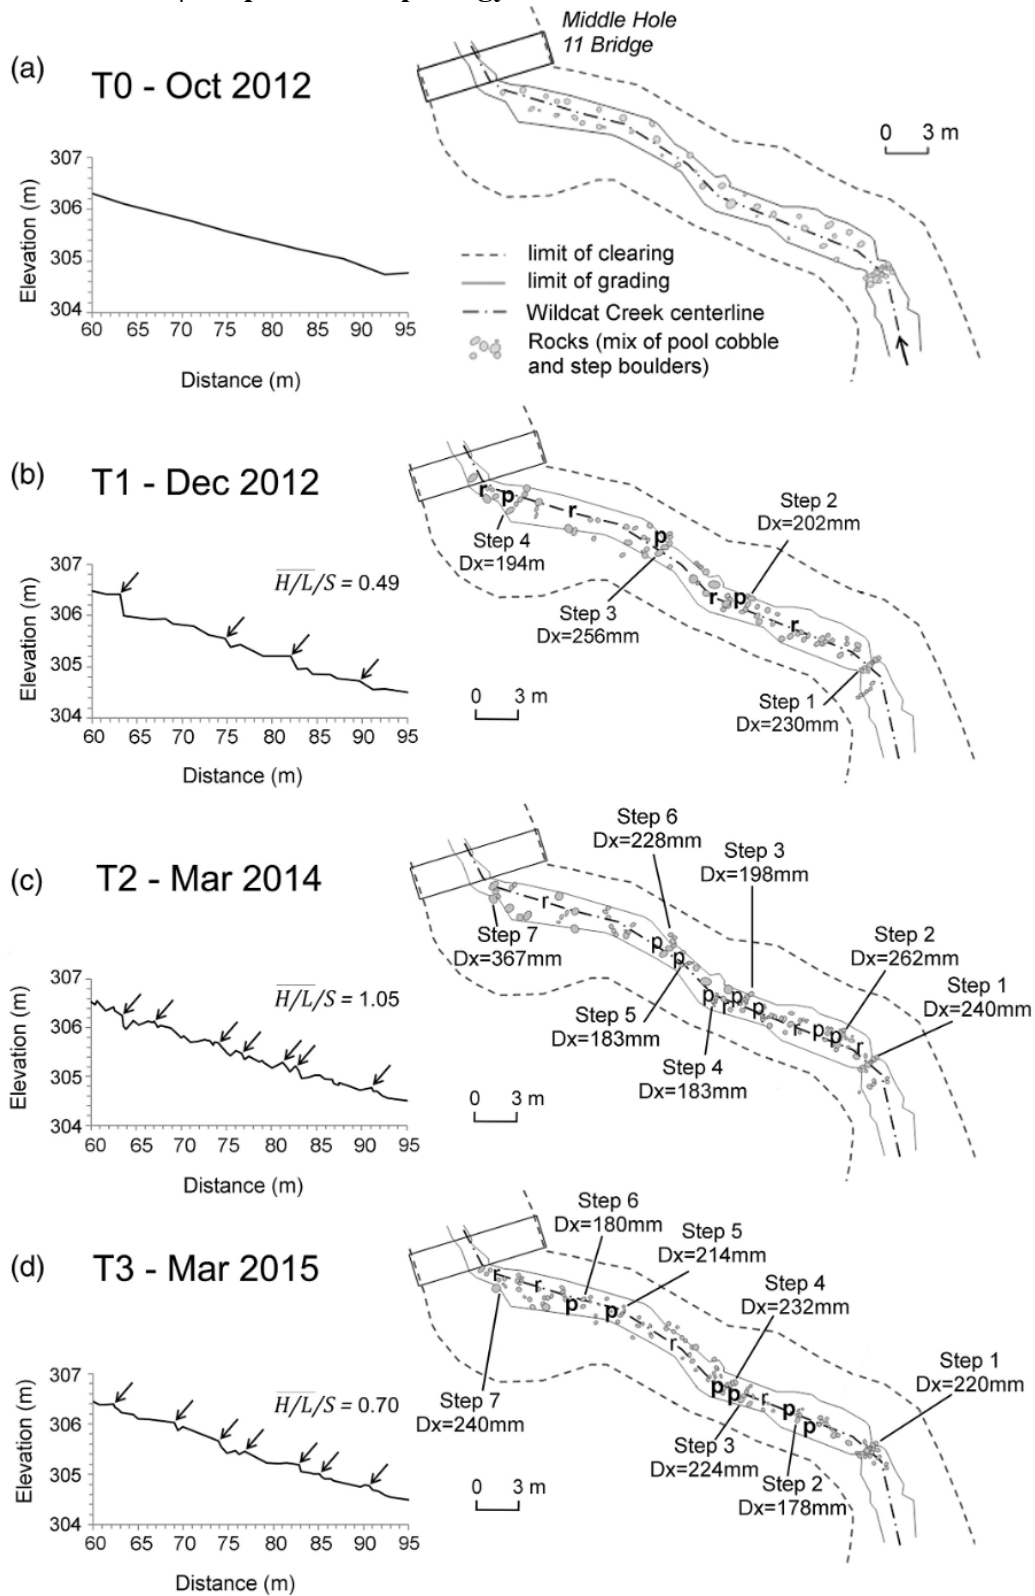
Chin et al., 2021 documented the fewest step-pools in 2012 (start of the project), with only four steps, and the most step-pools in 2014 and 2015 (end of monitoring) with seven steps (**Figure 12**). We identified fourteen step-pools (**Figure 13**), twice as many as in 2015. The Experimental Reach was initiated in 2012 before the rains, with no constructed step-pools and homogenous bed material of various sized-rocks conducive to step-pool formation (RDG, 2022; Chin et al., 2021). Since 2015 there have been two extremely wet water years, 2016-2017 and 2022-2023, with substantially more total precipitation than between 2012-2015 (Raguso, 2023). These storm events would have likely caused heavy flows in Wildcat Creek (no stream gauge data available), allowing for reformation and rearrangement of the step-pools

Figure 12: Plan view of step-pool morphology and five-largest rock average at each step from 2012-2015 in the Experimental Reach of Wildcat Creek in Berkeley, CA. Data from Chin et al. 2021

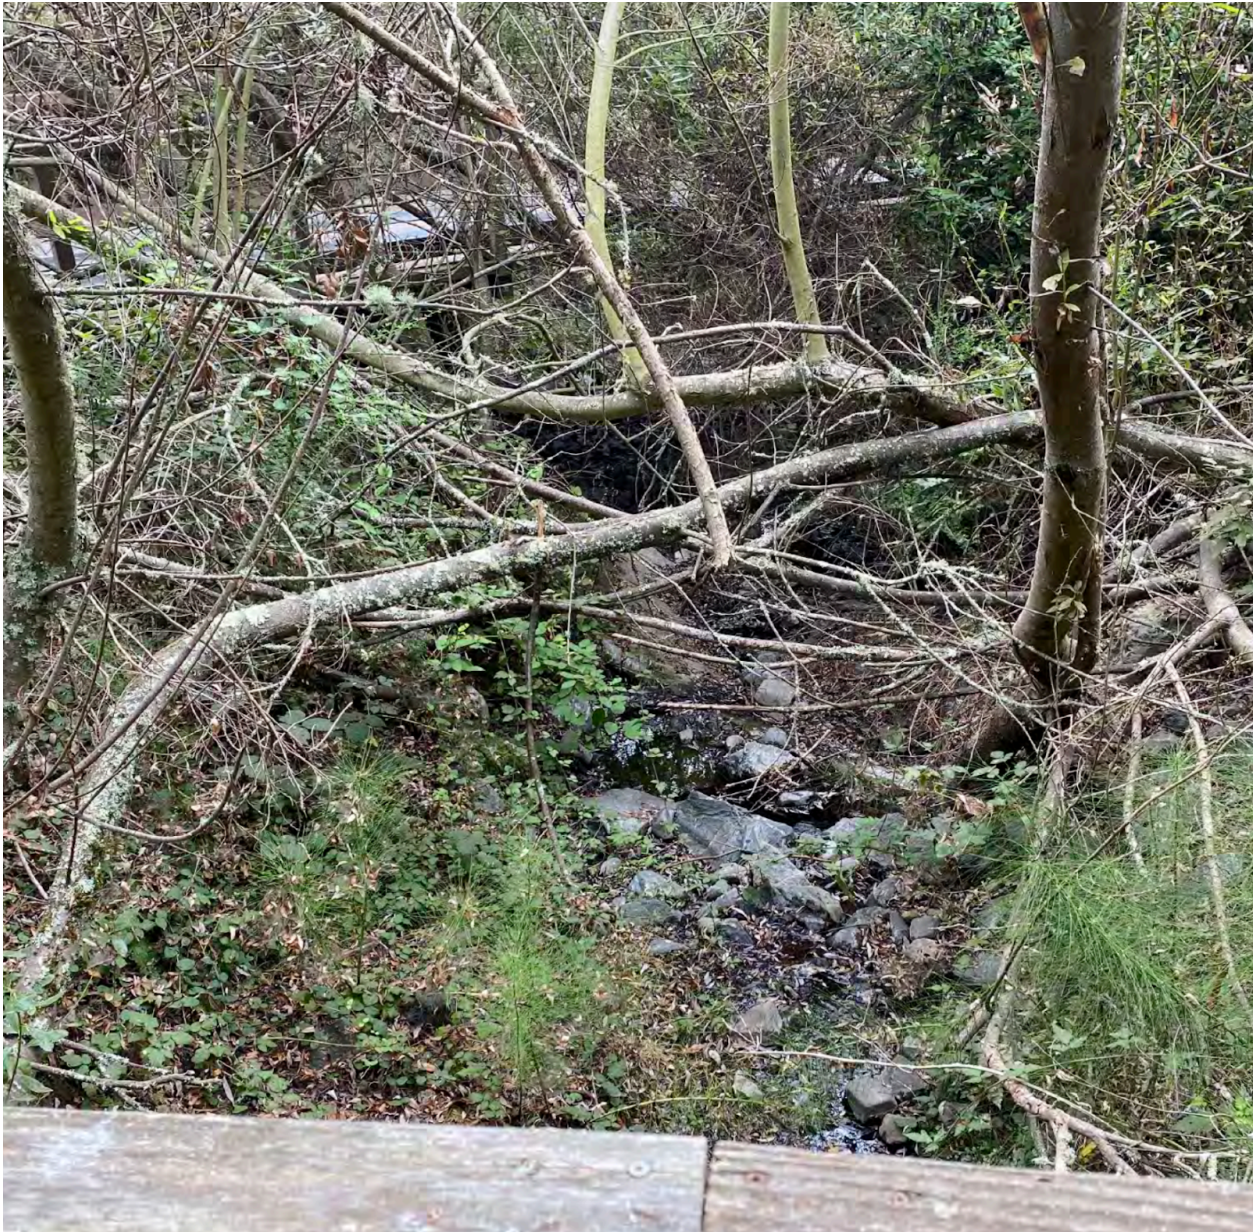
At Photo Point 5, which looks downstream from Middle Hole 11 Bridge at Lower Hole 11 Bridge, there are slight changes to specific rocks within the step-pools pictured in the photo point from 2022 to 2023. However, there remains a notable self-organization of rocks within the channel bed (**Figure 15 & 15b**). Additionally, at Photo Point 6, which looks upstream from Middle Hole 11 Bridge, shows a tree growing horizontally across the middle of the channel bed during the 2012 construction (**Figure 16**). This is likely the tree which fell and created a log jam in 2016, as it disappeared in subsequent photo points post-2016 and in its place is the log jam (**Figure 16b**). Each year's photos since then have shown bed aggradation upstream of the log jam and a resultant large pool forming downstream (**Figure 16c**). Photo Point 7, looking upstream from Upper Hole 11, shows that during the 2012 construction, the rocks were organized in very neat clasts creating steps and pools (**Figure 17a**). This distinct arrangement remained fairly visible in 2017 (**Figure 17b**), but in 2023, more medium-sized rocks appeared within the pools, creating a less clear distinction between step and pool than in the 2012 construction (**Figure 17c**). Apart from aforementioned photo points, most others, including ours and previously documented ones, are not very useful for comparing changes in the channel bed, as they were either taken at different perspectives than previous years or the landscape features of interest are obscured by vegetation.

Figure 15a: *Experimental Reach on Wildcat Creek, Berkeley, CA. Photo Point 5, taken in 2022. Originally presented in RDG's 2022 Monitoring Report.*

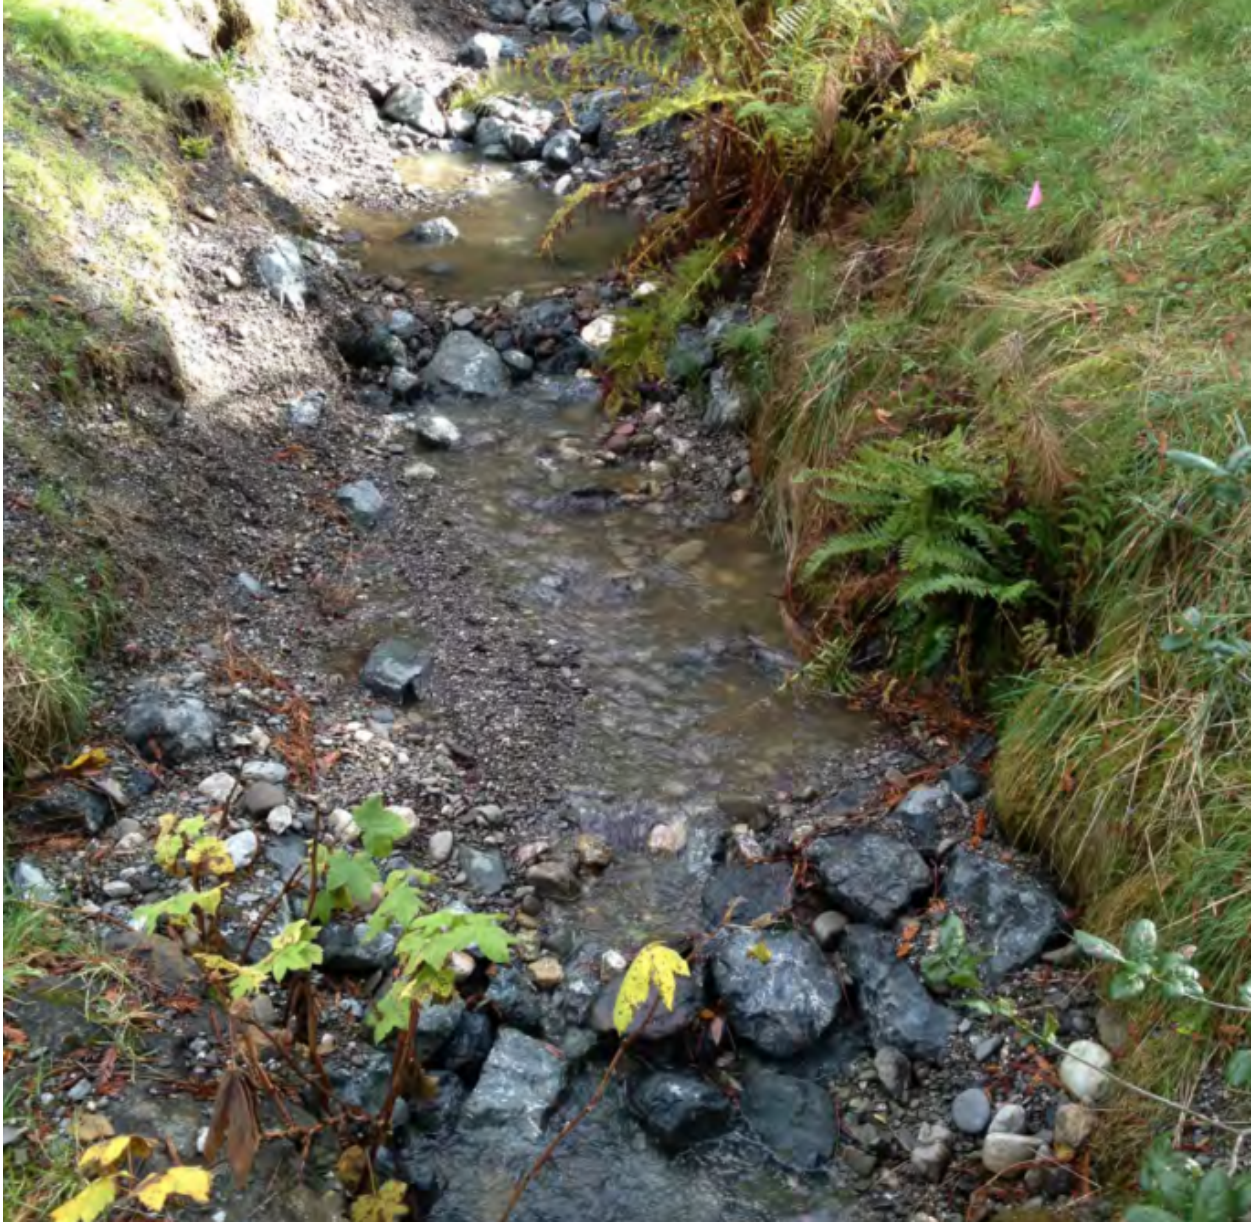
Figure 17a: *Experimental Reach on Wildcat Creek, Berkeley, CA. Photo Point 7, taken immediately post-construction in 2012. The grouping of large rocks as steps and areas with smaller sediment as pools is very clear at this point in time.*

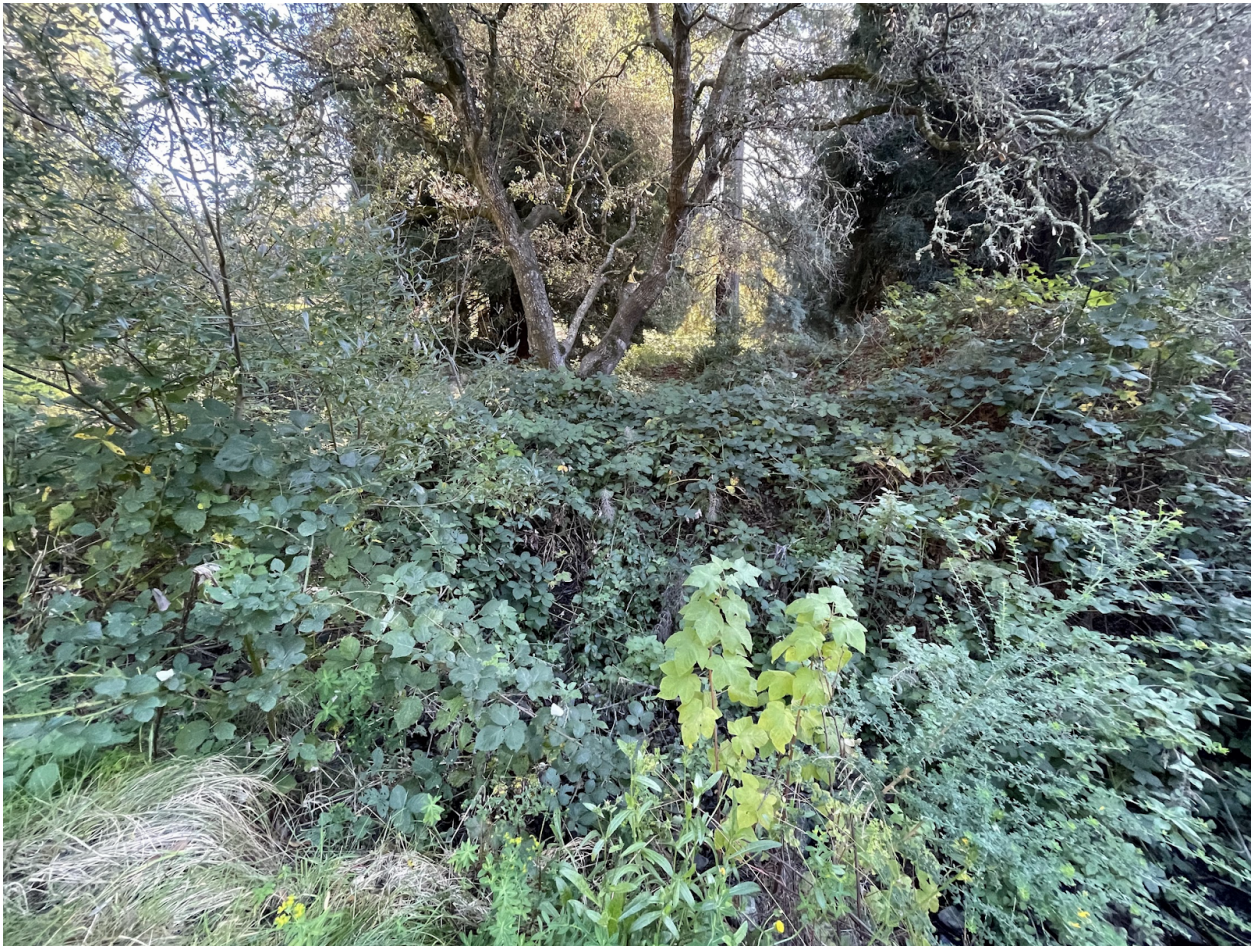
We identified following species in the Experimental Reach: Himalayan blackberry (*Rubus armeniacus*), stinging nettle (*Urtica dioica*), coastal live oak (*Quercus agrifolia*), coastal redwood (*Sequoia sempervirens*), thimbleberry (*Rubus parviflorus*), forget-me-nots (*Myosotis*), straggly gooseberry (*Ribes divaricatum*), pink-flowered currant (*Ribes sanguineum var. glutinosum*), arroyo willow, alder, and horsetail (**Figure 18**). Himalayan blackberry heavily dominated, outcompeting some of the other riparian vegetation. Despite the heavy overgrowth of Himalayan blackberry, there was still a diverse number of species in the riparian zone. The lower end of the experimental reach was more willow-dominated instead of Himalayan blackberry-dominated. This allowed for a different mix of vegetation to grow, causing greater diversification. The prebuilt conditions saw both straggly gooseberry and currant in the riparian zone. Neither were reintroduced by RDG's revegetation efforts, but are rebounding naturally (RDG, 2022). The majority of the plant growth in this reach was seen along the left bank looking downstream, which has a gradual slope without heavy signs of erosion. In contrast, the right bank looking downstream

Figure 18: Experimental Reach on Wildcat Creek, Berkeley, CA. Snapshot of general vegetation. Pictured and identified is Thimbleberry, Coastal Redwood, Coastal Live Oak, and Himalayan Blackberry.
