Concrete Overlay on Asphalt Pilot Project at Woodland SR 113: Construction

**REPORT DATE OF PUBLICATION: July 2021**  
**Research Report: UCPRC-RR-2020-01**

Partnered Pavement Research Center (PPRC) Project Number 3.39 (DRISI Task 3201):  
Implementation and Field Performance Evaluation of Concrete Overlay on Asphalt

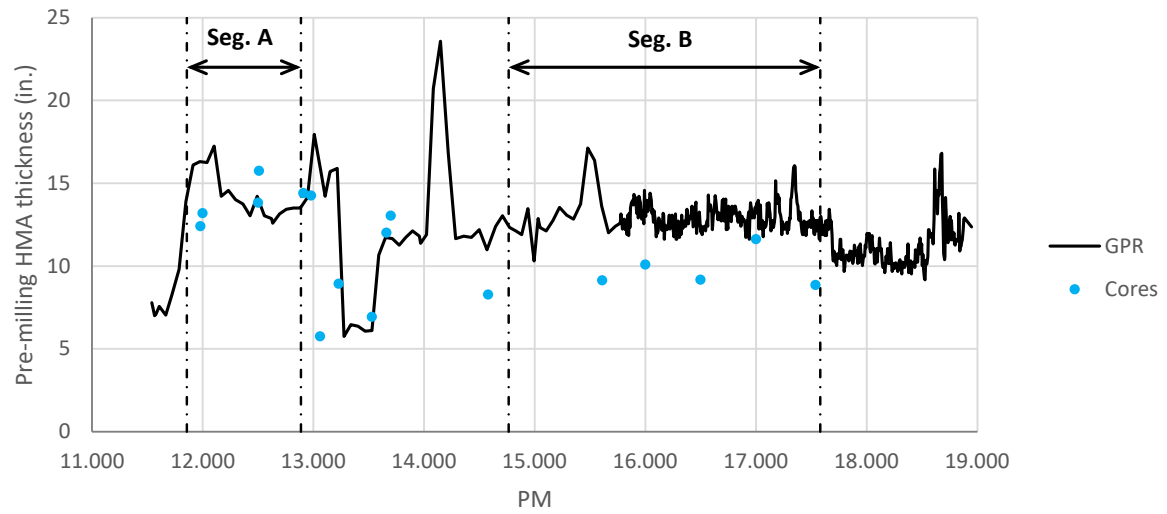
**Figure 2.4: Asphalt thickness before milling.**

Based on the data collected in a 2011 Caltrans ground-penetrating radar (GPR) evaluation, the existing pavement's asphalt thickness roughly varied between 13 and 16 in. along Segment A and between 12 and 14 in. along Segment B (Figure 2.4). While cores extracted in 2017 during the COA project's design phase confirmed the GPR measurements in Segment A, they also showed that the actual asphalt thickness along Segment B was roughly 9 to 11 in., somewhat less than the GPR measurements (Figure 2.4). The difference between the two thickness measurements may be attributable to one or more sources. Among them are GPR signal processing errors, moisture that affected the asphalt's dielectric constant, or the presence of an asphaltic material that was in the pavement during the GPR survey but which was destroyed during the coring process. Determining the actual source or sources of the difference would require more research. But whatever the reason, the difference in measurement emphasizes how important it is for an agency to conduct a thorough site investigation of an existing pavement before choosing a rehabilitation type and developing a design for that pavement. And this is true not just for COA: it applies to any rehabilitation project.

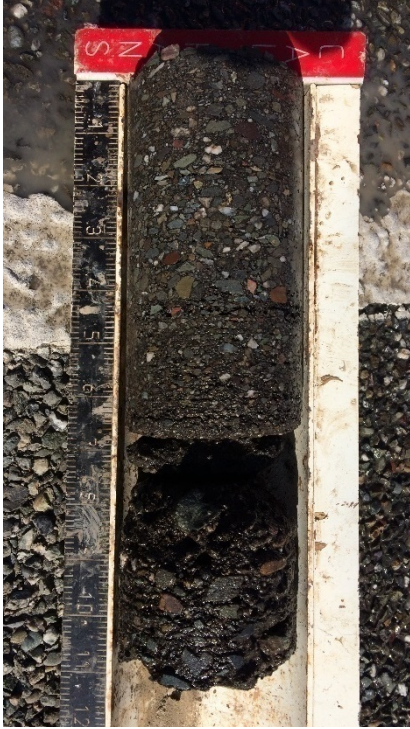
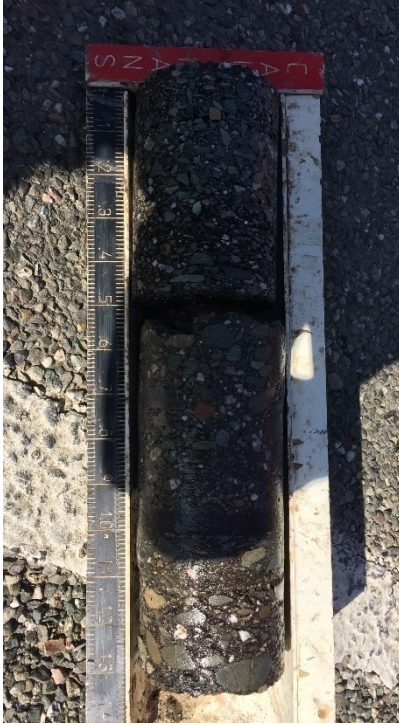
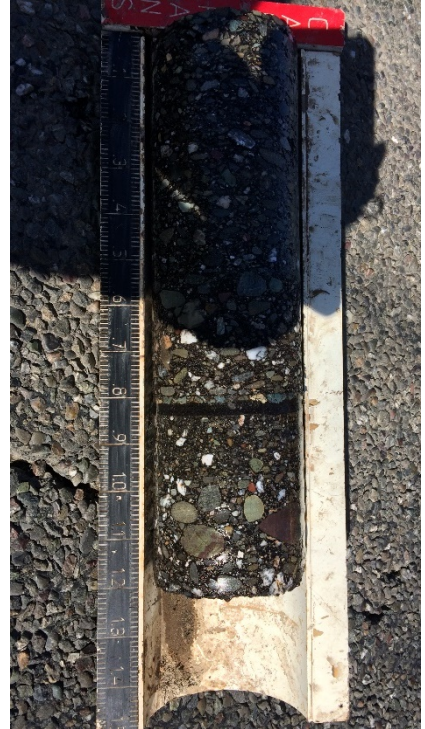
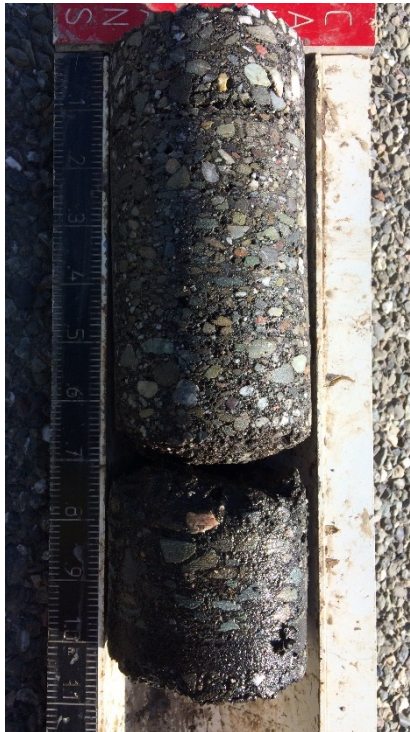
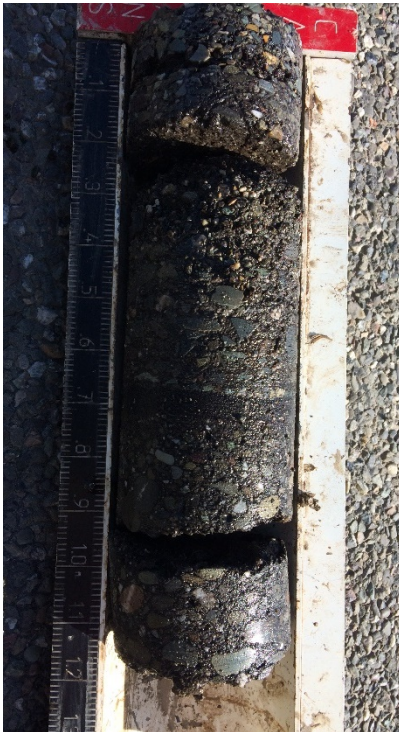
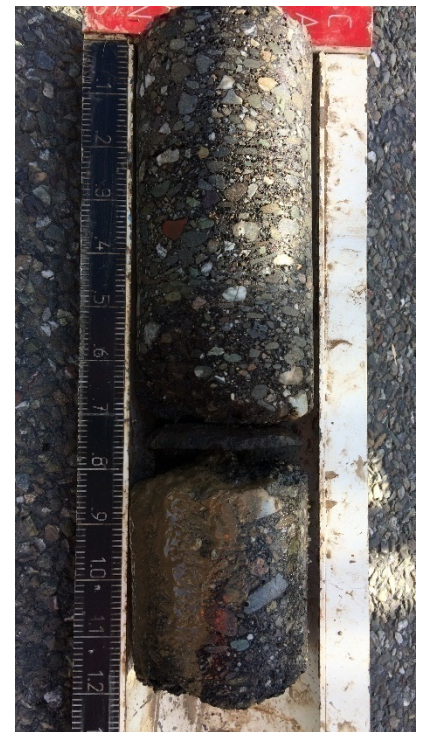
Figure 2.5: Cores extracted from between the wheelpaths: Segment A.

All the cores were extracted from spots in or between the wheelpaths. None were extracted at cracked locations or shoulders. The Segment A cores did show frequent delamination and some moisture damage (Figure 2.5) to the asphalt, but the Segment B cores showed the asphalt to be in good condition (Figure 2.6). A second set of cores was extracted from both segments on top of asphalt cracks. These cores showed that cracking had affected the full depth of the asphalt layer and that moisture had produced considerable damage in the lower asphalt lifts (Figure 2.7).

Based on these findings—the asphalt delamination risk that was seen in the Segment A cores (Figure 2.5) and the somewhat better condition of the asphalt in the top lift than in the lower lifts—a recommendation was made that the project include either a minor amount of grinding or no grinding. Ultimately, this recommendation was overridden by another recommendation included in a flooding-risk evaluation that warned against elevating the road surface.

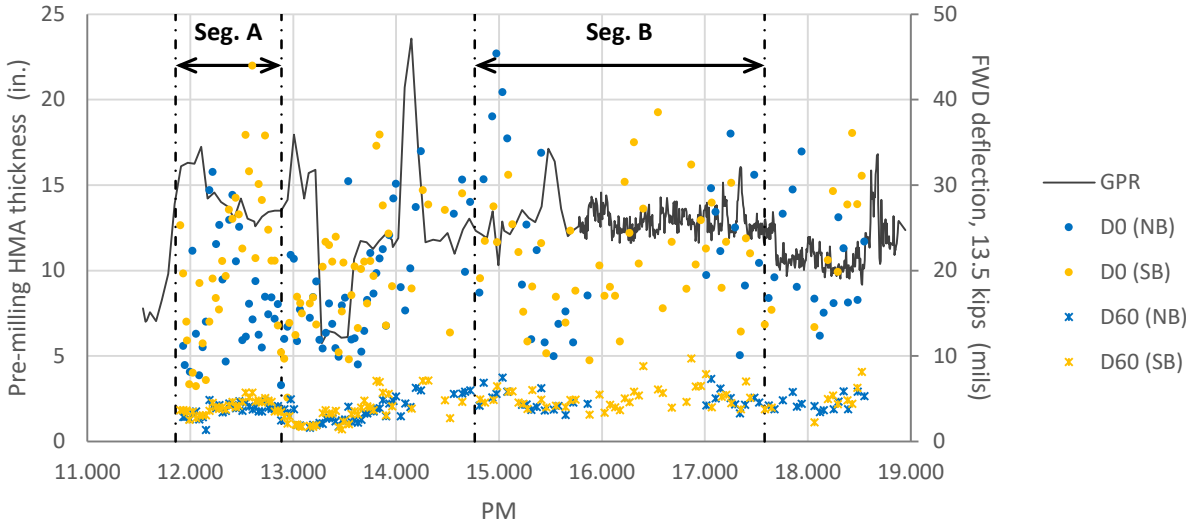
**Figure 2.8: Deflections measured under FWD loading.**

The existing asphalt pavement between PM 11.800 and PM 14.000 was evaluated with the FWD on March 30, 2017, and the pavement between PM 14.000 and PM 18.000 was evaluated on October 26, 2017. The evaluations revealed a highly variable bearing capacity, as evidenced by the variability in deflections shown in Figure 2.8. Based on these FWD results, the backcalculated asphalt stiffness varied from around 100,000 to 1.5 million psi, but with no clear pattern related to post mile or asphalt temperature (asphalt temperature varied between 57 and 71°F during the FWD evaluations). The lower limit of the backcalculated stiffness, 100,000 psi, corresponded to an asphalt layer in poor structural condition, while the upper limit, 1.5 million psi, corresponded to an asphalt layer in good structural condition. Subgrade backcalculated stiffness was relatively low, with values ranging from 5,000 to 15,000 psi (Figure 2.9).

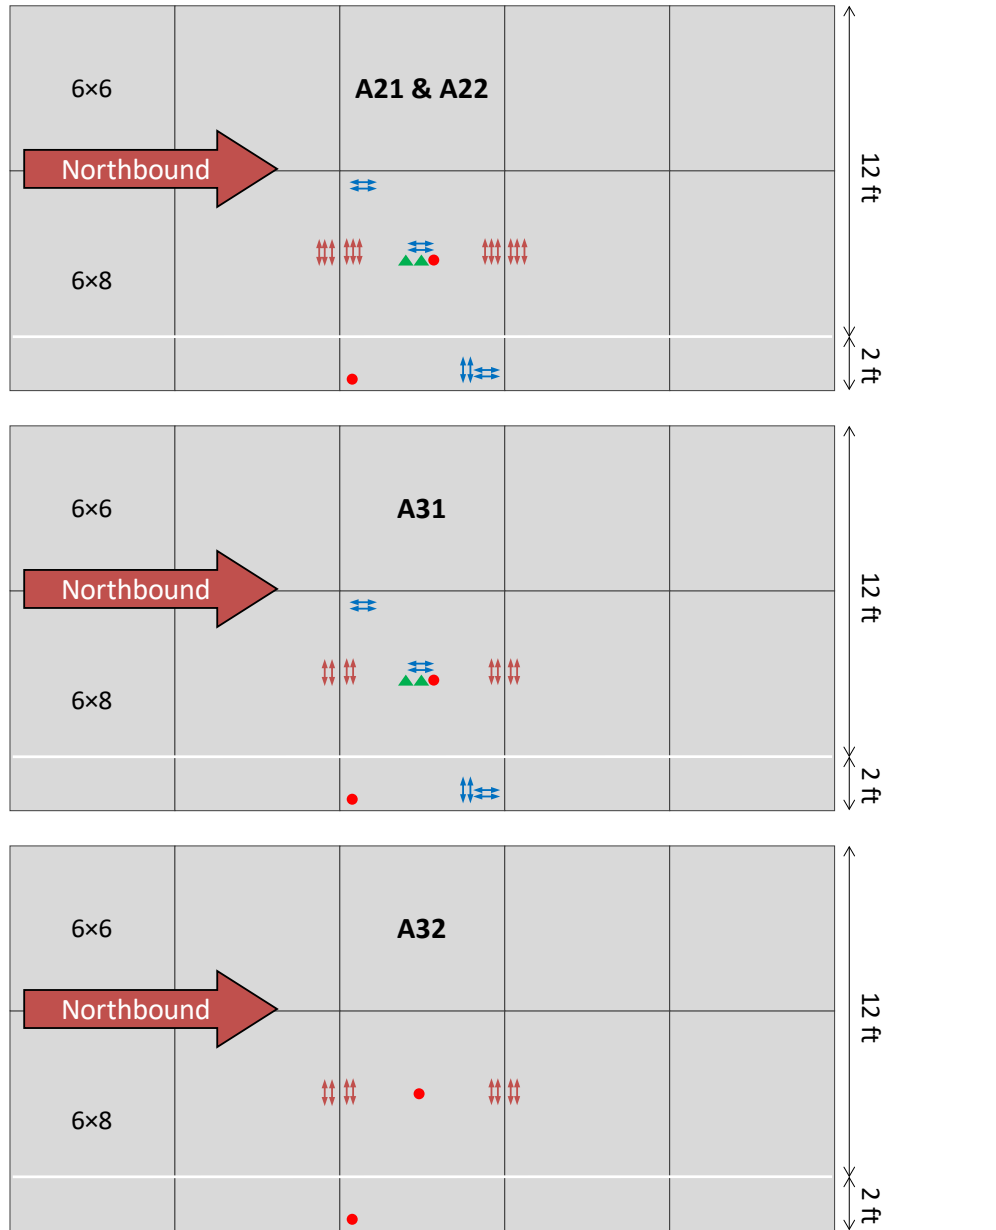
**Figure 3.2: Instrumentation layout.**

*Note:* Section A31 PCC thickness was planned to be 5 in., and sensor heights were set accordingly. However, due to a construction issue, that final height was 6 in. Consequently, the sensors located at the top of the slab ended up 1 in. deeper than expected (this is applicable to top strain gauges, relative humidity sensors, and three top thermocouples).

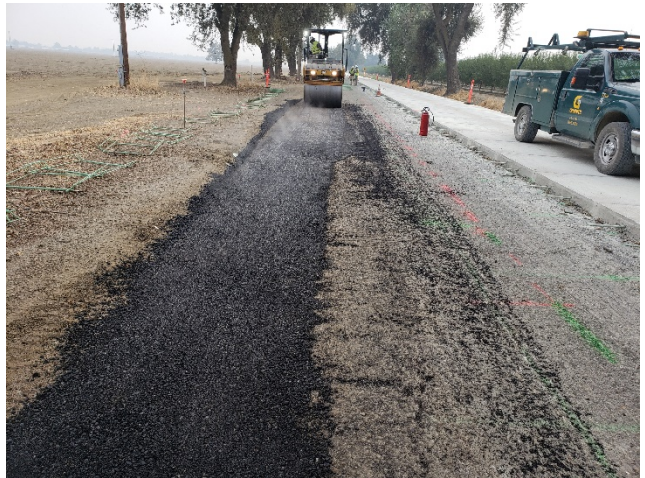
See asphalt patch on the right side of the picture

**Figure 4.5: Asphalt patching on areas with insufficient or missing asphalt base.**

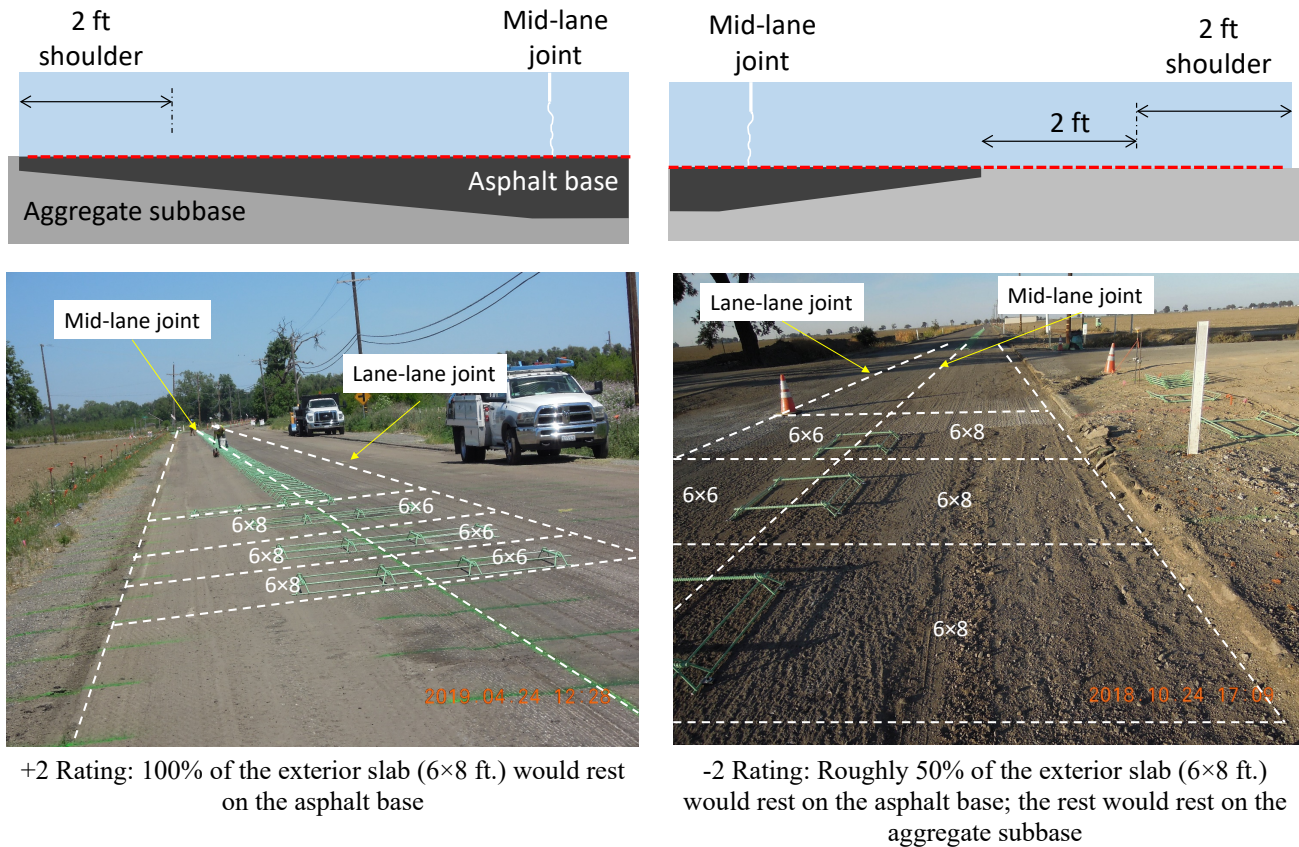
**Figure 4.6: Criteria for rating asphalt condition at the shoulder edge of the roadway.**

A visual survey was conducted to quantify the condition of the milled asphalt base at the shoulder edge of the roadway. In this survey, a rating between -2 and +2 was assigned to each 100 ft. long roadway segment. A -2 rating refers to a scenario where an insufficient asphalt base width ends about 2 ft. inside the lane-shoulder line while a +2 rating refers to a scenario where the asphalt base extends 2 ft. into the shoulder, as shown in Figure 4.6. A +2 rating was also assigned to segments where the shoulder had been paved with asphalt (Figure 4.5) after milling. The results of the visual survey are shown in Figure 4.7.

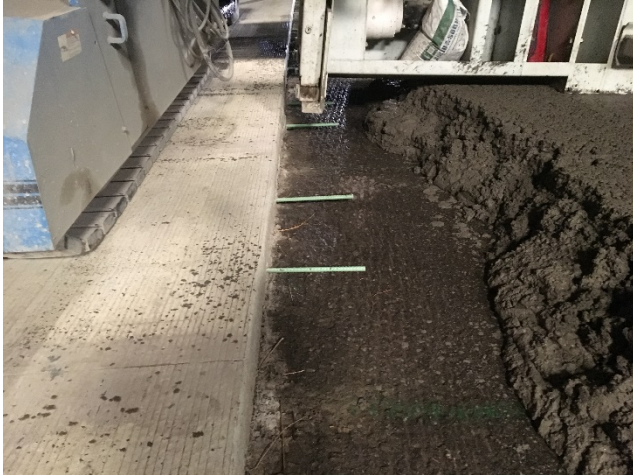
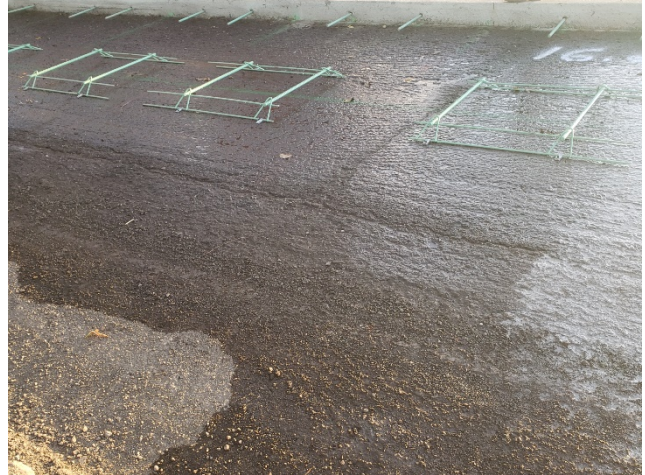
**Figure 4.12: Dirt on the asphalt surface before concrete paving.**

Preparing the asphalt surface for construction of the overlay included these steps: patching the asphalt where the milled asphalt base had been removed or was insufficient (Figure 4.5), placing the tie bar baskets, and moisture conditioning the asphalt surface. Despite a prescription in the project special provisions calling for a thorough asphalt surface cleaning before placement of the concrete overlay, this task was not performed. Instead, an asphalt surface cleaning operation was only performed after the milling was completed. Further, this cleaning operation did not include an air pressure cleaning that would normally ensure the removal of dust, grit, and foreign material. Similarly, the newly placed RHMA-G was not cleaned to eliminate surface contamination before placement of the concrete overlay. As a result, the asphalt surface was not as clean as is desired for COA construction (Figure 4.12), and this may have had a negative effect on the concrete-asphalt bonding.

*Note:* Dirt on the asphalt surface has a negative impact on concrete-asphalt bonding.

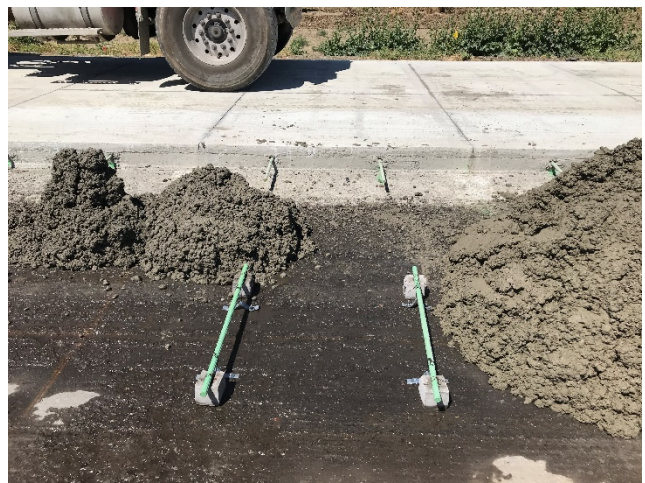
Tie bar baskets were used for the midlane longitudinal joint, as shown in Figure 4.13, except for a small portion in the northbound lane around PM 12.655, where a noncompliant handmade system was used. The tie bars of the longitudinal joint between lanes were inserted manually into the plastic concrete, as shown in Figure 4.14. This technique, which is not one of the options prescribed in Caltrans Standard Specifications, Section 40 yields little control of the tie bar position and allows air pockets to form in the concrete around the manually inserted tie bar.

Handmade system used on a small portion of the project, northbound lane around PM 12.655

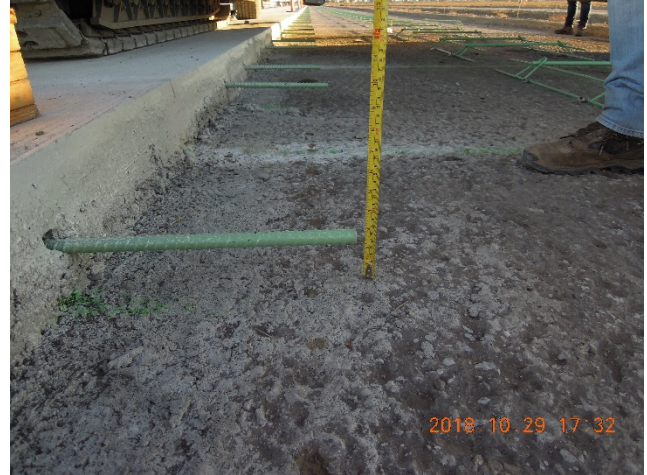
Air pocket around the manually inserted tie bar

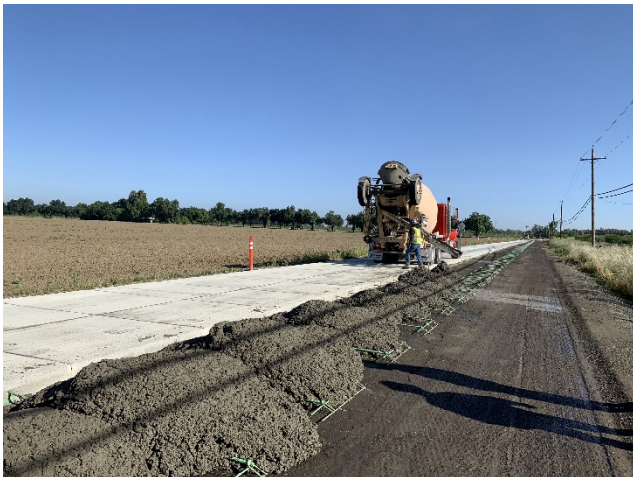
Asphalt surface is adequately wet conditioned: uniformly moist but free of standing or flowing water

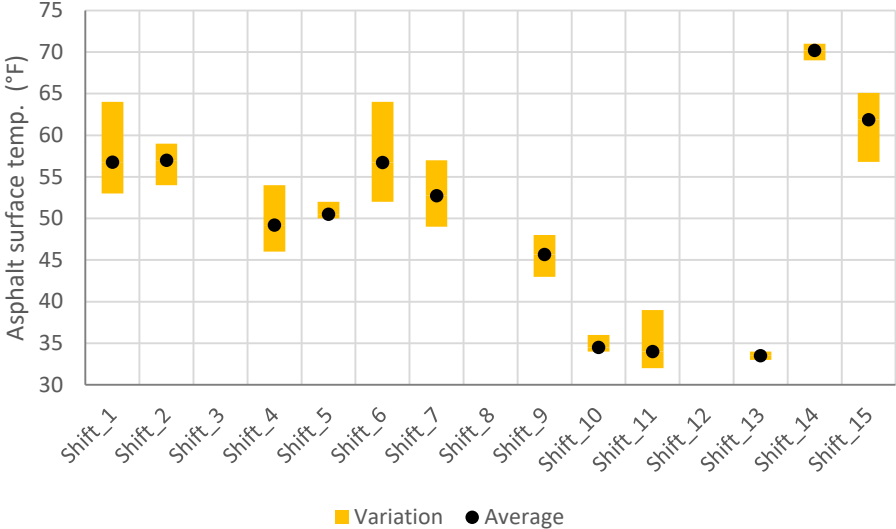
**Figure 4.21: Asphalt surface temperature variation during concrete paving.**

During the concrete paving, the asphalt surface temperature ranged from the low 30s to the low 70s Fahrenheit (Figure 4.21). The asphalt surface temperatures were much lower than the 120°F limit prescribed by the project special provisions. The asphalt surface temperature was particularly low during paving Shifts 10 through 13, due to the low air temperatures on those days and during the nighttime paving. Even though neither the Caltrans Standard Specifications nor the project special provisions prescribed a minimum asphalt surface temperature during concrete paving, it would still have been desirable for the temperature to not drop below 50°F. This 50°F minimum agrees with the Caltrans Standard Specifications, Section 90 requirement that “immediately before placing the concrete, the temperature of the mixed concrete must be from 50 to 90°F.” The temperature of the plastic concrete was also measured during the construction of the overlay, with the results shown in Figure 4.22. Some measurements were below 50°F, but these were taken between the side-belt spreader and the paver, not immediately before placing the concrete.

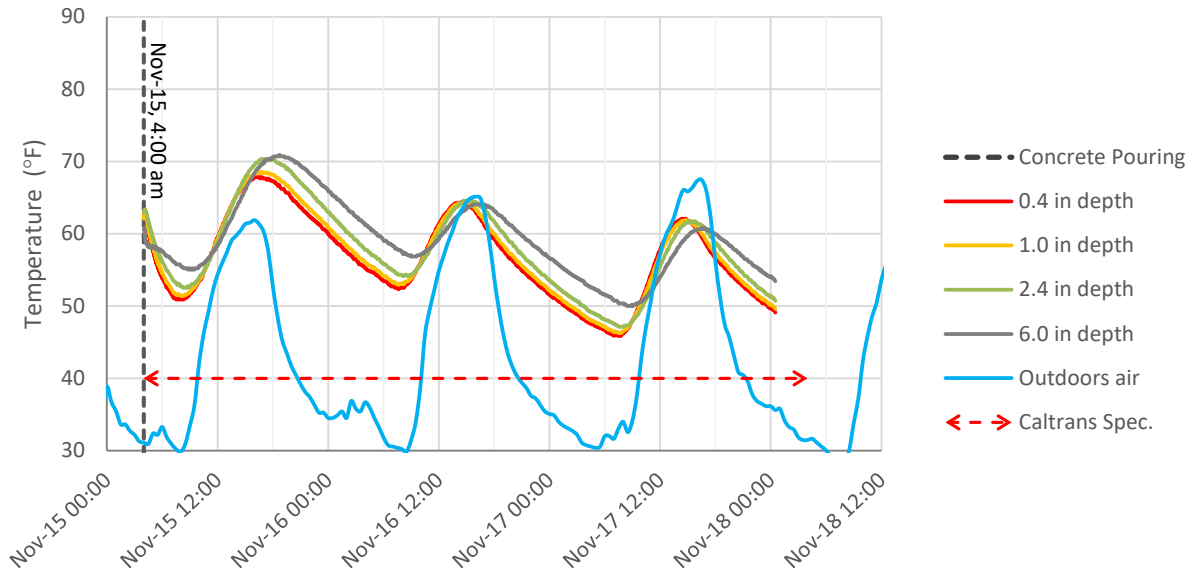
**Figure 4.23: Concrete temperature monitoring, paving Shift 13 (November 14, at night).**

Caltrans Standard Specifications, Sections 40 and 90 require that concrete remain at a minimum temperature of 40°F during the initial 72 hours after paving. To verify the fulfillment of this prescription, the temperature was monitored at different depths in the concrete overlay during and after one of the coldest paving shifts (November 14, at night). As shown in Figure 4.23, the concrete temperature remained above 40°F during the first 72 hours despite air temperatures having dropped to the freezing point.

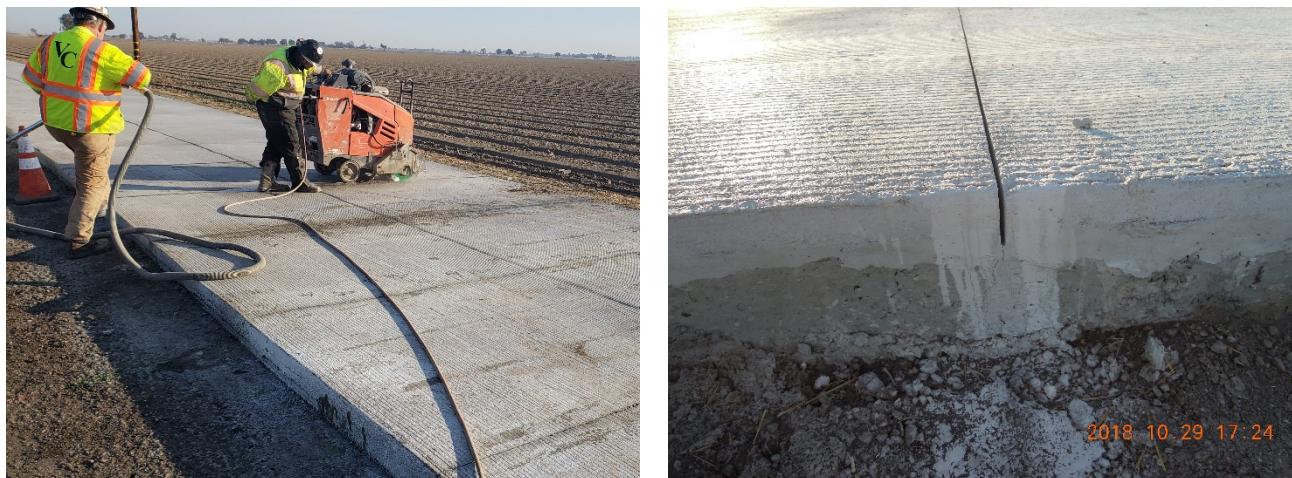
Joints were cut to a depth of one-third of the slab thickness, which resulted in 2 in. saw cuts (Figure 4.28). The cutting operation was conducted between six and eight hours after the concrete was placed. No early-age cracking was observed. If any random cracks were noticed, they would likely be due to late sawcutting.

**Figure 4.28: Sawcutting operation.**

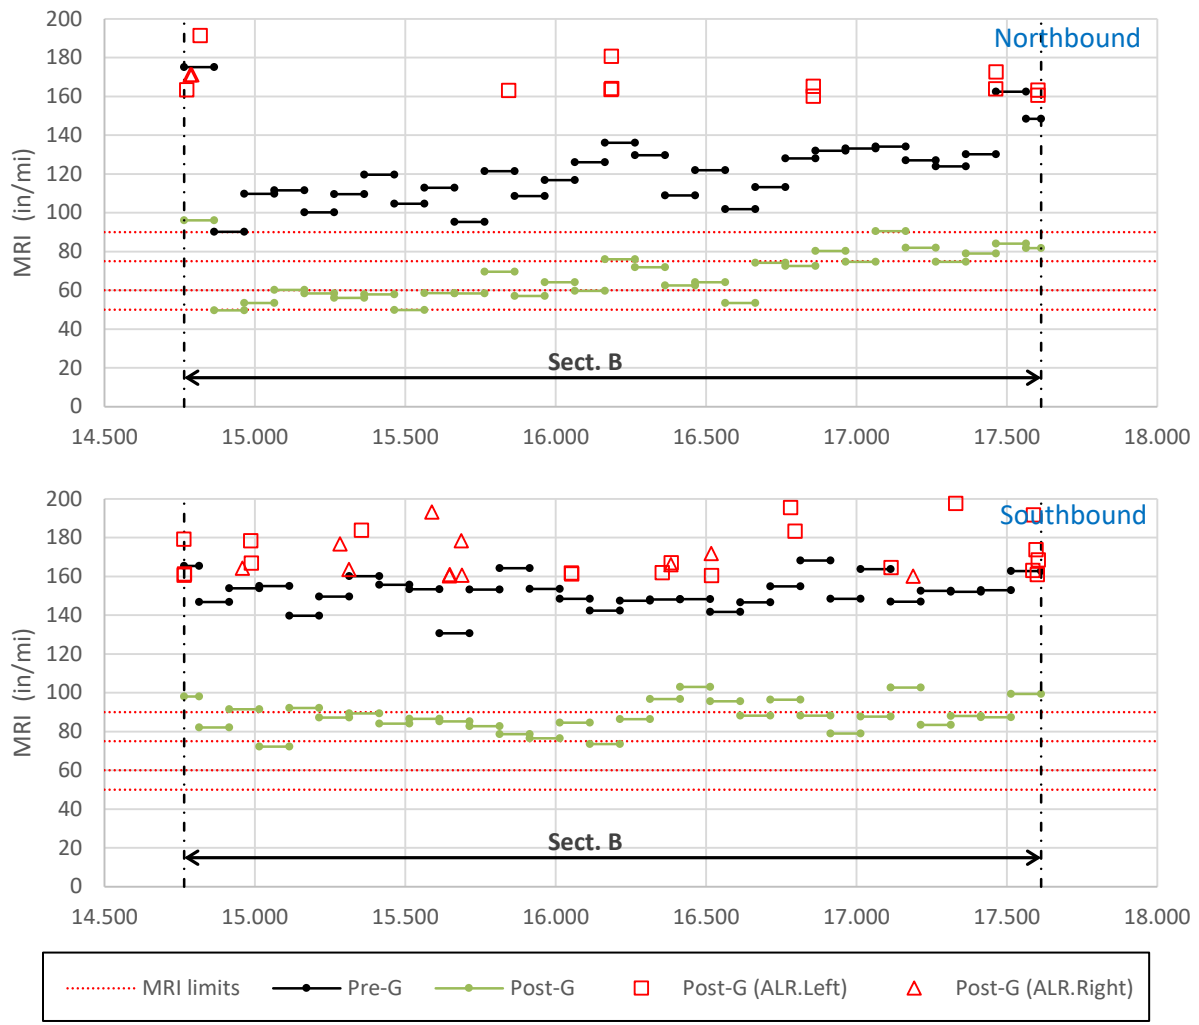
**Figure 4.30: Longitudinal smoothness: Segment B.**

The postconstruction longitudinal smoothness of the concrete overlay was relatively poor, as shown by the Pre-G (pre-grinding—i.e., before grinding) series in Figure 4.30 and Figure 4.31. The 0.1 mi. mean roughness index (MRI) varied from 70 to 175 in./mi., which was considerably higher than the 60 in./mi. upper limit prescribed by Section 40 of the 2015 Caltrans Standards Specifications that apply to this project. The MRI limits series in Figure 4.30 and Figure 4.31 are based on the 2019 Caltrans smoothness specifications, Table 67.5 (JPCP reconstruction). This table includes payment disincentives for MRIs between 75 and 90 and mandatory grinding when MRI exceeds 90 in./mi. Even though these specifications are not applicable to this project, an evaluation of the concrete overlay pre- and post-grinding smoothness followed by a comparison of those against the new Caltrans specifications was regarded as an interesting exercise. It revealed that the entire project would have required mandatory grinding since the MRI exceeded 90 in./mi at all the 0.1 mi. segments.

The cause of the Pre-G MRI being so high is unclear. The information collected for the overlay construction evaluation was insufficient to establish a sure explanation for the high postconstruction MRI, and finding the explanation would require an extensive monitoring program because concrete pavement smoothness is the result of a complex process that involves many factors (7). Evaluating each one's effect on smoothness far exceeds the scope of this project. The MRI values on Segments A and B were especially high considering that the segments are essentially flat, straight lines. Typically, changes in superelevation and vertical slope are likely to have a negative impact on smoothness. Here, the absence of curves on the segments eliminated the need to set a corresponding superelevation, and their flat layout eliminated the need to change the road's vertical slope. The paver was able to operate with almost no interruptions since the trucks had relatively easy access to the construction site and, overall, their arrival was steady. Further, the segments should have been smoother because there were no bridges, intersections, or other elements to interrupt the paving operation. Another factor that should

Based on the Post-G (post-grinding) series results shown in Figure 4.30 and Figure 4.31, few of the 0.1 mi. segments (around 14% of the project length) passed the 60 in./mi. requirement, but most of them (around 82% of the project length) would have passed the 90 in./mi. requirement.

Figure 4.30 and Figure 4.31 also show the areas of localized roughness present after the grinding operation; the roughness of these areas was categorized according to the 2019 Caltrans smoothness specifications (160 in./mi. limit). As shown in the figures, a considerable number of areas of localized roughness (ALRs) still existed after the grinding operation.

To try to meet Caltrans smoothness specifications, the complete project was subjected to grinding (blanket grinding). The appearance of the post-grinding surface can be seen in Figure 4.32. Grinding operations took place in April 2019 on Segment B and in the second half of May 2019 on Segment A. Overall, the grinding resulted in a 40% MRI improvement, although the improvement for individual 0.1 mi. segments varied from 19% to 53% (Figure 4.33).

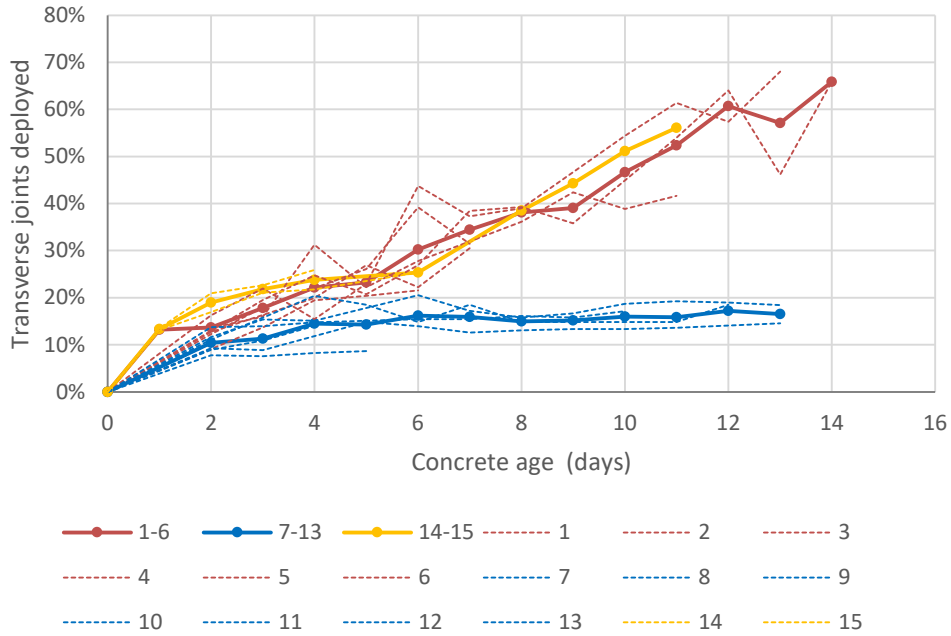
**Figure 4.35: Evolution of transverse joint deployment.**

The percentage of deployed transverse joints is shown in Figure 4.35. At first the transverse joints deployed over relatively long time intervals: roughly one out of every six to ten transverse joints deployed within one to two days after the overlay construction (as shown in Figure 4.35). That represents a cracking spacing of 35 to 60 ft., which is in the lower range of the values reported for regular jointed plain concrete pavements in the literature (8). This initial cracking was mainly driven by the thermal contraction of the concrete after setting. The next transverse joint deployments were mainly driven by the concrete drying from the top down. The joint deployment increased rapidly for most of the paving shifts until it reached about 60% after two weeks. This outcome agreed with the results from Project 4.58B, where 100% of the transverse joints deployed (9). It has been reported that in wet US states not all the transverse joints of 6 ft. long slabs get to deploy. The transverse joint deployment was very slow for paving Shifts 7 through 13 because the cloudy weather after the construction slowed the drying of the concrete overlay surface.

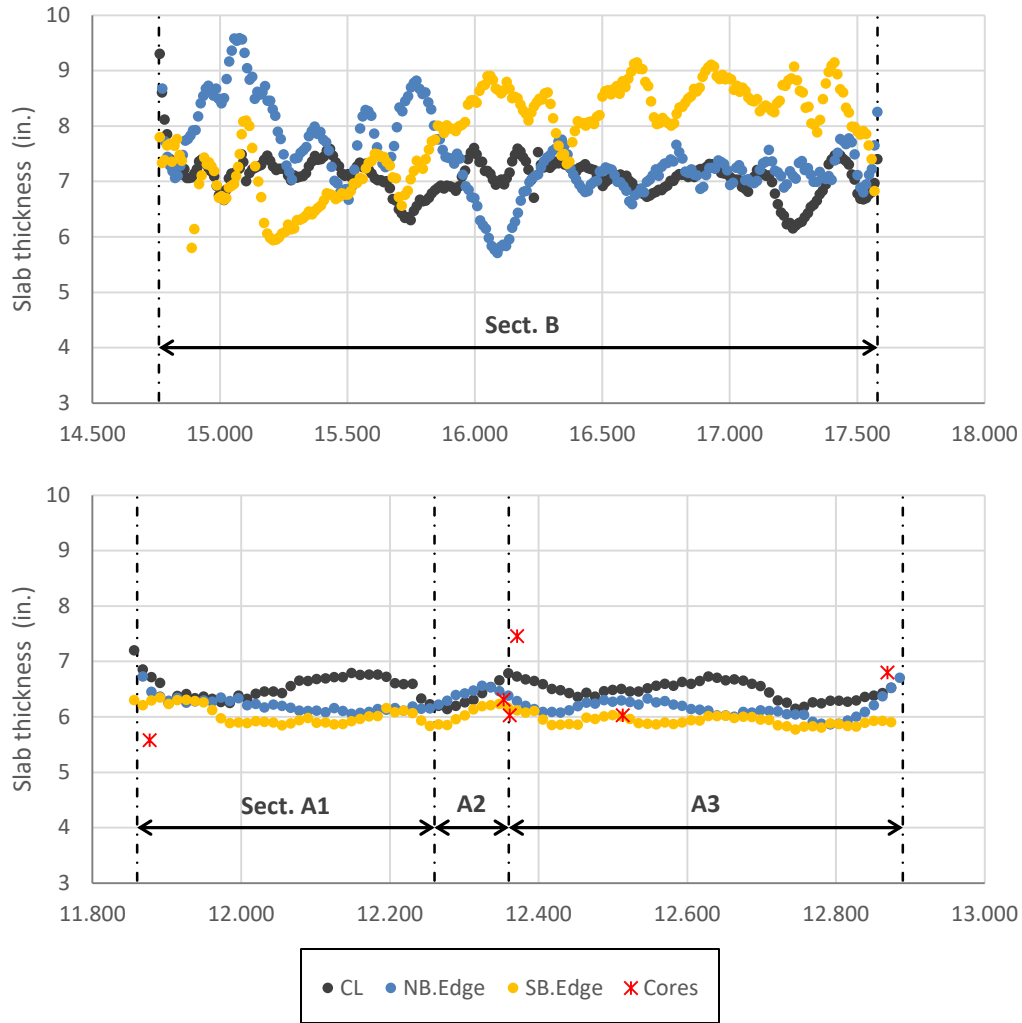
**Figure 4.36: Slab thickness.**

Slab thickness was measured manually after the concrete overlay placement, with one record taken every 10 slabs. The results are presented in Figure 4.36. As shown in this figure, the concrete overlay in Segment B was 1 to 3 in. thicker than the 6 in. target. The measurements were taken before the blanket grinding was applied, so concrete overlay thickness could be 1/6 to 1/4 in. thinner than the values shown in Figure 4.36.

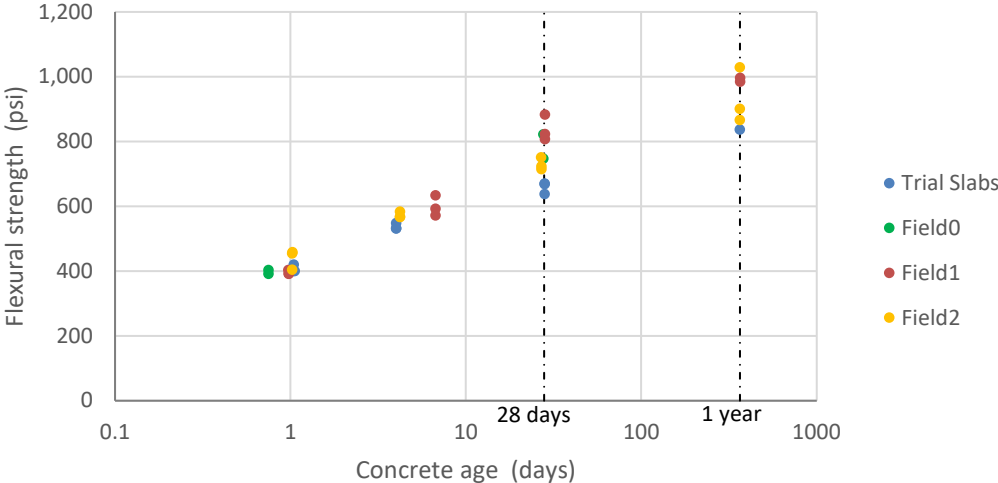
**Figure 5.1: Concrete flexural strength.**

The concrete flexural strength results are presented in Figure 5.1. Because the mixture was designed to be opened to traffic after 24 hours, it easily met Caltrans 28-day flexural strength requirement of 570 psi (note: there were some differences between the curing procedure followed in this research project and the one specified in Caltrans Test 523). The compressive strength and modulus of elasticity results are shown in Figure 5.2 and Figure 5.3, respectively. These results will be used with the flexural strength results in the mechanistic analysis of the pavement.

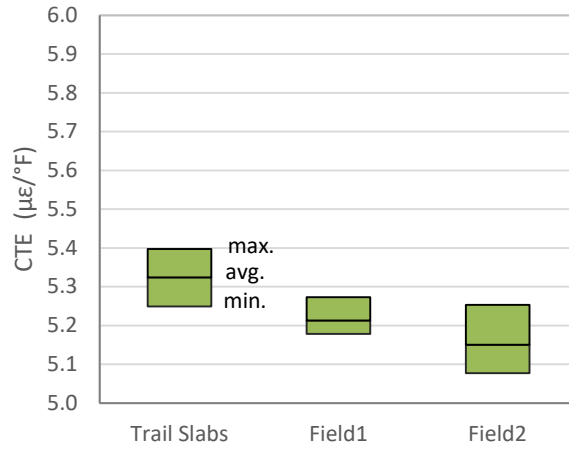
**Figure 5.4: Concrete CTE (at age 42 days).**

The concrete's CTE was around  $5.2 \mu\epsilon/^\circ\text{F}$  (Figure 5.4). This CTE value is within the typical range that can be expected for pavement concrete in California. A petrographic analysis of the concrete's coarse aggregate was unavailable.

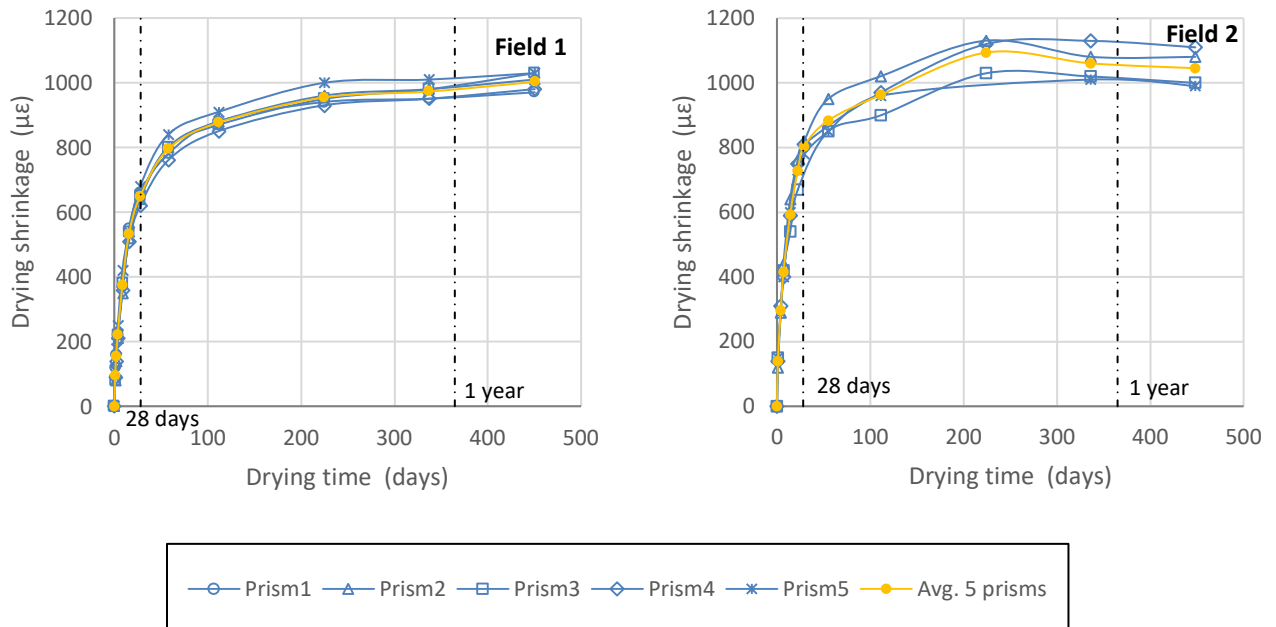
**Figure 5.5: Concrete drying shrinkage.**

The drying shrinkage results are shown in Figure 5.5. The measured drying shrinkage was relatively high, particularly compared to the limit of 500  $\mu\epsilon$  after 28 days drying that is prescribed by Caltrans Standard Specifications, Section 90. Field1 prisms reached 650  $\mu\epsilon$  shrinkage after 28 days while the Field2 prisms reached 800  $\mu\epsilon$  at that same age. Nonetheless, these values cannot be directly compared to the Section 90 500  $\mu\epsilon$  limit for two reasons. First, the moisture-curing period prescribed in Section 90 lasts until the specimens are seven days old, which is longer than the moisture-curing applied to the specimens in this research project. And second, the Section 90 limit refers to laboratory specimens, but the specimens used in this project were sampled and prepared in the field. According to ASTM C157-17 (note 2), field specimens “can show up to twice as much drying shrinkage as laboratory cast specimens from the same materials and proportions.”
