Landslides caused by the Mw7.8 Kaikōura earthquake and the immediate response

Bulletin of the New Zealand Society for Earthquake Engineering, 50(2)

LANDSLIDES CAUSED BY THE MW7.8 KAIKŌURA EARTHQUAKE AND THE IMMEDIATE RESPONSE

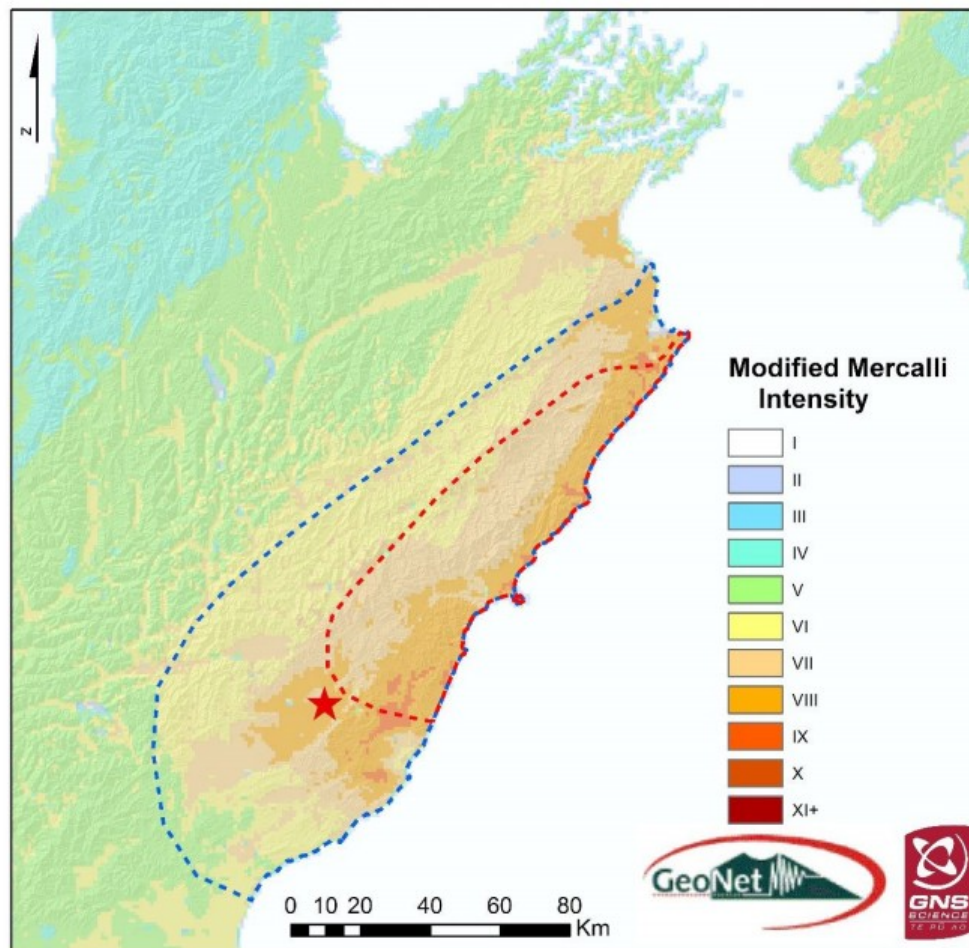
Figure 1: The 14th November 2016 M_w 7.8 Kaikōura Earthquake. The epicentre is shown by the red star in the south of the map. The colours depict the Modified Mercalli Shaking Intensity, with MM VIII in the worst affected areas with isolated pockets of MM IX where deep soils are present. The areas of no landslide damage; light to moderate landslide damage (blue dash), and severe landslide damage (red dash) are shown. The severity of the landslide damage corresponds well with the strength of ground shaking in areas of hills and mountains. (Map credits: MMI - Nick Horspool; Landslide observations - Dougal Townsend).

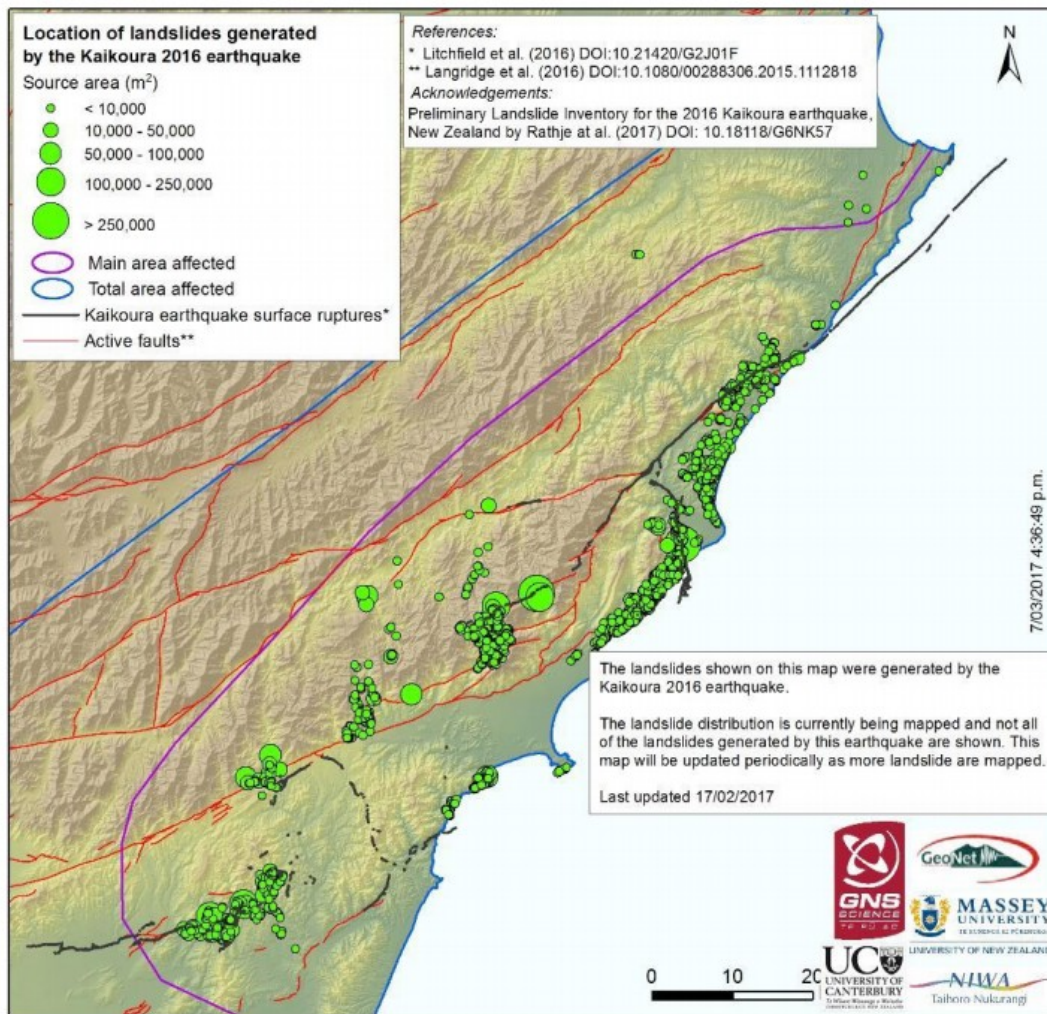
Figure 9: The landslide inventory for the 14 November 2016 M_w 7.8 Kaikōura earthquake as at 17 February 2017 (estimate 30% complete). The active fault ruptures caused by the earthquake are shown as black lines on the map. The landslides, and particularly the largest landslides cluster around the fault ruptures.
