Tidal channel and marshplain development : Cooley Landing salt pond restoration

Tidal Channel and Marshplain Development

Cooley Landing Salt Pond Restoration

December 8, 2003

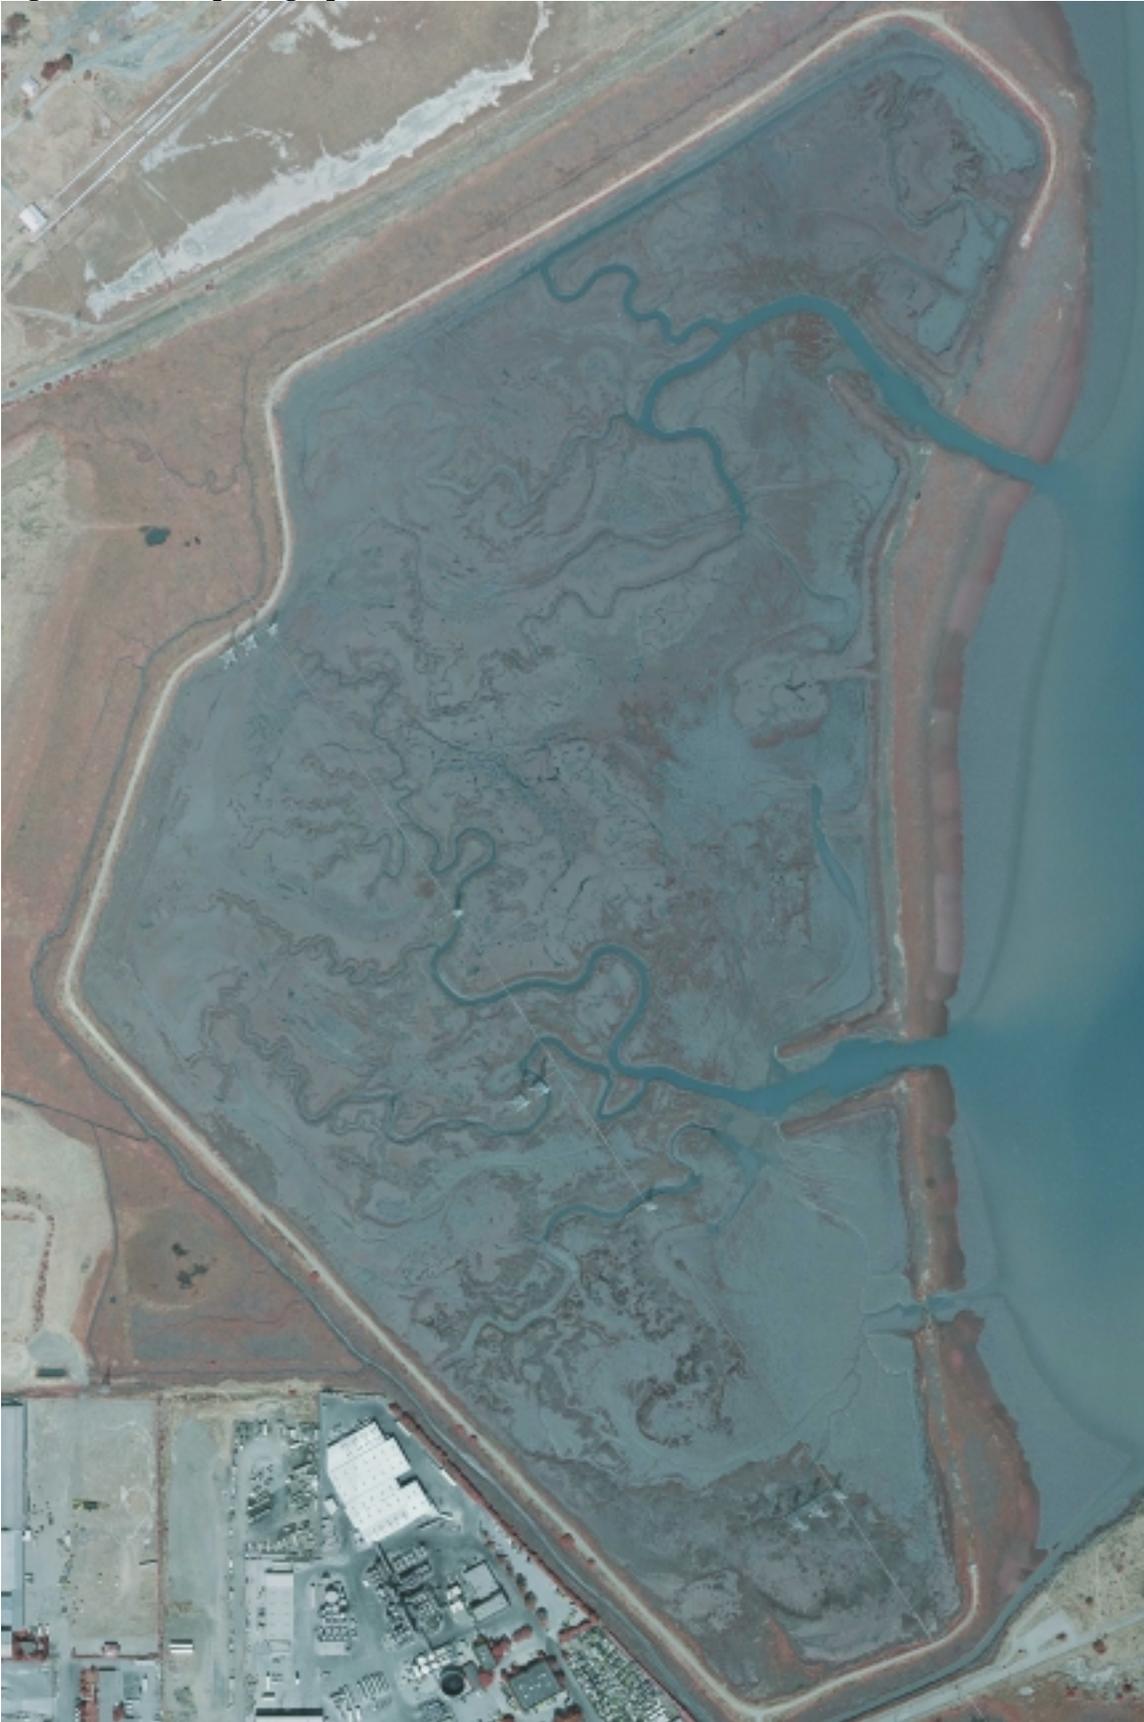
Figure 5. Aerial photograph of site taken on 9/22/03.

greater than channel erosion at the levee. A large hole has scoured to a maximum depth of 14.6 ft below MHHW (elevation -10.3 ft NGVD) in the south breach channel between the training berms. The aerial photograph shows the formation of mudflat channels that drain around the ends of the training berms. This suggests that the scour hole has formed as the mudflat areas on either side of the training berms drain around the ends of the berms. Due to channel scour caused by the large tidal prism draining through the south breach (see discussion of tidal drainage below), the current dimensions of the south breach channel are larger than the predicted long-term dimensions (Table 1). The force of this drainage would have certainly scoured the borrow ditch along the former levee in the absence of the training berms. A small channel has formed parallel to the north side of north training berm that connects to a short portion of the borrow ditch (Figure 16), however this small channel may not persist as the marshplain accumulates sediment and vegetation establishes.

transect. Along the southern boundary of the site, it has aggrades up to an elevation of 2.8 ft NGVD (2.4 ft above MTL). Low marsh vegetation species (i.e. cordgrass) establish on mudflats starting at elevations of 1 ft above MTL (1.4 ft NGVD for Cooley Landing). Most of the marshplain is above the minimum elevation for vegetation colonization. The color infrared aerial photograph (Figure 5) shows many individual colonies and larger patches of vegetation that are concentrated on the channel banks have established. Photo-documentation shows that the vegetation is pickleweed. Figures 24 and 25 shows the extensive pickleweed coverage that has colonized the outboard levee and channel training berms.

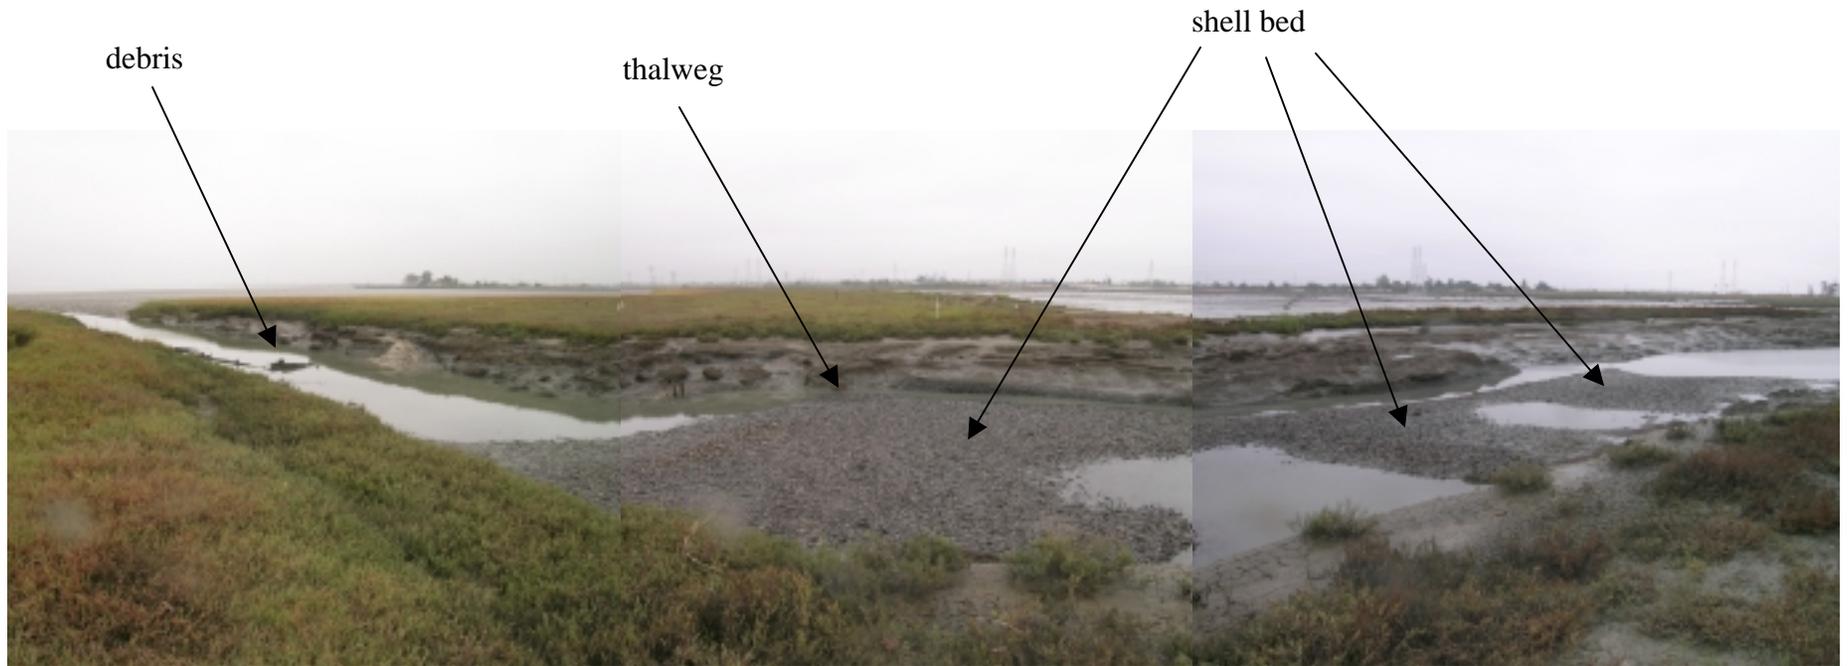
Figure 15. North breach channel.

The cross-sections for the Cooley Landing breach cross-sections in the outboard marsh and at the former levee are plotted in Figures 11-14. In the outboard marsh, the cross-sectional area of the north breach channel has increased since September 2001. The channel thalweg depth and top width have not changed significantly. The channel through the north levee breach has down-cut by 1.3 ft at the thalweg and has widened through bank erosion since September 2001. If the current rate of channel erosion by down cutting persists, the channels will reach expected long-term depths within two years. The shell bed shown in the photographs in Figure 15 may slow the scour of the bottom of the north breach channel. The current cross-sectional areas and widths are larger than the predicted equilibrium dimensions and do not cause tidal muting within the site (PWA et al 2002).

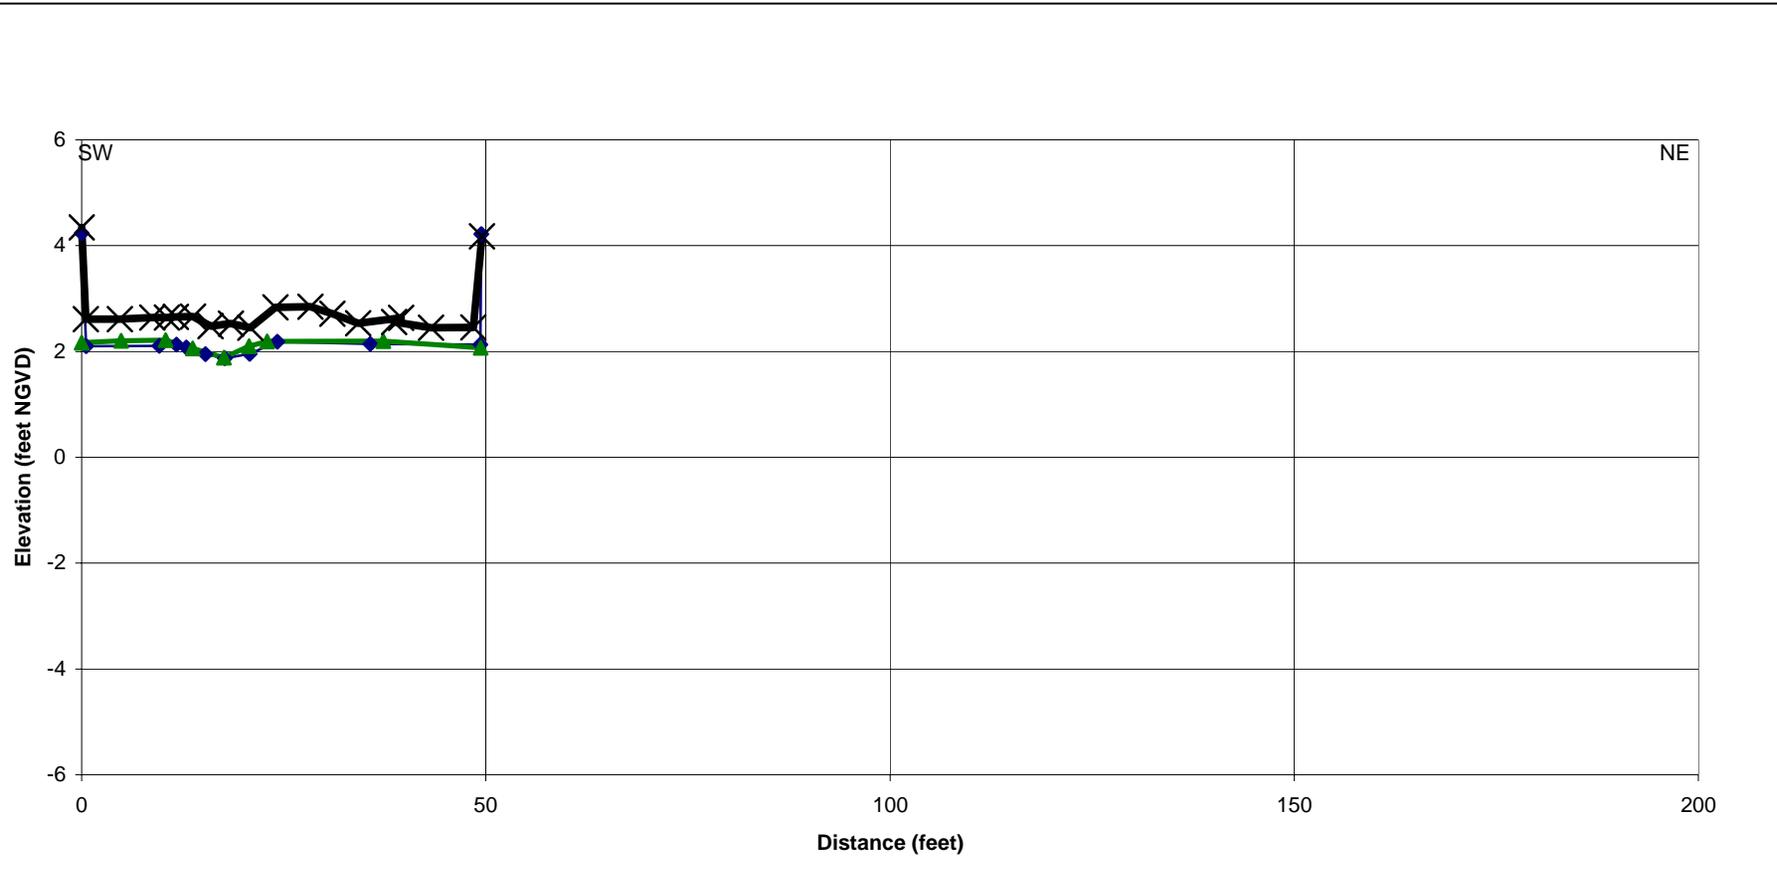
figure 21

Cross-sections of lower order channels upstream of the south breach (Figure 17 to 20) show the re-occupation of these historic channels through scour. The marshplain transect along the PG&E boardwalk also shows the formation of several smaller channels (first and second order) across the site. PWA identified a channel nick-point that scoured the pre-breach grade of the historic channel bottom up to 800 ft upstream of the south breach by September 2001. Since then, the main branch of the historic channel has scoured beyond XS 6 (Figure 20), which is 2,500 ft upstream of the breach. At the back of the site near the boardwalk (Figure 21), this channel has filled with sediment, however the photo-documentation shows that other mudflat channels have formed in the location of historic channels in this part of the site (Figure 22).
