Finding a Foothold on an Uncertain Bank: An Assessment of Cerrito Creek into the Blake Garden

Nery Barrera Lopez, Moyan Chen, Timothy Cole, Tanner Howe, and Sara Mahmoud

LA 227 Restoration of Rivers and Streams  
University of California, Berkeley  
December 16th, 2019

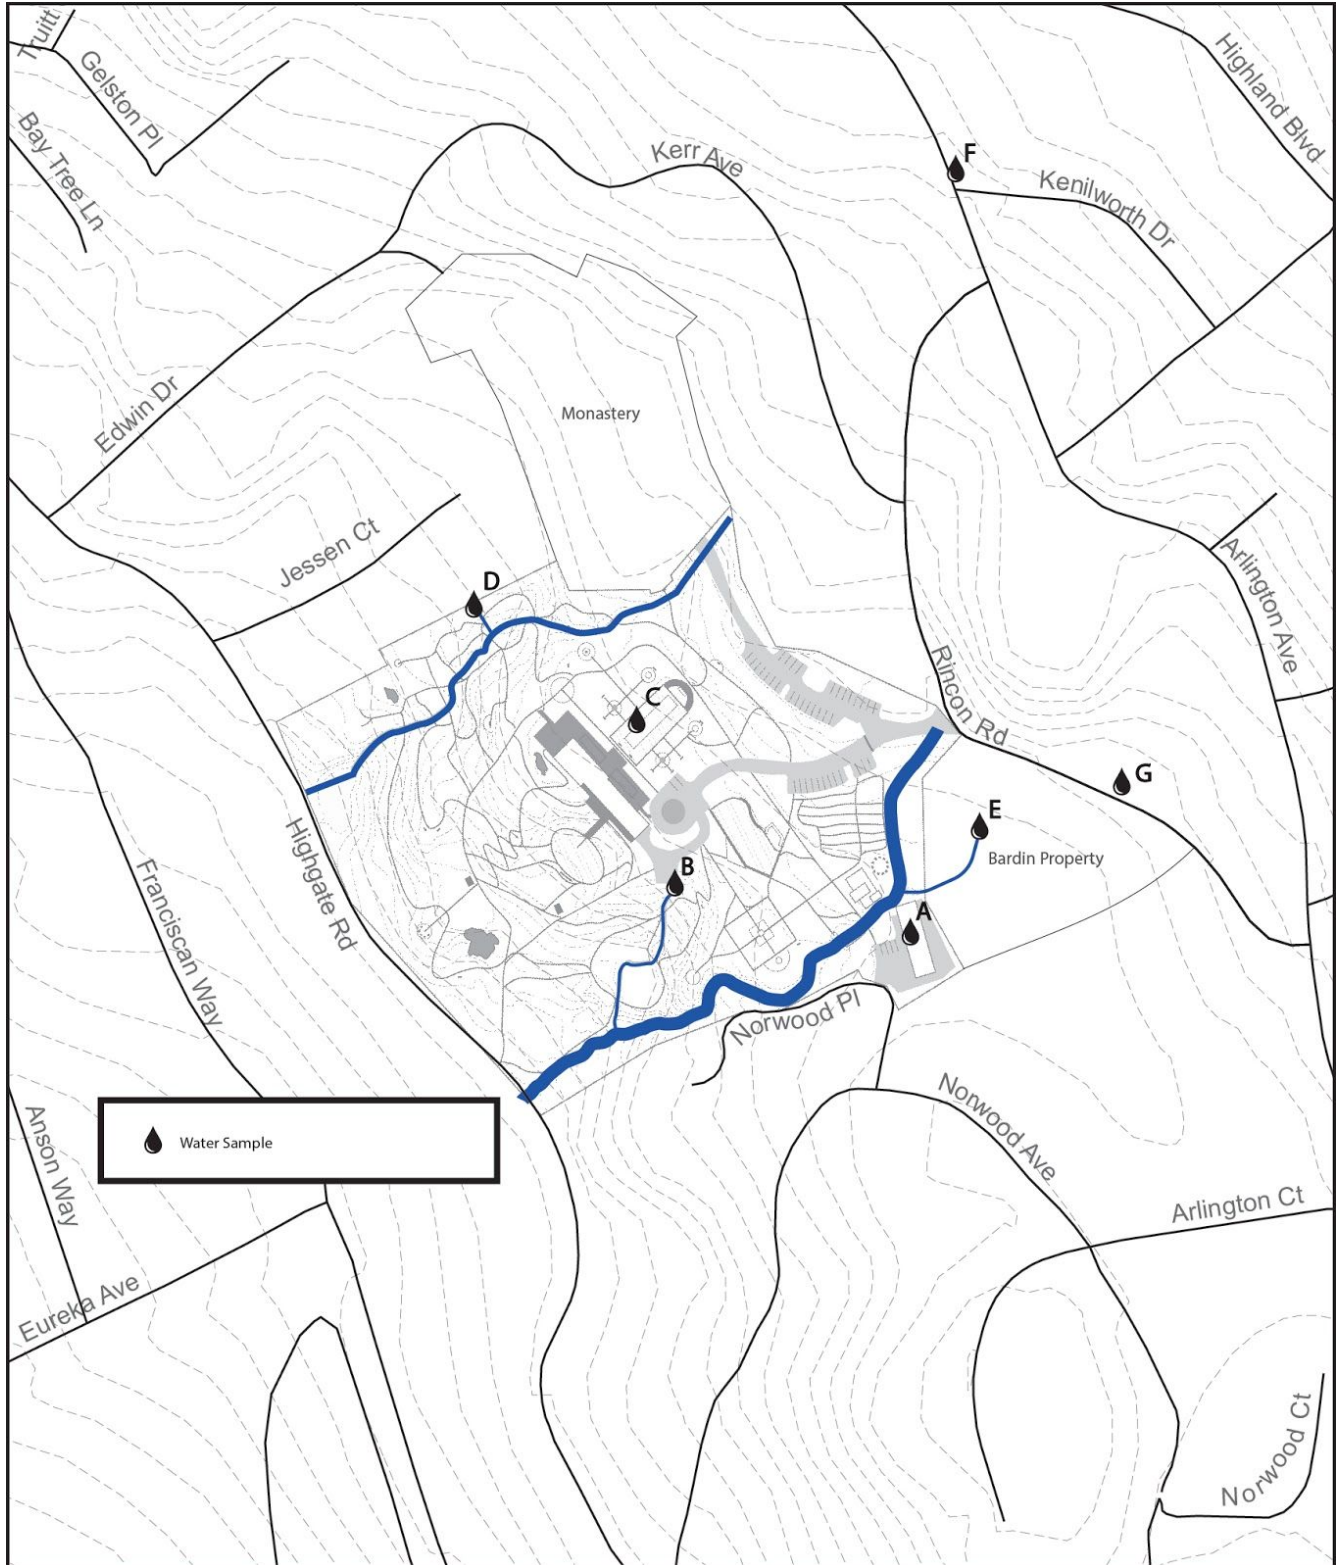
Figure 5. Locations of water samples (Tables 4&5)

We selected six locations relevant to the Blake Garden to be analyzed using the "ClearPool 6 Way Test Strips" (Figure 5). These six locations included three within the Blake Garden, being the Australia hollow spring, reflection pool, and a seep that flows into redwood canyon via Jessen Ct. (formerly part of the neighboring Edwin Blake estate), and three outside of the garden being a wetland pool on Marion Bardin's property, an upstream drain in front of 15 Arlington, and a drain exiting the rear of the property of the Arlington Community Church and Guidepost Montessori School at 52 Arlington Ave. (the sample was collected near the property line by 71 Rincon Rd.). We further collected a tap water control from the garden headhouse for comparison. It should be noted that there is a confirmed spring on site (Australia Hollow) which can also be used in comparison to the other water samples. However, with the possibility of contamination, we primarily referenced the tap water as the control. We initially collected each sample in a designated cup, making sure that each cup was free of any debris that could bias the results of the test. Following this we obtained a bulk sample of water from each specified area, by holding the cup up to any drainage or trickling from the targeted water source until the cup was

From our observations, the upper reach of Cerrito Creek within Blake Garden is fed by multiple perennial water sources (Figure 5). The north branch of the upper reach receives flows from the culvert below Rincon Road. These flows can be observed fluctuating in the dry season, evidently due to leaks in East Bay Municipal Utility District (EBMUD) water lines. Another water source originates from the west corner of Arlington Community Church, along Rincon Road, where a perpetual trickle of water runs into the ditch on the northside of Rincon Road. In dry conditions, this stream does not appear to flow to the culvert that feeds the main influent line, but flows into the ground and toward the Bardin property to the south. This stream most likely contributes to the east branch of the upper reach of Cerrito Creek within the Bardin property.

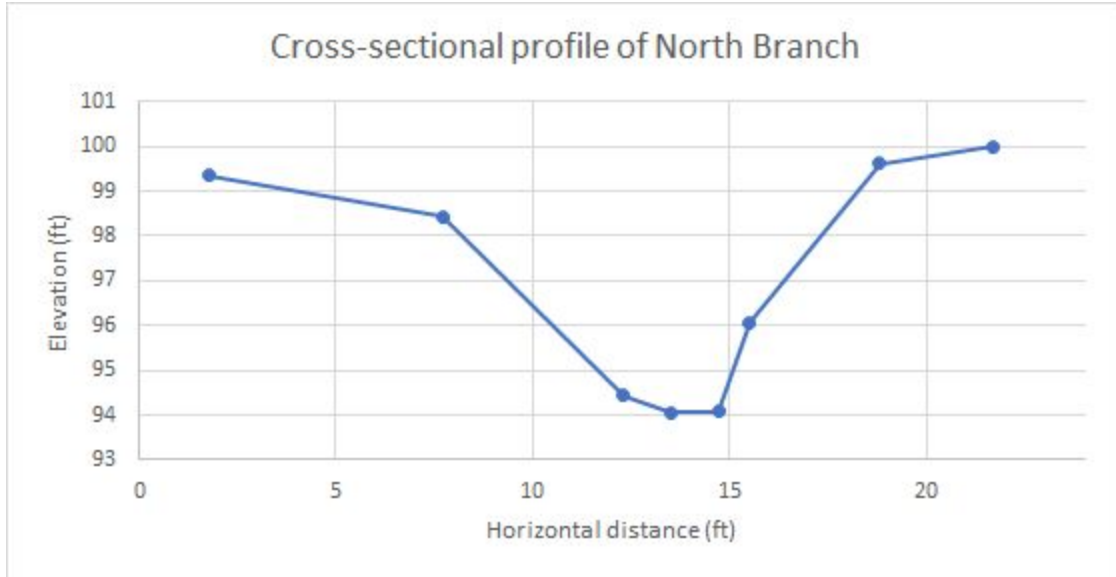
The cross-sectional profiles allowed us to see that both branches possess a wide channel. However, we could determine that vertical incision is occurring in the east branch of the upper reach, which, we have observed over the past year to carry less water (Figure 9). This might be an indication of regressive erosion in the east branch. In contrast, the bottom of the north branch has a wider bottom (Figure 10). This part of the channel was widened and its banks were reinforced with concrete (Sasaki et

Figure 10. Cross-sectional profile of North Reach. All elevations are in respect to the last point, which was given an elevation of 100 ft.

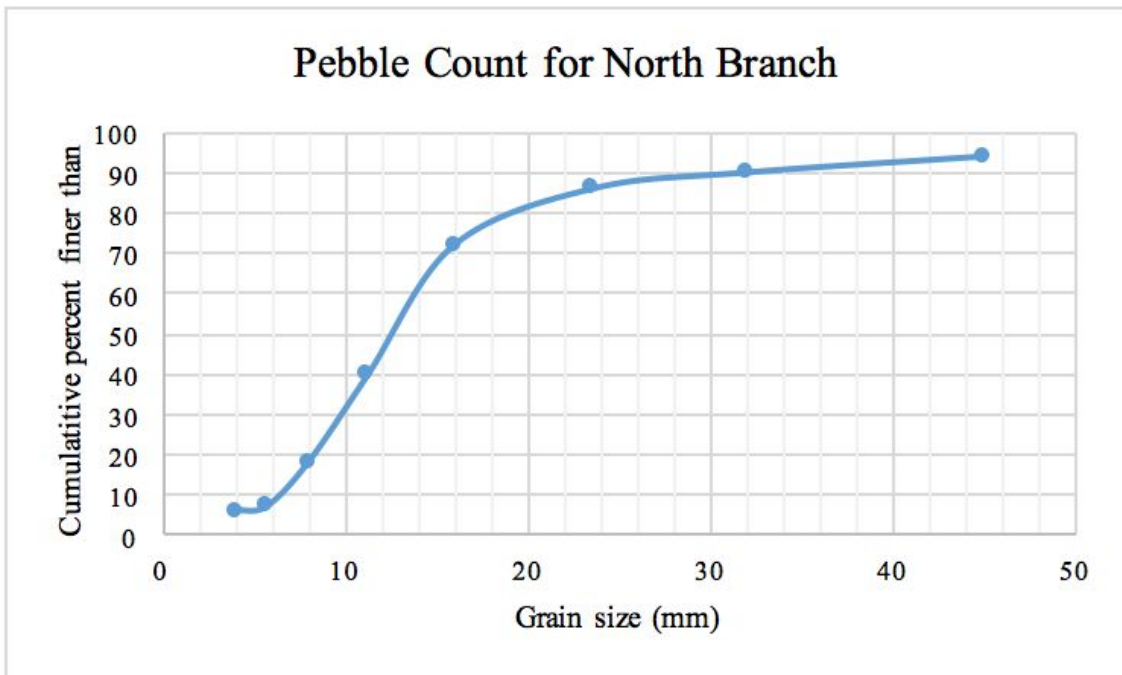
We viewed the pebble count as an additional measure in characterizing the Blake Garden streams (Figure 11). There appears to be variability in the range of pebble sizes comparing the north reach to the area after the confluence with the east reach. The north reach gravel bar had reached pebble sizes as large as 44 mm, being very coarse gravel where as the largest pebble size downstream of the confluence gravel bar reached was 23.6 mm, coarse gravel (Figures 12&13). The majority of the pebble count for the north reach was at found at size 16, between coarse and medium gravel, in contrast to after the confluence at 11.6, one magnitude lower than 16 on the gravelometer, or medium sized gravel (Figures 12&13). Both reaches however display a reasonable distribution of sizes given their respective ranges. In considering the dp50 values for both pebble counts, the dp50 value for after the north branch is approximated at 12.5 mm whereas the dp50 value for after the confluence is approximated at 10.0 mm.

Figure 12. Histogram representation of pebble count for North Branch

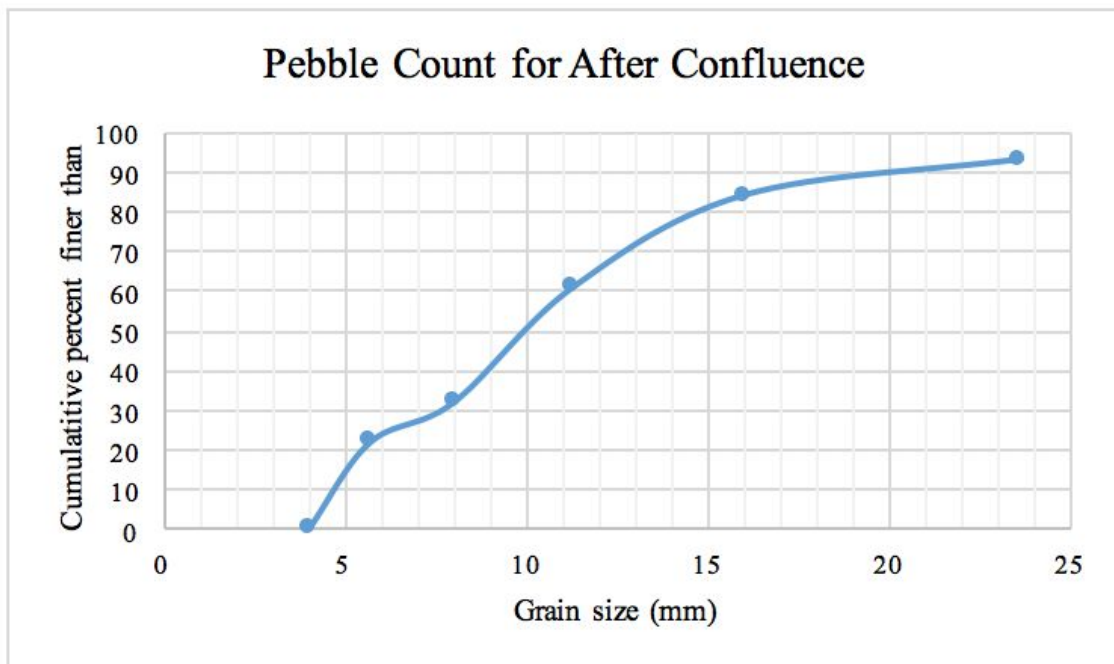
Figure 13. Histogram representation of pebble count for after confluence

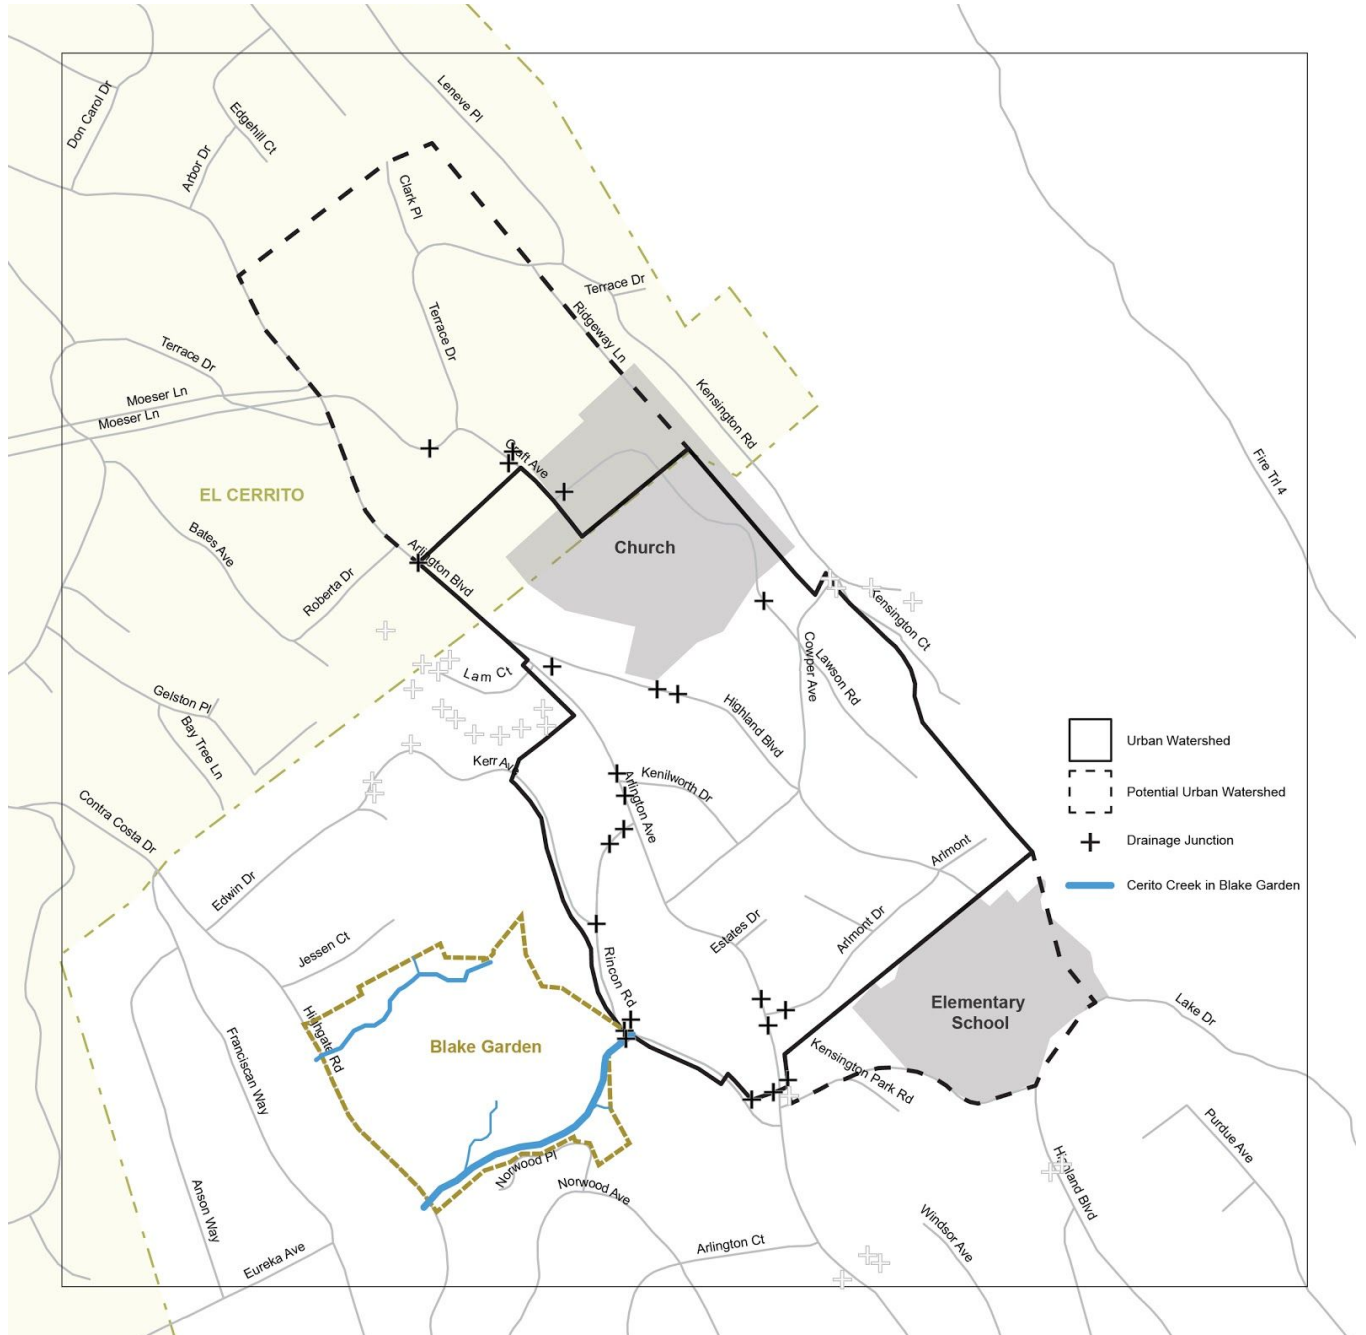
After two inspections of the watershed above the Blake Garden, we could not determine the exact catchment area. However we were able to delineate what we believe to be the most accurate estimations to date (Figure 14). Figure 14 shows the catchment area for the water that drains into the southeastern reach Blake Garden, and it is divided into three subsections. The section in the middle of the catchment, denominated “Urban Watershed”, is the area that certainly drains into the creek. This area includes the topographic catchment area and the area that drains into the creek by piping. The two areas (north and south of the Urban Watershed), denominated “Potential Urban Watershed” are areas that potentially and likely drain into the Blake Garden depending on certain conditions. These areas were included because the storm drains maps provided were inconclusive, the north being within the city limits of El Cerrito, and the south mostly consisting of Kensington Elementary School. The catchment area then could vary from 46.75 acres, the area which certainly drains into the garden, to 77.39 acres, which

Figure 14. Delineation of Watershed/Catchment Area

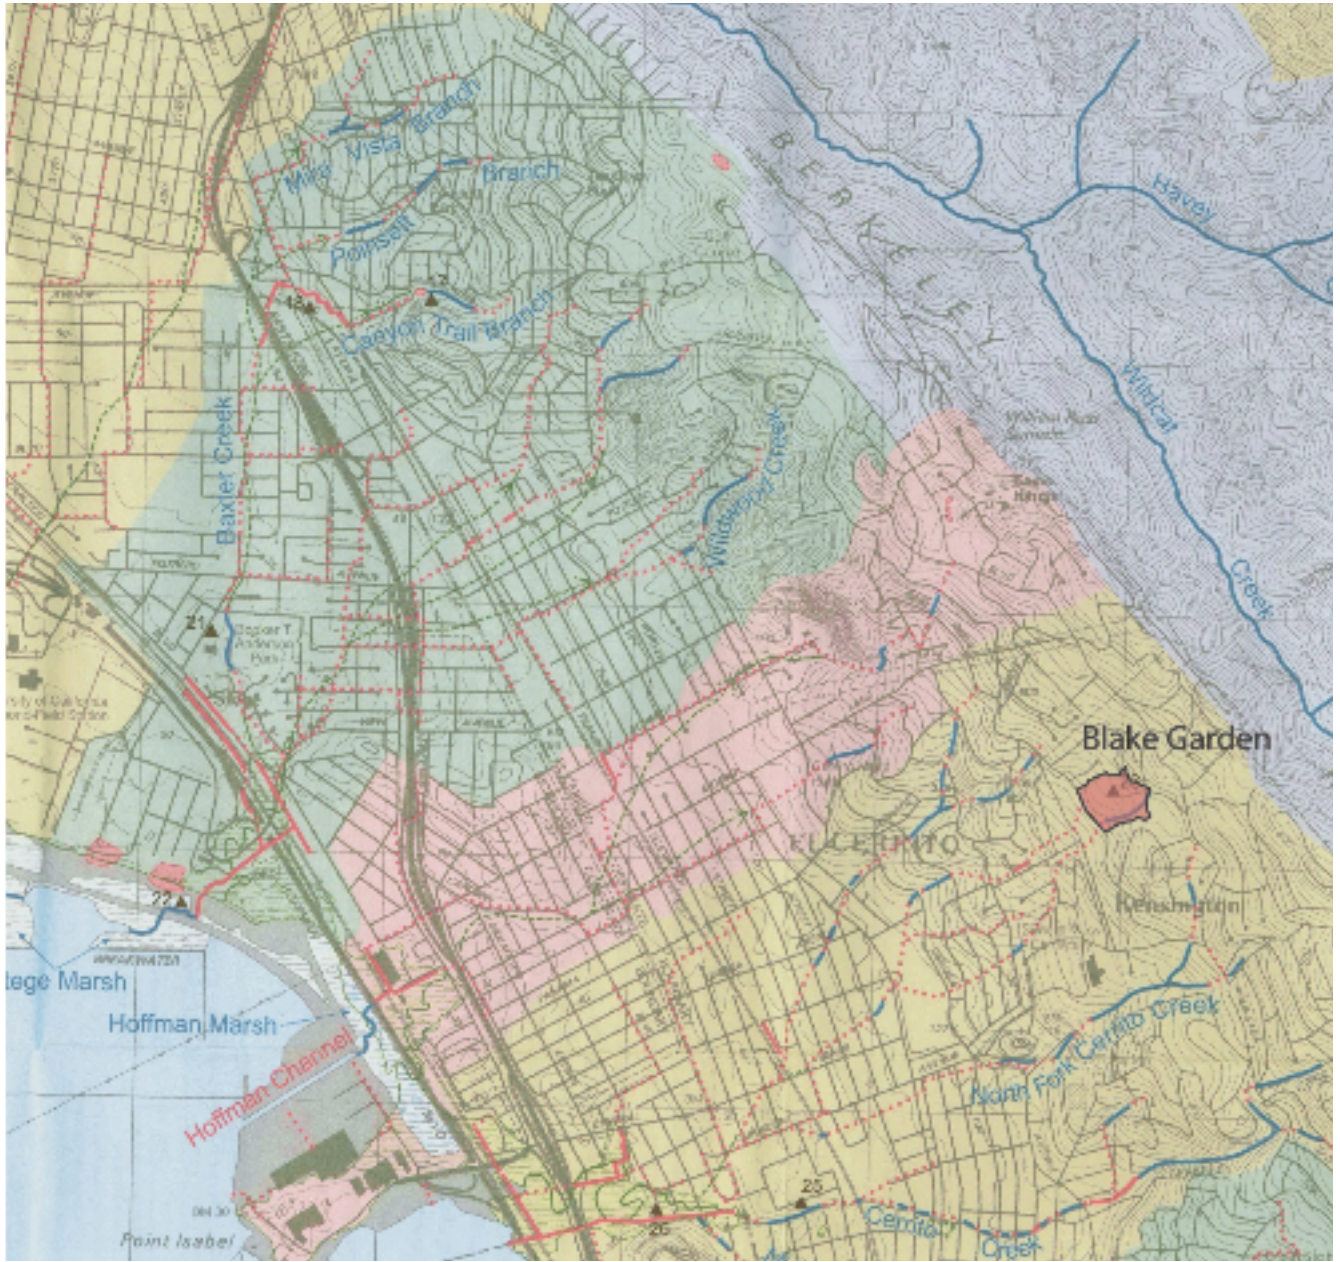
Our initial thought was to analyze topographic maps of the region around the upper reach of Cerrito Creek in parallel with the drainage area maps (Figures 16 & 17). We observed a relatively flat region depicted on the topographic map east of the reach of Cerrito Creek within Blake Garden. We suspected this region to be the extent of the floodplain. Upon field observation, our suspicions were confirmed. With the permission of Marion Bardin, owner of the property east of the Blake Garden, we examined the flat portion of land as shown on the topographic map. The plain included abundant riparian vegetation, standing water, and was level with the plain extending into Blake Garden, as shown in figure 14. It was also evident that there are active flows through the Bardin property, mostly in the subsurface. The water that originates in the Bardin property flows into the eastern branch of the upper reach of Cerrito Creek, which in reality originates from the Bardin property, not the Blake Garden.

Figure 17. Cerrito Creek watershed (Oakland Museum).
