Liquefaction and Related Ground Failure from July 2019 Ridgecrest Earthquake Sequence

Bulletin of the Seismological Society of America, 110(4)

# Liquefaction and Related Ground Failure from July 2019

## Ridgecrest Earthquake Sequence

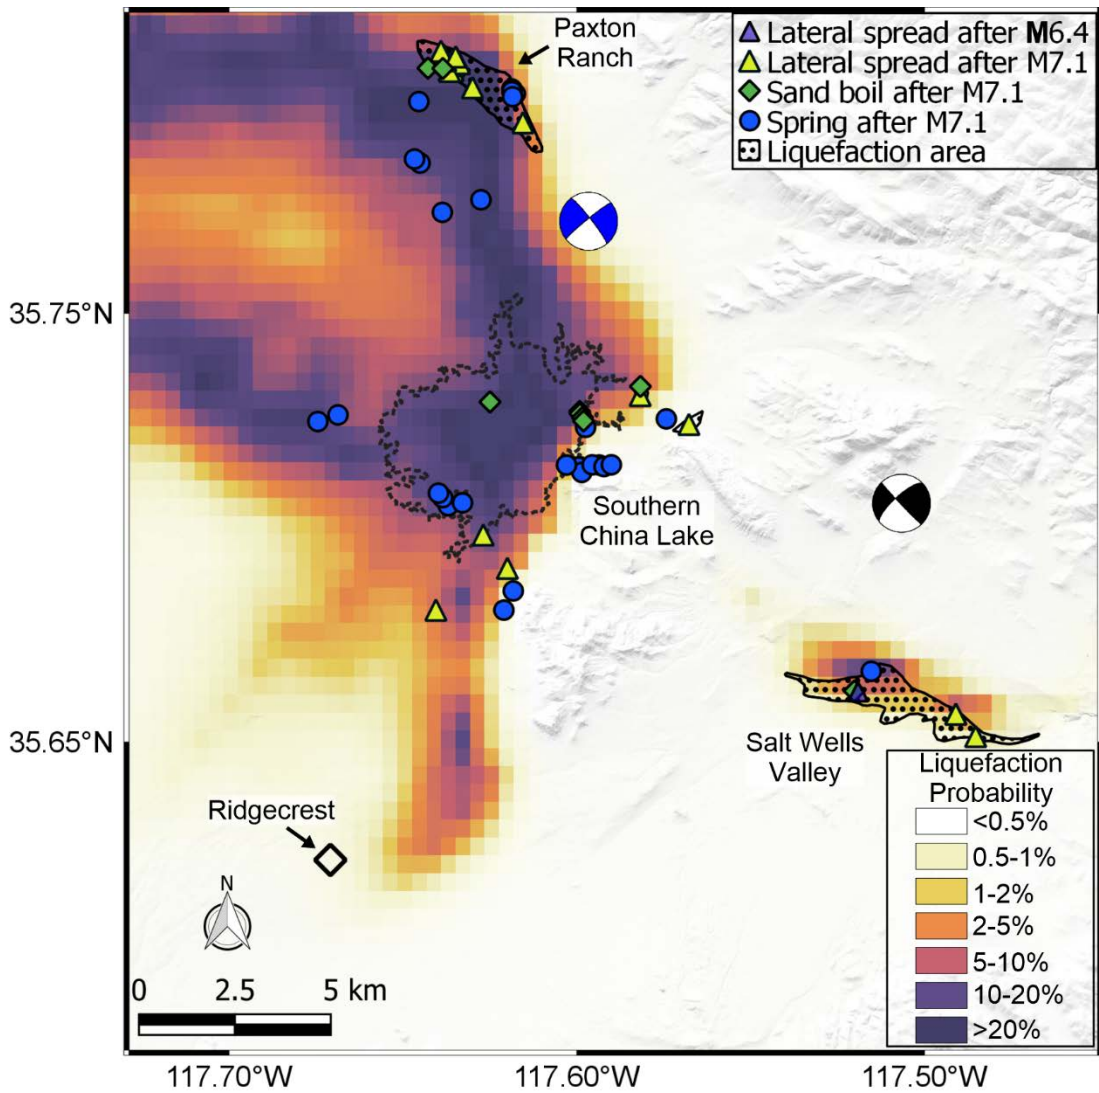
886  
 887 **Figure 4.** Map of the Indian Wells Valley, observed liquefaction features, and USGS near  
 888 real-time liquefaction hazard map.

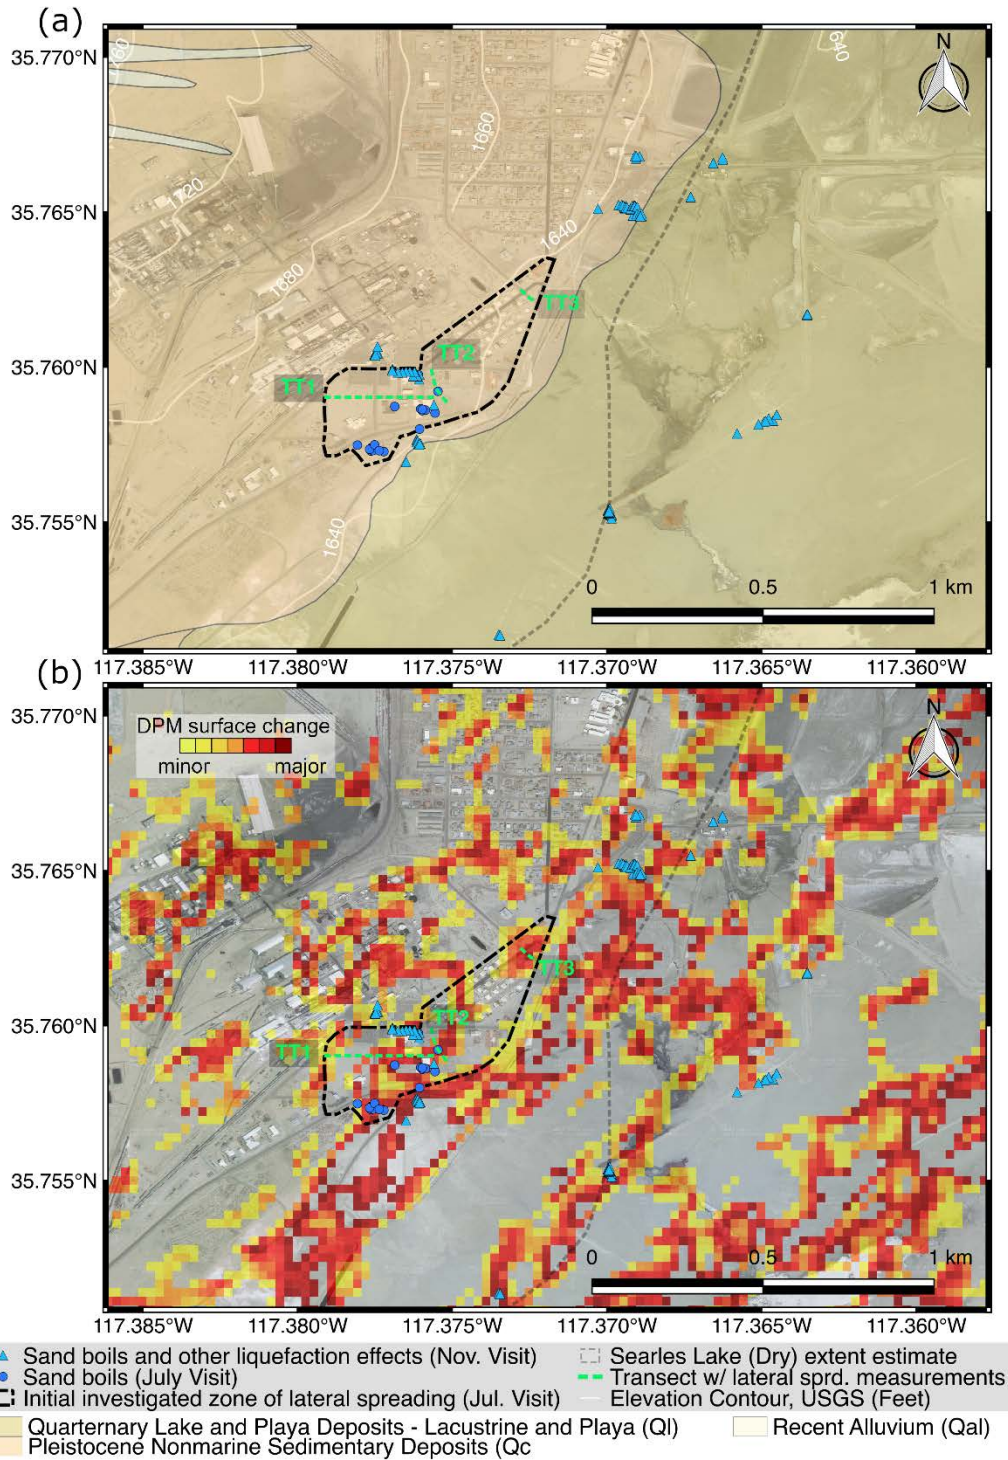
894 **Figure 5.** Map of Trona showing locations of observed liquefaction effects and lateral  
 895 spreading measurement transects overlaid on (a) surface geology map and (b) damage  
 896 proxy map. Geologic units are labeled following descriptions from Smith (2009).

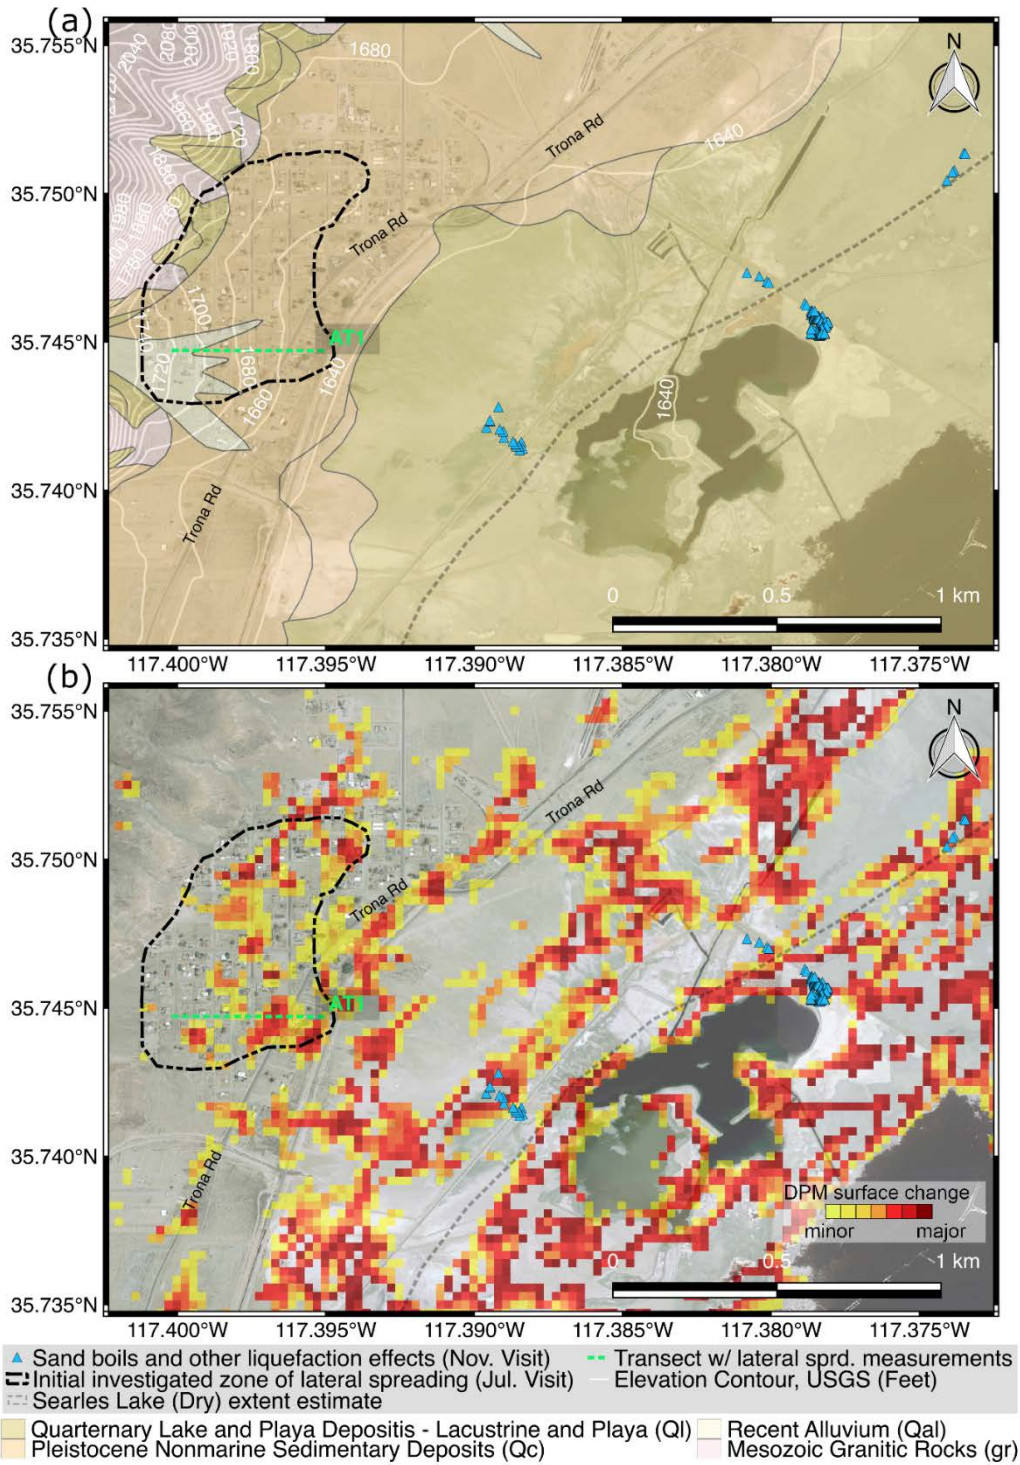
910 **Figure 8.** Map of Argus showing locations of observed liquefaction effects and lateral  
 911 spreading measurement transects overlaid on (a) surface geology map and (b) damage  
 912 proxy map. Geologic units are labeled following descriptions from Smith (2009).

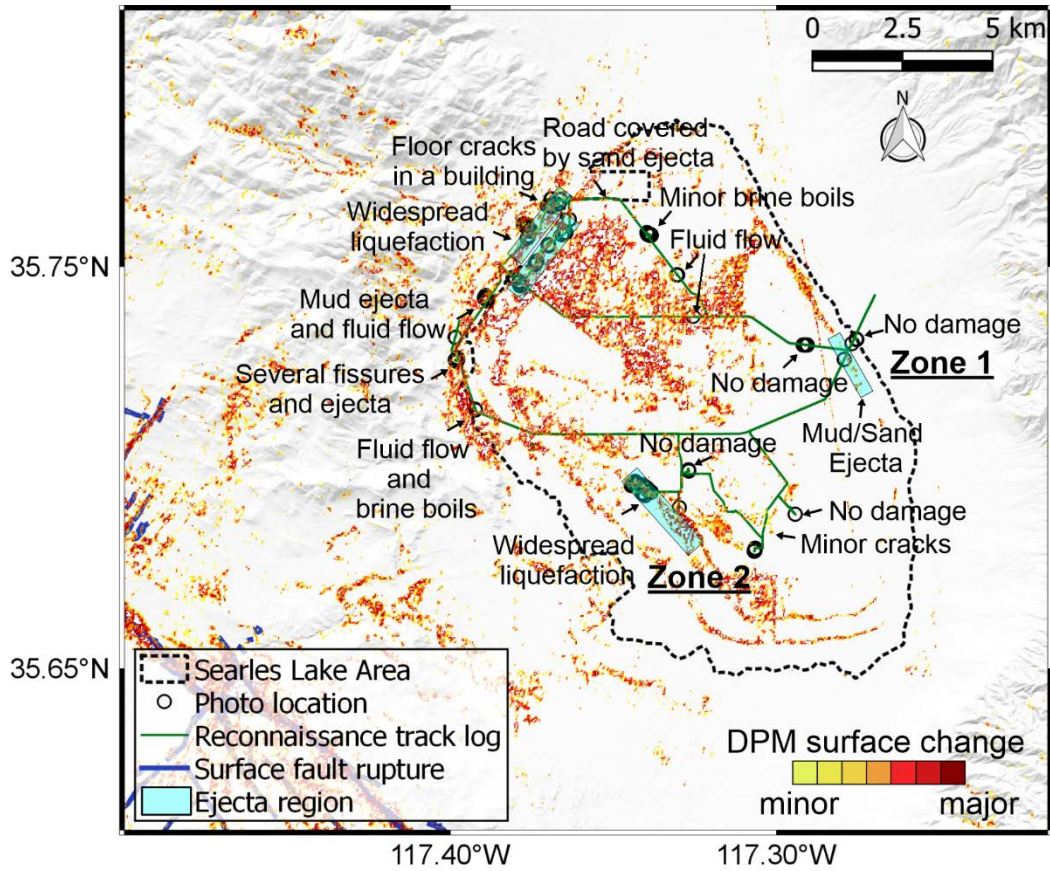
490 The DPM in Figure 10 shows non-zero damage proxies roughly aligned with the lake  
491 margins. Portions of the lake boundary that exhibit such patterns include the north-west  
492 edge of the lake and two semi-circular concentric zones in the south-west area of the  
493 lake. In the area of the lake south-west of Trona a large portion of the lake is covered by  
494 a cluster of non-zero damage proxies, while in the area south-west of Argus, a large  
495 number of proxies are aligned along the lake margin. Figure 11 shows the USGS near  
496 real-time liquefaction hazard map produced following the **M7.1** mainshock. This map  
497 shows high probability of liquefaction in the central zone of the lakebed. It predicts low or  
498 no liquefaction hazard along the lake margins.

500 Figure 10 shows the track log from the reconnaissance and locations of geotagged  
501 photos. Figure 10 also provides an overview of the reconnaissance findings. Figure 12a  
502 shows a photo of the central zone of the eastern edge of the lake (Zone 1 in Figure 10).  
503 This photo was taken from the road located southwest of the linear damage zone

509 Massive liquefaction was observed near the southwest edge of the lake (labelled Zone 2  
510 in Figure 10). Thousands of sand boils (Figure 12c), ground fissures and cracks (Figure  
511 12d), and abundant sand, gravel (Figure 12d,e), and brine-evaporite ejecta (Figure 12f)  
512 were observed along the relatively narrow NW-SE line depicted on the DPM. We use the  
513 term brine-evaporite to indicate that after the brine fluid was ejected onto the surface,  
514 evaporites precipitated out of the solution as it evaporated. Figure 12f shows a sand boil  
515 entirely covered by a thin brine-evaporite layer. This sand boil covers an area containing  
516 sand from two smaller (and older) boils. Two hypotheses can be formulated to explain  
517 this phenomenon: (1) both manifestations occurred during the same event - the smaller  
518 sand boils were caused by liquefaction occurring in a more surficial layer, while the brine

524 Widespread liquefaction manifested in hundreds of sand boils, cracks, and fissures was  
525 observed in the area southeast of Trona (highlighted in Figure 10). Ground movements  
526 are also indicated in this area by the DPM. Similar observations were made on the

540 zones in the south and southwest zones of the lakebed (labelled as “No damage” in Figure  
541 10). Neither DPM false positives (areas where non-zero damage proxies are present but  
542 no ground deformations are observed), nor DPM false negatives (areas where non-zero  
543 damage proxies are not present but ground deformations are observed) were observed  
544 at Searles Lake. However, these outcomes do not represent a comprehensive validation  
545 of the DPM at Searles Lake as many areas were not accessed and inspected.  
546 Nonetheless, these preliminary findings are encouraging regarding the effectiveness of  
547 DPMs for the no-vegetation conditions in the Searles Lake area. False positives were  
548 also observed in the USGS liquefaction hazard maps. At two of the four locations labelled  
549 as “No damage” in Figure 11 (west of Zone 1), the USGS liquefaction hazard map

920  
 921 **Figure 10.** Damage proxy map produced following the **M7.1** event, route of the November  
 922 2019 reconnaissance mission, geotagged photo locations, and reconnaissance findings.

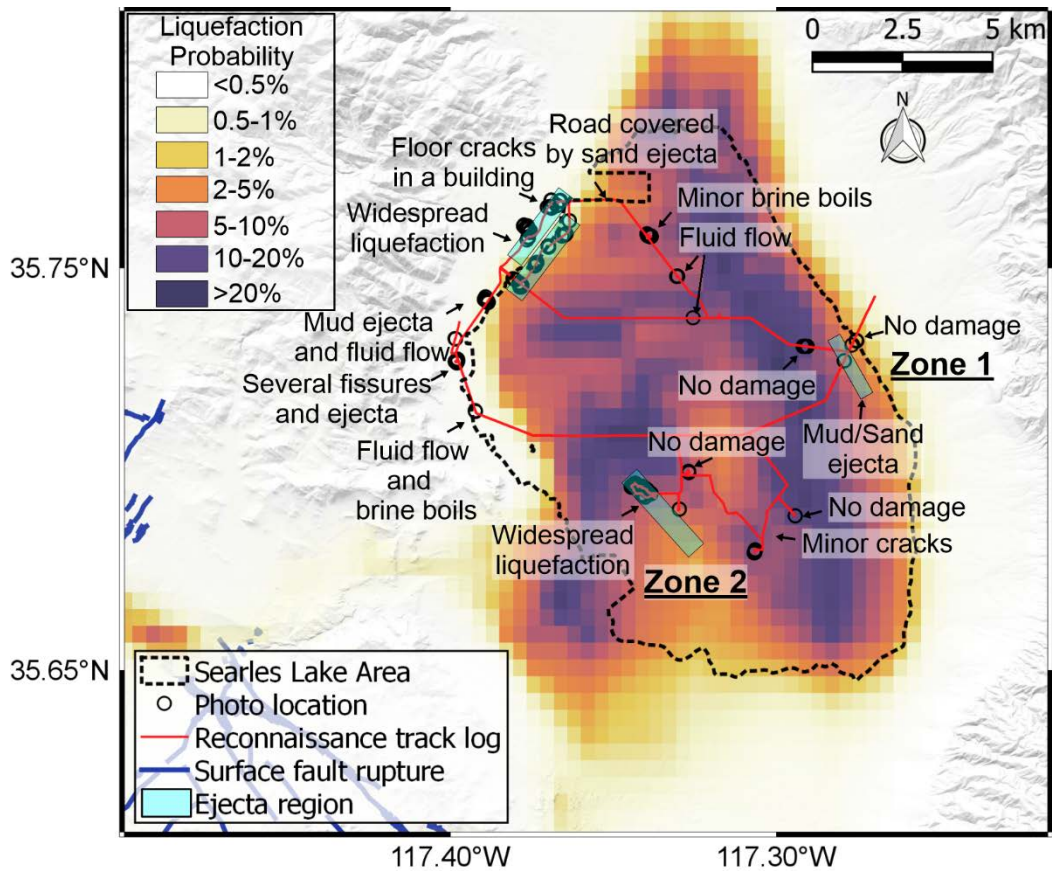
529 Observations at Searles Lake confirmed ground deformation patterns reported in the  
530 DPM. The USGS liquefaction hazard map predicts liquefaction in the lakebed region but  
531 the actual observed deformation patterns are not consistent with the map. The mismatch  
532 is especially pronounced along the margin of the lakebed where liquefaction was  
533 observed at various locations, but predicted liquefaction probabilities are low. Zones 1  
534 and 2 in Figure 10 represents clear examples of DPM true positives (areas where non-  
535 zero damage proxies are present and ground failure features are observed). True  
536 positives from the DPM were also observed in the area immediately southwest of Trona  
537 and at the southwest edge of the lakebed. Some spot checks were performed to identify  
538 potential true negatives (areas where colored damage proxies are not present and no  
539 ground deformations are observed). Such occurrences were observed in at least four

924 **Figure 11.** USGS liquefaction hazard map produced following the **M7.1** event, route of  
 925 the November 2019 reconnaissance mission, geotagged photo locations, and  
 926 reconnaissance findings.
