The removal of Saeltzer Dam on Clear Creek : an update

## **The Removal of Saeltzer Dam on Clear Creek: An Update**

Mike Ferry and Peter Miller  
June 2, 2003

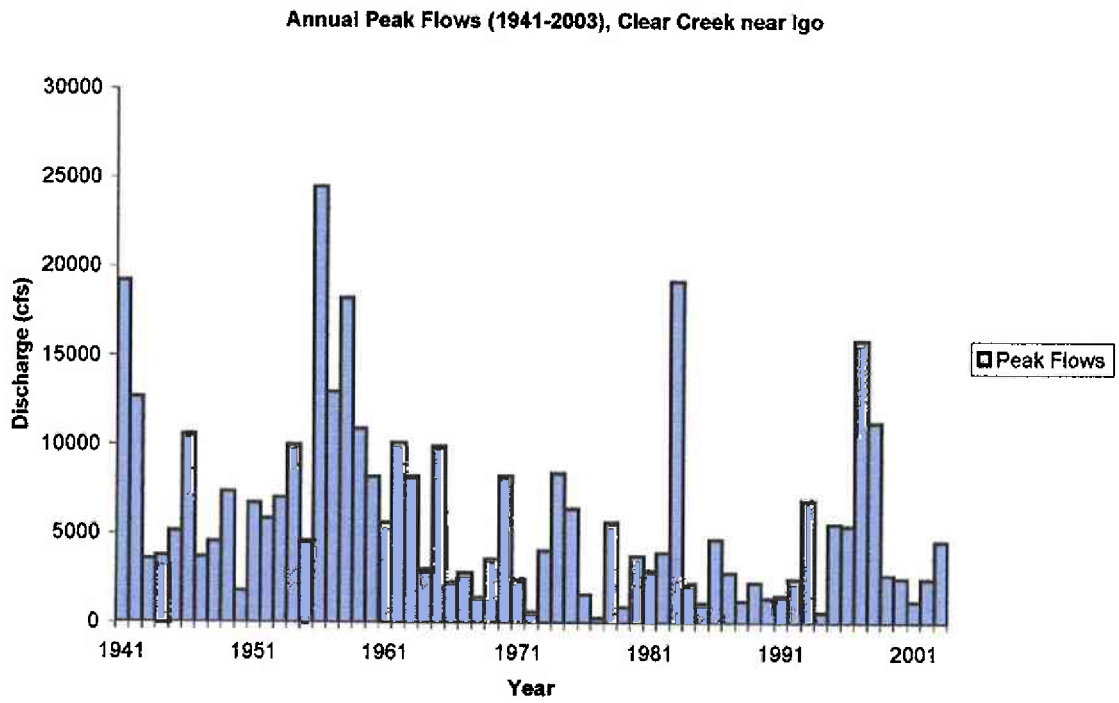
Figure 2: Annual Peak Flows on Clear Creek at Igo

Flows on Clear Creek during the winter of 2000-2001 were exceptionally low. The highest level of flow on Clear Creek that winter was only 1,220 cfs, among the lowest over the period of record. (Figure 2, Table 1) In contrast, since that first winter, there were three floods greater than the Q2 level of 2,800 cfs, including a peak flood of 4,600 cfs on December 31, 2002. (Table 3)

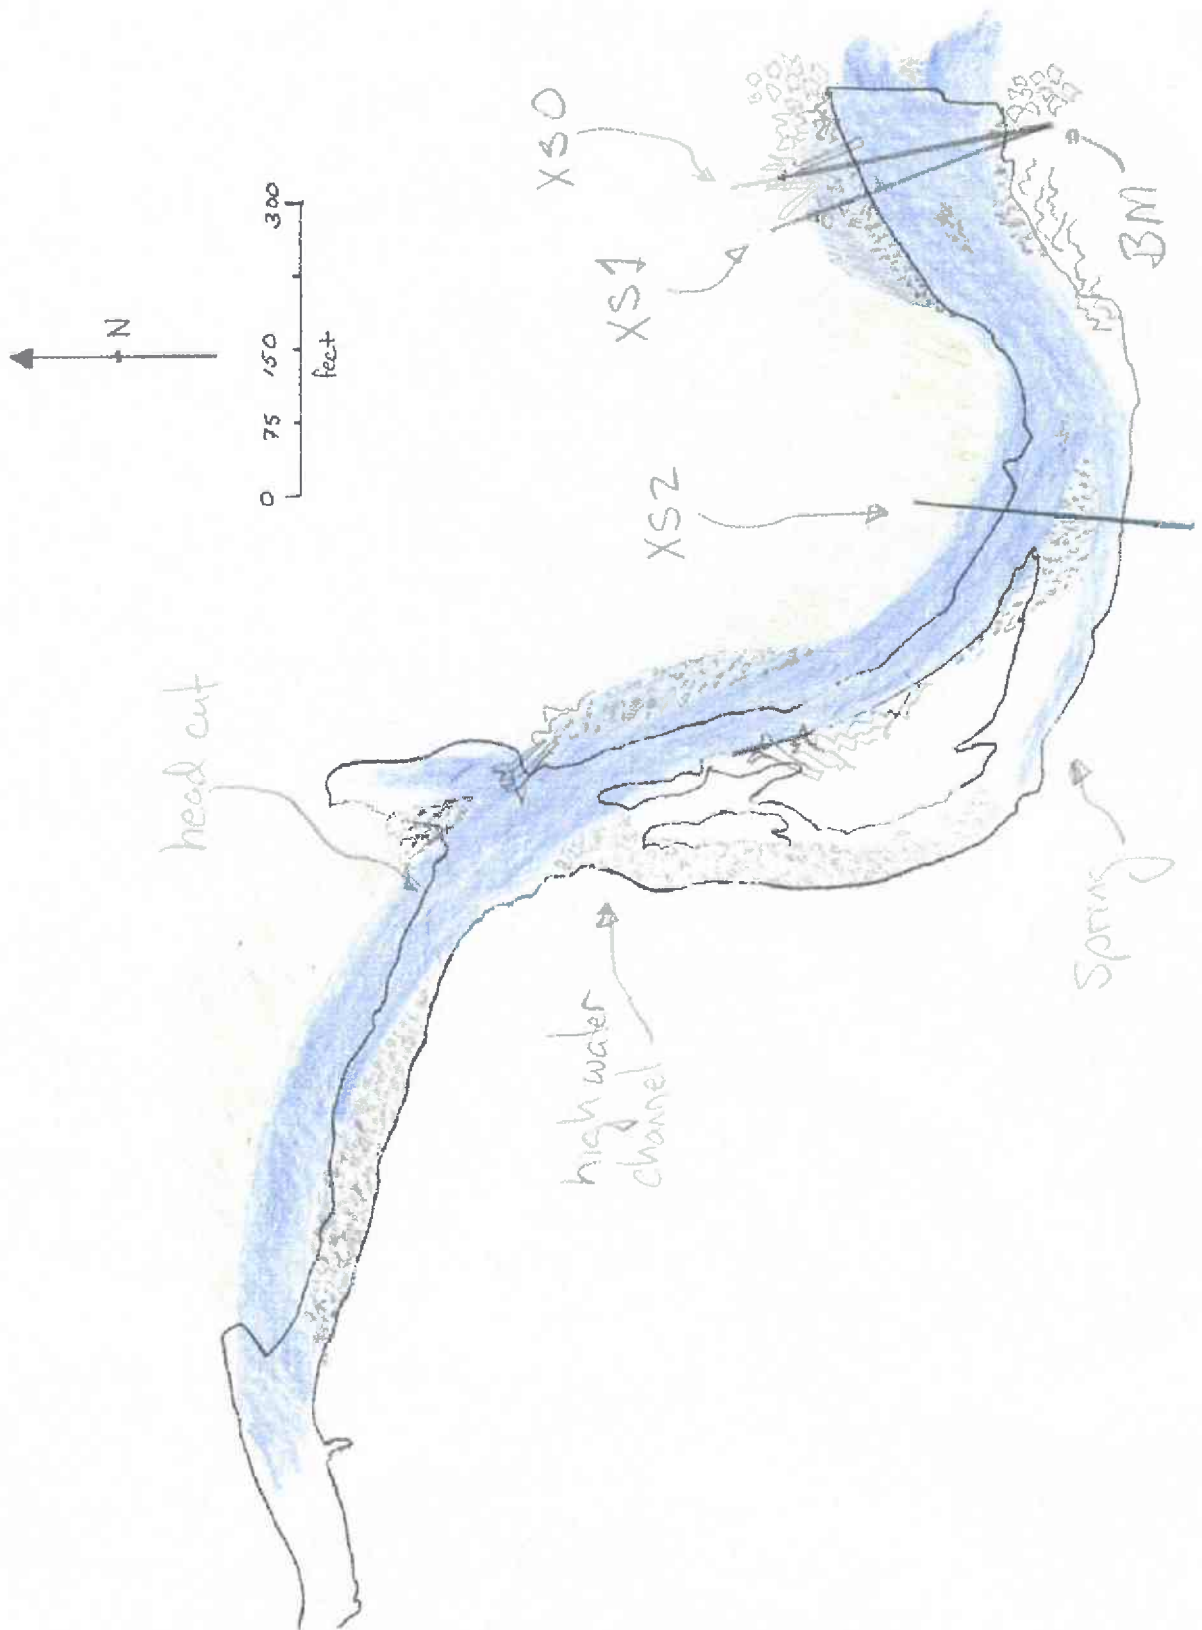
Figure 7: Sketch Map of Study Site

Figure 7 presents a sketch map of the study site overlain on a tracing of Saeltzer Dam and its reservoir. We have indicated on this figure the locations of our two cross sections as well as a corresponding cross section from May 2001. The cross section collected by Stillwater is labeled cross section #0 (or XS#0). Our cross sections are labeled, XS#1, and XS#2. The approximate location of the channel and adjacent features (e.g. sediment deposits, large woody debris, bedrock outcrops and rip rap) are indicated on the map. We were unable to include bed features in the sketch map due to the high water level during our visit.

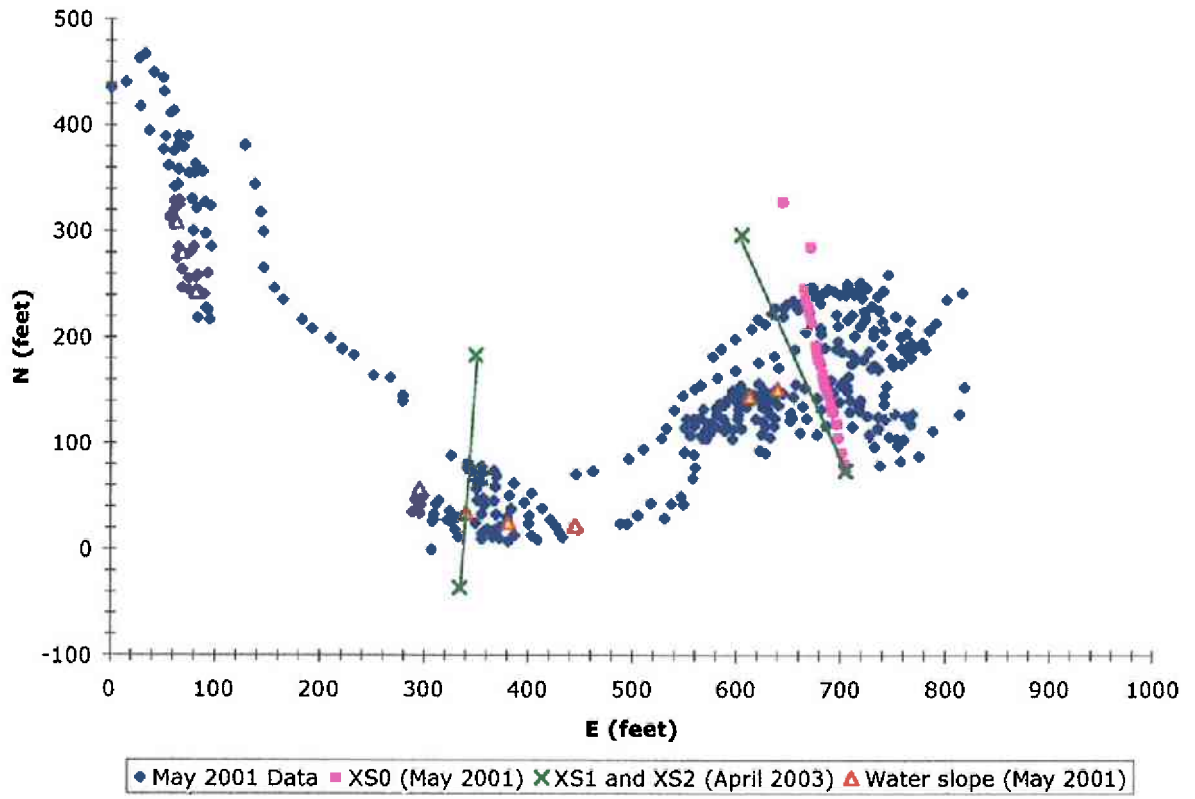
Figure 9: Layout of Data for Study Site

Evidence for this finding comes, in part, from a comparison of a cross section we surveyed (XS#1) with a cross section surveyed in May 2001(XS#0) by Stillwater Sciences, six months after the dam was removed. The locations of these two cross sections are indicated on Figure 9. As can be seen, XS#1 and XS#0 are slightly offset.<sup>2</sup> However, we believe that the two cross sections are close enough to provide a clear indication of the extent of the changes that have occurred. The two cross sections are plotted in Figure 10. This figure shows erosion of the left bank of approximately 60 feet but with little change in the right bank topography.

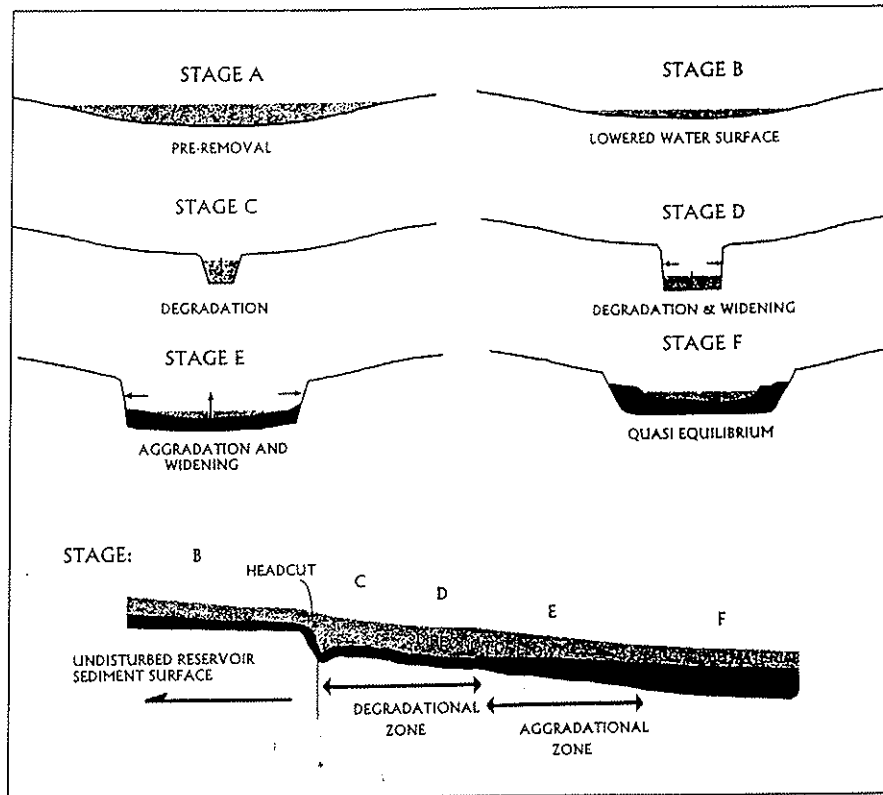
Figure 15: Generalized Pattern of Geomorphic Change Following Removal of a Dam

Figure 15 identifies a series of geomorphic processes that may occur following removal of a dam. (Stanley and Doyle 2002; see also Pizzuto 2002) Prior to dam removal, the reach is characterized by high, slow water and deep sediment deposits. Following dam removal, the reach proceeds through degradation (incision), widening (bank erosion), and aggradation (through bank collapse and deposition), as it moves toward a state of quasi-equilibrium in which the depth and width of the channel are relatively constant and erosion is greatly reduced. This series of changes occurs both at a
