Using neutrons to fight forest fires

USING NEUTRONS TO FIGHT FOREST FIRES

Hal Egbert, Ronald Walker, R. Flocchini

THE UNIVERSITY OF CALIFORNIA, DAVIS- MCCLELLAN NUCLEAR RADIATION CENTER
MCCLELLAN, CALIFORNIA, USA

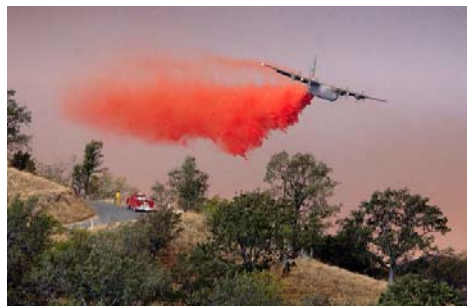
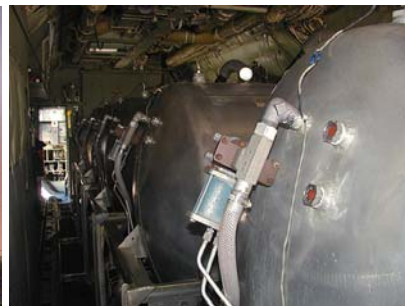
The United States Forest Service uses MAFFS in Air National Guard C-130 aircraft to deliver fire retardant to the scene of forest fires.

MAFFS is the acronym for the entire unit containing the components to deliver the fire retardant. Failure of a tank or component of the system could be costly. There could be a very high cost of cleanup or worse, loss of life or aircraft. The retardant is very corrosive, requiring fresh water rinsing following use. Inside the aircraft, it would not be a simple hose down. These systems have been in use since the early '70's. There have been some minor to major failures. The USFS wants to minimize the failures. DynCorp International won the contract to upgrade, repair, and certify the MAFFS for five years.
