Report of Field Site Visit District 3, Sacramento Interstate 5, PM 17.2-17.9 RAC-O Overlay

**Report of Field Site Visit  
District 3, Sacramento  
Interstate 5, PM 17.2-17.9  
RAC-O Overlay**

**Technical Memorandum TM-UCB-PRC-2005-7**

June 2005

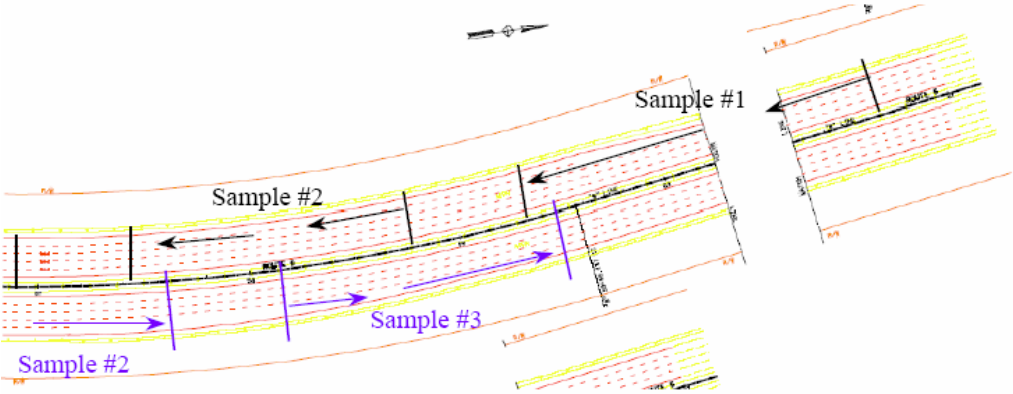
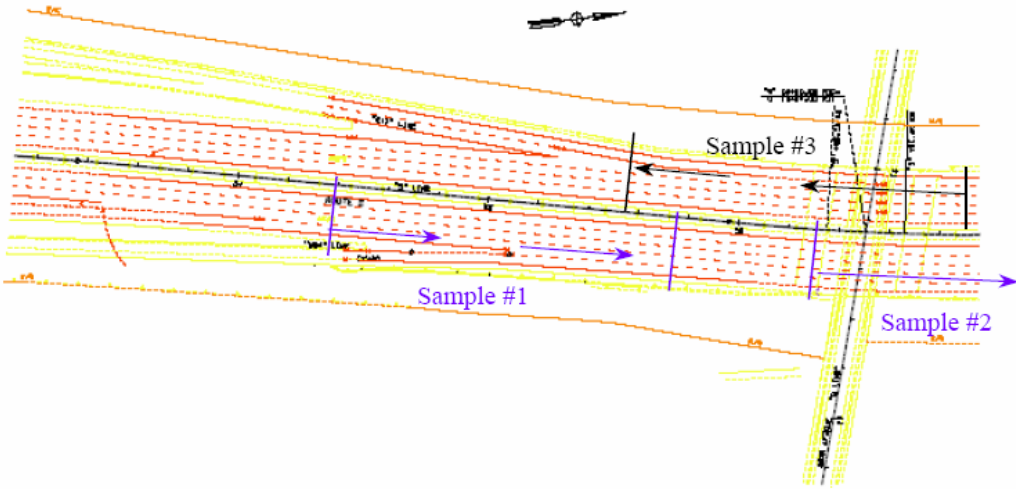
Figure 1. Caltrans Environmental Division noise measurement sections.

According to a slide in a PowerPoint presentation prepared by Caltrans Environmental (Figure 1), noise measurements were conducted on the section by Caltrans Environmental between approximately Station 55+40 and Station 60+80 on the southbound lanes and between Station 54+40 and Station 59+60 on the northbound lanes. According to the presentation sent to the Pavement Research Center (PRC) by Caltrans Environmental (Figure 1), both the northbound and southbound directions were divided into three segments of roughly equal lengths (exact stationing of measurements cannot be read from the presentation) and noise levels were obtained for each segment. The total distance over which noise measurements were made for each direction, as approximately read from the presentation, are shown in Figure 2 against the total length of the project. Measurements were repeated three times for each segment to account for measurement errors. According to the presentation, the segments are separated by gaps.

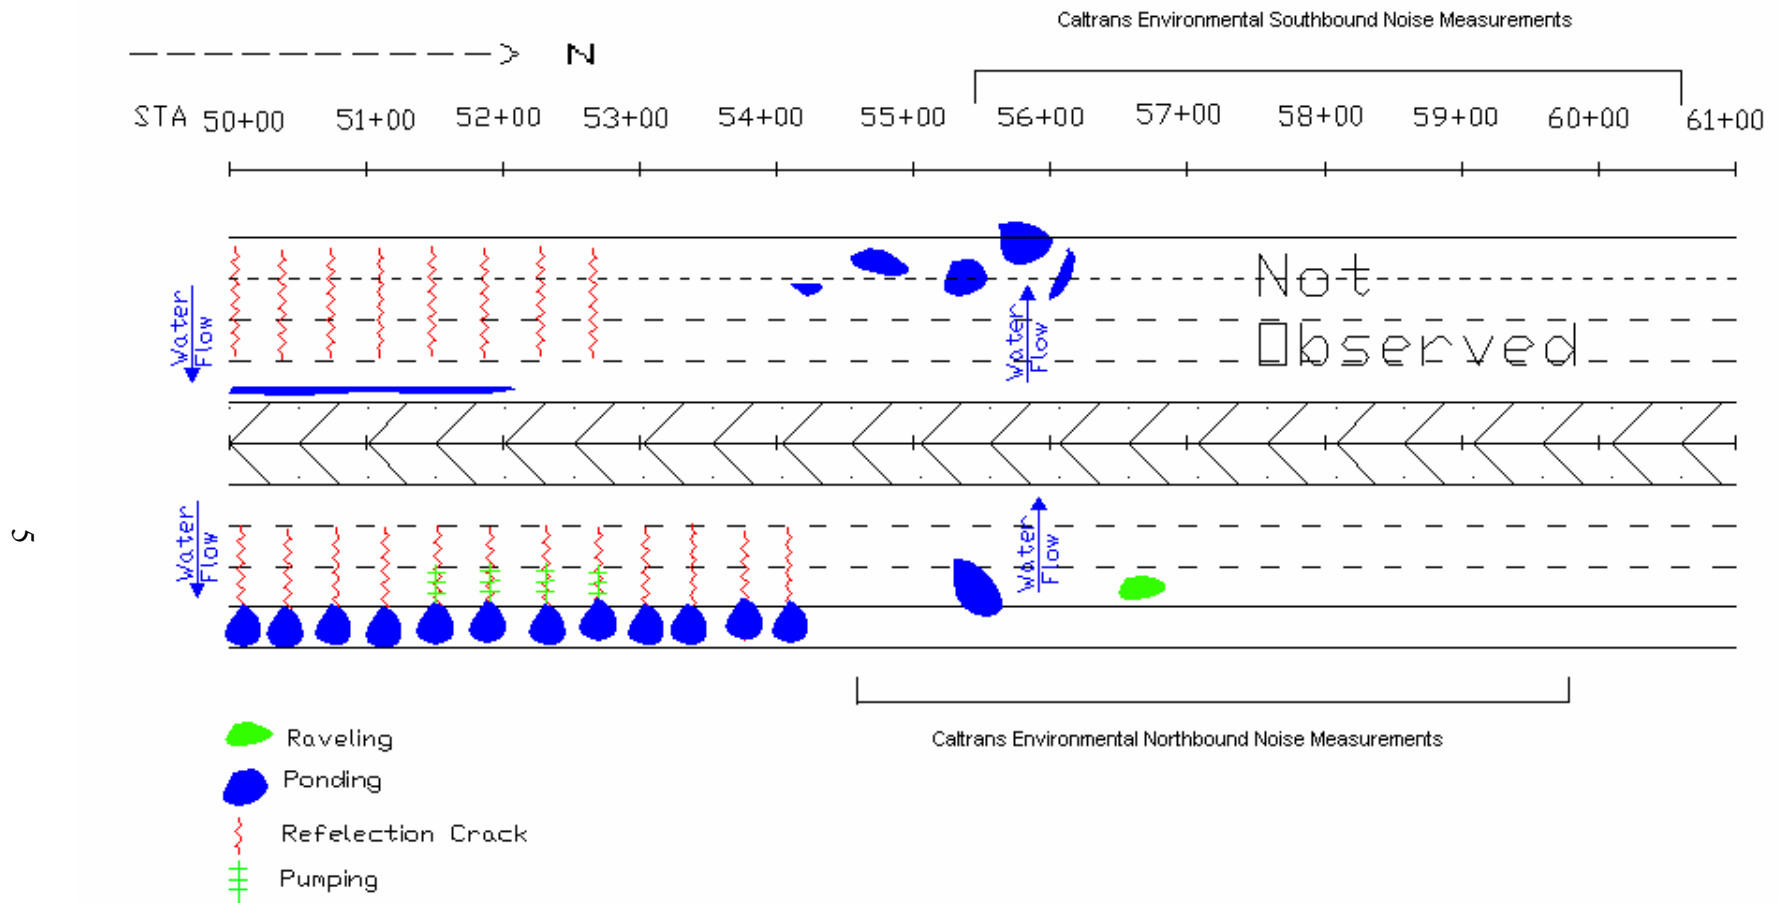
Ponding was present in the same locations as the reflection cracking. Water flowed easterly (from outside to inside lanes) on the southern portion of the project as shown in Figure 2. Moving northward against traffic in the southbound lane, the section climbs a mild hill, and then descends and the super-elevation reverses in the middle of the section, with water in the northern part of the southbound direction flowing westerly (from inside to outside lanes). Figures 7 through 12 show the pavement and ponding on the southbound direction of the site as the viewer progresses against traffic.

**Figure 2. Plan of the section and the distresses (from Caltrans Environmental).**

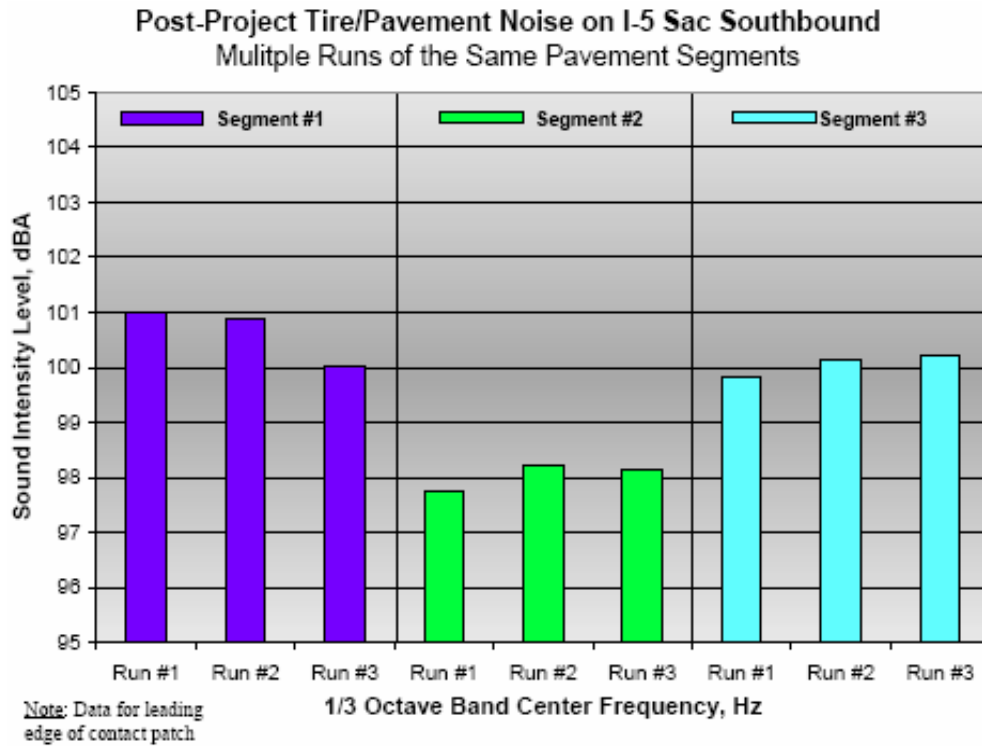
PRC evaluation of the results presented in the Caltrans Environmental presentation (Figures 3 and 4) indicate that the maximum difference within the southbound direction is about 3.5 dB, and the difference between the average north and southbound directions is less than 1.5 dB. Verbal communication with Caltrans Environmental indicated that all sound intensity measurements were taken in the outside lane.

**Figure 3. Tire pavement noise on I-5 Sacramento southbound (from Caltrans Environmental presentation).**

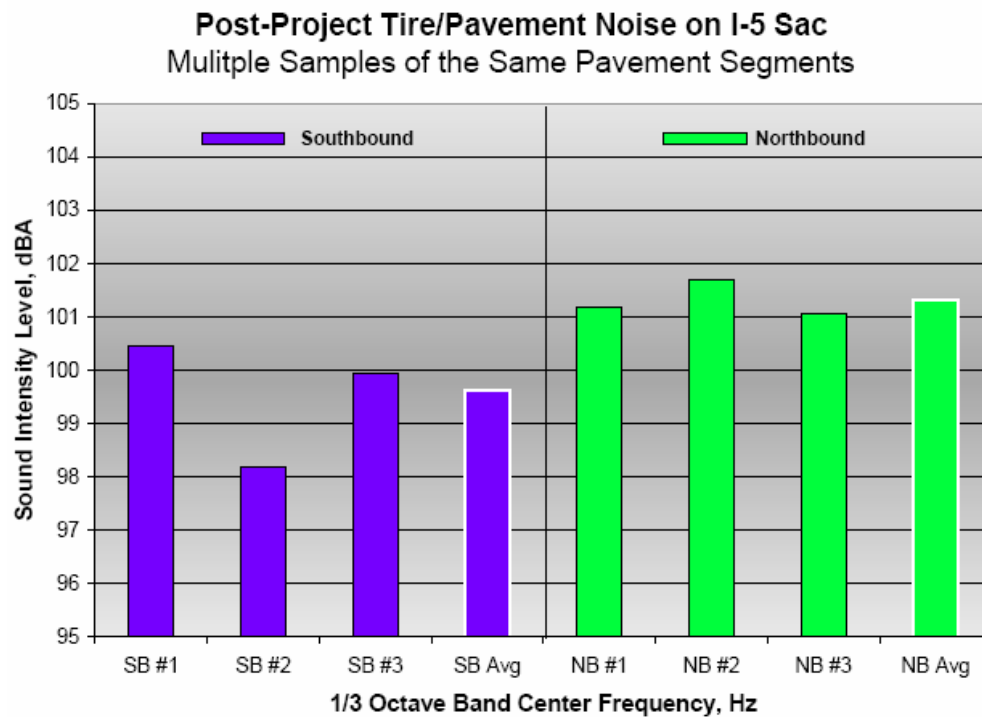
**Figure 4. Tire pavement noise on I-5 Sacramento southbound and northbound (from Caltrans Environment presentation).**
