EXTENDED FLATTOP OPERATION OF EEVATRON RESULTS FROM STUDIES OF GENERATOR DOVETAIL FAILURE

UCRL-18779

W. W. Salsig and H. W. Vogel

February 20, 1969

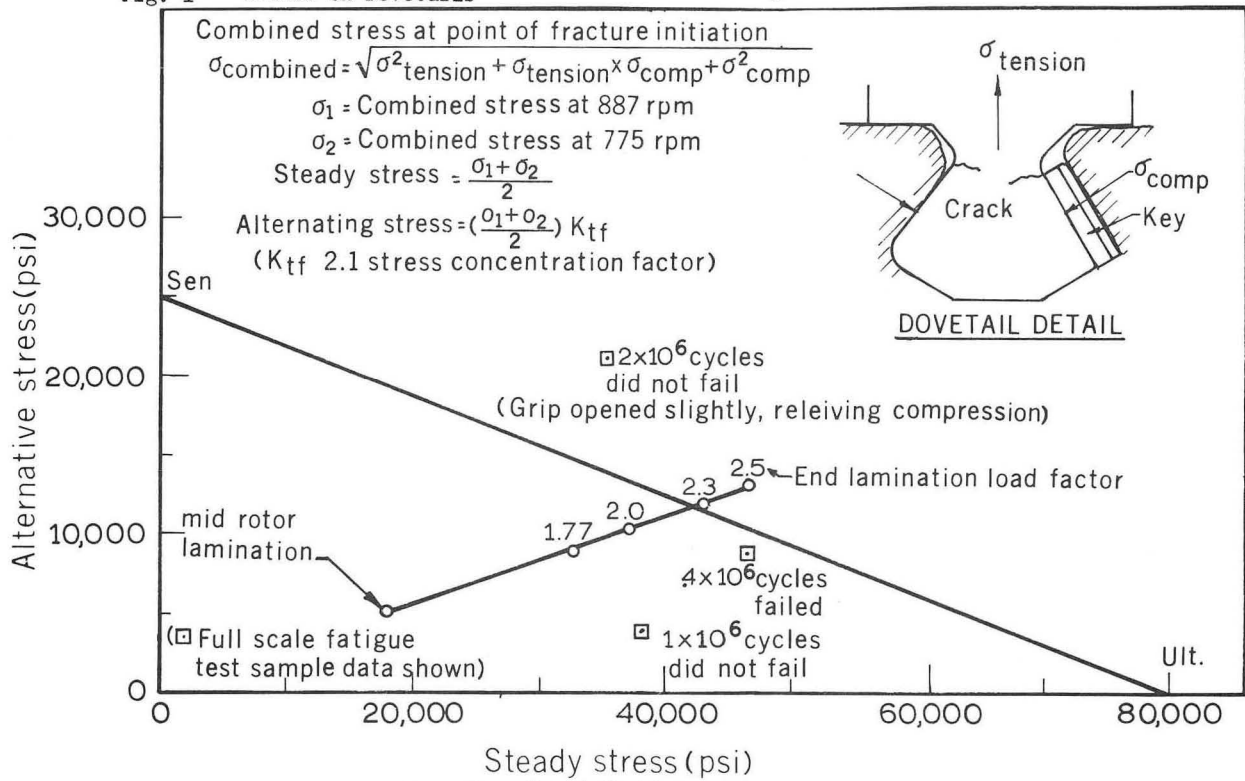
Fig. 2 Extent of Dovetail Cracks

Dovetail Neck Cracks and Fractures

During the first 10 months of operation with the new poles, five new cracks were observed on end laminations. Their growth was carefully watched, and eventually small holes were drilled at the ends to stop further propagation. As long as the cracks were confined to the first one or two laminations it was presumed that their initiation could be attributed to load-relieving mechanisms peculiar to the poorly restrained end faces. However, after 10 months and 1.9 million pulses, another crack generated and progressed rapidly (1 week) into the 3rd and 4th laminations. Drilling holes to stop propagation had little effect. The cracking finally reached the 9th lamination. At this juncture the speed range due to flattopping was again restricted, as shown in Table I. No further propagation of existing cracks was observed and no new cracks were initiated in the next two months. At this time the new mode of flattopping described in the following sections was introduced. Flattop of 0.6-s showed generator speed change of 40 rpm--less than that for full-energy pulsing. Speed change for 2-s flattops is comparable to that for full-energy pulsing. No further crack initiation or propagation has been observed. At some future scheduled shutdown the pole with defects through the 9th lamination should be exchanged for an existing spare. Thereafter, with care, further increases in flattop time or energy should be permissible, provided generator speed change is
