Blackberry Creek Daylighting Project, Berkeley : Ten-Year Post-Project Appraisal

Blackberry Creek Daylighting Project, Berkeley: Ten-Year Post-Project Appraisal

By Stephanie Gerson, Jane Wardani, and Shiva Niazi

Landscape Architecture 227, Fall 2005, Professor Matt Kondolf

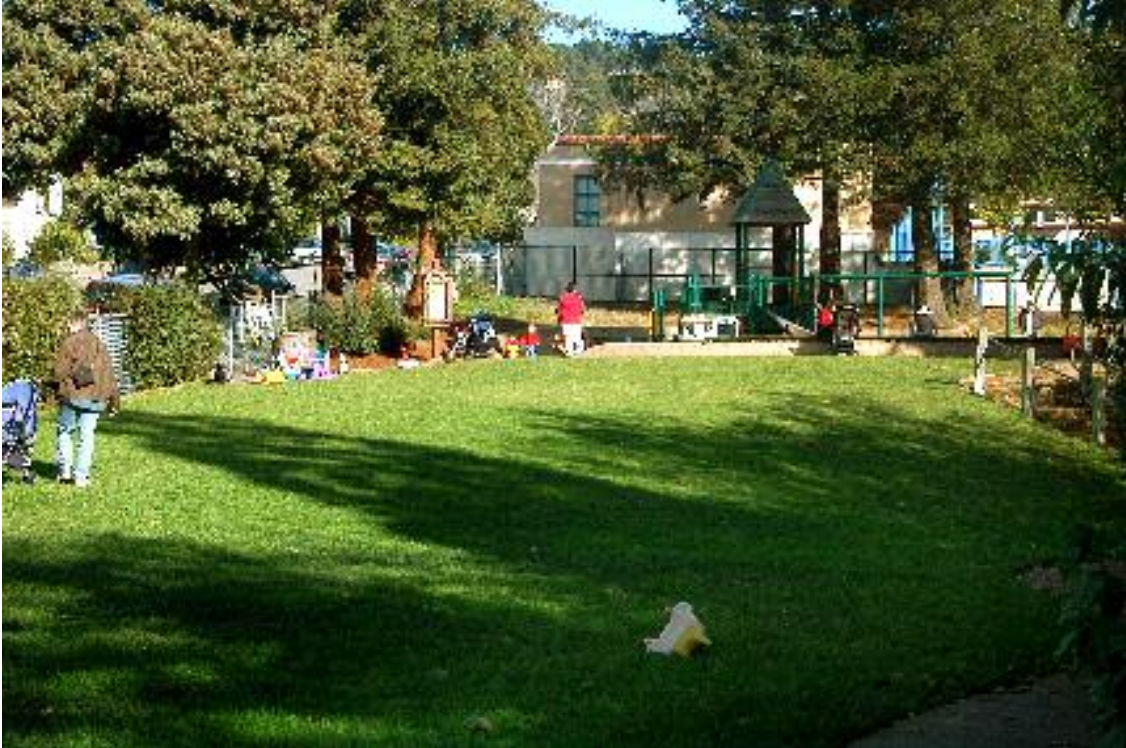
Figure 3: Tot Lot (viewed from west end of park, creek at bottom of stairs to the right). Note school buildings in the background; Dec 2005.
