Blackberry Creek Daylighting Project, Berkeley: Ten-Year Post-Project Appraisal

By Stephanie Gerson, Jane Wardani, and Shiva Niazi

Landscape Architecture 227, Fall 2005, Professor Matt Kondolf

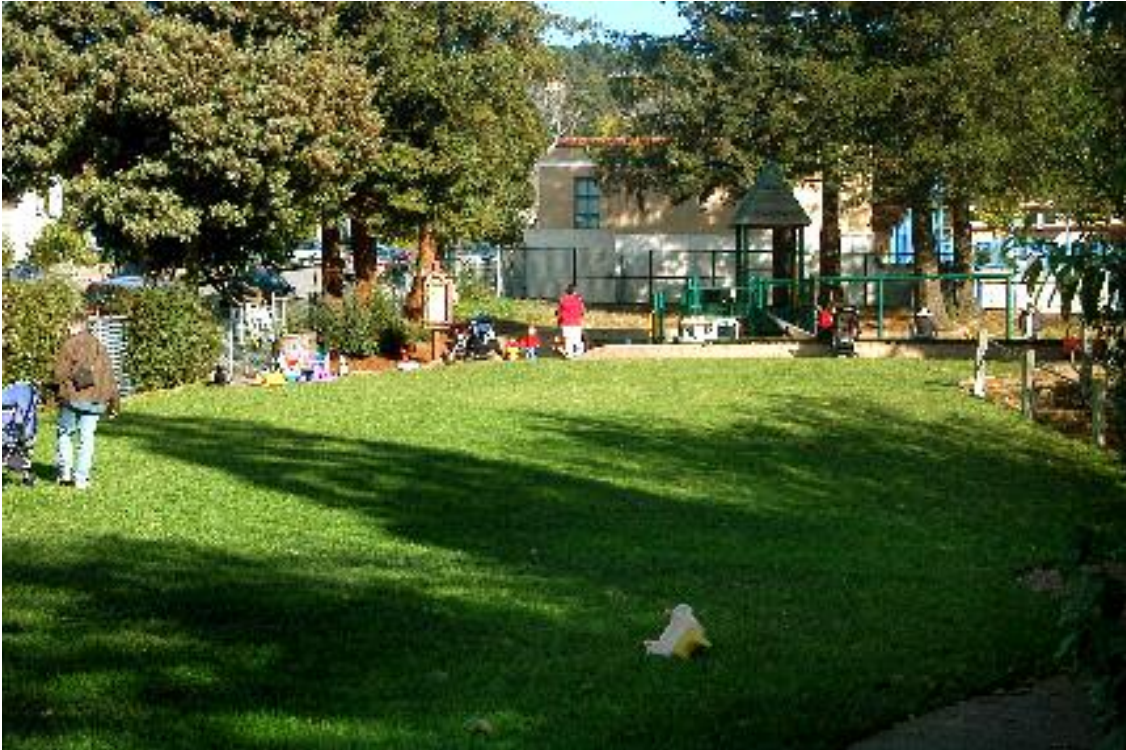
because it was the meditation tree of a local Tai Chi group and shortening the reach of the creek from the 250 feet that was originally planned (Askew, 1996). Also, the daylighting entailed the removal of a widely used tot lot (see Figures 3 and 4), and due to objections by community members, the Thousand Oaks school board mandated that \$25,000 of the CDWR grant be allocated towards constructing a new one (Bronstein, personal communication, 2005).

Figure 3: Tot Lot (viewed from west end of park, creek at bottom of stairs to the right). Note school buildings in the background; Dec 2005.

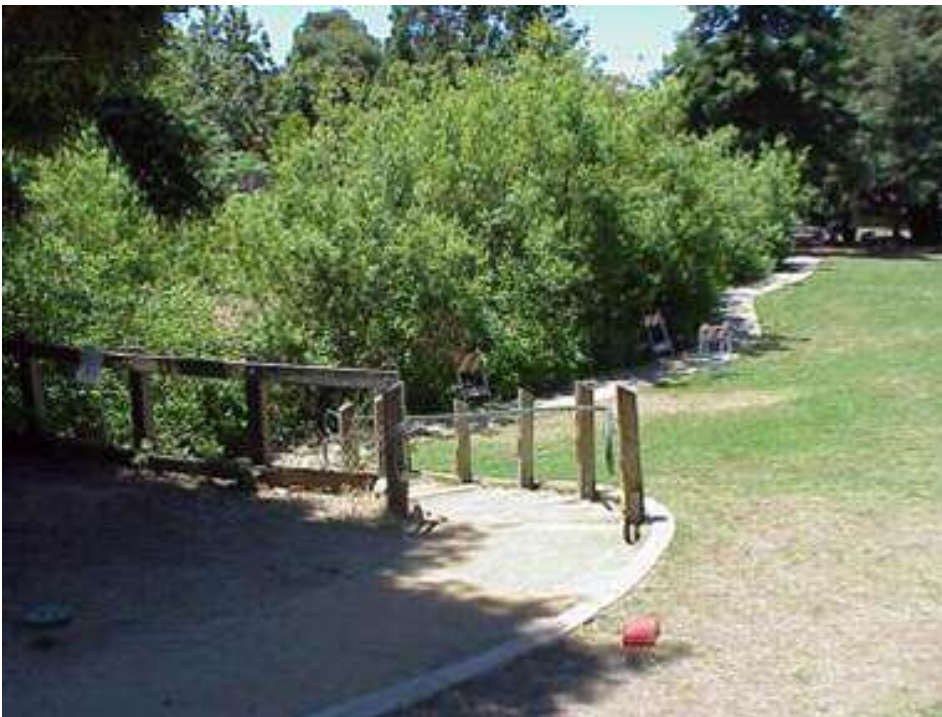
Figure 4: View of Blackberry Creek from tot lot area; 2001
Source: <http://www.acme.com/jef/creeks/blackberry/>
