Case study field evaluation of a systems approach to retrofitting a residential HVAC system

# Case Study Field Evaluation of a Systems Approach to Retrofitting a Residential HVAC System

Iain Walker, Jennifer McWilliams and Steven Konopacki  
Energy Performance of Buildings Group  
Lawrence Berkeley National Laboratory  
Berkeley, California 94720

September 2003

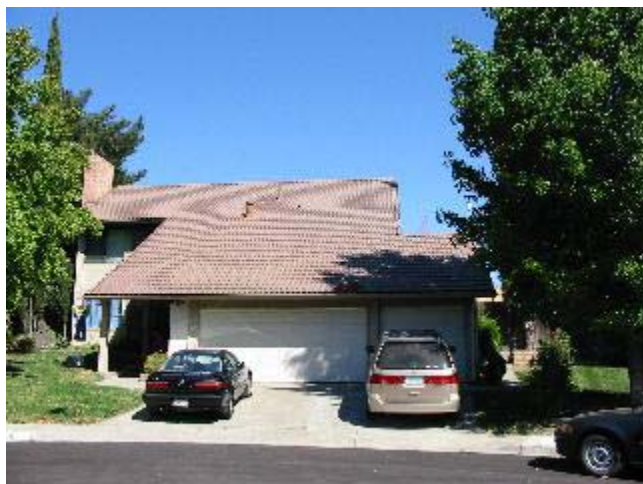
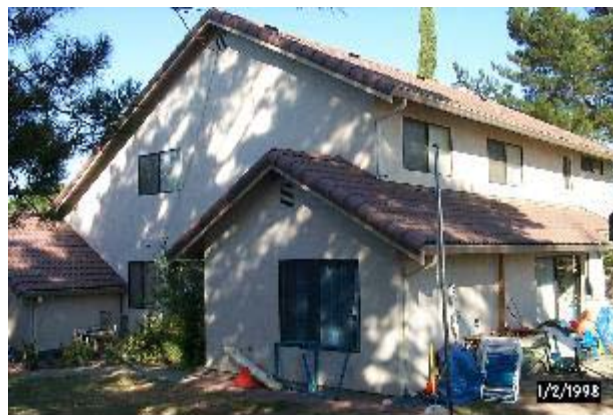
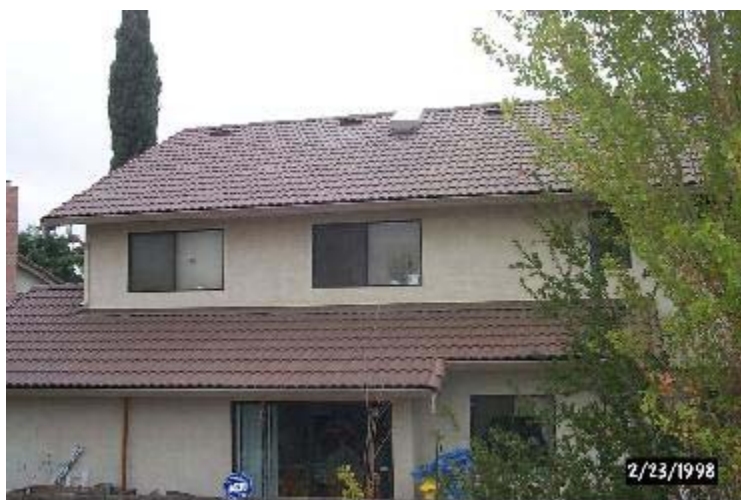
**Figure 2(a). Exterior front view of Concord test residence.**

**Figure 2(b). Exterior side view of Concord test residence showing gable attic vents and existing outside AC condenser unit placement [lower left].**

**Figure 2(c). Exterior rear view of Concord test residence.**

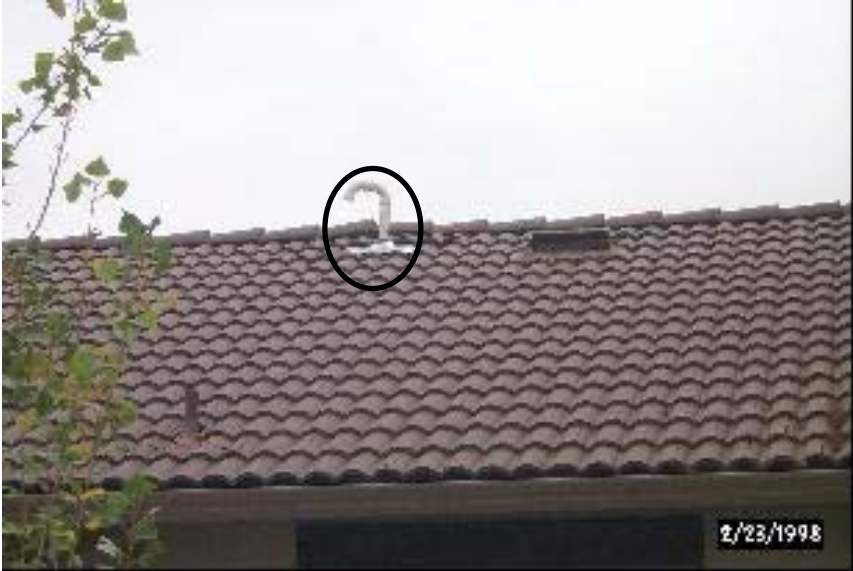
**Figure 9. Installed roof mounted furnace flue pipe.**

is designed to draw combustion air from the outside; however it was installed to draw combustion air from the attic. The furnace flue pipe was installed through the roof as shown in **Figure 9**. The air handler is equipped with a General Electric ECM (Electronically Commutated Motor) (2.3 Series). These motors are advertised to be 20% more efficient than a standard motor at full load and 30% more efficient at low speed. The DC design allows the fan speed to be easily adjusted over a large continuous range of speeds. The new system used a control strategy that slowly increased the air handler speed at the beginning of each cycle. Another advantage of these motors is that the torque does not change much with an increase in load so the fan is able to overcome ductwork resistance, and deliver a given airflow regardless of duct restriction.

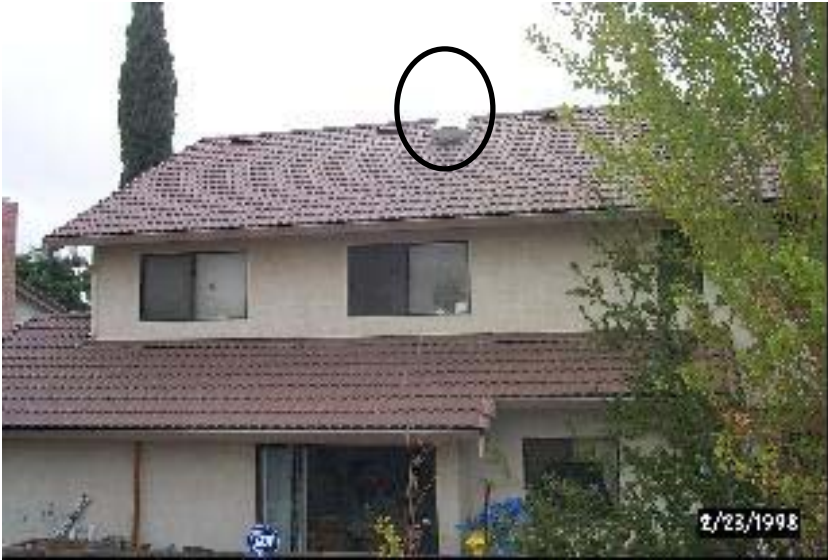
**Figure 10. Installed roof mounted economizer vent.**

6. Installed “Smart Vent” (fresh air ventilation controller model SV10) temperature-controlled economizer in attic (through the roof – the economizer roof-vent is shown in **Figure 10**). The economizer monitors indoor and outdoor temperatures. When the set temperature difference is met the fan is turned on and a vent damper is activated allowing filtered outside air to cool the house. The damper for the fresh air inlet was located in the upper hallway return. The damper was designed so that when it opens the outdoor air inlet, it automatically closes the return air pathway through the upper hallway return grille. Another damper was installed in the return duct from the downstairs part of the house to close off this return air pathway when the fresh air inlet opens. A pressure relief damper also opens (to the attic) during economizer operation to prevent pressurization of the house. The economizer has 3 settings: On, Off, and Auto. *On* means the outside vent opens and the air handler fan turns on (in "fan on" mode), independent of what the inside and outside conditions are. *Off* means the vent closes and the air-handler fan is controlled by the zone thermostats. *Auto* means that the vent will open if the outdoor temp is 4°C (8°F) lower than indoor temperature, and if the smart vent thermostat setpoint is at least 0.5°C (1°F) lower than the indoor temperature (measured at the return). To adjust the indoor/outdoor differential condition (factory set at 4°C (8°F)) the rheostats in the control box in the attic can be adjusted. When the outside air is cooler than the indoor air (usually at night or in shoulder season), the economizer will use the air outside to cool the house. The conditions for the economizer to operate are that the house temperature has to be 2°C (4°F) greater than the outside temperature and that the economizer must turn off if the indoor temperature drops to 17°C (62.6°F).

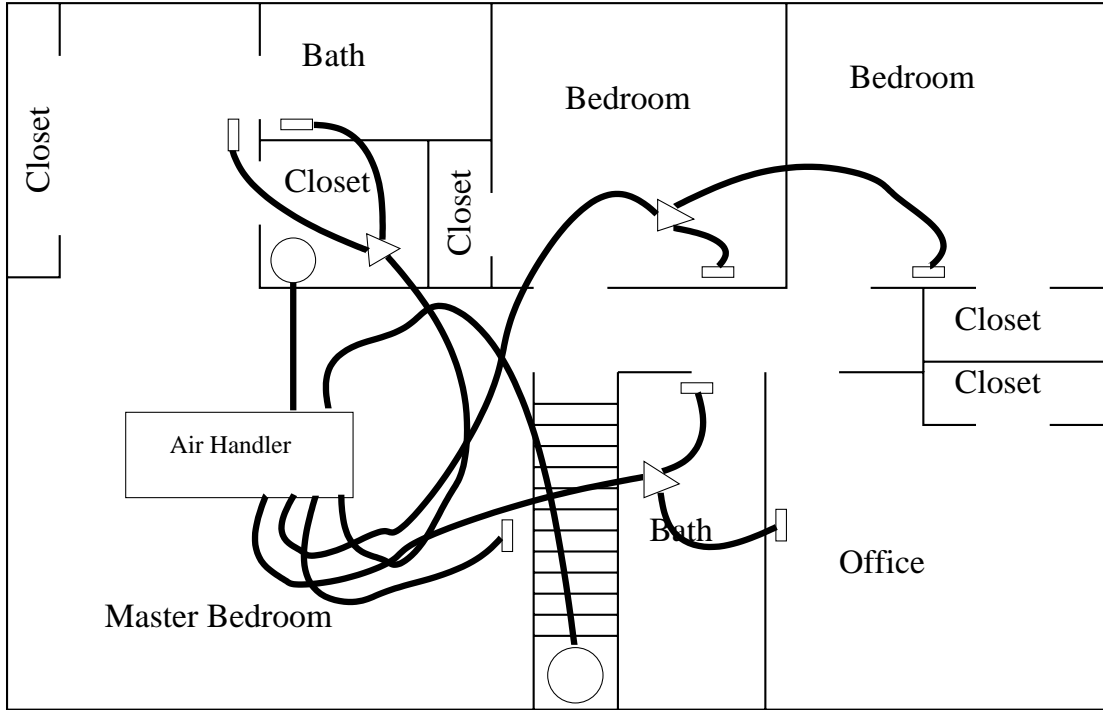
**Figure 11. Retrofit duct schematic of case study residence. Changes were only made to the upper level ducts. The return was modified as well, and is not shown.**
