Early post-restoration re-vegetation performance and critical social and institutional factors in a landowner-involved restoration project on lower Wooden Valley Creek, Napa County, CA

LA227: Restoration of Rivers and Streams, Term Project; Fall, 2010

Morgan Levy and Charles Post

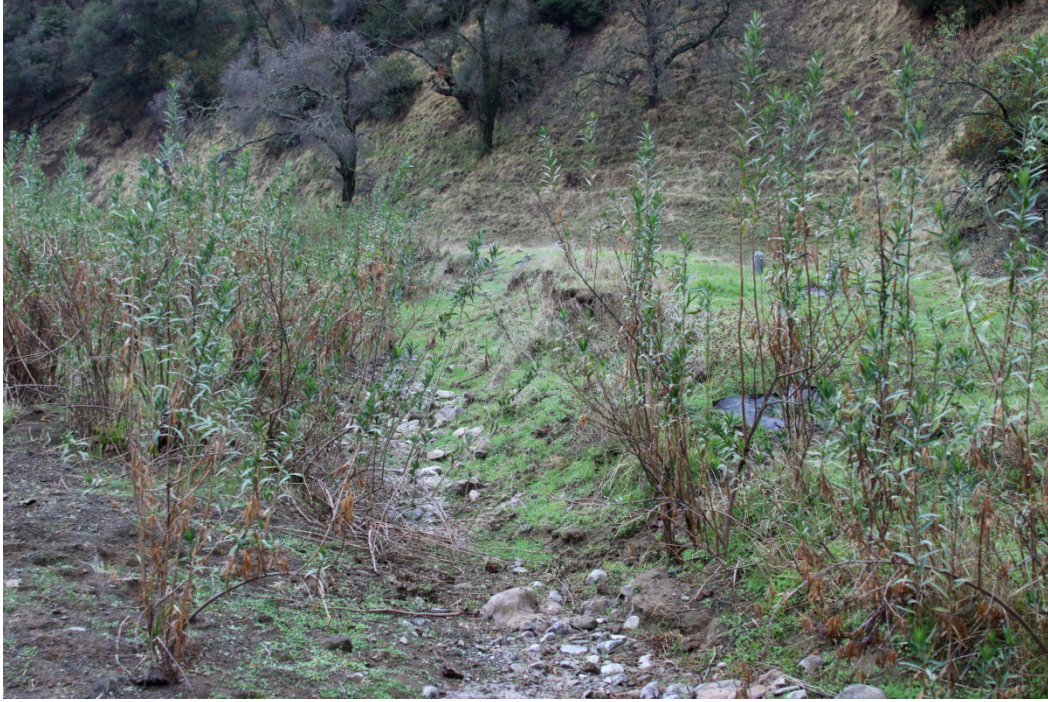
Image 3: looking north up eastern bank of lower Wooden Valley Creek along zone 14 of the McQueeney restoration site; plantings (along stream bank) on right of image.

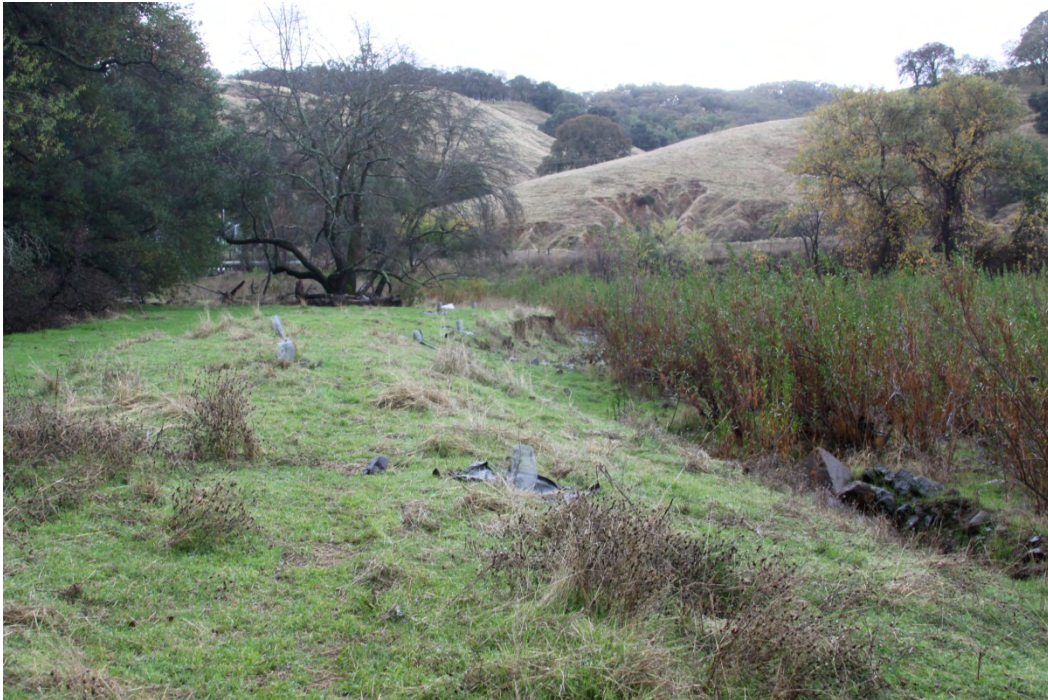
Image 4: looking south down eastern bank of lower Wooden Valley Creek along zone 14 of the McQueeney restoration site; plantings down center (along stream bank) of image.

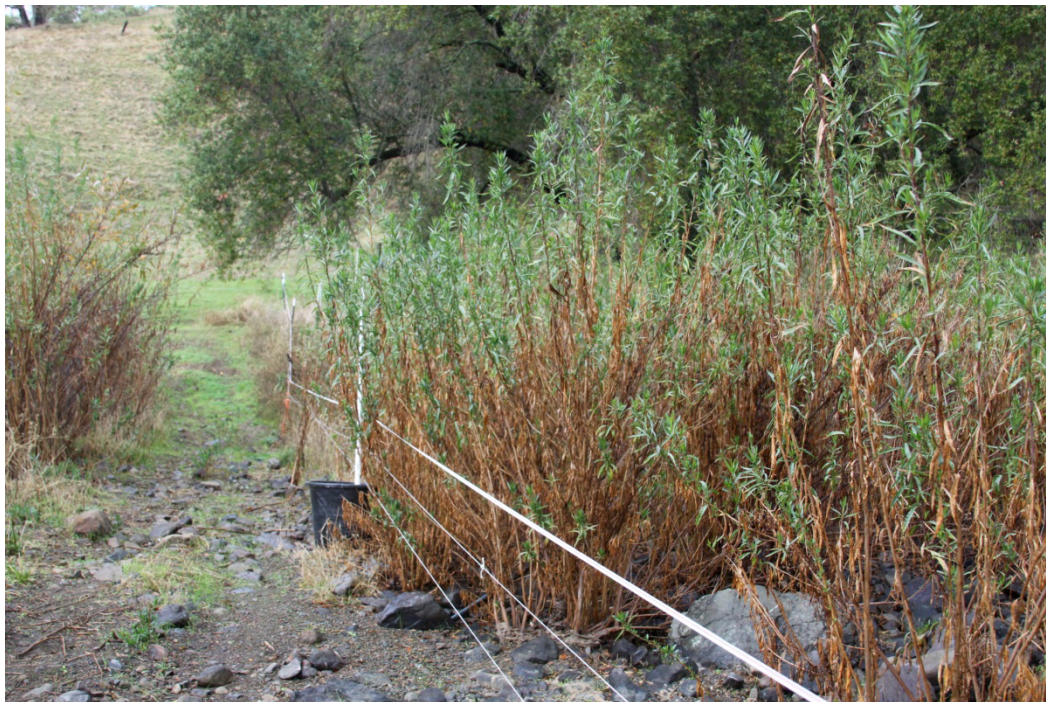
Image 16: See image 15. This is looking east across the same section of Lower Wooden Valley Creek on the McQueeney property.
