Evaluation of collapse and non-collapse of parallel bridges affected by liquefaction and lateral spreading.

EVALUATION OF COLLAPSE AND NON-COLLAPSE OF PARALLEL BRIDGES AFFECTED BY LIQUEFACTION AND LATERAL SPREADING

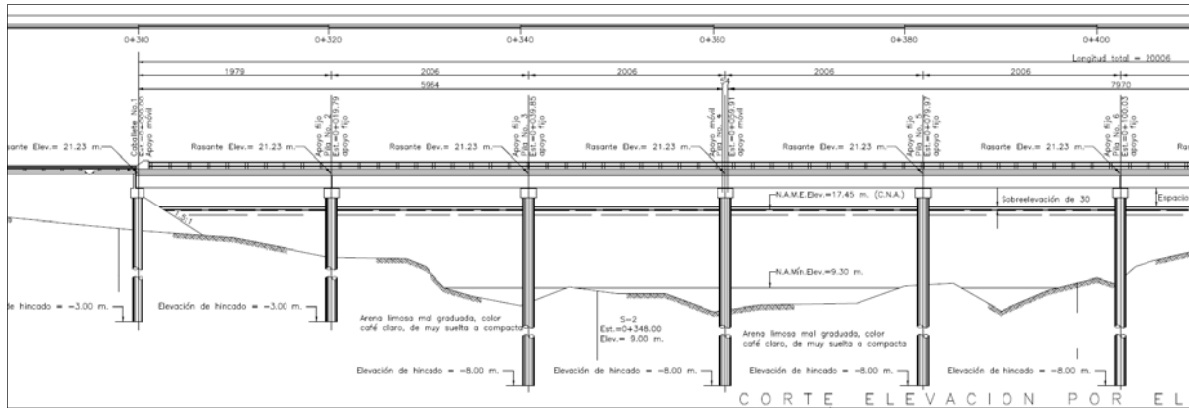
Figure 3: Western half of highway bridge, from original construction plans (SCT 1998).

The highway bridge consists of approach fills up to 6m thick leading to ten 20m-long simply-supported spans (Figure 3). Each span consists of seven precast-prestressed 1.15m-deep I-shaped girders spaced approximately 1.6m on-center in the transverse direction. Precast slab panels rest on the top flanges of adjacent girders, covered by a cast-in-place deck slab. The deck slabs are cast continuously across spans 1-2-3, 4-5-6-7, and 8-9-10, i.e. in three separate sections. The girders are supported on 60cm-wide concrete masonry plates on 1.6m-wide pier caps, which are in turn supported on four extended shaft columns. The elastomeric bearings are 20cm wide in the longitudinal direction.

Vertical diaphragms connect the ends of the girders in the transverse direction. A prestressing strand in the transverse direction passes through the diaphragms and ducts in the girder-ends across the entire 11m width of the bridge, forming a continuous member to provide lateral force resistance in the transverse direction.
