EVALUATION OF COLLAPSE AND NON-COLLAPSE OF PARALLEL BRIDGES AFFECTED BY LIQUEFACTION AND LATERAL SPREADING

Benjamin Turner¹⁾, Scott Brandenburg²⁾, and Jonathan Stewart³⁾

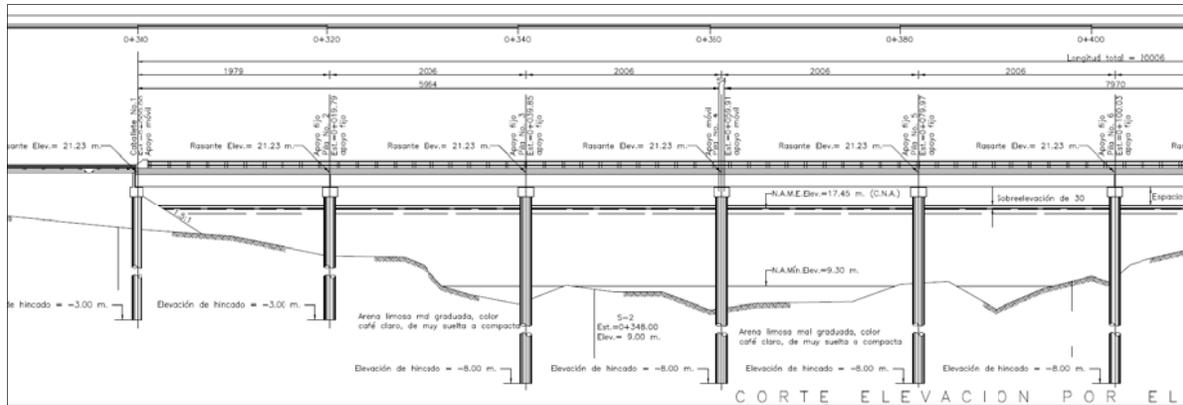
Figure 3: Western half of highway bridge, from original construction plans (SCT 1998).

The highway bridge consists of approach fills up to 6m thick leading to ten 20m-long simply-supported spans (Figure 3). Each span consists of seven precast-prestressed 1.15m-deep I-shaped girders spaced approximately 1.6m on-center in the transverse direction. Precast slab panels rest on the top flanges of adjacent girders, covered by a cast-in-place deck slab. The deck slabs are cast continuously across spans 1-2-3, 4-5-6-7, and 8-9-10, i.e. in three separate sections. The girders are supported on 60cm-wide concrete masonry plates on 1.6m-wide pier caps, which are in turn supported on four extended shaft columns. The elastomeric bearings are 20cm wide in the longitudinal direction.

Vertical diaphragms connect the ends of the girders in the transverse direction. A prestressing strand in the transverse direction passes through the diaphragms and ducts in the girder-ends across the entire 11m width of the bridge, forming a continuous member to provide lateral force resistance in the transverse direction.
