Post-project appraisal of the Sausal Creek restoration project, Oakland, California

POST-PROJECT APPRAISAL OF THE SAUSAL CREEK  
RESTORATION PROJECT, OAKLAND, CALIFORNIA

University of California  
Landscape Architecture 227  
Professor G. Mathias Kondolf  
Fall 2005

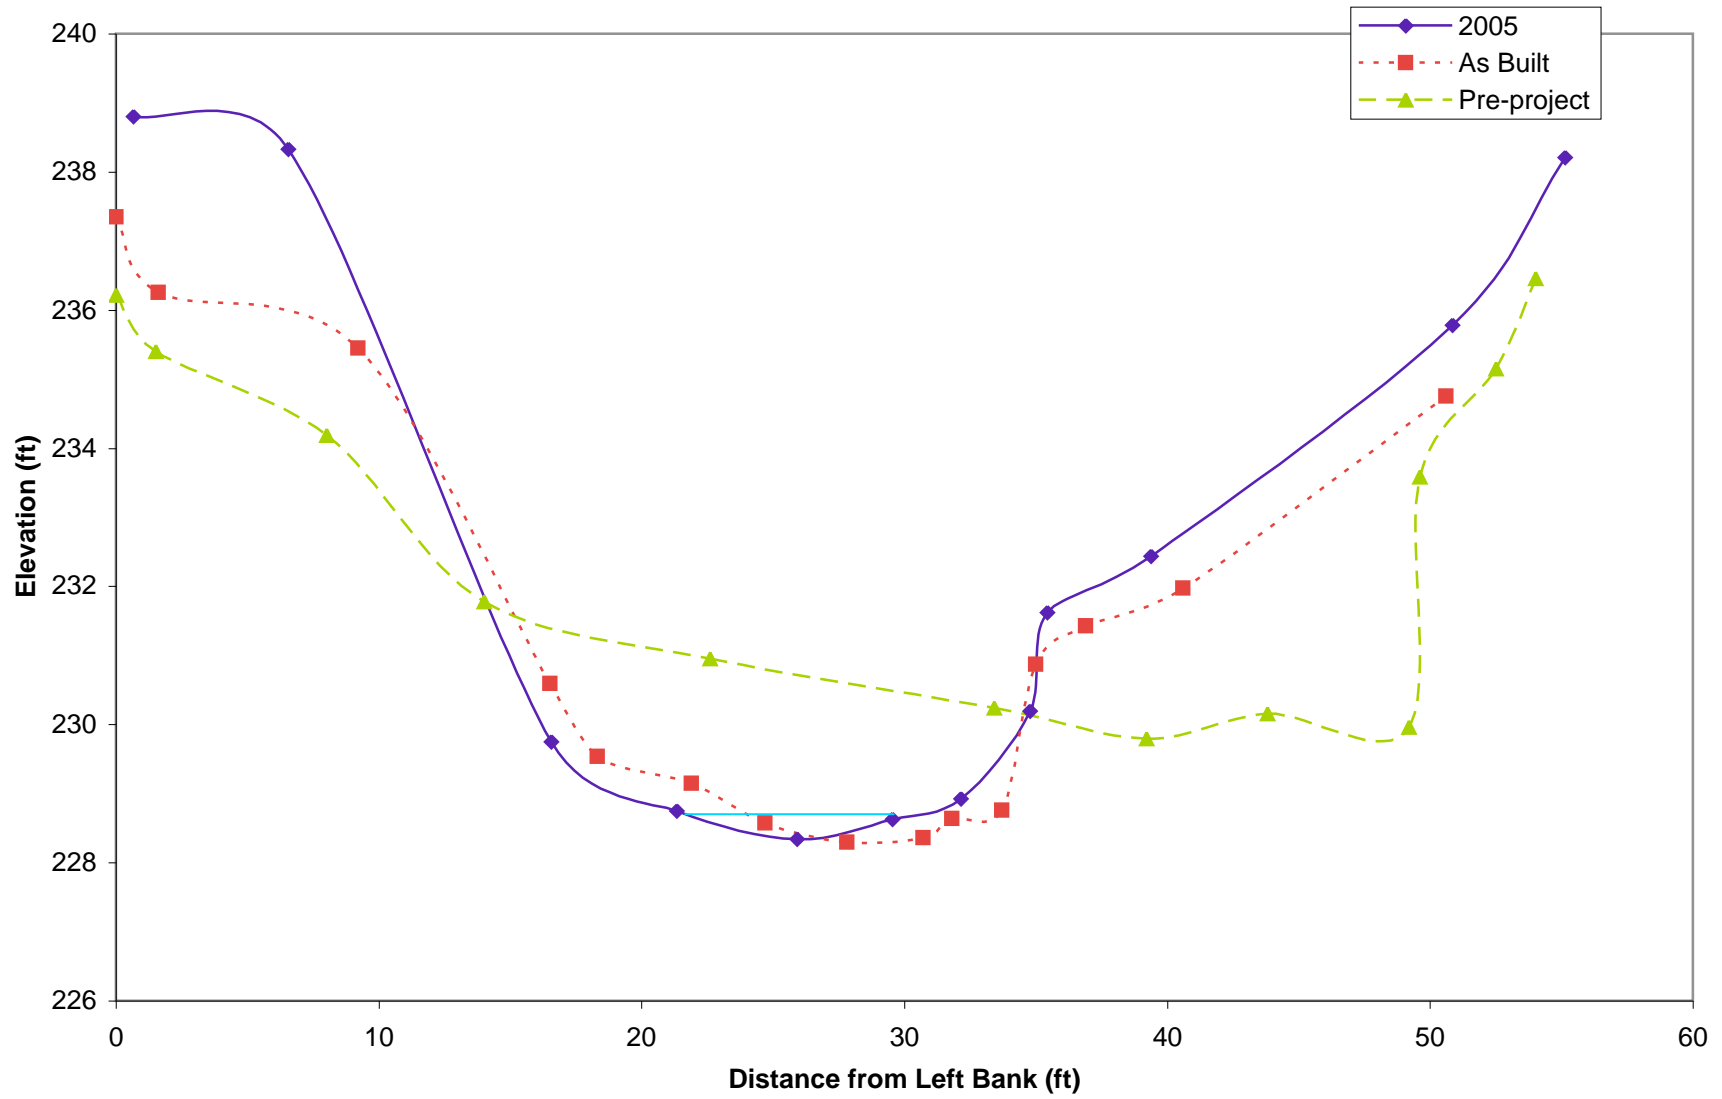
Figure 25: XS "I"

The as-built and current channel morphology at cross-section I (Figure 25) match up well except for the elevations at the trail, which probably have not changed. Other than this anomaly, the channel has remained stable and the thalweg has shifted slightly to the left.

Cross Section ID:	Location on 2005 LP	Observed Changes
A	683'	No as-built cross section
B	652'	Slightly incised channel, channel widened, deposition along edge of trail (from eroding hillside, dog trail),
C	584'	Slight channel incision, erosion along left bank, general same width.
D	514'	Channel stable, minor bank erosion and deposition
E	437'	Cross sections do not match up, inconclusive.
F	N.S.	Not surveyed
G	N.S.	Not surveyed
H	N.S.	Not surveyed
I	283'	Stable, slight shift to left of thalweg
J	234'	Stable
K	198'	No as-built cross section

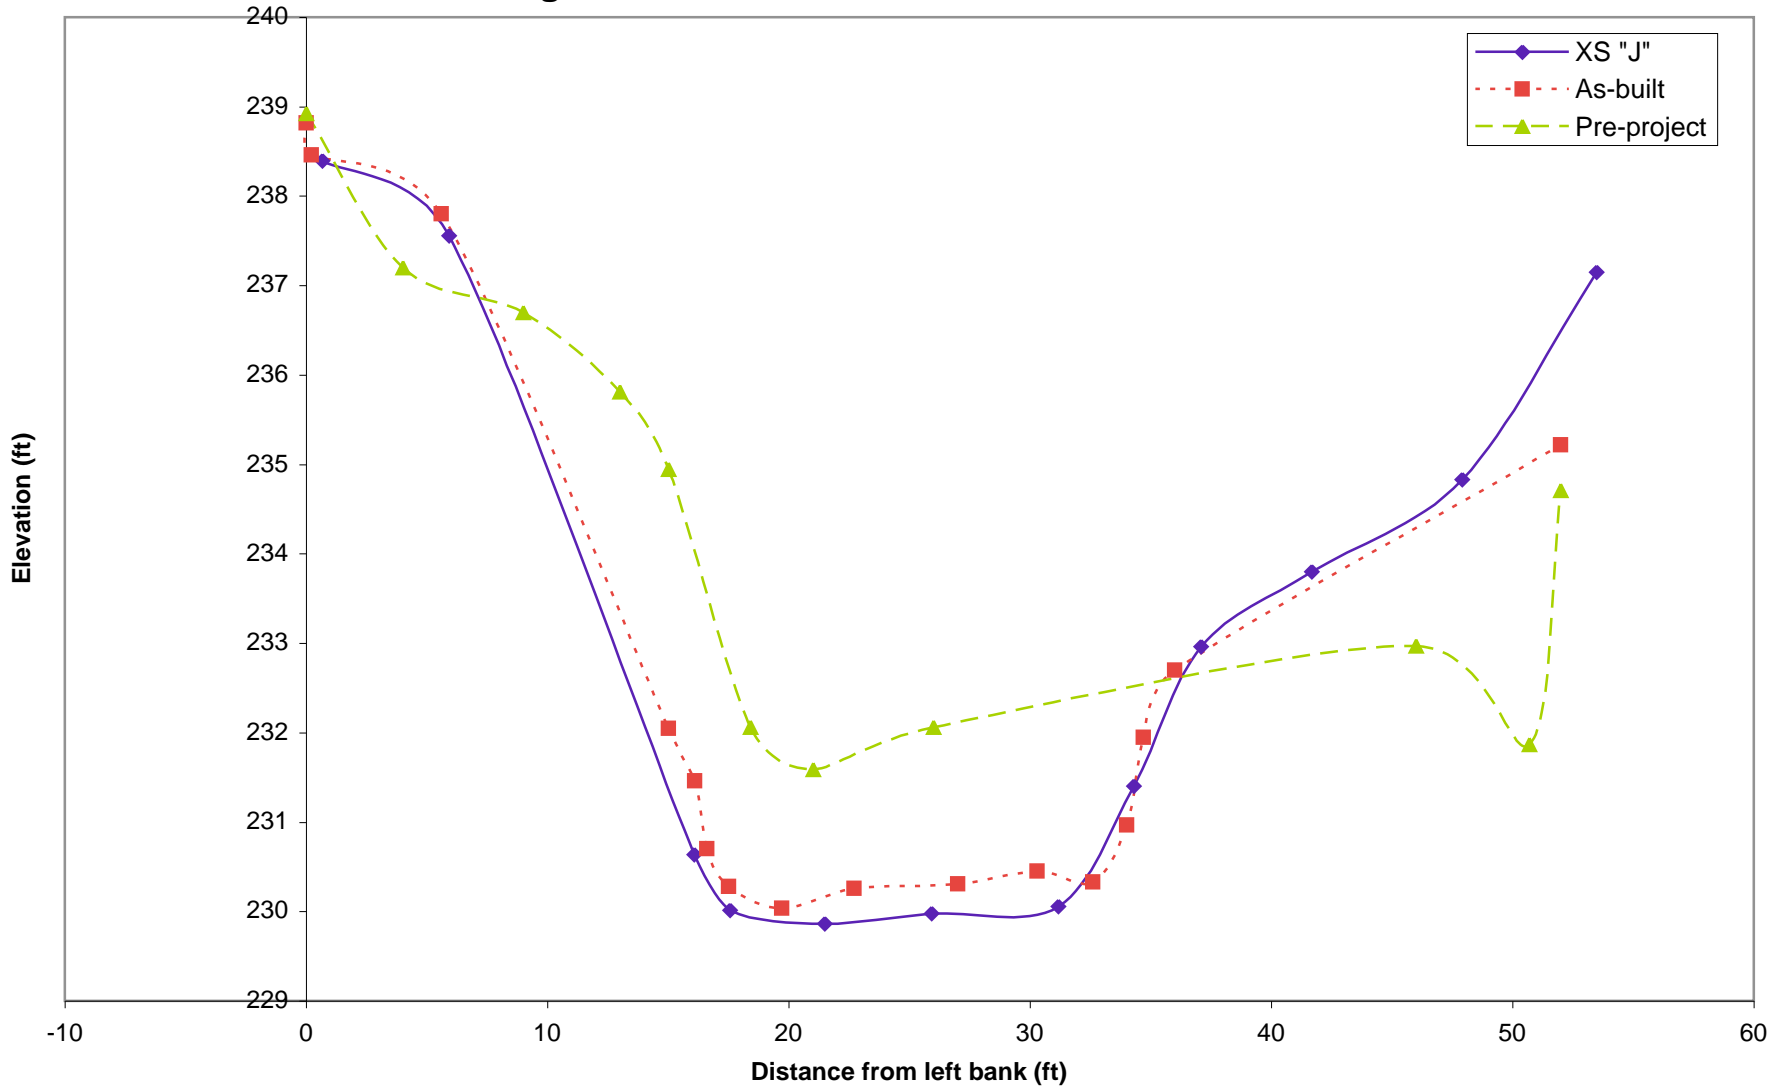
Figure 26: XS "J"

Cross-section J (Figure 26) indicates that the channel and banks are stable. There was no as-built data for cross-section K (Figure 27), so our survey provides baseline data for future surveys.

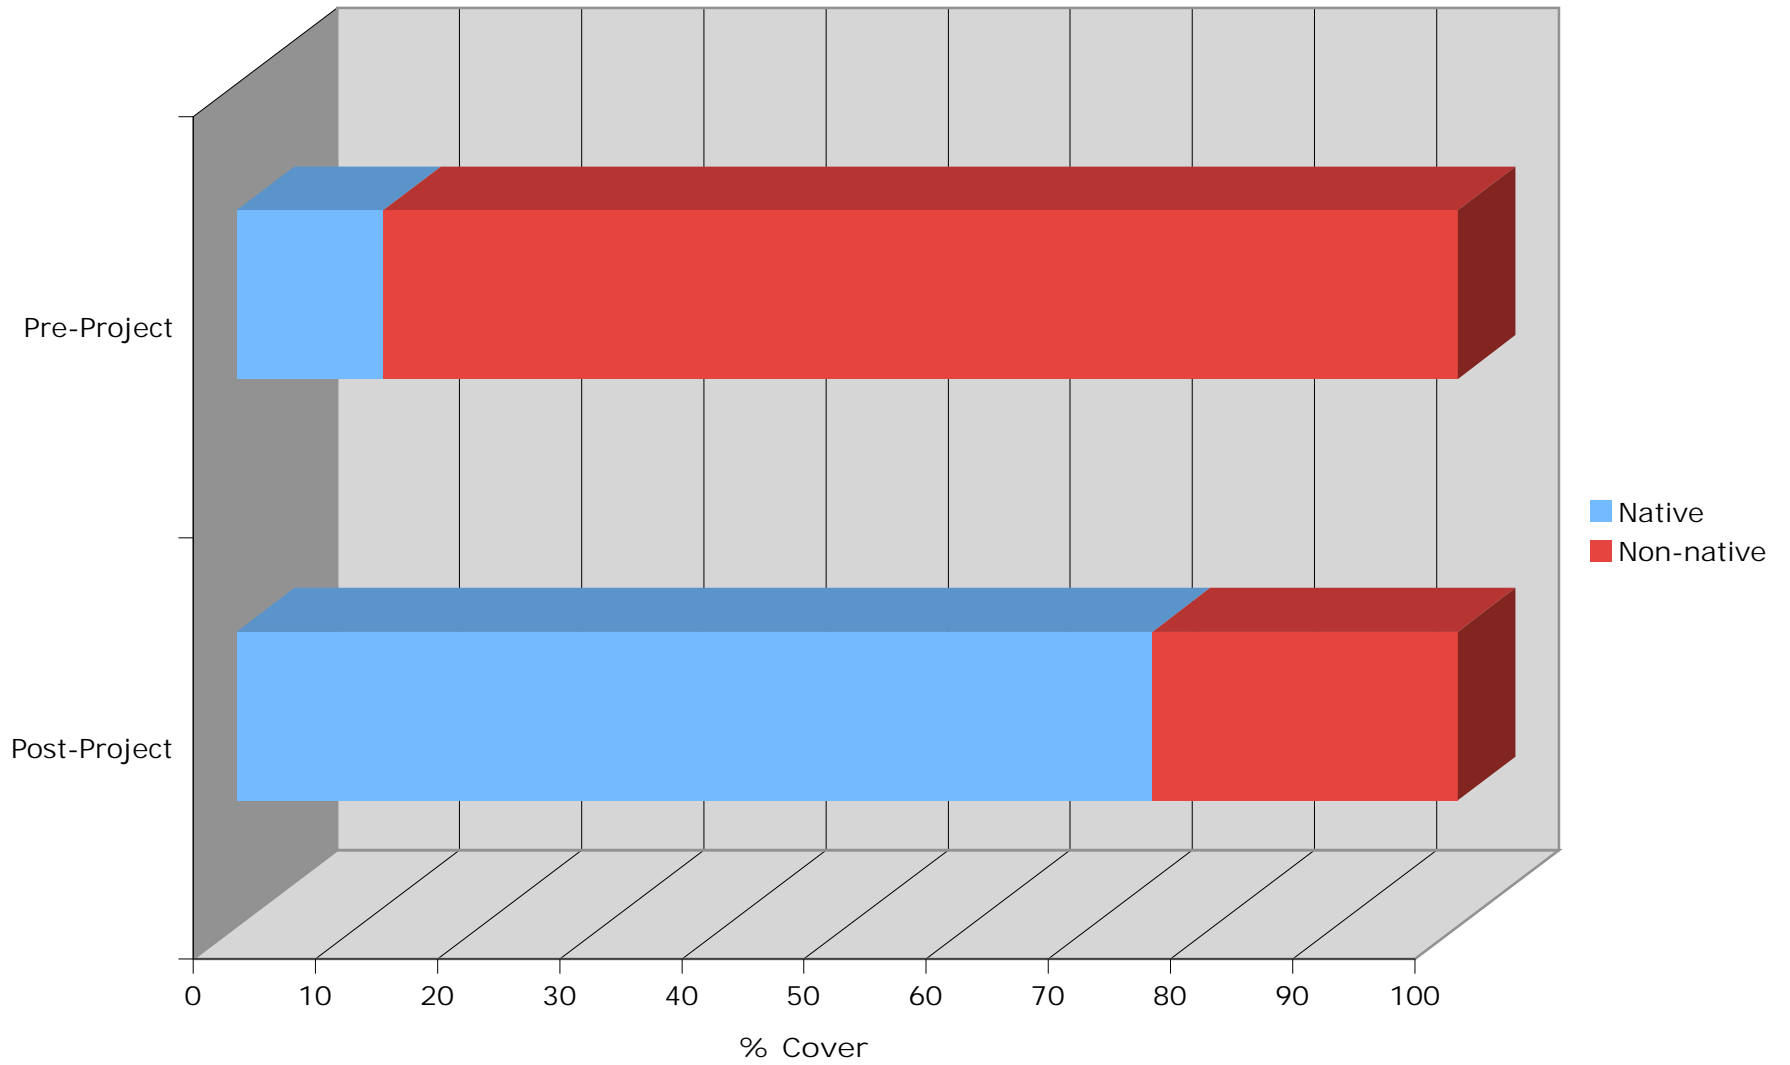
Figure 29. % Cover of Native and Non-Native Vegetation

(Pausell, 2005, p. 11). Before the restoration project, the percent cover of native vegetation was 12 percent compared to 75 percent in the riparian area (Figure 29). Also, the Simpson's Diversity Index Values indicated that plant diversity drastically increased after the project.

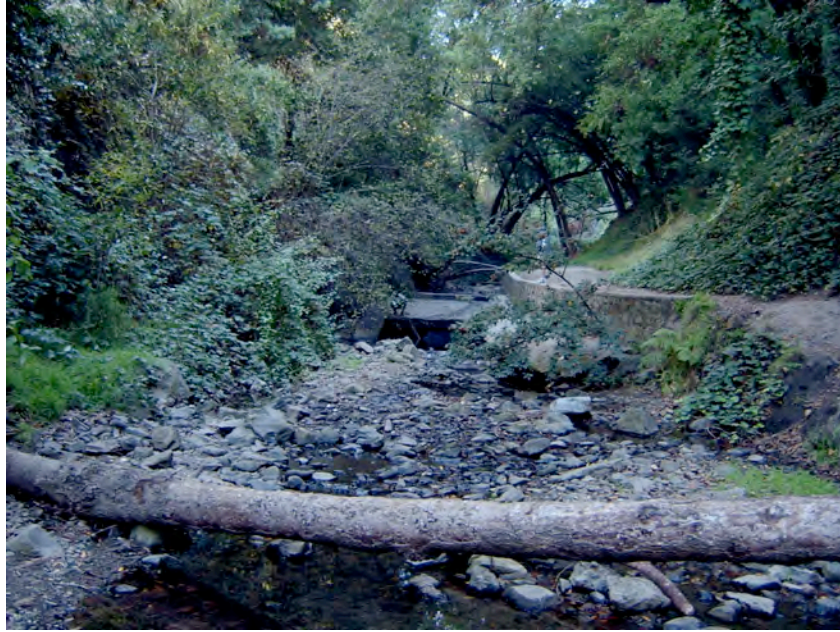
**Remnants of removed debris rack**

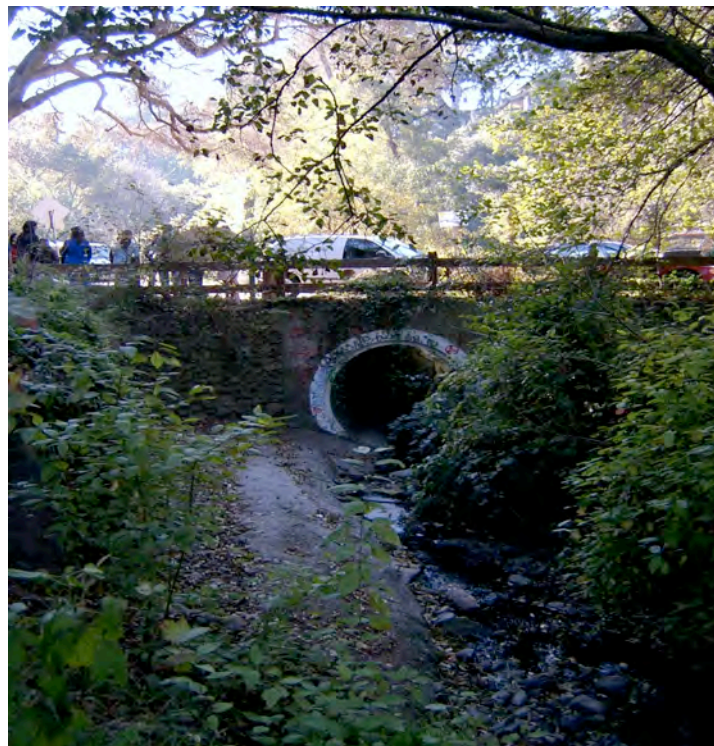
**Sewer Line in Bottom of Channel**
