Engineering Reconnaissance following the October 2016 Central Italy Earthquakes - Version 2

Engineering Reconnaissance Following the October 2016 Central Italy Earthquakes *Version 2*

Geotechnical Extreme Events Reconnaissance Association
Report No. GEER-050D
8 May 2017

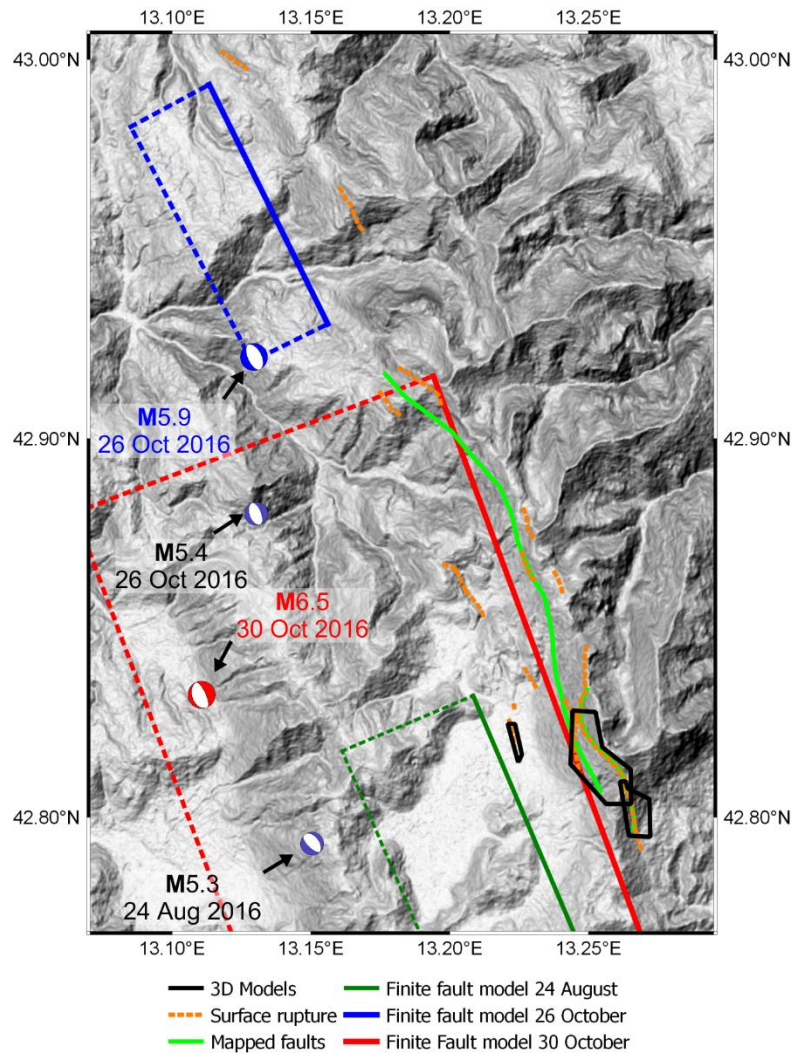
Figure 2.4. Detailed map of surface fault rupture, pre-event mapping of Mt. Vettore-Mt. Bove (green) fault system, and locations of 3D models.

As shown on Figure 2.4, the locations of the observed surface ruptures coincide with a segment of the Mt. Vettore fault as mapped by Falcucci et al. (2016). This segment of the fault did not rupture in the 24 August event. No information about the last known rupture of this fault segment is available. It has likely ruptured during past events on the Mt. Vettore fault as identified by Galadini and Gali (2003) through paleoseismological studies.

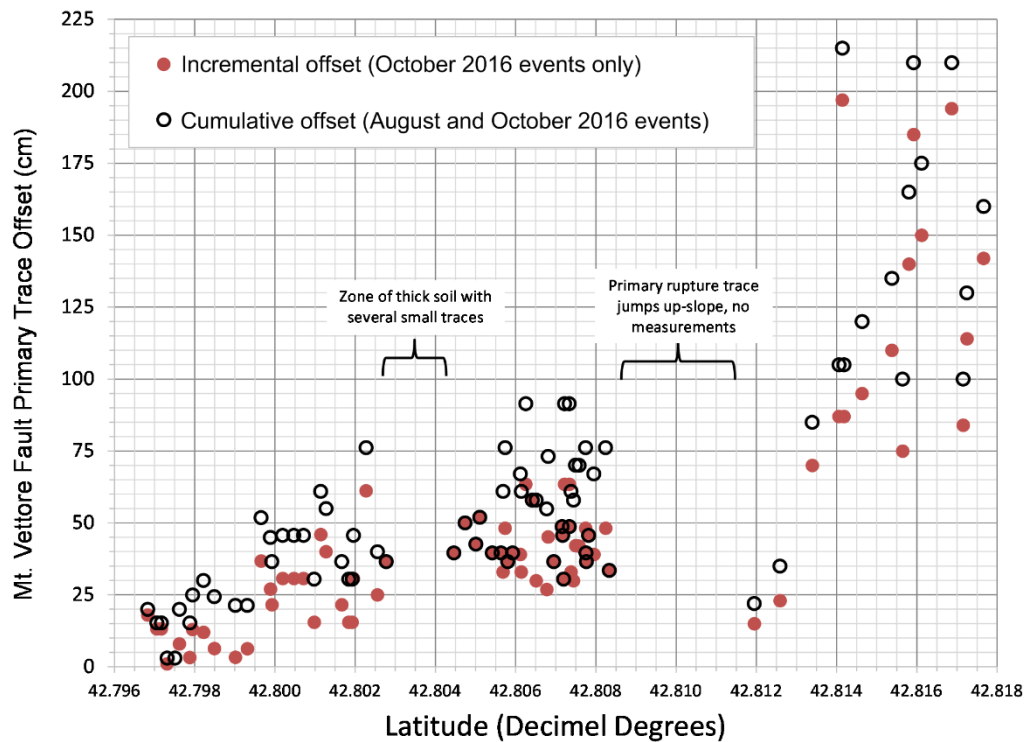
Figure 2.6. Distribution of incremental and cumulative fault offsets for the southern half of the Mt. Vettore fault. All data in this Figure from hand measurements.

In the southern portion of Mt Vettore fault, slip occurred on three segments. The primary segment is on the ridge of Monte Vettore at the contact between bedrock and thin overburden talus and alpine deposits. An apparently secondary segment occurs lower on the ridge, which ruptured in the 30 October event but not in the earlier events. Another secondary segment is in the lower-lying basin, Piano Grande, in lacustrine and alluvial deposits that have infilled the basin. Rupture on this segment was only observed following the 30 October event.

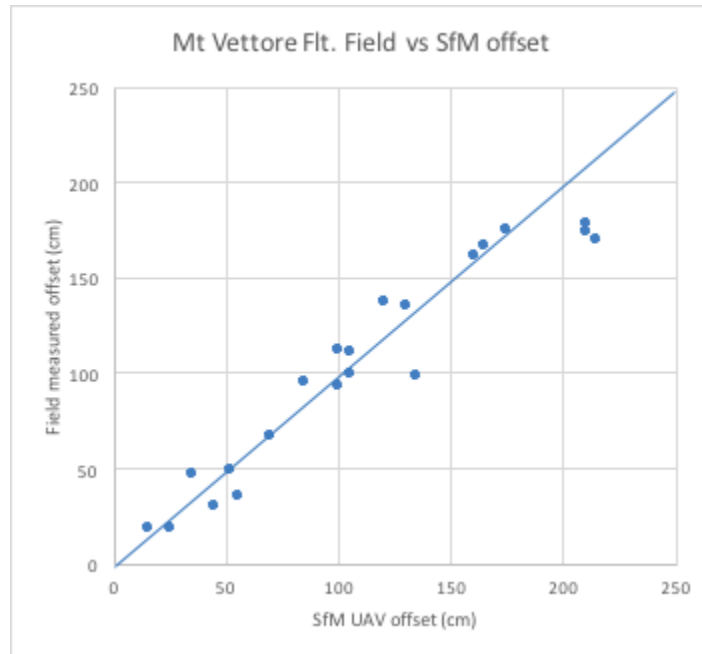
In Figure 2.7 we compare displacements along the primary (highest elevation) segment of the Mt. Vettore fault as measured by hand and from the 3D terrain model. These displacements were made along the portions of Mt. Vettore that are on the west face of the ridge and on the branch descending the ridge towards SP477. Figure 2.7 shows cumulative displacements across

all events, which for this portion of the fault arise from the 24 August and 30 October events. The 3D model in these areas is based on UAV point cloud data, and the displacements were measured from the model using the program Dronedeploy. The comparison is considered quite good, with no clear evidence of bias. Further comparisons in other areas will be undertaken in future work.

Figure 2.7. Surface fault rupture displacements from August-October event sequence as evaluated from hand measurements in the field and UAV-based 3D model.

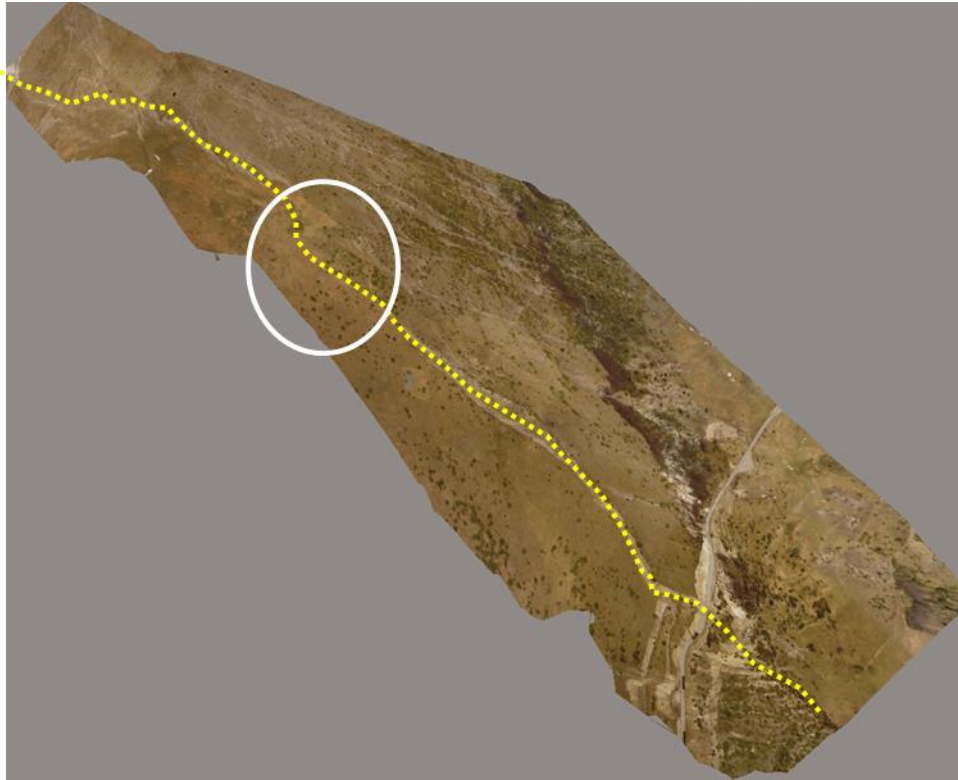
An interesting observation from both 3D point cloud and conventional mapping is that there is a zone of apparently thick and soft (ductile) soil sediment overburden on the slope where the distinct single fault rupture surface is defrayed into several smaller scarps. This area is shown in Figure 2.9. Above and below this area, the fault trace is singular and well defined. Within the

area, the fault splinters into 4 to 6 distinct, short, small displacement traces roughly parallel to one another.

Figure 2.9. 3D digital terrain model from merged SfM and LiDAR data of the Mt Vettore fault on the southern flank of the Mt Vettore Massif. Approximate main fault trace indicated in yellow. Looking from the west to the east. The upper left of the image is the top of the slope. Area of soft sediments where the fault trace breaks into several (4 – 6) small scarps is indicated in white.

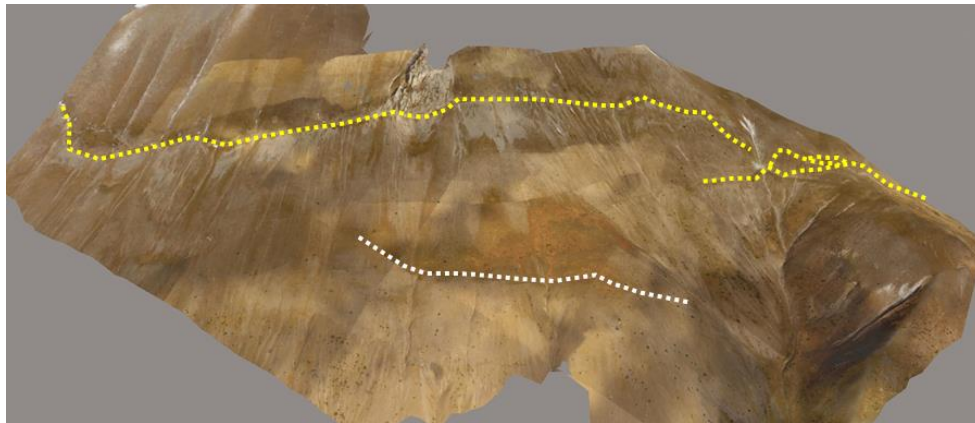
Rupture displacements increase as the fault extends to the north. Also, the rupture becomes more centralized to a single surface as the fault moves north between Figures 2.9 and 2.10. On the south (right) of Figure 2.10, the fault has several distinct rupture scarps that we have interpreted as fault scarps. Several other scarps were measured, mapped, and are shown in the 3D model. These other scarps are interpreted as minor slope instability scarps and are discussed in Chapter 4 (Section 4.2.10).

Figure 2.10. 3D digital terrain model from merged SfM and LiDAR data of the Mt Vettore fault on the western flank of the Mt Vettore Massif. Approximate main fault trace(s) indicated in yellow, a second visible trace of the “Western Trace” shown in white (See Figure 2.11 for more details). Looking from the west. The left of the image is to the north. The slope moves from top to bottom of the image.

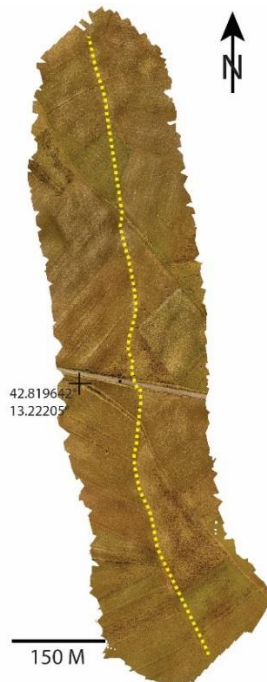
The final 3D point cloud model is from LiDAR imaging of the Piano Grande fault at the western foot of the Mt. Vettore Massif (location shown by the orange rectangle on left side of Figure 2.8). The Piano Grande fault has been interpreted as a secondary rupture surface. This fault was not observed after the August 2016 event. Figure 2.11 presents an image of this 3D model.

Figure 2.11. 3D digital terrain model from merged SfM and LiDAR data of the Piano Grande fault on the western toe of the Mt Vettore Massif. Approximate fault trace(s) indicated in yellow. Looking from the west. The left of the image is to the north. Mt. Vettore on the top of the image

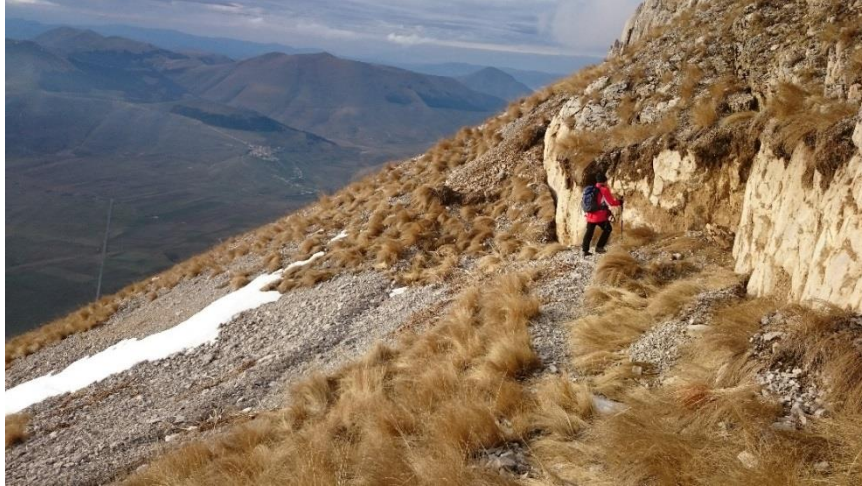
Figure 2.14. Location of maximum fault offset of 210 cm following October 2016 events. The August event offset at this location is estimated as 20 cm, based on nearby data points. Lat = 42.81687, Long = 13.25503.

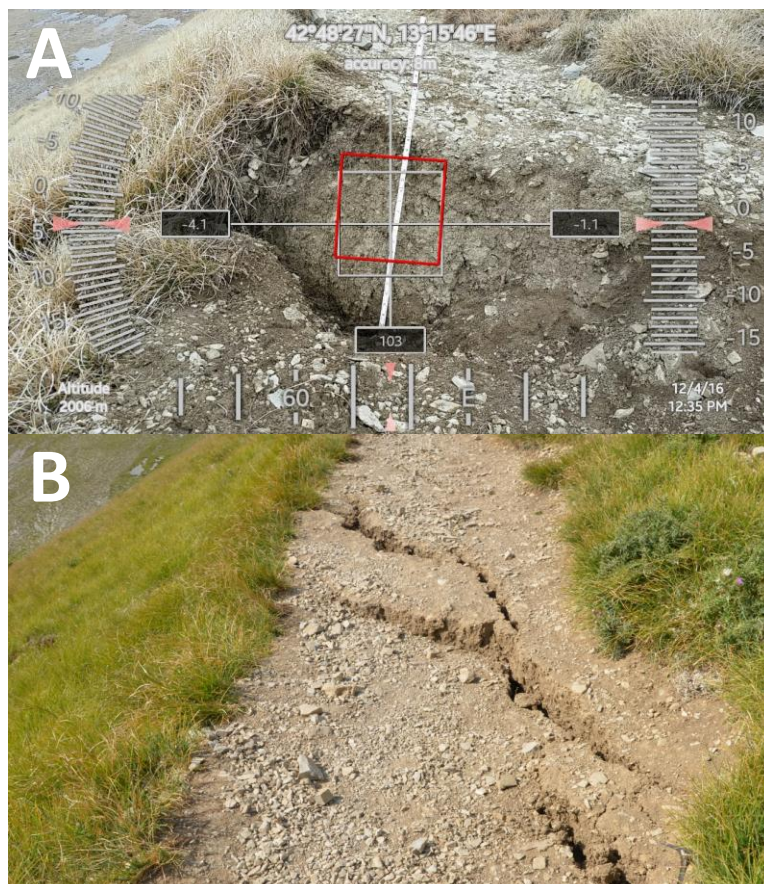
Figure 2.15. Fault offset measurement across the footpath on the west face of Mt. Vettore. Offset measured as 80 cm following October events (a). This offset was 30 cm following August events (b). Lat = 42.807379, Long = 13.262966.

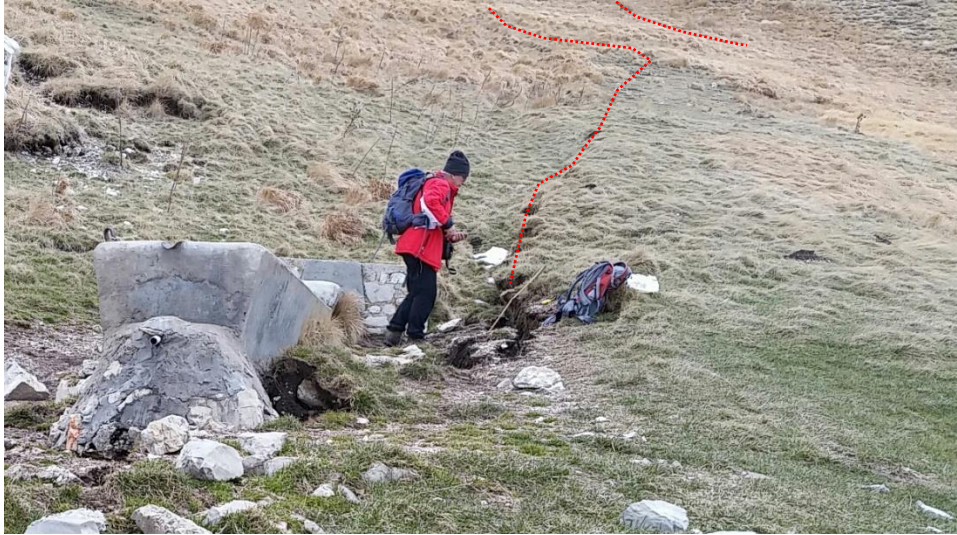
Figure 2.16. Fault trace on the south face of Mt. Vettore, where the fault has ruptured along the path of buried polyethylene pipe supplying the pictured spring. Rupture partially hidden by long grass. Offset measured at 45 to 65cm. August offset data nearby is 0 to 15cm. Trace(s) above the spring indicated in red. Lat = 42.80474, Long = 13.26441.

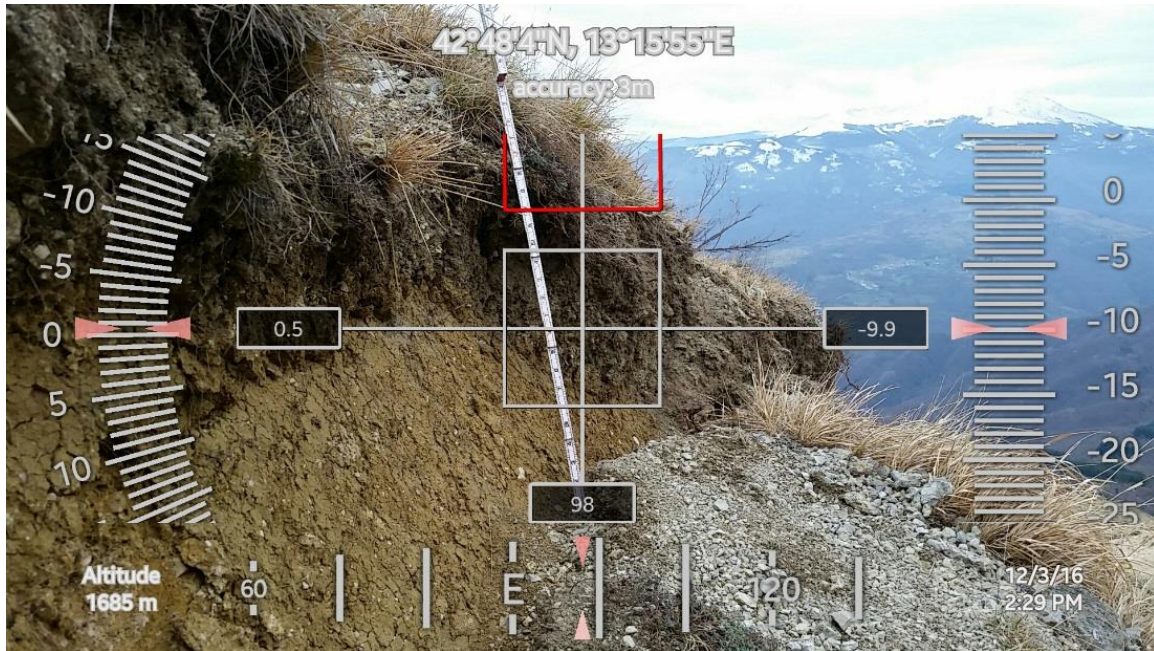
Figure 2.18. Fault offset measurement in gulley on south face of Mt. Vettore. Offset measured at 80cm. August offset data nearby is 15cm, indicating October 2016 offset of 65cm.

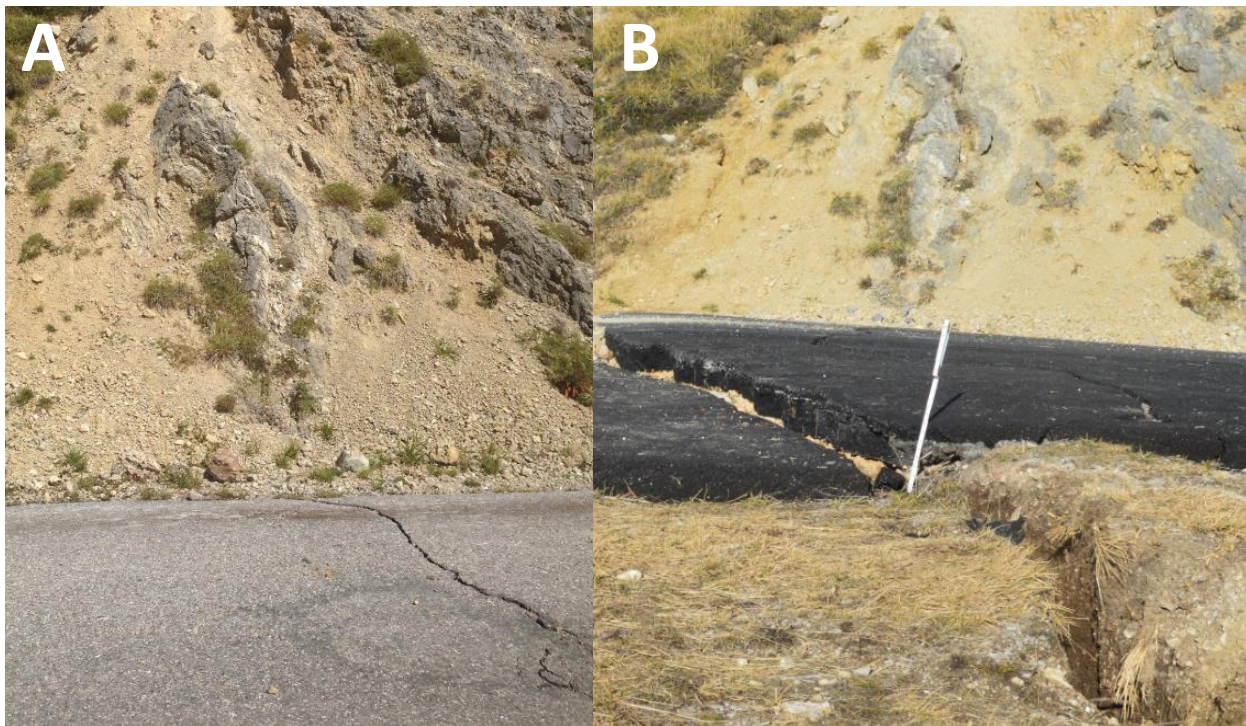
Figure 2.19. Fault offset measurement across SR477 on south face of Mt. Vettore. August offset data nearby is 2cm (a). Offset measured at 18cm to 20cm after October (b). Lat = 42.796829, Long = 13.265899.

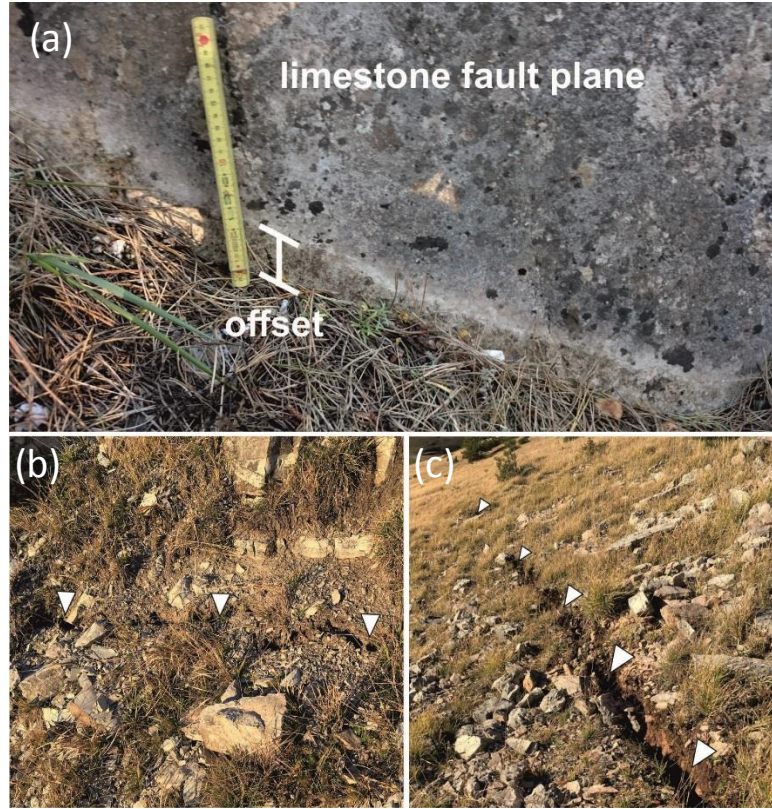
The Mt. Vettore fault crosses variable surficial geologies, with differences in fault rupture manifestation for each surface material type. Figure 2.21 presents three different images of the fault rupture. The fault occasionally followed a well-defined limestone fault plane. This was especially true in the “gulley” on the south face of Mt. Vettore and along much of the west face of the Massif for both the main and western splays of the fault. Measurements are relatively straightforward in these areas. In areas where a near-surface limestone fault plane was not present (i.e. thick soil sediment cover), the fault rupture often appears as shown in Figures 2.21a and 2.21b, with lateral gapping developing and the fault trace occasionally splitting into two or more traces. Displacements across these individual traces often sum to be as much as the displacement in adjacent areas with shallow or exposed limestone. For example, between latitudes 42.806 and 42.808, the fault trace splits into several traces, converges, and then diverges again before becoming a single distinct surface north of Latitude 42.808. In the locations of a single trace, the measured offset is 92 cm. In the nearby locations with 2 or 3 traces, the individual traces measure 30 to 40 cm, but the sum is very close to 90 cm.

Figure 2.21. Fault offset measurements along the south and west faces of the Mt. Vettore Massif showing differences in fault rupture offset through soil versus along the rock fault plane (where visible on the slope).

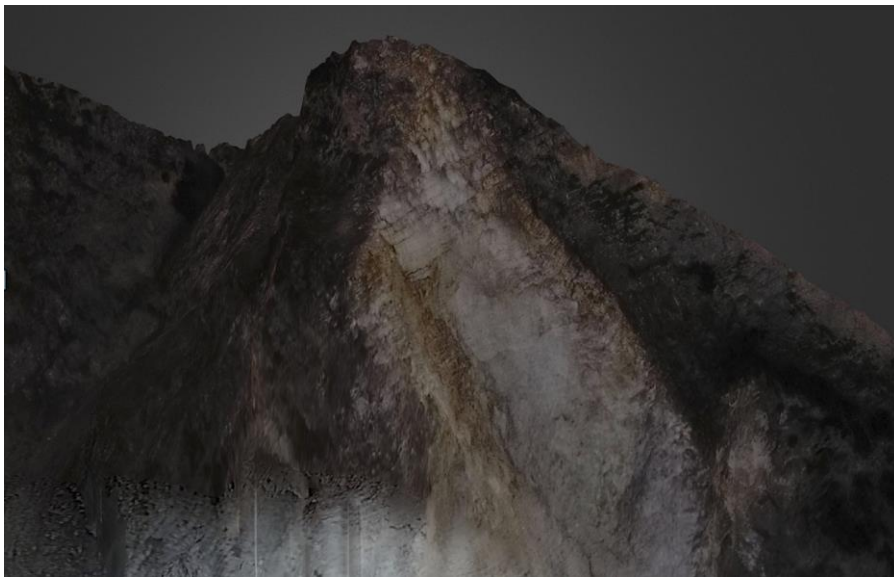
The upper detachment zone can be seen in the SFM imagery of Figure 4.6-4.7. In these images, the bedding is seen with an apparent dip towards the east of 20°-30°, and the wedge is apparently a double joint set orthogonal to the bedding. The failure occurred along the joint sets. Further analysis of the SFM data may resolve the strike and dip of the bedding and the joint sets that resulted in the detachment.

Figure 4.6. Headscarp of Nera rockfall.

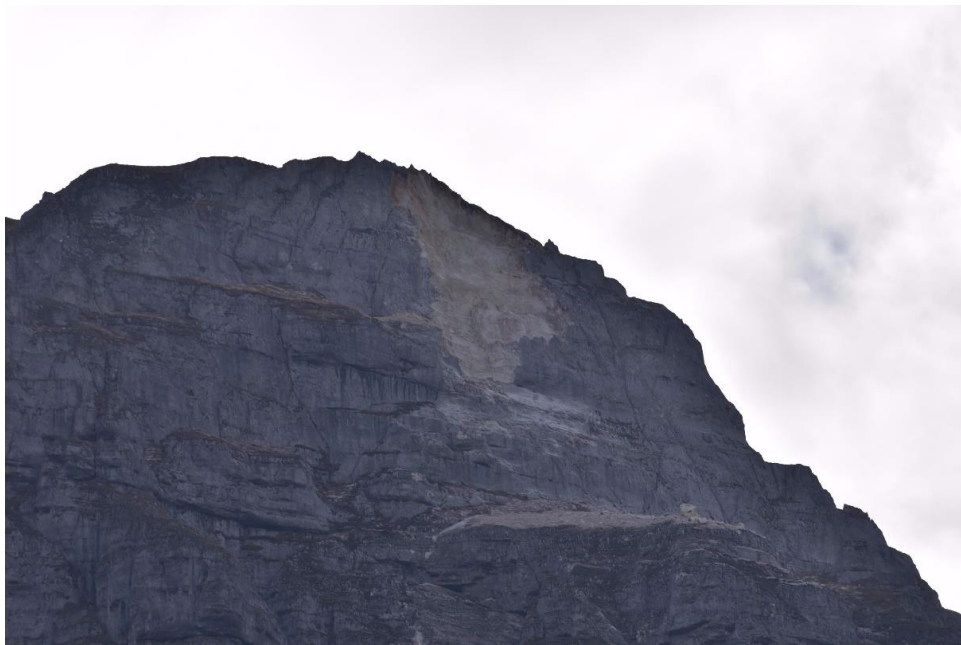
Figure 4.10. Photograph (300 mm) of the upper rockfall near the summit of Monte Bove.

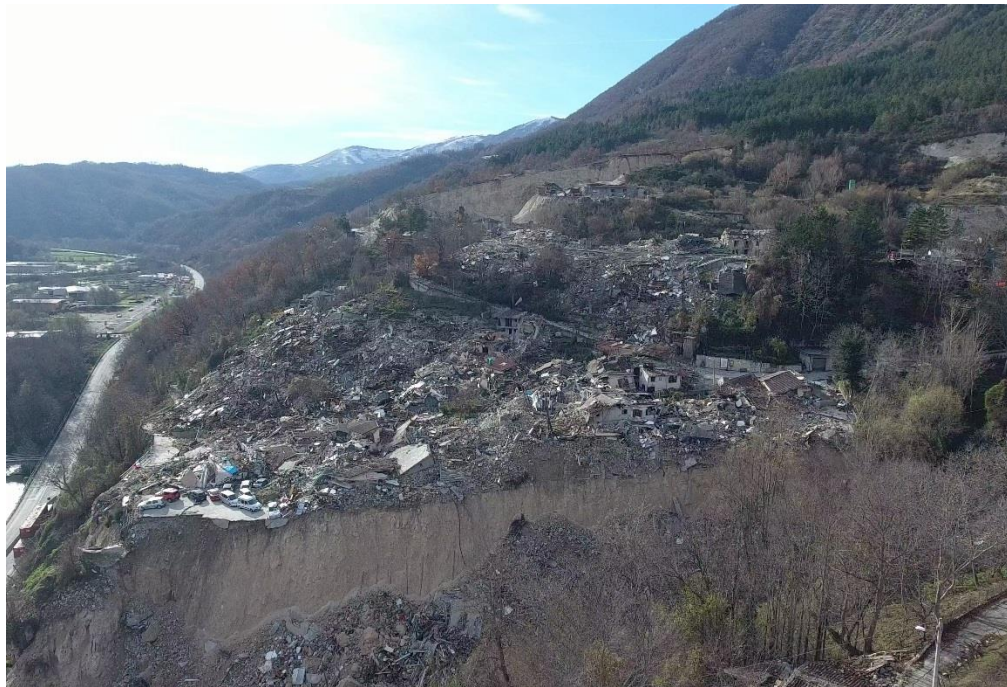
Figure 4.13. Pescara del Tronto aerial photograph taken from the Phantom 4 UAV.

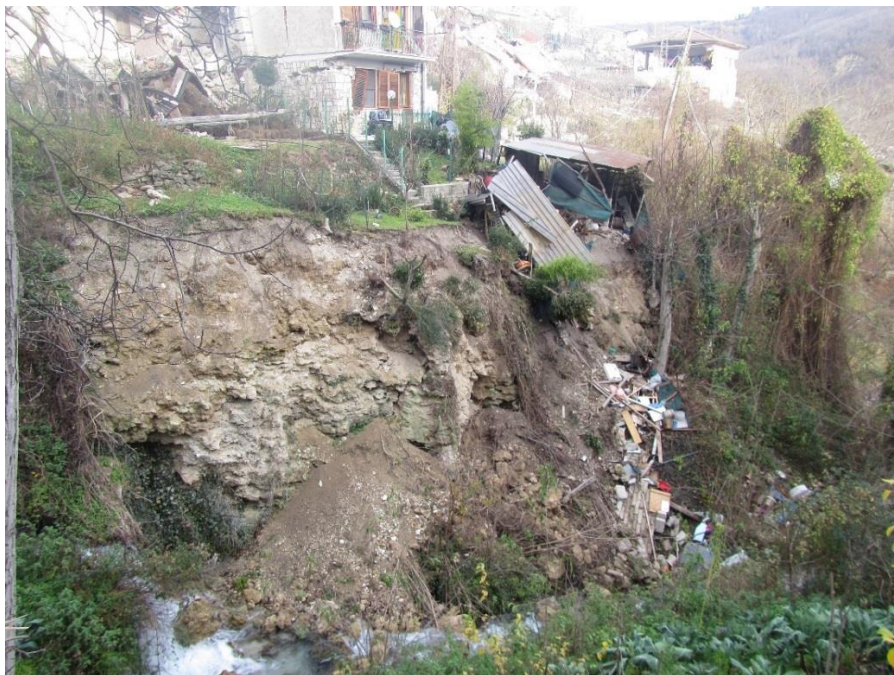
Within the village of Pescara del Tronto, there exists a natural creek that flows down a gulley located in the middle of the village. The presence of the gulley gives Pescara del Tronto the appearance of an inverted horseshoe shape or upside-down “U” when observed from the air (see Figure 4.12). During the December reconnaissance mission, GEER team members observed that portions of the gulley wall had failed in localized landslides, causing any overlying structures to fall into the gulley (Figure 4.20). The exposed scarps revealed talus comprised of heavily weathered limestone.

Figure 4.20. Failure of steepened talus gully wall material and crest area above (Location 3e).

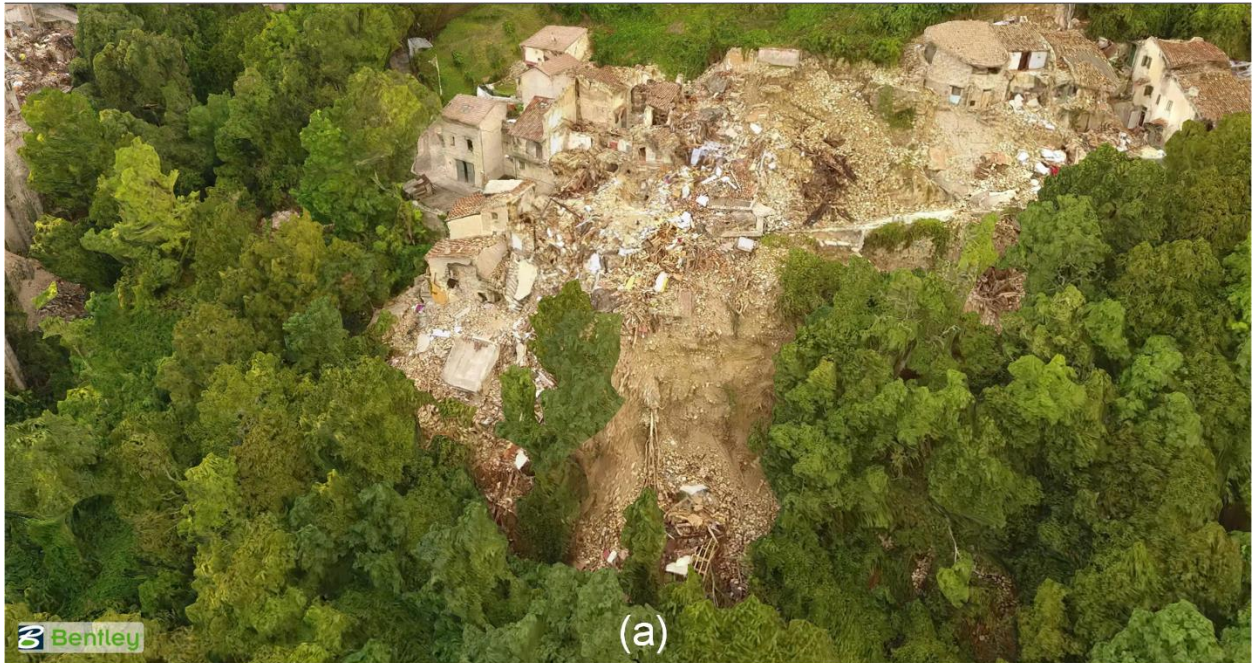
Area 6: Landslide on the Northern Slope of the Village: A shallow landslide was observed on the northern slope of the city following the 24 August event (Figure 4.27a). This landslide was observed to have exposed some tree roots and undermined a few residential structures. Investigation of the same slope in December following the October events revealed that the depth of the landslide remained relatively unchanged, but the width of the landslide appears to have expanded from 17 m in September to more than 36 m in December (Figure 4.27b). However, it is difficult to discern from the UAV images and 3D model whether the flattened trees along the slope are due to an expansion of the shallow landslide or due to structural debris from above the slope.

Figure 4.27. 3D model comparison of the landslide beneath the northern slope of Pescara del Tronto between September 2016 (a) and December 2016 (b).

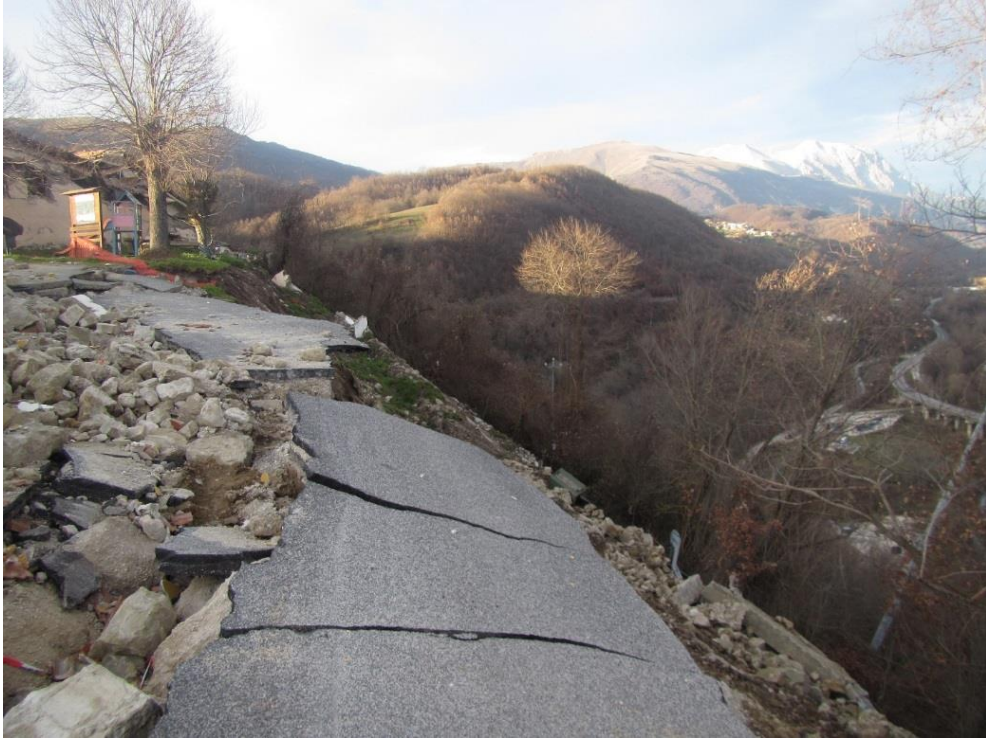
During the December GEER deployment, much more damage was observed. It appeared that a shallow landslide developed beneath the retaining wall and caused the entire structure to slide several meters down the slope. Figures 4.30 and 4.31 present photographs of the head of the shallow landslide showing the retaining wall's former location. Figure 4.32 presents an aerial screenshot of the 3D model developed from Phantom 4 UAV imagery of the site. Several features of interest are identified in Figure 4.32, and will be discussed below.

Figure 4.30. Failure of retaining wall due to shallow landslide (Point 4a, looking towards north).

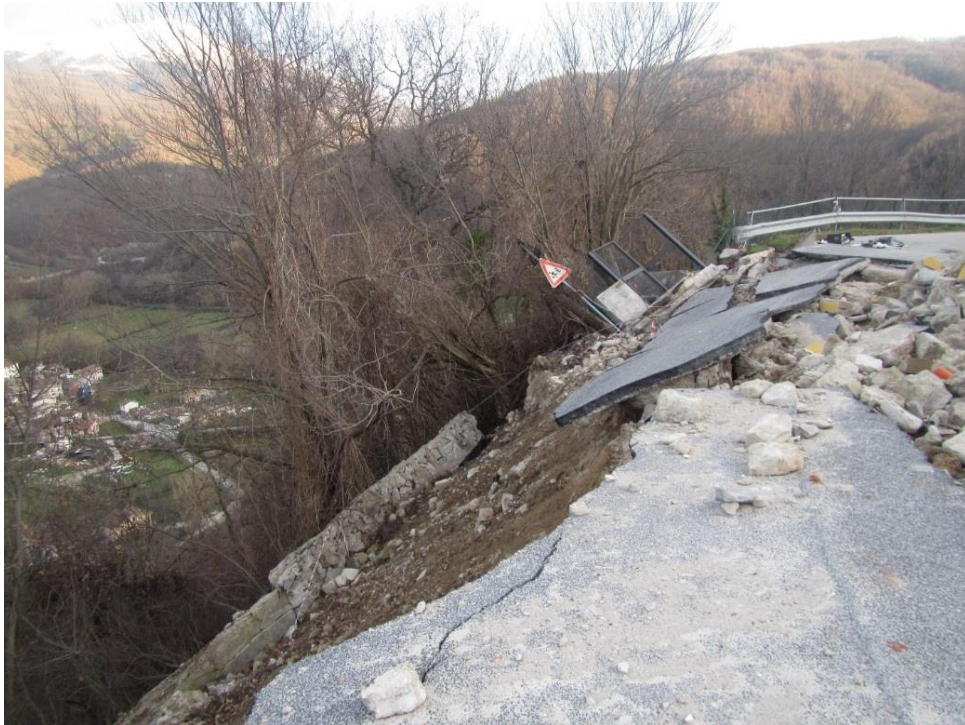
Figure 4.31. Failure of retaining wall due to shallow landslide (Point 4a, looking towards south).

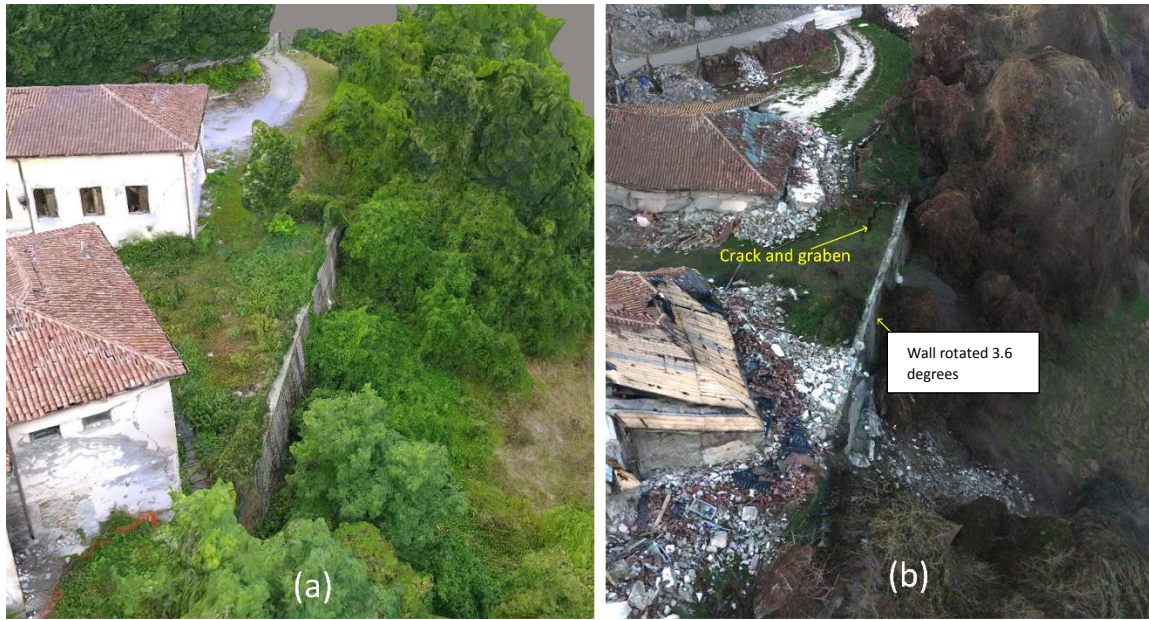
Figure 4.32 also shows a second damaged retaining wall located approximately 60 m to the northwest of the collapsed wall (42.6948 N 13.2496 E). 3D model screenshots of the wall in September 2016 and December 2016 are presented in Figure 4.34. In September, no rotation of

the wall or cracking in the soil were observed. The structure adjacent to the wall was damaged, but still standing. In December, the wall was observed to have rotated outward 3.6 degrees, with a 1.8 m-wide graben forming behind the wall. The soil in the graben was measured to have settled approximately 29 cm. The structure adjacent to the wall was completely collapsed. The similarities in the observed damages with this wall with the observed damages of the now-collapsed wall in September are remarkable, and suggest that another shallow landslide may have formed beneath this damaged wall.

Figure 4.34. 3D model screenshots showing a retaining wall beneath the northeastern slope of Accumoli (a) undamaged in September 2016, and (b) damaged in December 2016.

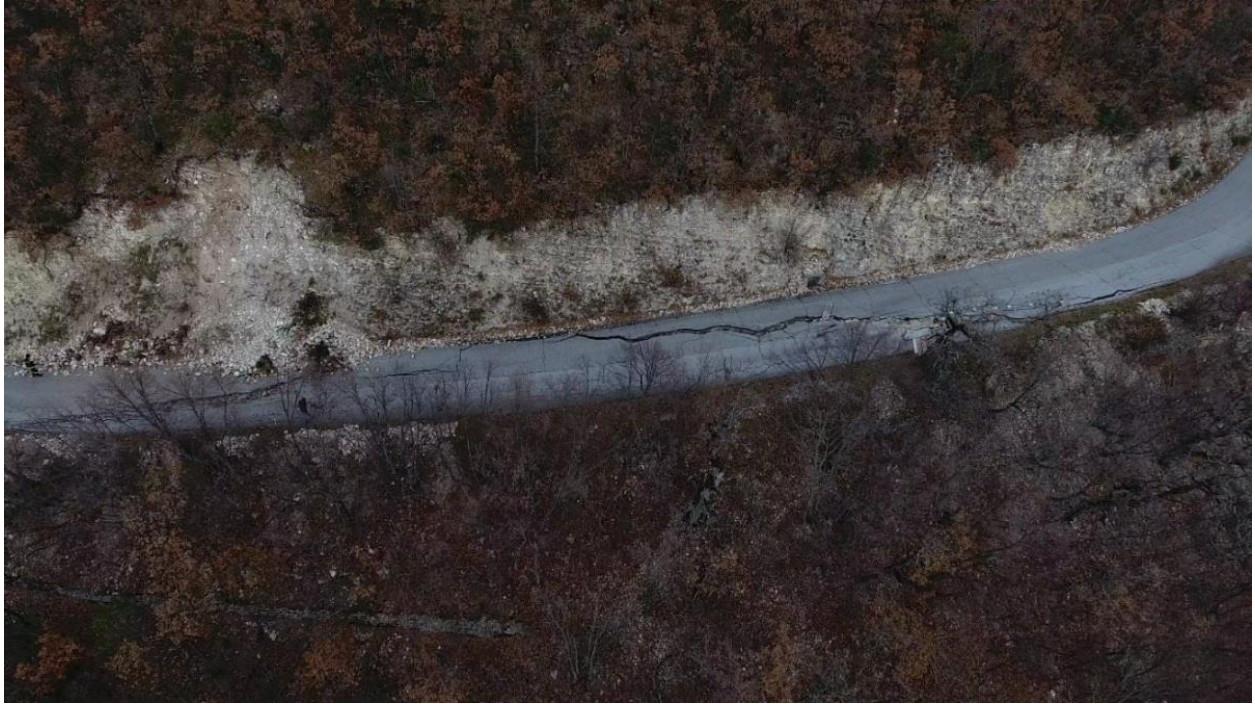
The first site encountered (Point 5a) was a landslide in the soil slope through and beneath the road. An aerial photograph of the landslide is shown in Figure 4.37 (note the fire fighter in the upper left corner for scale). The landslide was measured to be 55-60 m in width. While the head of the landslide was easily seen in the road pavement, no toe or side scarp of the landslide could be traced on the heavily vegetated slope below the road. On the road, the vertical offset measured in the pavement ranged from 10-70 cm, and the horizontal deformation ranged from 2-40 cm. The GEER team observed that the eastern portion of the landslide headscarp showed a distinct crack and displacement (Figure 4.38), while the western portion of the landslide headscarp appeared more gradual and showed more pavement cracking (Figure 4.39). This landslide was believed to have occurred in the shallow soils along the side of the mountain slope, and appeared limited in its extent.

Figure 4.37. Landslide encountered along mountain road in the Valle di Panico (Point 5a).

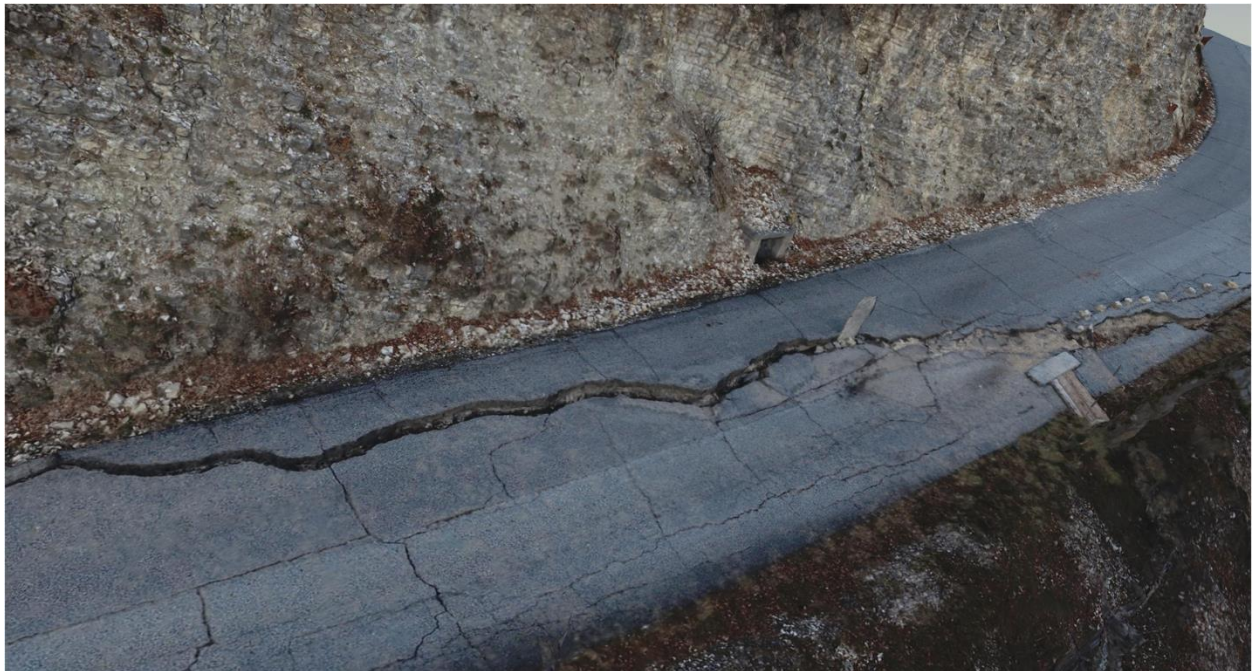
Figure 4.38. 3D model of the eastern half of the Valle di Panico landslide headscarp.

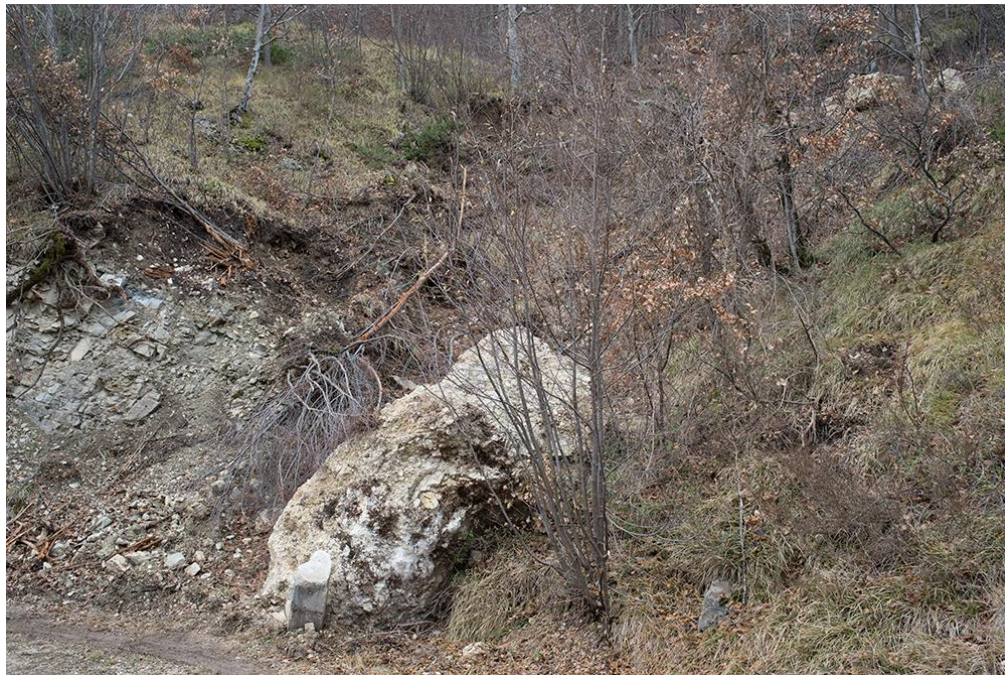
Figure 4.41. Photograph of the largest observed boulder fragment in the Valle di Panico rockfall. The boulder measured approximately 3.0 meters in diameter.

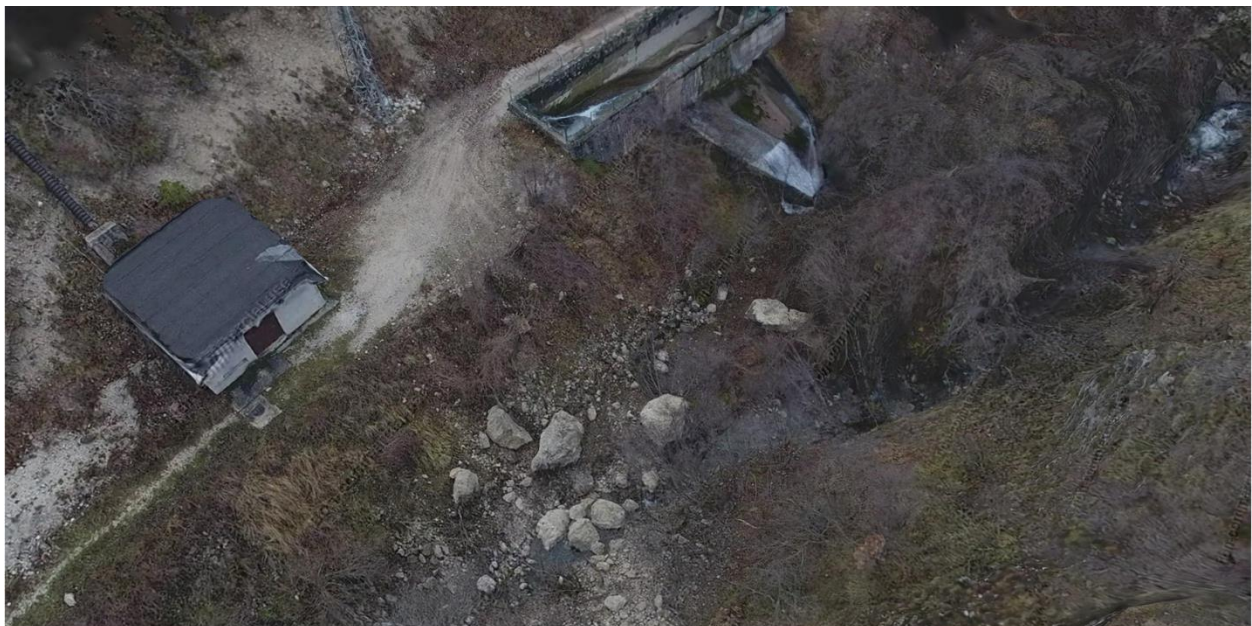
Figure 4.43. 3D model of the boulders and small power or pump house at the toe of the Valle di Panico rockfall.

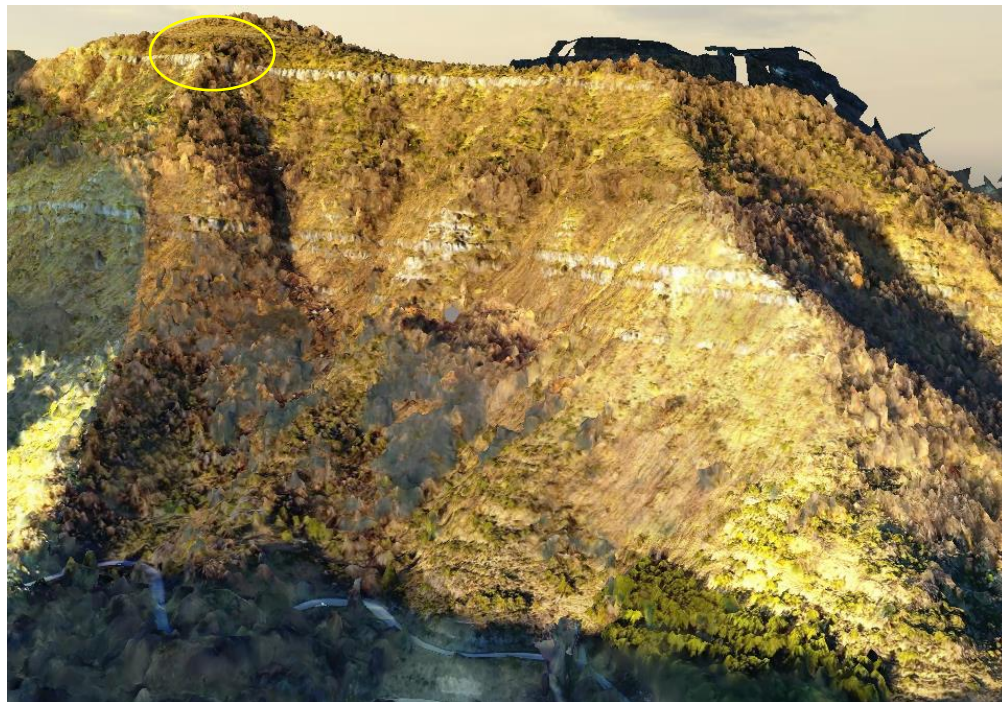
The rock source itself is an 8 m-thick massive arenaceous limestone exposure that sits at the top of the slope like a rim. The primary source area of the rockfall was measured using 3D point cloud models to be 8 m tall (the entire thickness of the exposure) and 10.5 m wide, and at least 3 m deep. Several other, smaller, source areas on the rim-rock exposure were identified and on

Figure 4.45. 3D SfM model of rockfall site near Cervaro village (Crognaleto). Primary rockfall source circled in yellow.

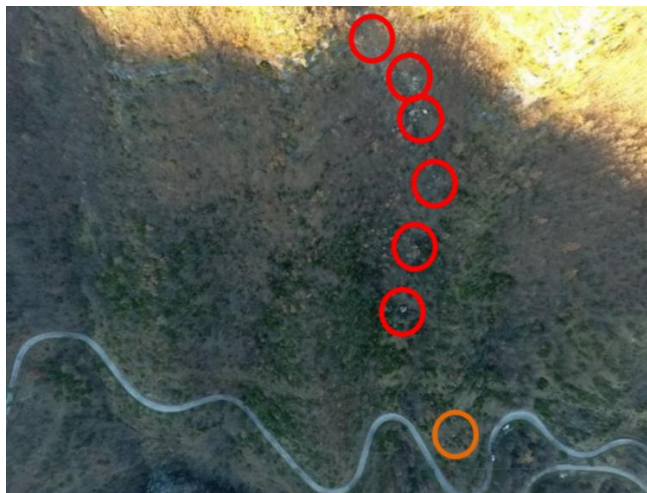
Below the primary rock source, the large rock mass(es) followed the path of a drainage feature to the bottom of the slope just above the Via Trieste where the final large boulder came to rest. Figure 4.47 shows an overhead photo from the UAV with large boulder fragments identified. It may have been that the source rock was already fractured prior to the earthquake into 1 to 4 m blocks that dislodged. It may also be that the rock dislodged in one or two large masses that broke apart on the runout down the slope towards the road. The final boulder is 4 m and is shown in Figure 4.48, with a 1.7 m tall GEER team member next to the boulder for size perspective.

Figure 4.47. UAV aerial image of rockfall path from source at top of slope to the road at bottom of slope. Red circles show boulder fragments larger than 1.5m. Last boulder fragment from rockfall near road at base of slope is circled in orange.

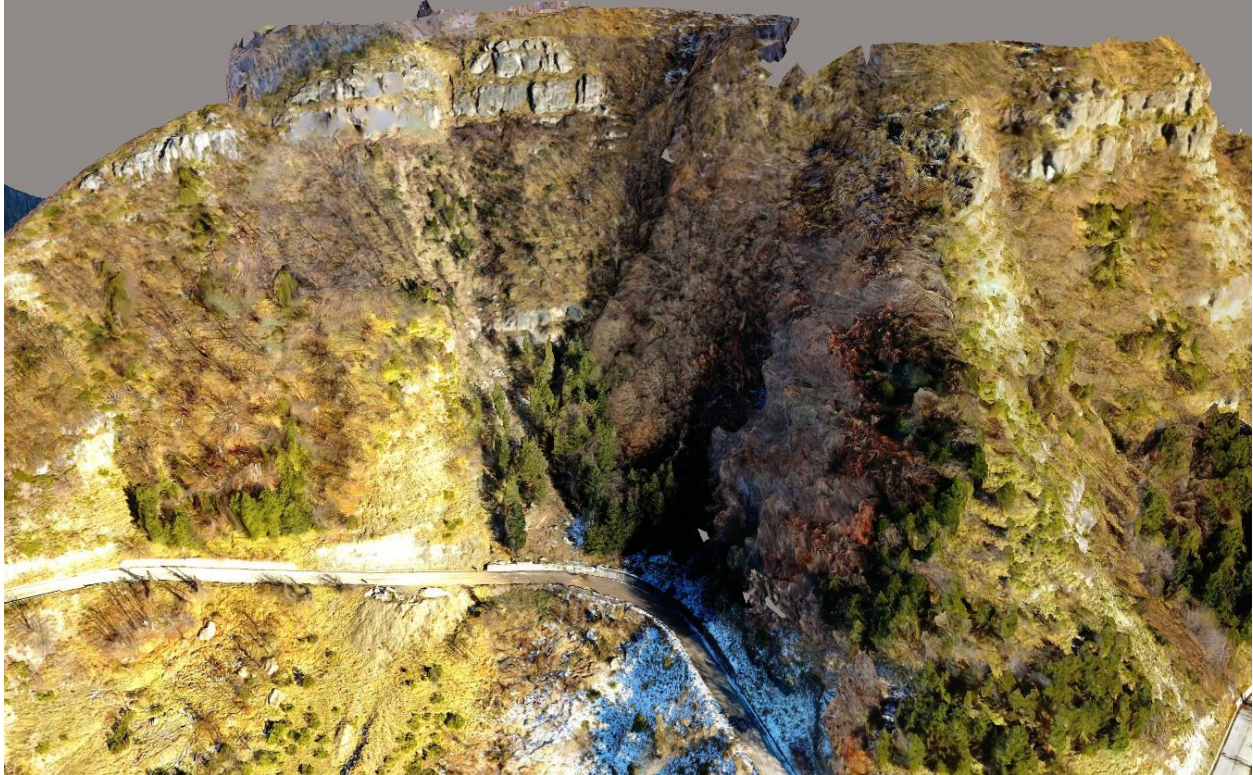
Figure 4.50. 3D SfM model from UAV imagery of the rockfall site near Crognaleto village.

We did not examine closely the rock source at the top of the slope due to the steepness of the terrain. However, mapped geology and observations of the boulders both indicate that the rock source is massive arenaceous limestone and limestone breccia. The rock in the boulders was very strong and hard. Boulders ranged from 1 to 3 m in size. The provincial highway officials had blasted apart and cleared several of the larger boulders off of the SP45a roadway, so our observations of some boulders are post-blasting. It is possible that several of the boulders may have been 6-8 m during the rockfall event. The rock source is a sheer face of two massive layers of rock at the top of the slope, each layer approximately 8 m thick. Below of the vertical faces, the slope is 30° to 34° and rises 84 m above SP45a. Below SP45a, the slope is approximately 20°.
