Engineering Reconnaissance following the October 2016 Central Italy Earthquakes - Version 2

Engineering Reconnaissance Following the October 2016 Central Italy Earthquakes *Version 2*

Geotechnical Extreme Events Reconnaissance Association
Report No. GEER-050D
8 May 2017

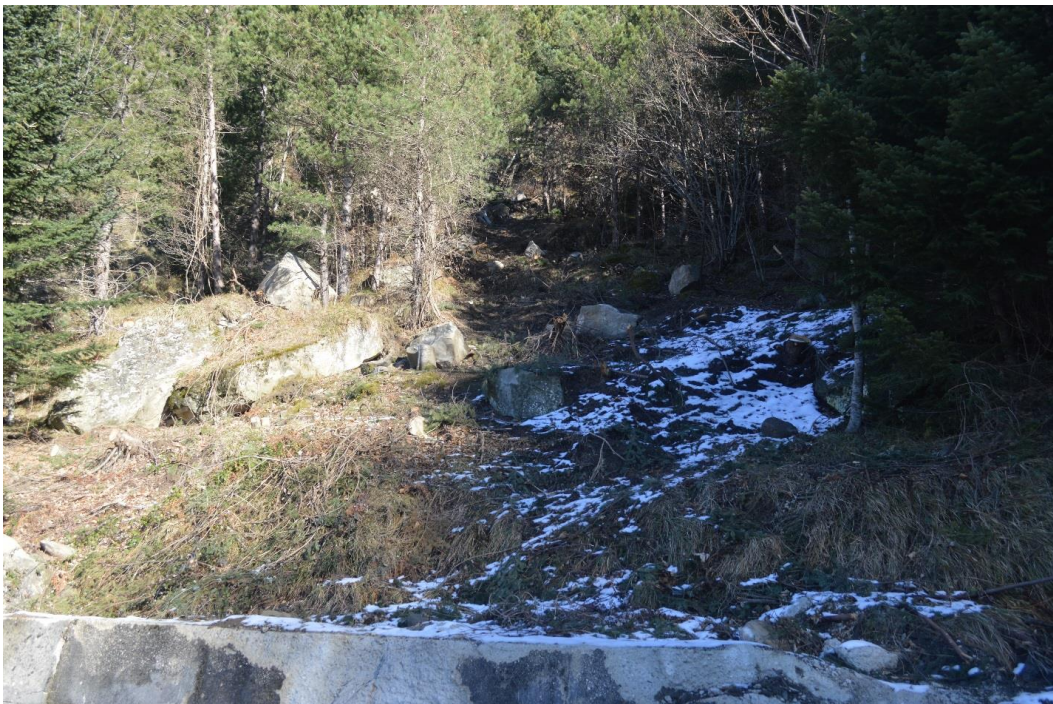
shows that the area has regular rockfall, and that strong ground shaking from the October 30, 2016 earthquake has merely accelerated the rate of rockfall at the site.

Figure 4.53. View upslope of damaged retaining wall, boulder fragments and runout chute from road at rockfall site near Crognaleto village.

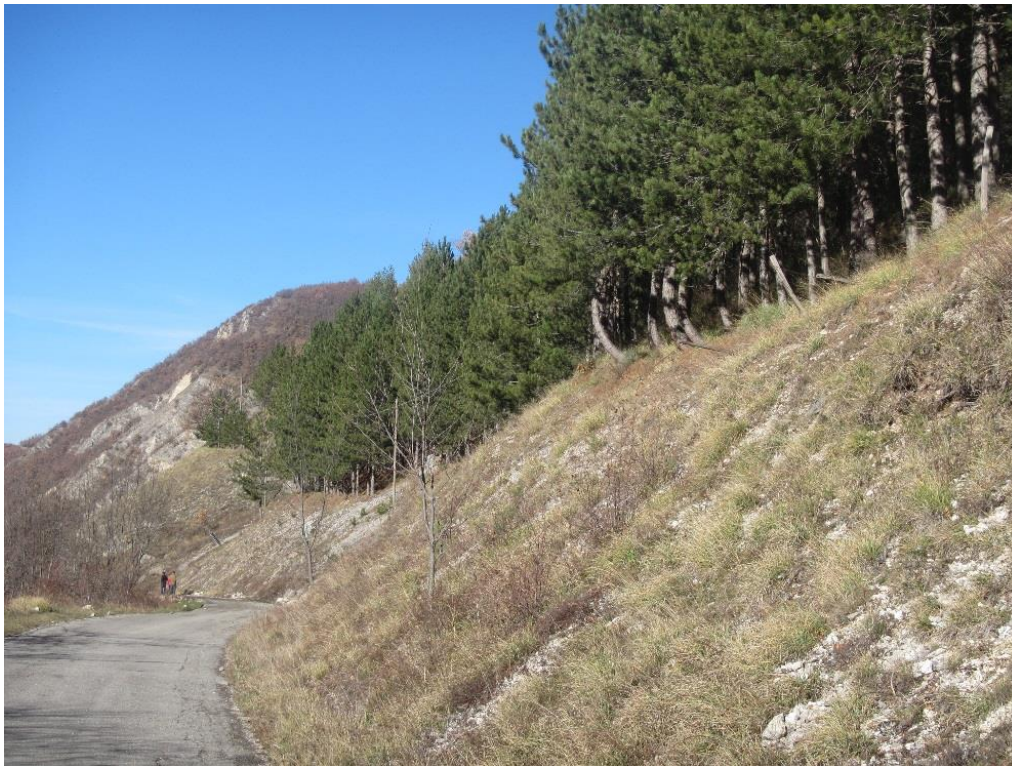
Figure 4.55. Pescia rockfall. Possible soil slope creep shown by tree trunks. (site 9a).

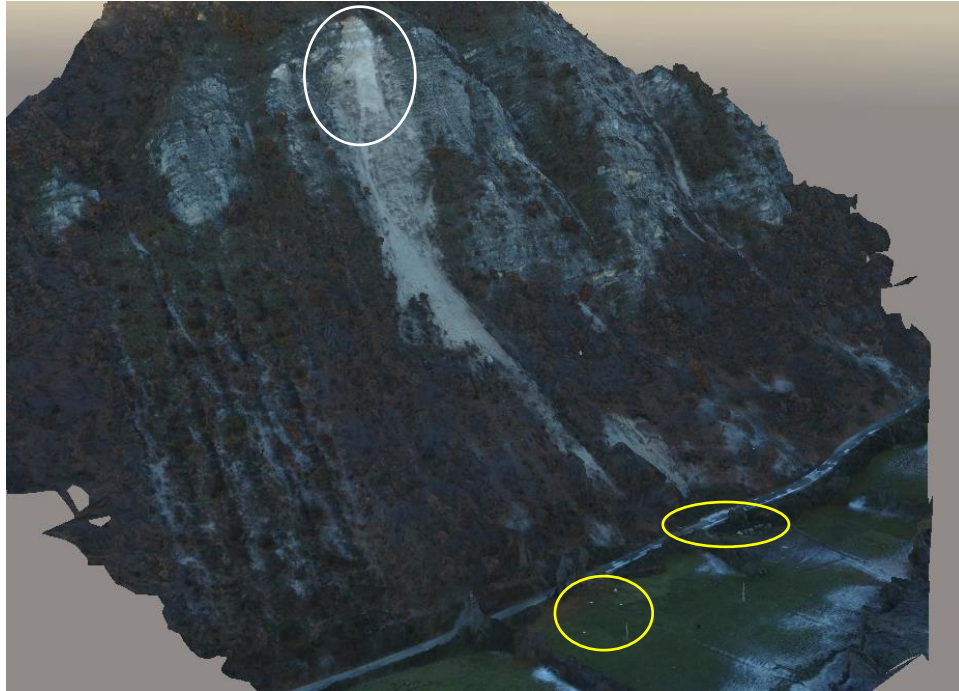
The larger landslide that occurred during the 30 October 2016 earthquake at site 9b was a rock avalanche. The site is shown in Figure 4.59 using a 3D SfM model orthophoto developed from UAV imaging. The source rock face is massive but weathered and jointed limestone is at least 50 m high. The source of the rock avalanche itself is 16 m wide and 32 m high. The slope below the rock face varies from 28° to 32° and is around 57 m from the rock face to the road. A flat field and Via del Passero lay at the bottom of the slope. The source is shown in Figure 4.59 as the light colored part of the rock face. We did not climb the slope to perform a close-up assessment of the rock at Site 9b. However, the limestone boulders that travelled to the base of the slope and out into the field below Via del Passero indicate the geology and rock type. These boulders were 0.75-1.25 m. Figure 4.60 shows the perspective of the rock avalanche from the field, where the runout down the slope is seen through the trees.

Figure 4.59. Pescia rockfall site 9b. 3D SfM model from UAV data. Boulders that have rolled into field below the road are circled in yellow. Source is indicated by white circle.

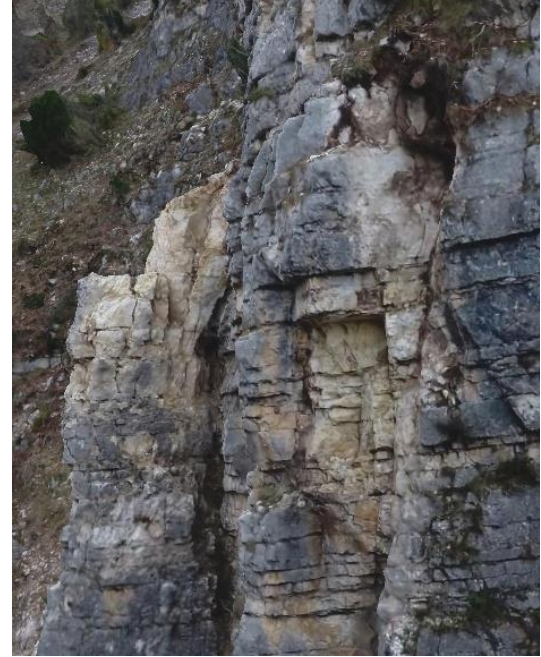
UAV surveys (Figure 4.62) suggest that one half of the cap collapsed and the other was damaged as a consequence of the shaking. Similarly, a 4-m-high hanging wedge (center-left of Figure 4.62b) and a 5-m-high wedge high (upper-left in Figure 4.62b) failed along a bedding joints and slid along two vertical joints, respectively.

Figure 4.62. Lateral view from the drone of the rock column at km 3 of SP134 (right valley flank) (a). The left part of the column cap collapsed producing two small avalanches towards the column front and along the column free side. Scars left from two wedges on the adjacent cliff (b). Leftward tilting of the column cap is also visible in figure 4.61.

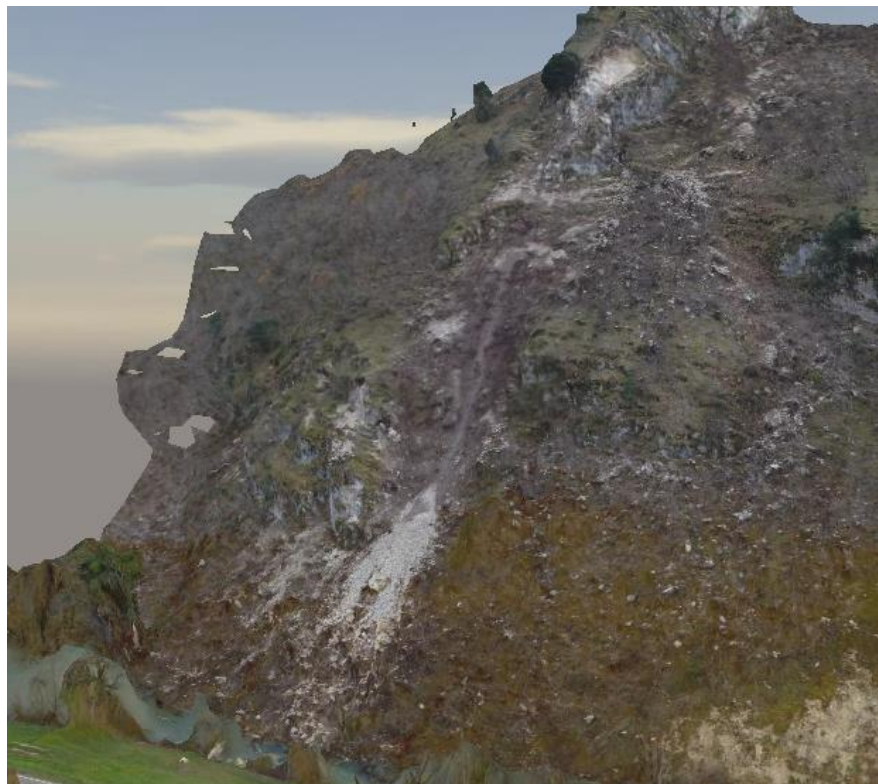
On the opposite valley flank a rock slide occurred at a height of about 100 m above the valley bottom and evolved into a small rock avalanche that fell into the Nera River (some blocks reached the opposite riverside). UAV drone surveys were instrumental in understanding landslide geometry, rock mass quality and failure mechanism. The oblique view in Figure 4.63a shows that the failed mass suffered intense fragmentation and eroded the slope with significant entraining of debris overlying the bedrock. Figure 4.63b indicates that sliding involved an intensely fractured wedge of Maiolica limestone delimited by two persistent joints.

Figure 4.63. General oblique view of the rock slide and subsequent rock avalanche on the left flank of the Nera valley (km 3 of SP134 motorway) (a); detail of the detachment area (b). Images taken from the 3D model generated by BYU on the basis of drone surveys.

The left joint (observing the slide from the opposite flank) was a sub-vertical, persistent, relatively smooth and striated fault plane, whilst the right joint seems a relatively planar joint dipping at low angle toward the valley. It is not clear if the mechanism was planar or three-dimensional. The wedge is sector-shaped with a height of 19 m and maximum transversal dimensions of 8m and 4 m respectively.

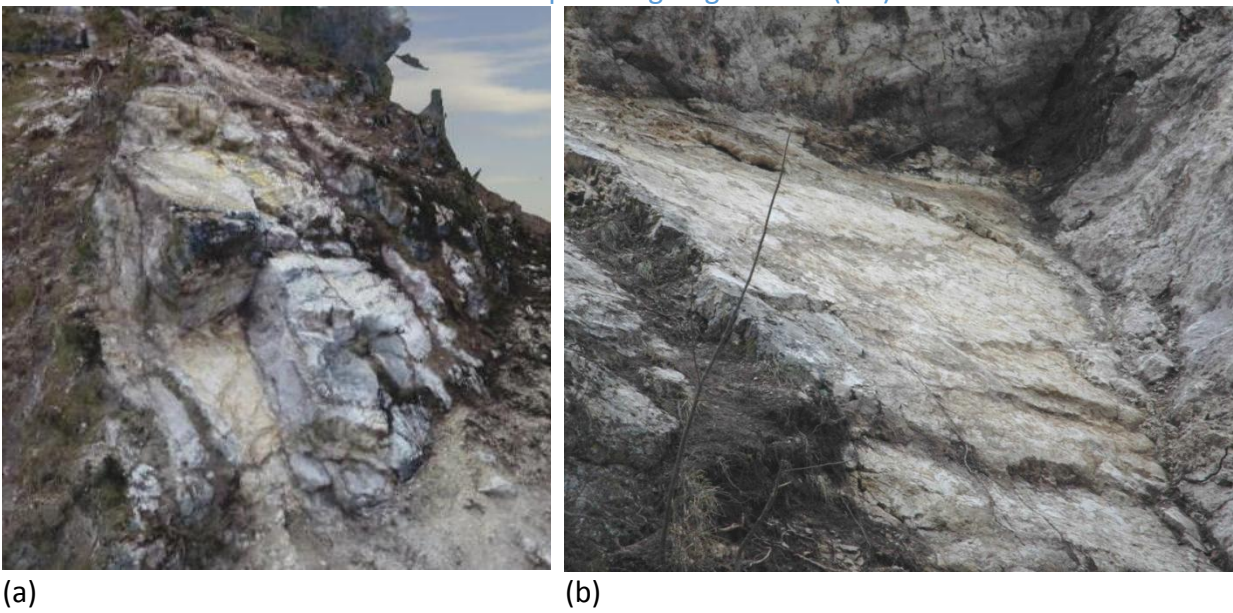
A major failure occurred on the northeast flank of the valley at km 4 of SP 134 within the Maiolica limestone formation (Figure 4.64a). The subsequent rock avalanche invaded the motorway and the valley bottom below for a stretch of about 70 m with large blocks (Figure 4.64b and Figure 4.64c). The main slide scar, located on a rock spur, suggests that the slide was planar and occurred along a surface composed of a number of bedding joints dipping parallel to the slope. Bedding dip progressively increases from top to bottom of the slide scar (about 15°). The sliding surface is stepped both longitudinally and transversally (Figure 4.65a) due to well-spaced joints of two sets roughly striking parallel and normal to the slope. On the left side (viewing from the opposite, southwest, valley flank) the slide had no confinement. Bedding joints are relatively planar and smooth with apparent signs of weathering and oxidation (Figure 4.65b). Weathering seems to affect also the sub-vertical joints. The rock mass appears to be loosened and the rock material intensely fractured.

Figure 4.65. Close-range drone image of the detachment area (a) and detail of a bedding joint forming the sliding surface taken from the slide foot (b).

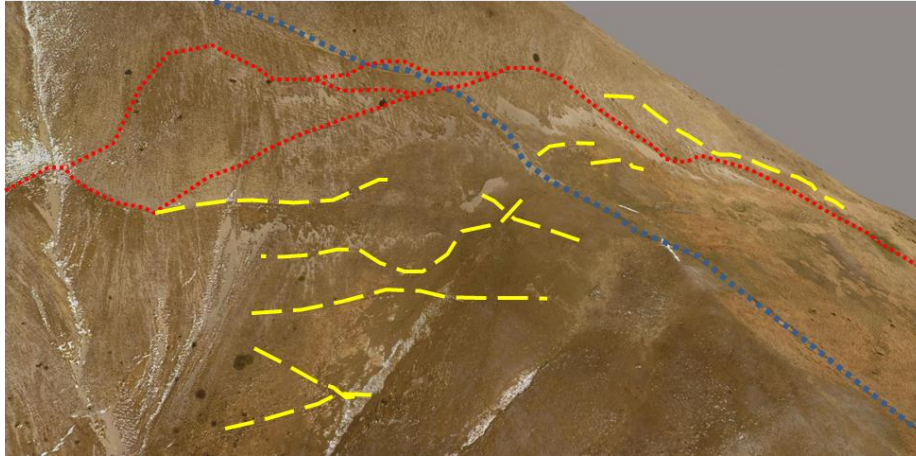
One means of identifying fault versus slope instability deformations or compaction of talus was lateral movement. Scarps with lateral (strike) offset were interpreted as related to the fault, while scarps with no lateral offset were interpreted as caused by slope instability or compaction of talus. Thus, two main factors were used to determine fault versus slope instability: 1) rock outcrop proximity and 2) lateral offset. When examining 3D SfM or LiDAR based point-cloud models, it is impossible to differentiate between the slope instabilities and fault movement since rock outcrops can be difficult to discern due to tall grass and low coniferous shrub vegetation and the inability to see lateral displacements over such a large area. Conventional field mapping thus still plays an important role in determining fault movements.

Figure 4.68. Excerpt from 3D SfM model from UAV data of the side of Mt. Vettore. The blue dashed line indicates the footpath. Red dashed line indicates scarps interpreted as the fault rupture trace(s). The yellow lines indicate scarps interpreted as minor slope instabilities. Looking from the west to the west face of Mt. Vettore. On the right of the image the slope descends on the south face towards road SR477.

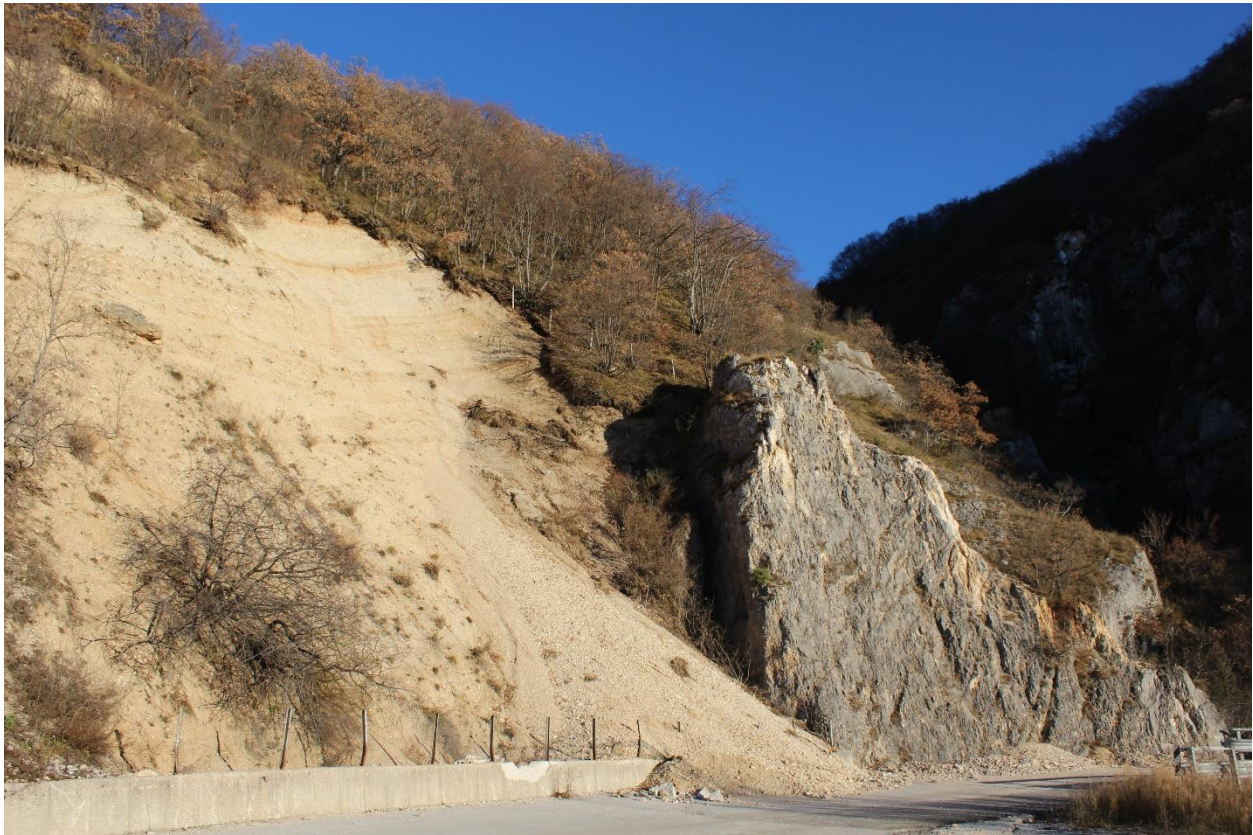
Figure 4.76. Debris avalanche along the scarp of a previous landslide.

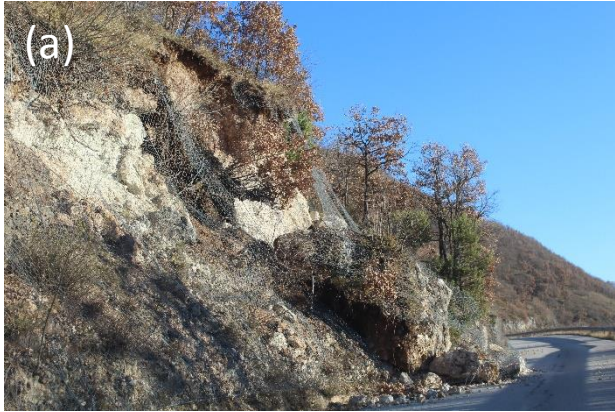
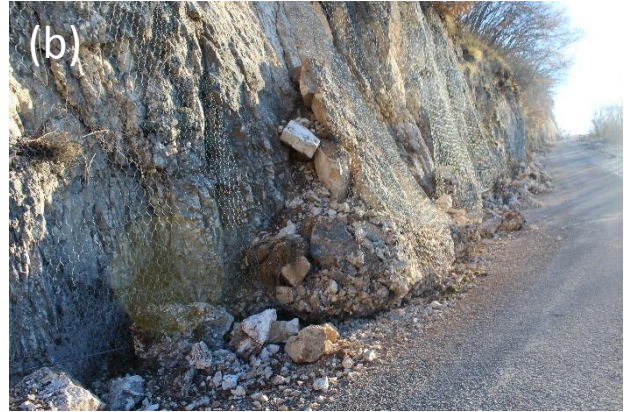
Figure 4.77. Debris and boulders captured by the rockfall protection nets.

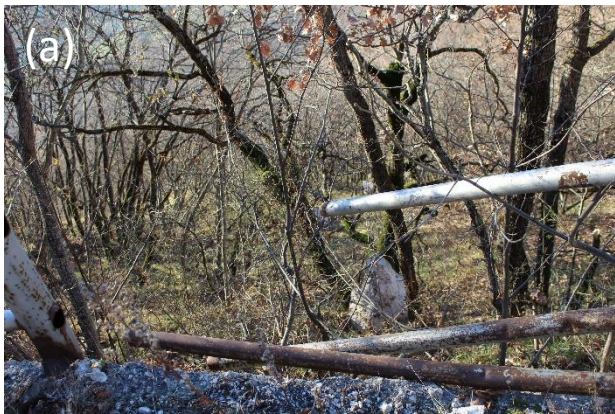
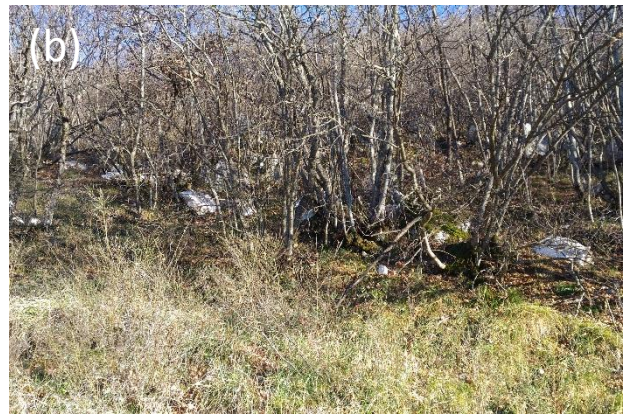
Figure 4.78. Boulders supported by the vegetation.

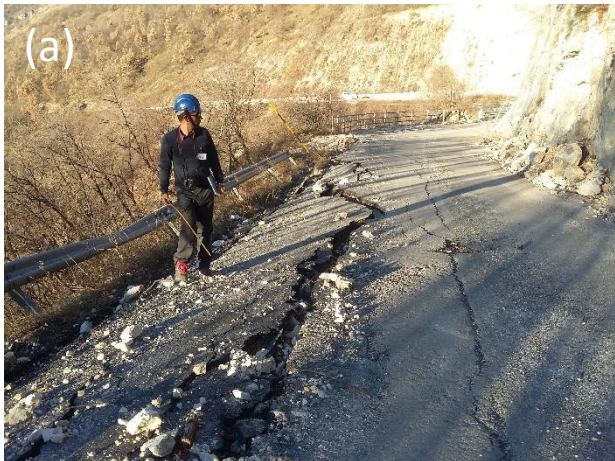
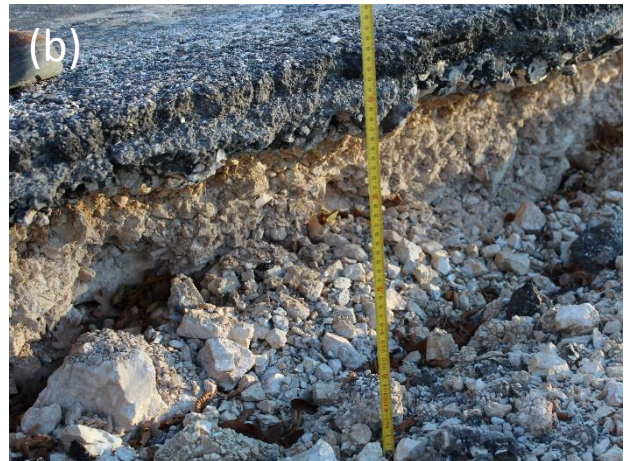
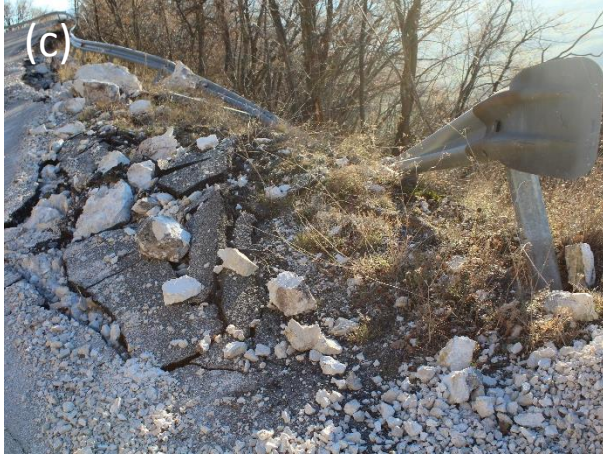
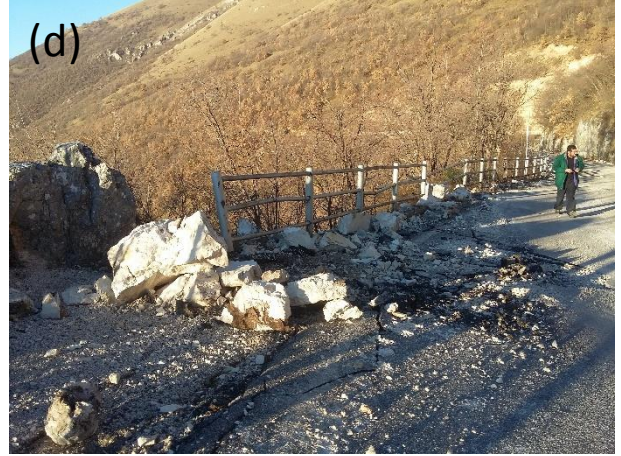
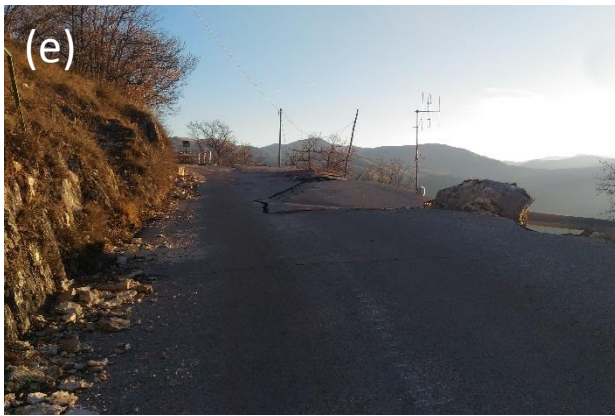
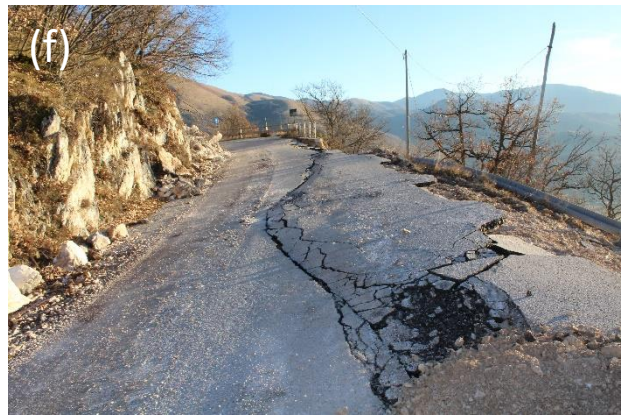
We performed a field reconnaissance along the SP 477 (indicated in Figure 4.71). During our visit (December 10, 2016), public vehicular movement along the road was not possible because of pavement fissures, embankment failures and rock obstructions. Indeed, several rock fall sites and mass movements along SP477 were observed between 42.776881N 13.143958E and 42.770243N 13.151854E. Roadway damage mainly consisted of cracks along the road, uneven track trails, edge barriers destroyed by rock falls, and damaged rock protection nets. Several boulders were unstably supported by vegetation on the steep mountain slopes. Due to steep slopes, most of the falls should have run down, however countable debris was still present on road pavement during our visit. Generally, boulder sized rocks were present in debris and the same sized were found in the unstably supported condition. A systematic overview of the various damage features is presented in Figures 4.74-4.79. Minor damage in culvert was observed across the road section. A telecommunication facility near the road pavement was found to be not damaged due to rockfall (see Figure 4.80).

Figure 4.79. Fracture along the road, large vertical offset due to fracture and ultimate movement, damaged edge barriers and debris and boulders on the road surface.

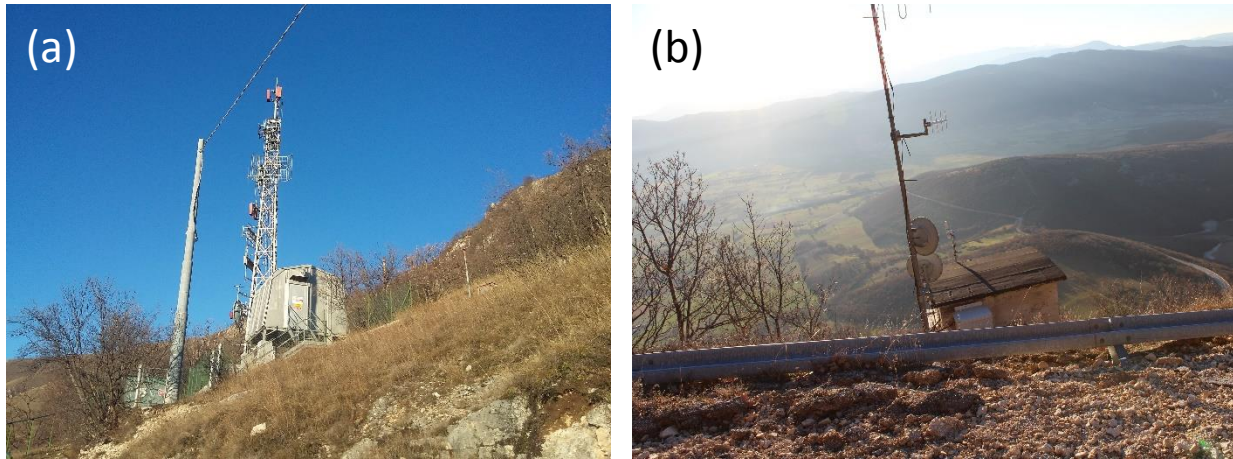
Figure 4.80. Telecommunication facility (a) over and (b) under the road.

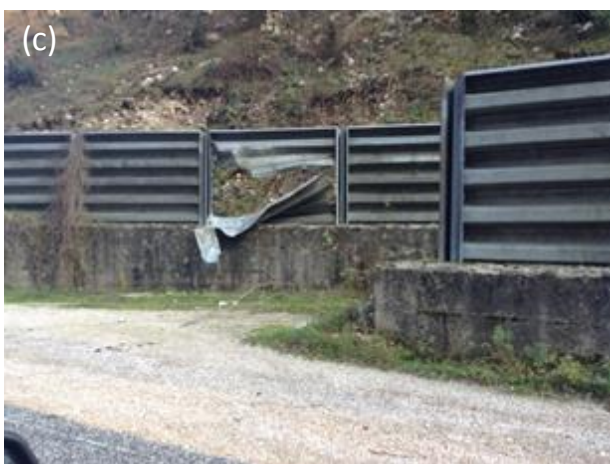
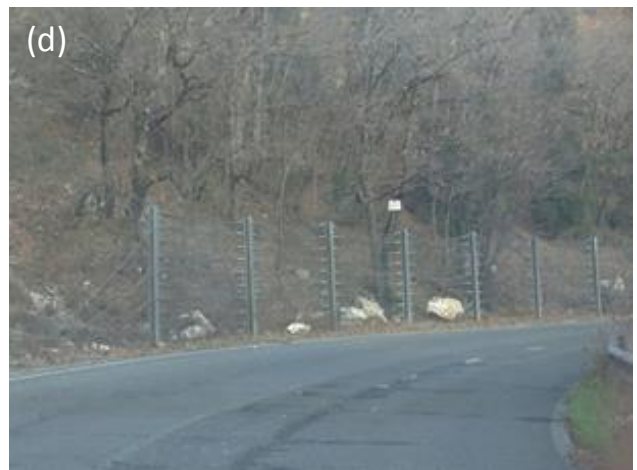
The area has been subjected to slump failures in the past. As a result, slope protections (i.e. rockfall nets, dynamic rockfall barriers or catch fences) are present along the road. Figure 4.83 shows many cases in which rock-nets have been passed over or damaged by boulders and rock-blocks. The slope located on the right bank of the Nera river has been interested by various slope instability events. They consisted of gravel debris. These features (Figure 4.84) are similar to those observed for the Nera landslide (Section 4.2.1) but very limited spatially and in volume.

Figure 4.83. Slope protection damaged by boulders and rock-blocks.

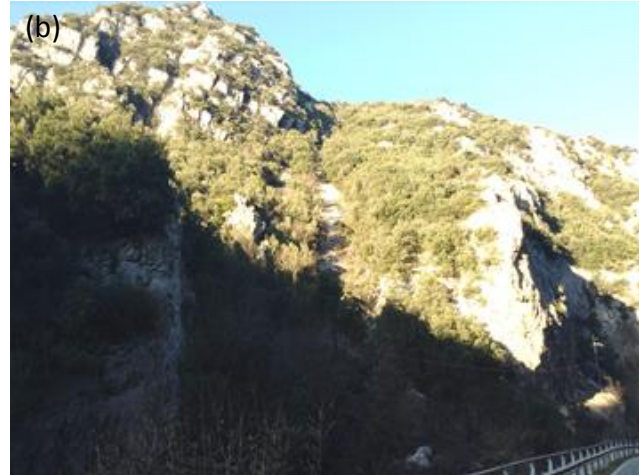
Figure 4.84. Debris occurred on the right bank of the Nera river along SP209 (lat 42.9157N, lon 13.0456E).

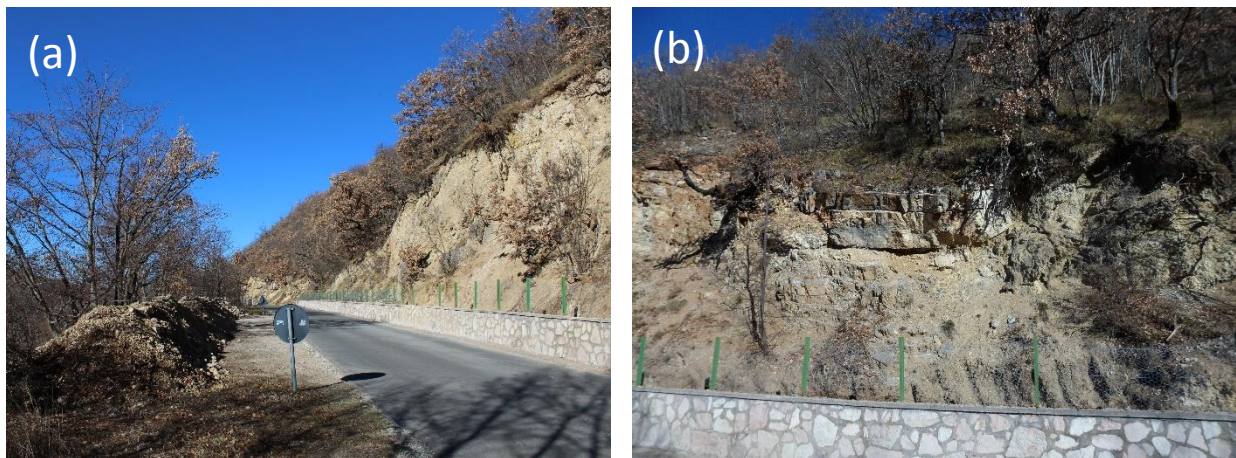
Along the SP746 road between Cittareale and Norcia a localized landslide was observed (Figure 4.87). The landslide was located in the vicinity of the *Calcareous Breccia* failure site as reported by earlier GEER report (see GEER 2016). The landslide occurred in the carbonate sequence named Corniola as from the geological map of the Umbria region (<http://www.regione.umbria.it/paesaggio-urbanistica/cartografia-geologica-per-google-earth>). From a general inspection of the area, no damage to the road was observed however the debris from the road was already cleared during our visit (Figure 4.88) so that a minimum level of damage can be assigned. The overall mass movement was confined to ~50-70 m. Along the mass movement site, a retaining structure was present that appears to have limited damage. The wall itself was undamaged (Figure 4.89). Other nearby locations presented some rock falls although such rock falls were confined to rockfall protection nets and no road obstructions were observed (Figure 4.89). In case of absence of rockfall protection nets, debris including boulders were observed beside the pavement (Figure 4.89).

Figure 4.88. Landslide between Cittareale and Norcia along the SP746: (a) General view of the area; (b) Zoom on the crown and main body of the scarp.

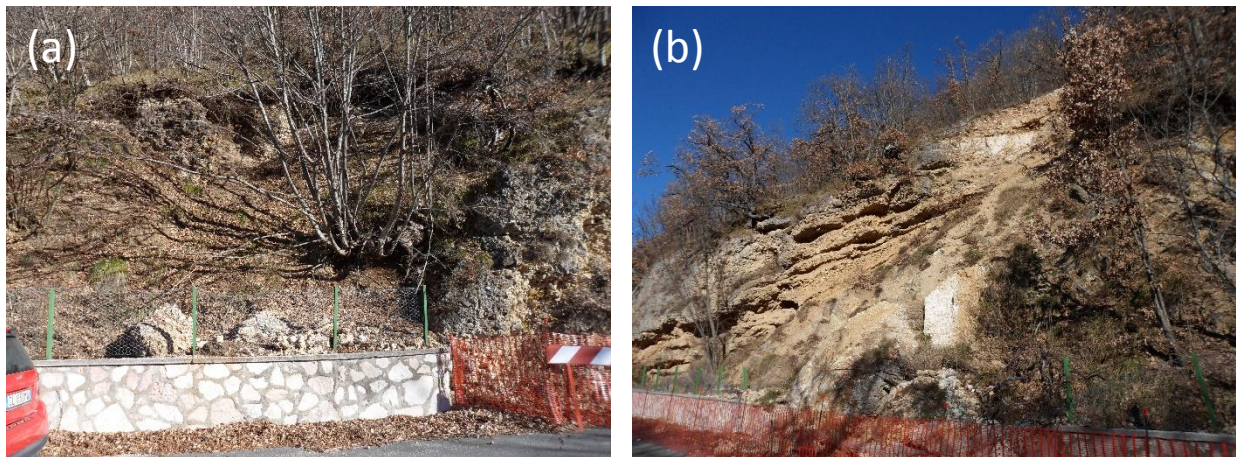
Figure 4.89. Failure in calcareous breccia between Cittareale and Norcia along the SP746: from (a) to (e) view of the all facade; (f) rockfall on the road.

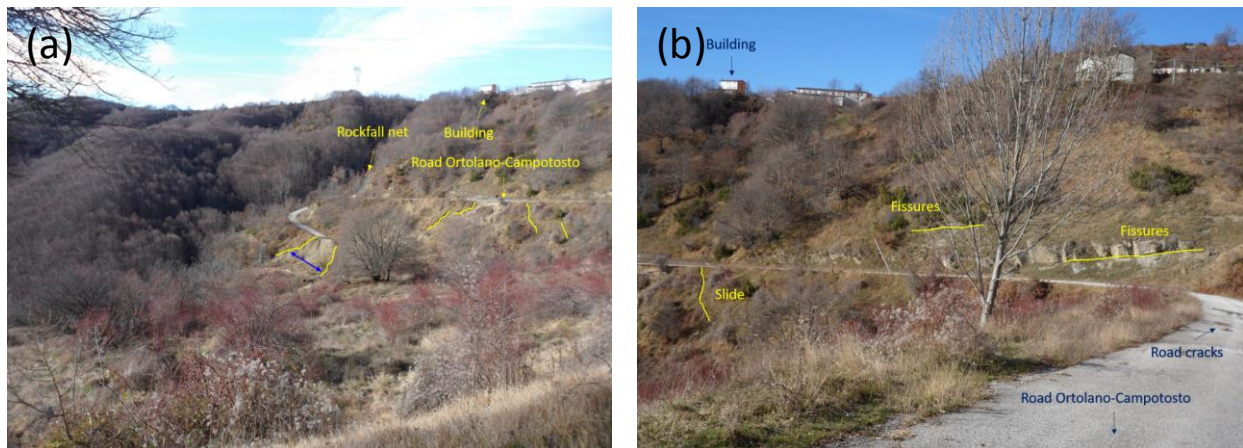
We observed a shallow landslide along the road of Ortolano-Campotosto (Figure 4.90). Figure 4.91 shows the extension of this feature. Along the whole longitudinal extension of the landslide, there is a cut and fill road. The landslide has a spatial extension, along the road of 100 m, with observed maximum vertical offsets of 3-5 m. According to the official geologic map of Italy (sheet 139, 1:100,000 scale; http://193.206.192.231/carta_geologica_italia/tavoletta.php?foglio=139, last accessed April 29, 0217) and the ISPRA geologic map (sheet 349, 1:50,000 scale; http://www.isprambiente.gov.it/Media/carg/349_GRANSASSO/Foglio.html, last accessed April 29, 0217), the formation in this area comprises highly fractured sandstones and marly-clayey strata. The sandstone stratum, is buried by a weathered soil cover, which was affected by the observed landslide feature.

Figure 4.91. (a) Overview of the whole longitudinal extent of the landslide area; (b) close up view of the landslide-related features from the road Ortolano-Campotosto.

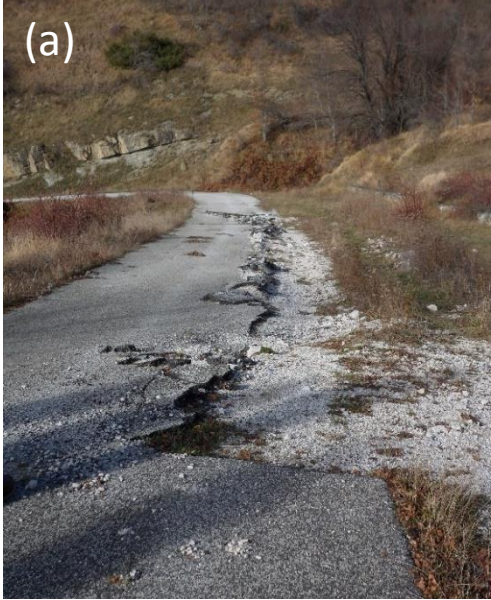
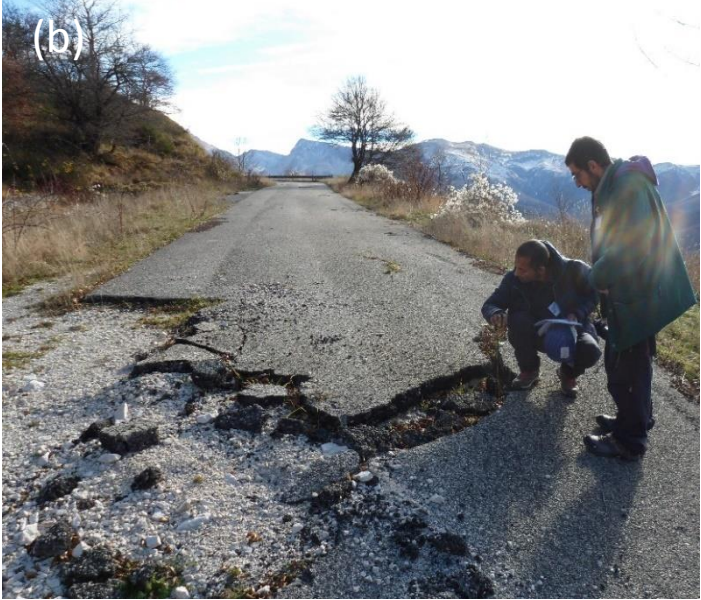
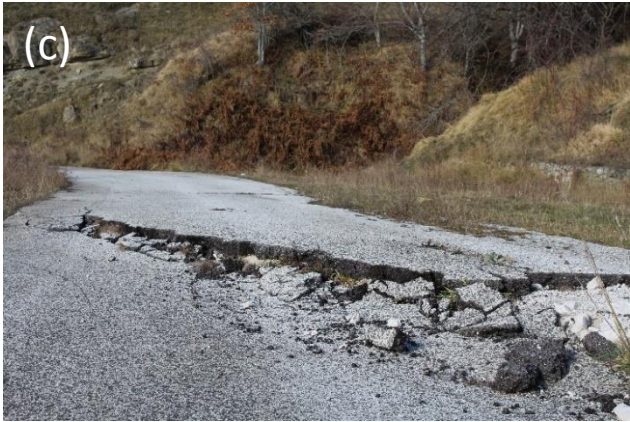
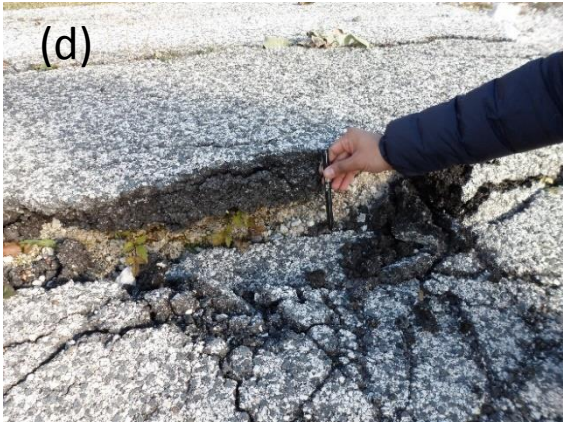
On the exposed surface of the landslide we observed silty clay with traces of sand, gravel, and cobbles. Figures 4.92-4.96 show several cracks on the road, fissures and minor scarps on the cut slope, and minor slide features on the fill slope. We did not observe major damages on the slope protections (i.e. rockfall nets) present along the road (Figure 4.97)

Figure 4.92. Cracks along the road.

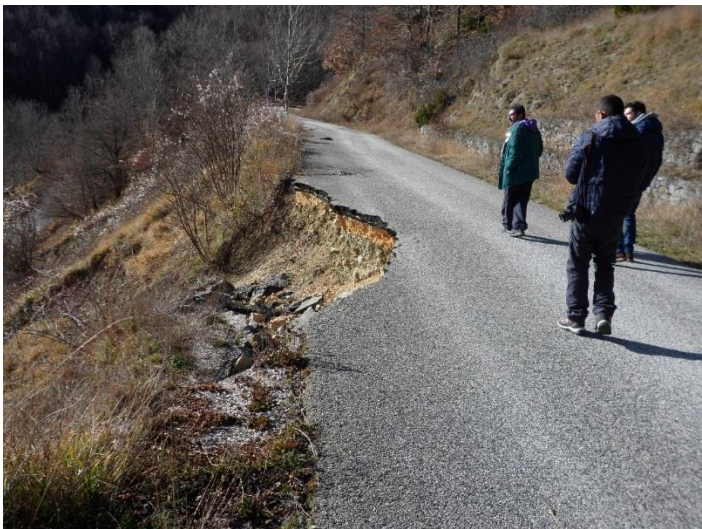
Figure 4.93. A slide observed on the fill slope.

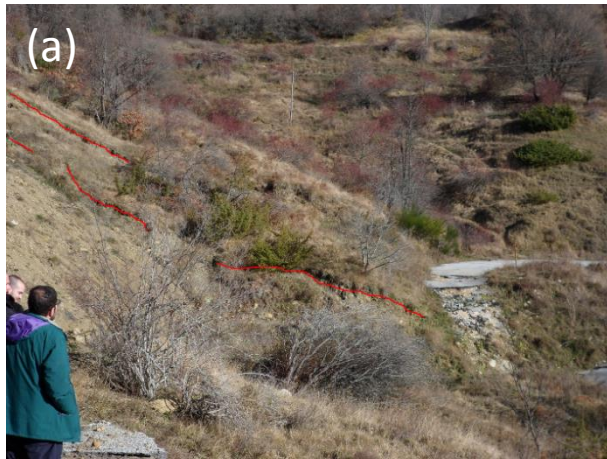
Figure 4.94. Fractures on the cut slope.

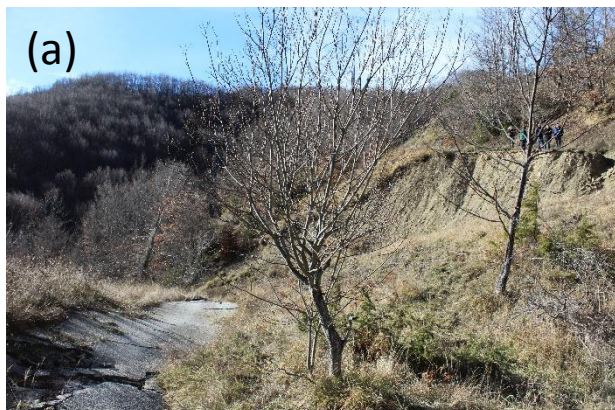
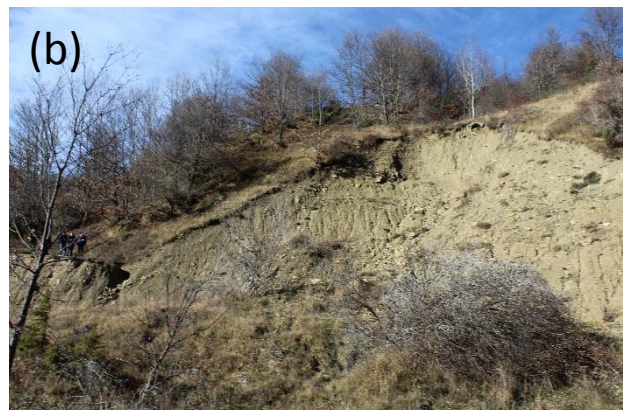
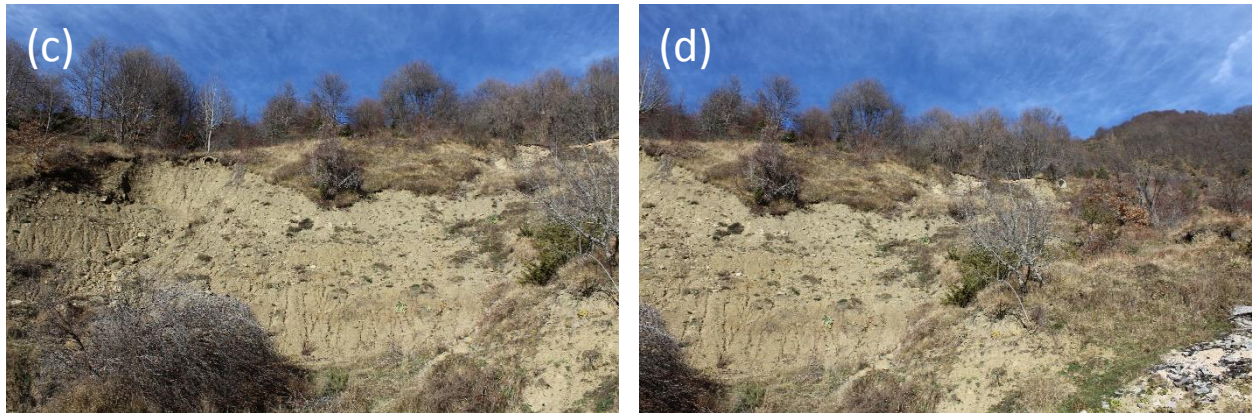
Figure 4.96. Minor scarps observed on the cut slope side of the road.

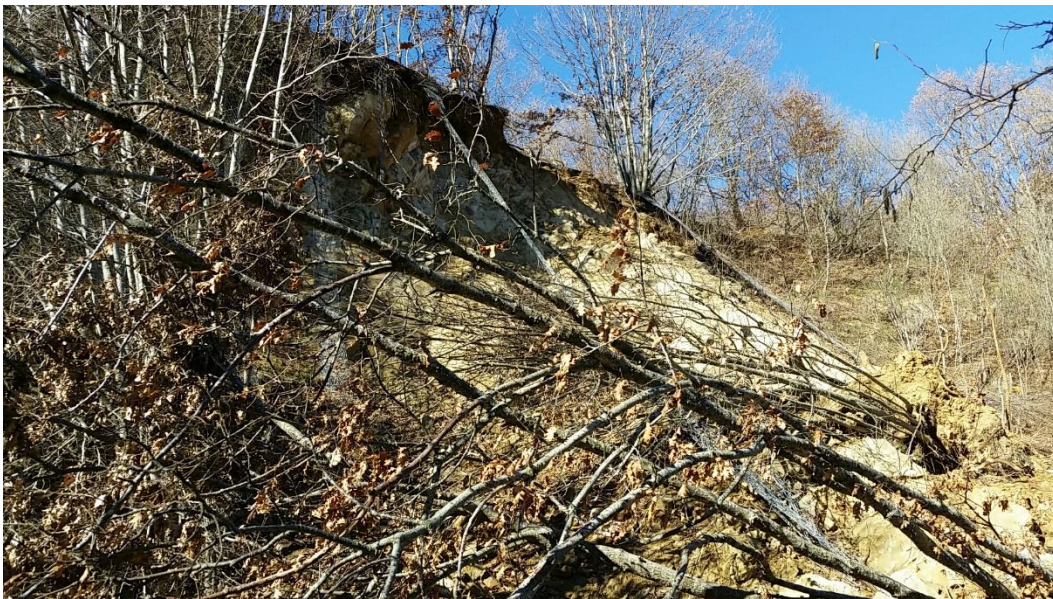
Figure 4.102. Landslide debris and head scarp. Also pictured is rockfall netting.

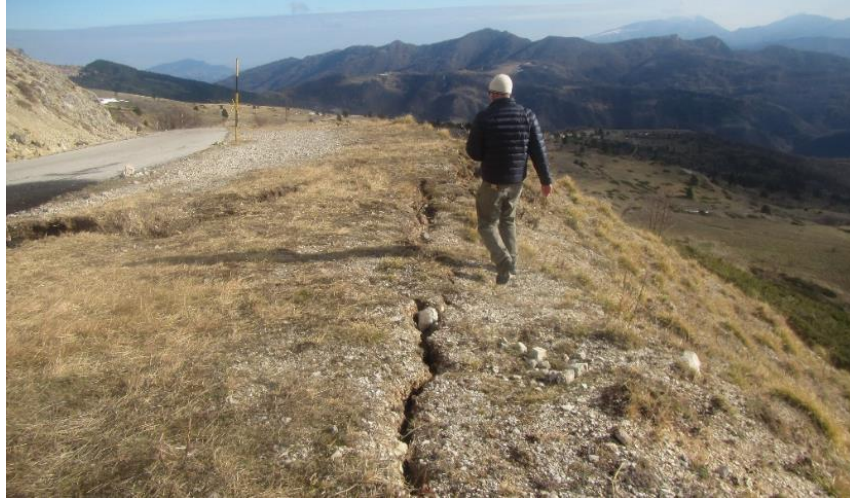
Figure 4.105. Road embankment damage along SP477 road, Mt Vettore (Location 19, viewing North). Note fault trace across road and black (new) bitumen repairs following previous (24 August 2016) earthquake.

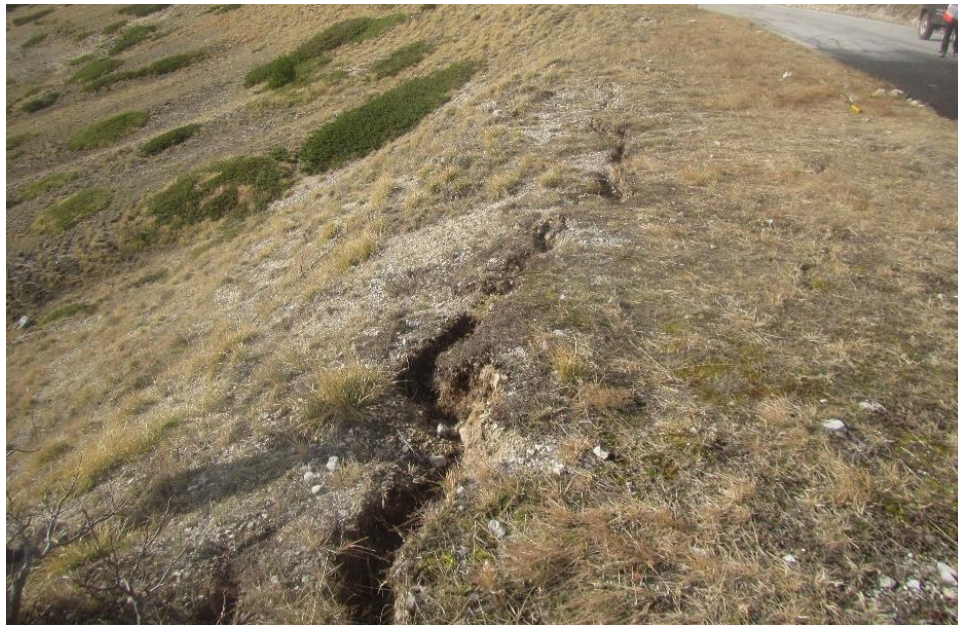
Figure 4.106. Road embankment damage along SP477 road, Mt Vettore (Location 19, viewing west).

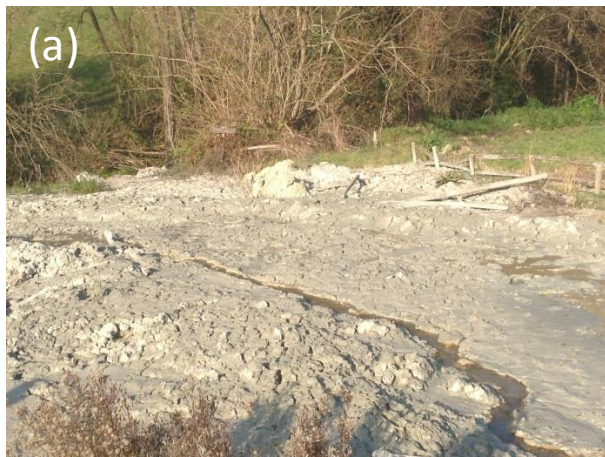
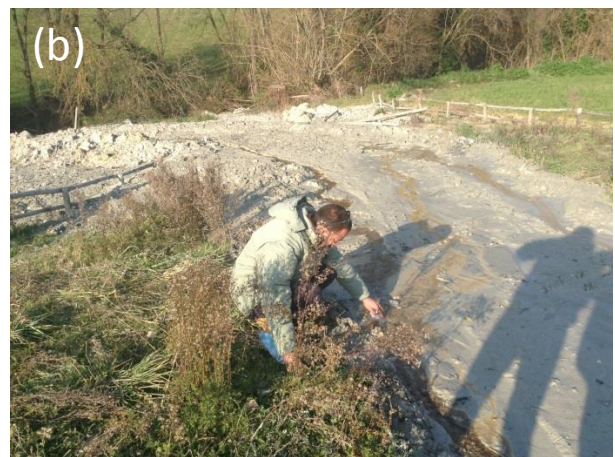
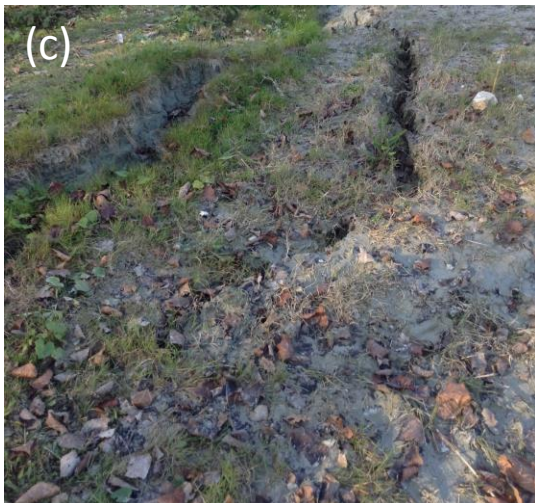
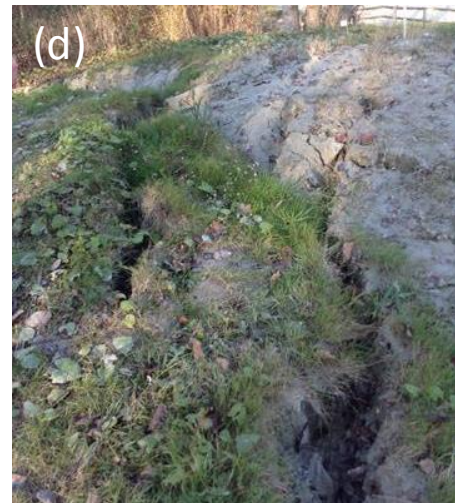
We inspected two mud volcanoes that erupted within one day from the **M6.5** 30 October earthquake event (Figure 5.3): (1) Santa Maria in Paganico (Figures 5.4a-b) and (2) Valle Corvone (Figures 5.4c-d-e-f). In both cases, we observed fresh deposits of ejected material. Both eruptions, are located within 45 km from the epicenter. . During our reconnaissance activities, both mud volcanoes showed a reduced activity, with a small emission of water. We inspected the sites about one month after the INGV reconnaissance mission. We did not detect any new activity or variations in the soil surface conditions in the inspected area as shown in Figure 5.5. As shown in Figure 5.4c-d-e-f, the material erupted by the mud volcano located in Valle Corvone covered a wide area involving both the river and the pavement of the road. This mud volcano is characterized by radial fractures 140 cm long, 38 cm wide and 80 cm deep. This eruption partially blocked the Ete river's course (Figure 5.4f).

Figure 5.4. (a) overview of the mud volcano in Santa Maria in Paganico; (b) sampling activities in in Santa Maria in Paganico; (c) crack originated by the mud volcano in Valle Corvone, (d) mud volcano in Valle Corvone, (e) details of a crack in Valle Corvone, (f) close-up view of the material ejected in the Ete Vivo river (Valle Corvone).

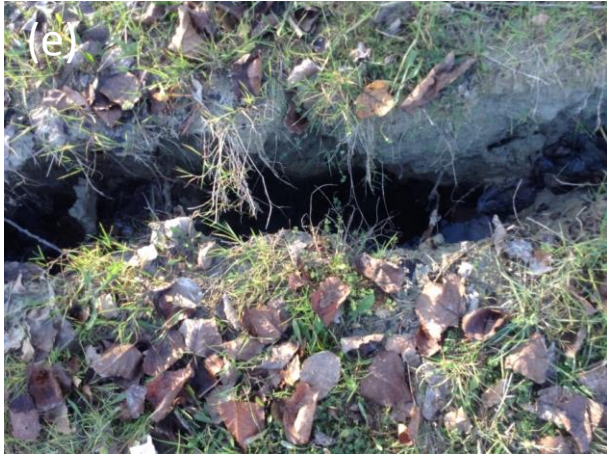
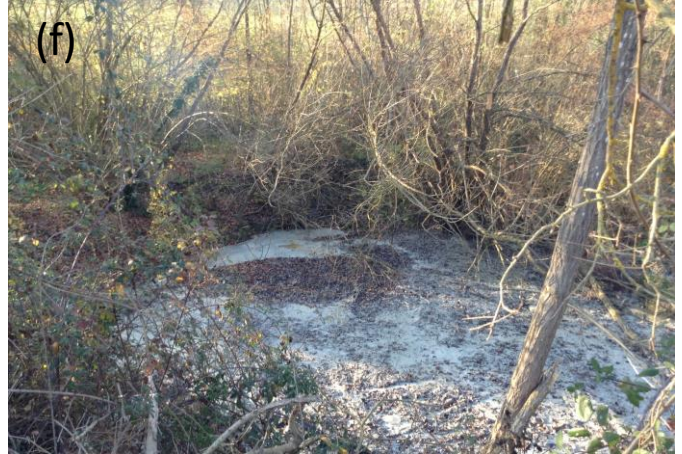
Figure 5.4b shows the sampling activities performed in Santa Maria in Paganico. We sampled soil and water erupted from the volcano in Santa Maria in Paganico (SP1), and soil in Valle Corvone (SP2). Both samples were taken on 13 December, 2016. We performed conductivity, alkalinity, and chemical analyses on the water erupted from the volcano in Santa Maria in Paganico (SP1); sieve analysis, along with Atterberg limits on soil ejected by both volcanoes (SP1 and SP2). The erupted water presents a value of conductivity of $791 \mu\text{S}/\text{cm}$ and a pH of 7.97. Moreover, the chemical analysis revealed the presence of potassium (K^+), sodium (Na^+) e magnesium (Mg^{2+}). The water appears to be slightly alkaline and with the presence of alkaline-earth materials. No metal elements have been found. These values are consistent with typical ranges observed in other mud volcanoes globally.

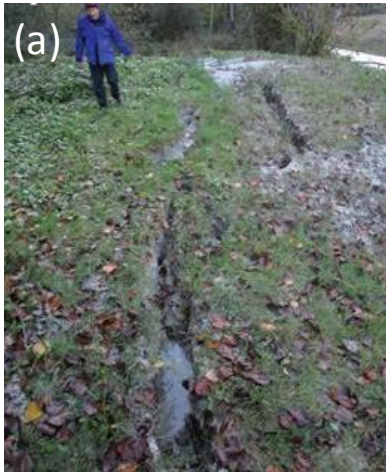
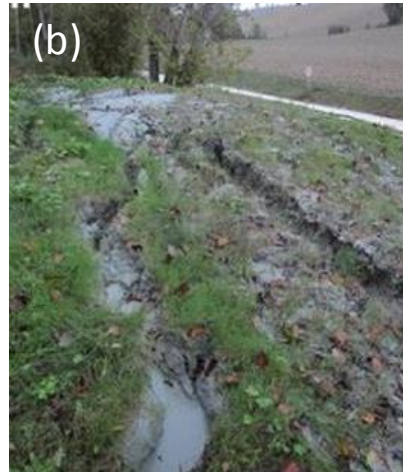
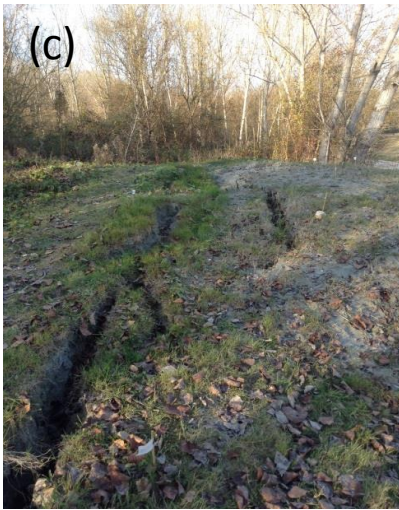
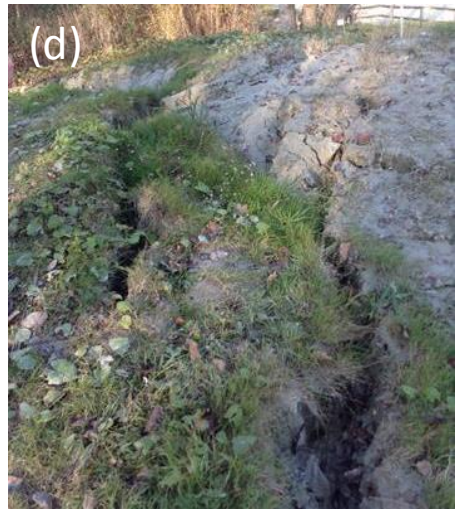
Figure 5.5. (a) and (b) photos of the mud volcano in Valle Corvone taken by INGV in November 2016 (INGV, 2016); (c) and (d) photos of the mud volcano in Valle Corvone taken from a common perspective by GEER in December 2016.
