Engineering Reconnaissance following the October 2016 Central Italy Earthquakes - Version 2

Engineering Reconnaissance Following the October 2016 Central Italy Earthquakes *Version 2*

Geotechnical Extreme Events Reconnaissance Association
Report No. GEER-050D
8 May 2017

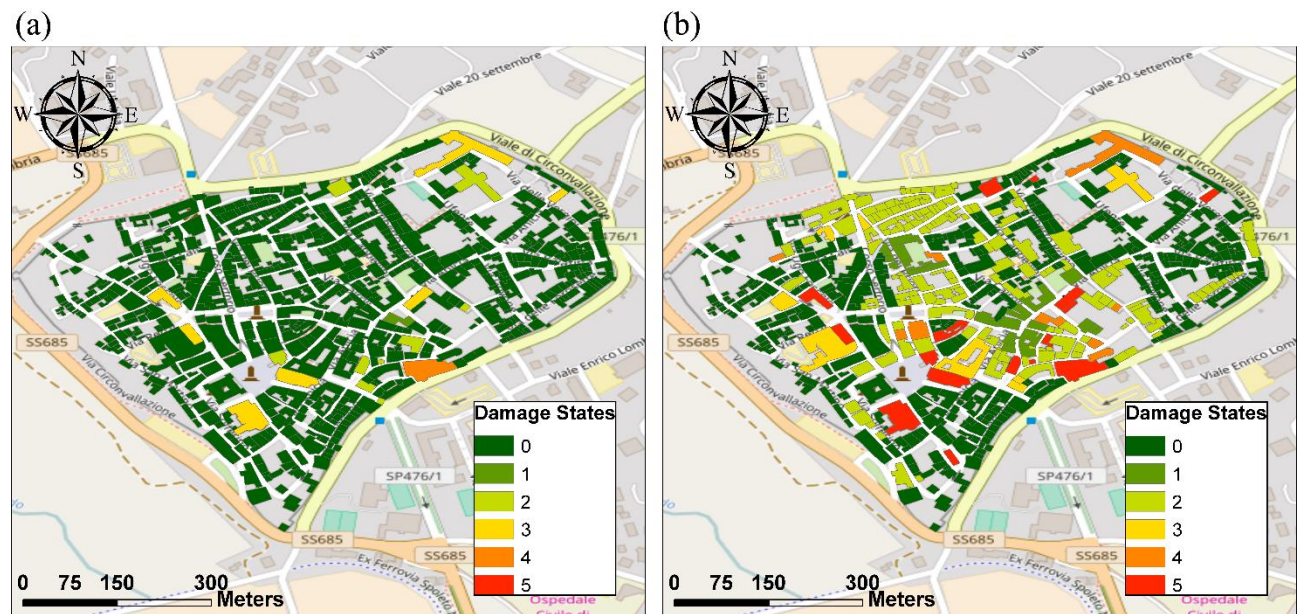
Norcia's buildings were not severely affected by the first event in August 2016. After the multiple October events, several structures suffered moderate-to-significant of damage or collapse. Figure 6.1 shows the evolution of damage between the two inspections. The distribution of Damage States among the buildings inspected in the red-zone of Norcia is shown in Figure 6.2. These figures show that the structural damage in Norcia was much more severe in the October events than in the earlier August events.

Even though the majority of the building stock is masonry, there is no disproportional damage observed between the first and the sequence of seismic events (Figure 6.1). This is because, unlike Amatrice (Section 6.1.3), the initial damage state of most buildings after the August earthquake was D0, hence the structures had adequate strength to resist the subsequent earthquakes. By focusing more carefully on Figure 6.2, it is also evident that the few structures that suffered damage during the first event, indeed presented a disproportional level of damage increase shifting from DS3 to DS5. Based on the above comparative assessment it can be concluded that masonry structures are particularly prone to failure under cascading seismic events provided that one event in the sequence initiates non-catastrophic damage, a fact that highlights the importance of quick visual inspection and reliable retrofit.

Figure 6.1. Evolution of damage after (a) the 24 August earthquake, and (b) the October events.

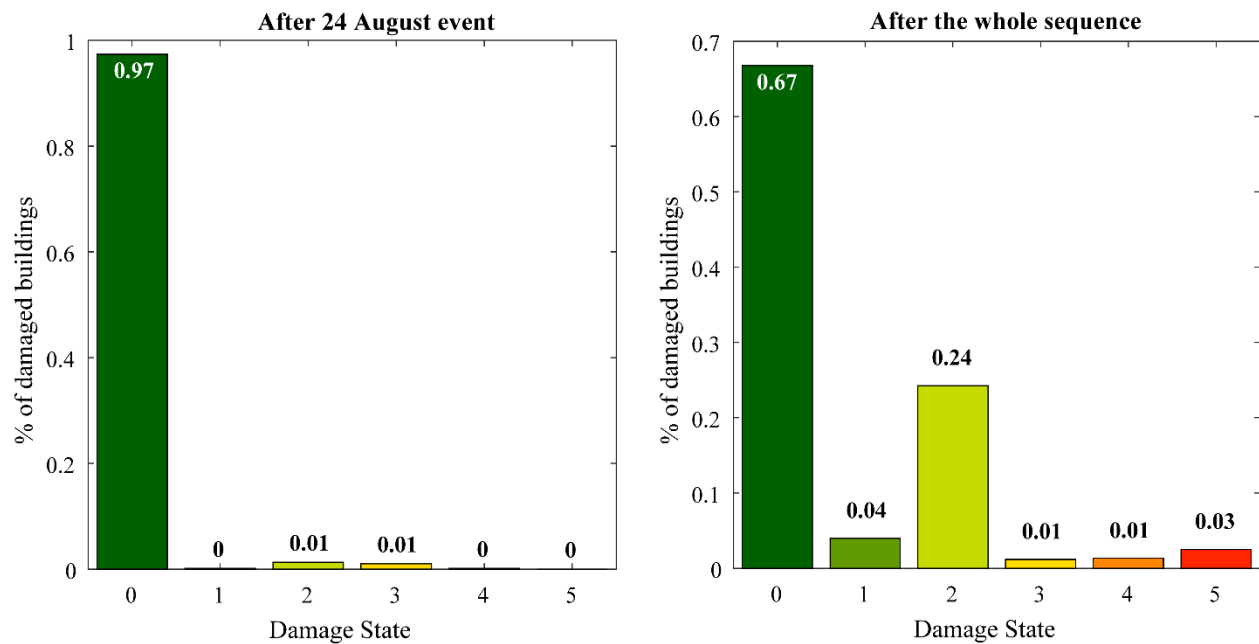
Figure 6.2. Percentage of damaged structures (a) in the aftermath of first event and (b) after the whole sequence.

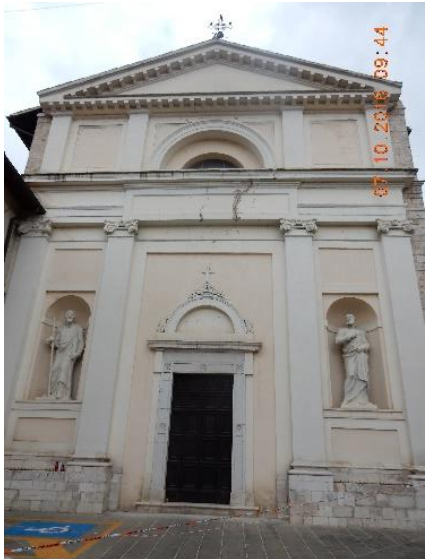
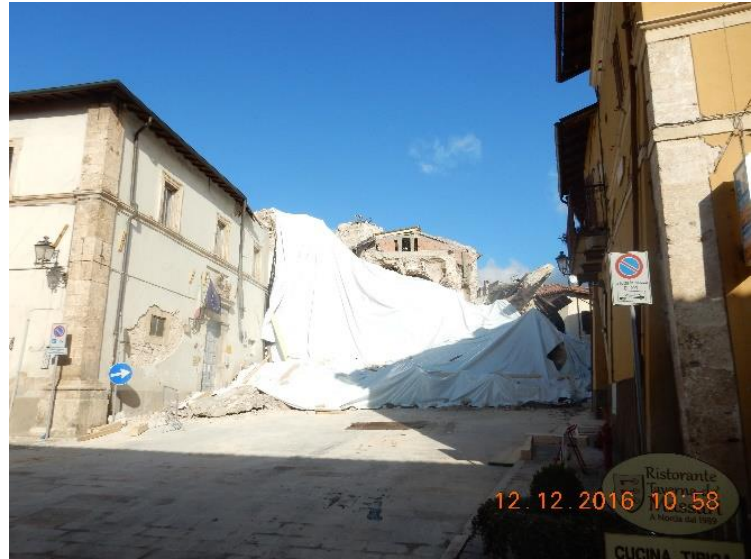
Figure 6.4. Building M1.

Apart from the wider assessment, a side-by-side comparison of significant structures with multi-epoch surveys is made. Figure 6.3 depicts the locations of the buildings presented. Figure 6.4 illustrates one of the churches that were slightly damaged by the first seismic event, but completely collapsed subsequently. Many historical churches in Norcia experienced the same kind of damage evolution. Figure 6.5 shows one exceptional case of a typical residential masonry building where the evolution of damage was rather moderate (damage state shifting from DS2 to DS3). Conversely, Figure 6.6 shows a residential building with irregular masonry construction. This group of buildings experienced an abrupt damage evolution, with an out-of-plane mechanism and increased in-plane damage. Finally, Figure 6.7 depicts the out-of-plane failure of an historical monastery leading to partial loss of support of the roof. Notably, the wall failure was concentrated at a level higher to that of the seismic retrofit, thus highlighting that local interventions should not be only localized on the ground level but also take into consideration the reduced axial load and weak diaphragm action of the masonry walls at higher levels.

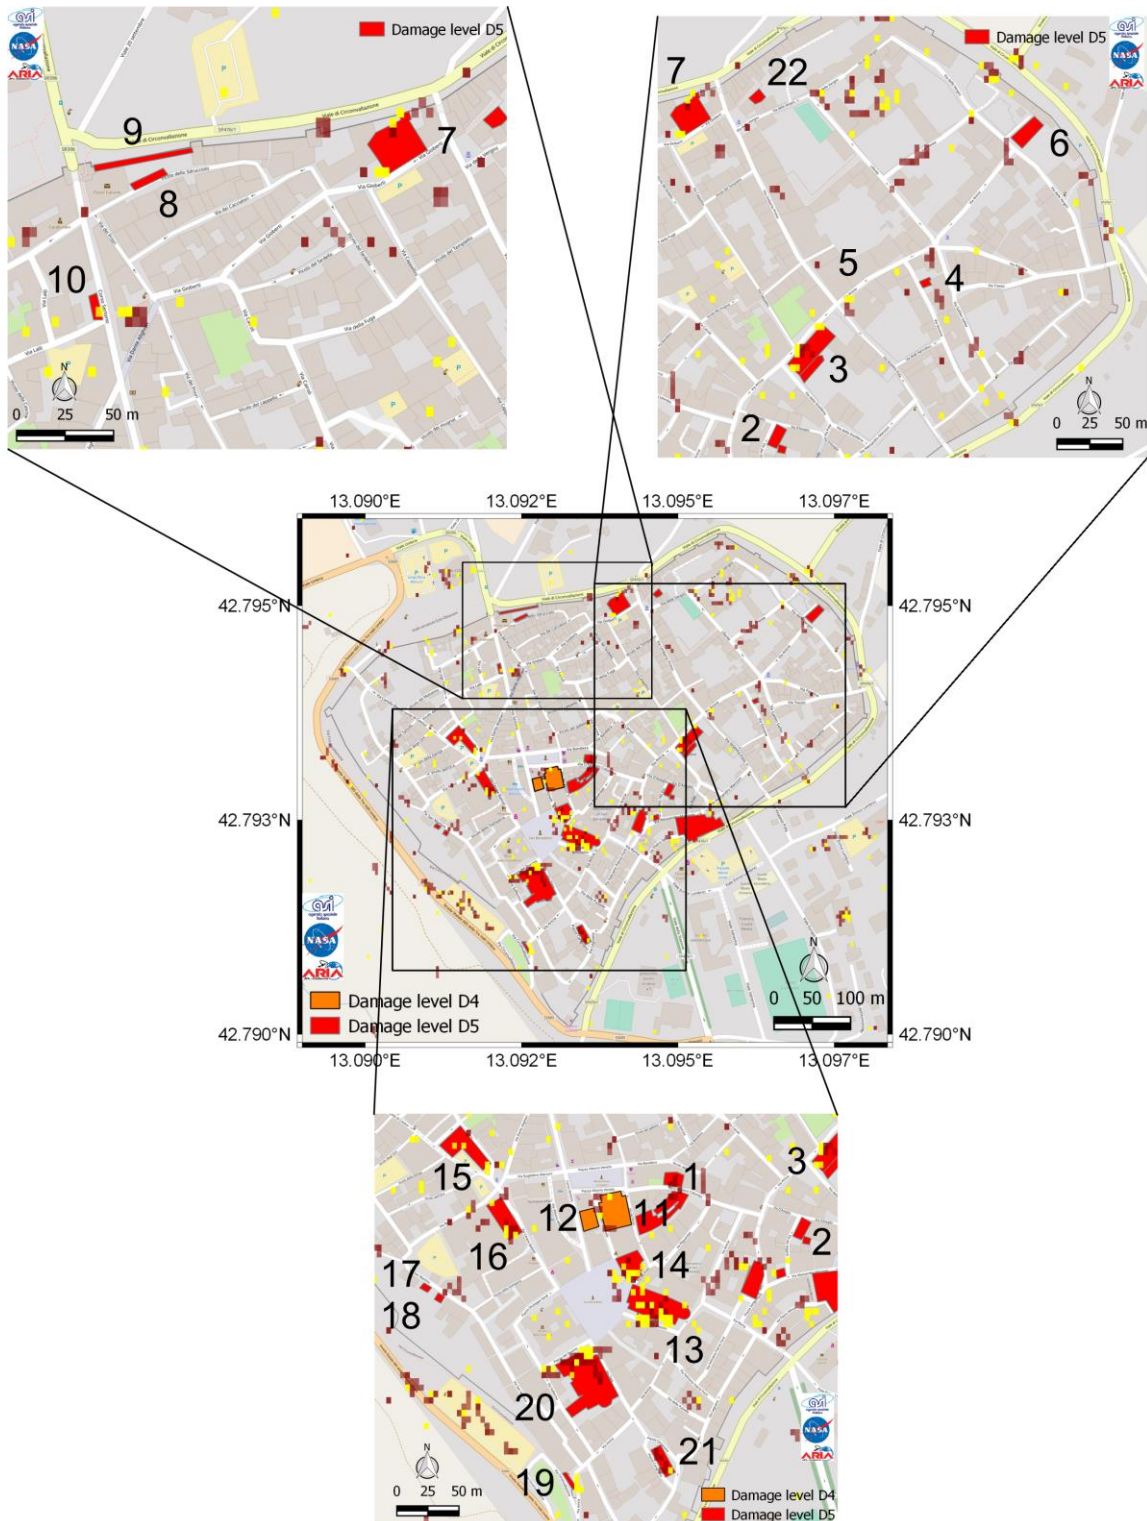
We analyze 22 structures assigned damage levels D5 and D4; within this group is the full inventory of D5 structures as identified in our field inspections. Figure 6.16 shows the spatial distribution of these structures, along with their identification numbers.

Figure 6.16. Zoom-in of the damage proxy map of Norcia, along with the identification numbers of all structures with assigned damage level D5 from field inspections and available high-quality on-site information and photos.

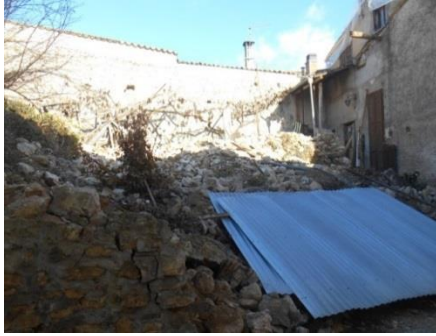
N. 1 Via Cristoforo Colombo

Figure 6.17. Pictures of all structures with assigned damage level D5 in the city center of Norcia, along with their identification numbers.

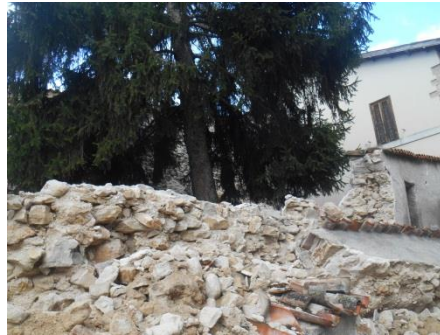
N. 8 Collapsed wall

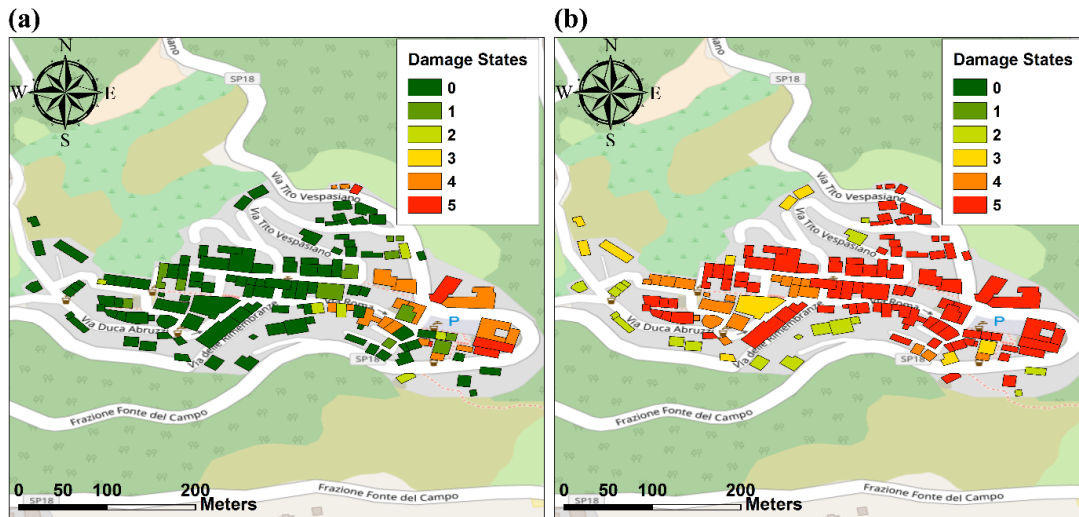
The seismic sequence in October caused total devastation of the village. As shown in Figure 6.18, the vast majority of the buildings that were damaged during the August earthquake, eventually collapsed. The evolution of damage after multiple seismic events is also evident as also depicted in Figure 6.19, where a drastic shift from low (DS0/DS1) to high (DS4/DS5) damage states is clearly observed.

Figure 6.18. Evolution of damage after (a) the first seismic event and (b) the sequence of events.

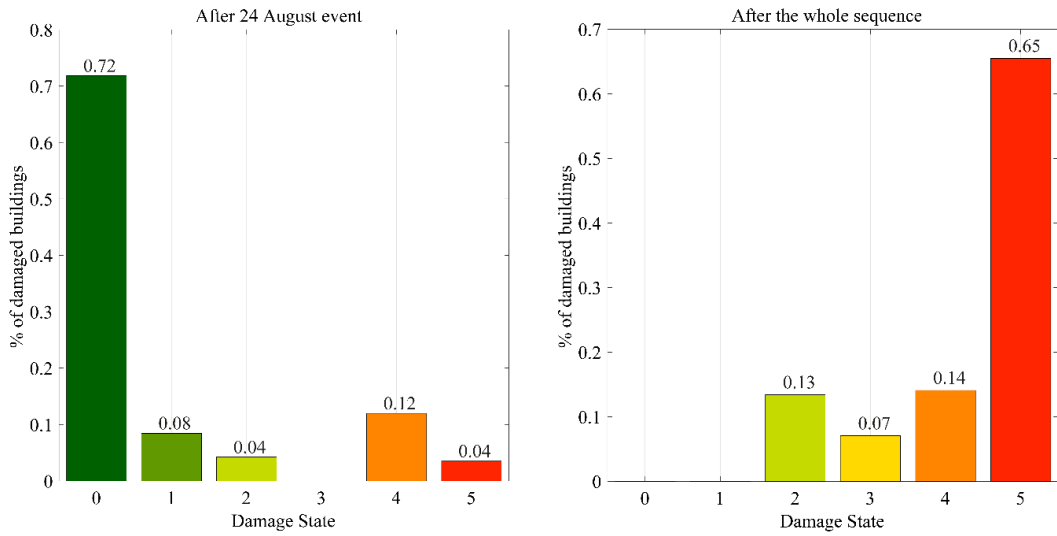
Figure 6.19. Percentage of damaged structures (a) after the first event and (b) after the whole sequence.

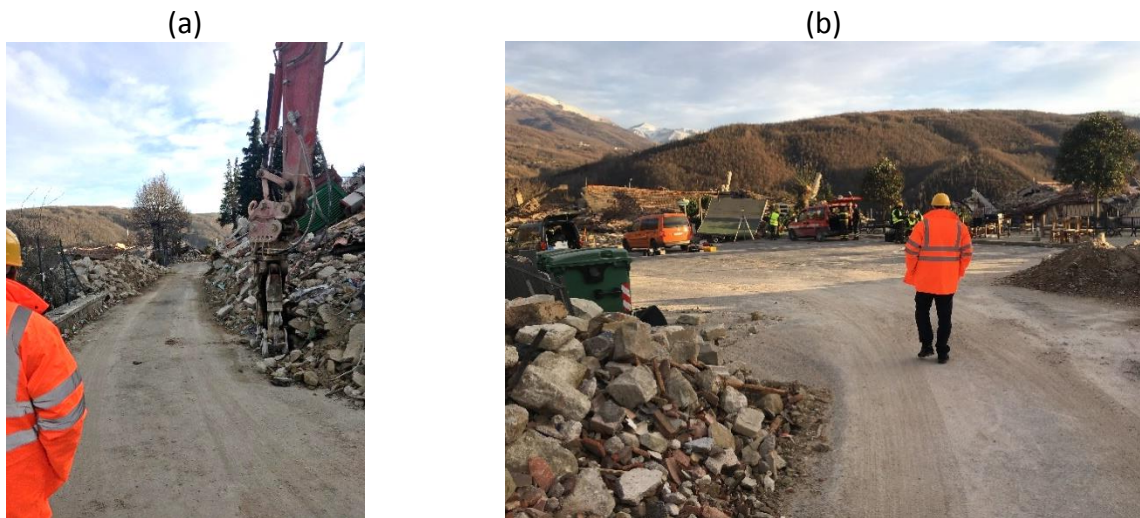
At the time of the visual inspection by the GEER team, the only accessible walking route was the one connecting the village entrance to the main square, because of the major building damage and collapse in the surrounding areas (Figure 6.20). As a result, a detailed inspection was feasible only within the eastern part of the village, the western part being inspected by means of UAVs. Figure 6.21, Figure 6.22, and Figure 6.23 illustrate the upper part of the village with a colored scale distinguishing three main zones of distinct level of damage.

Figure 6.20. (a) Access route to the lowest (easternmost) portion village (V1). (b) Piazza San Francesco (V2).

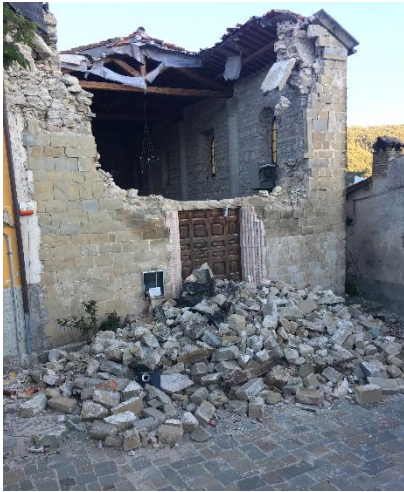
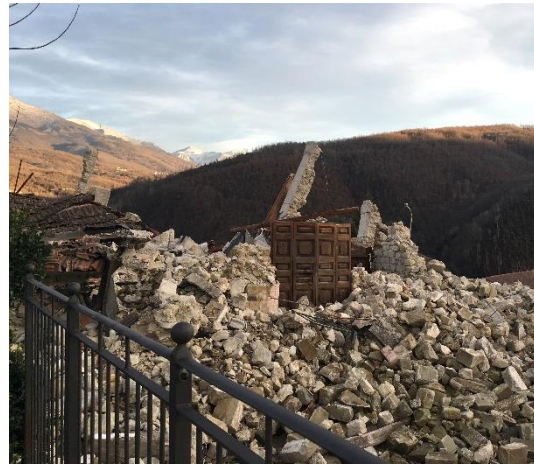
P01 (Church)

Figure 6.25. Representative pictures taken in Accumoli during the GEER survey (see Table 6.2).

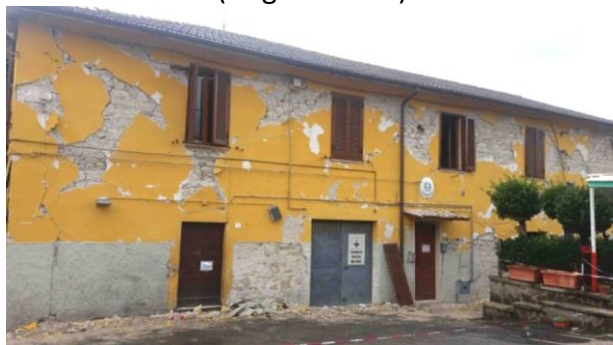
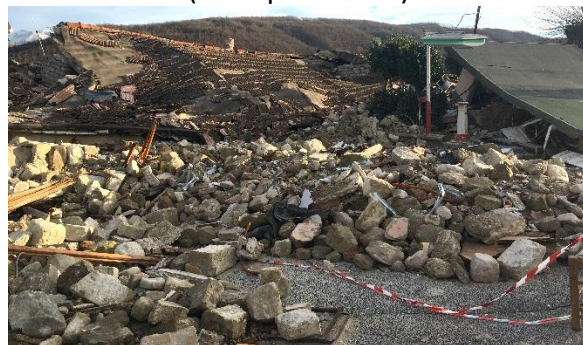
P03 (Police station, square side)

of the police station and the small church. Moreover, the retaining wall along the eastern side of the village experienced significant relative movements, most likely associated to the instability of the slope below.

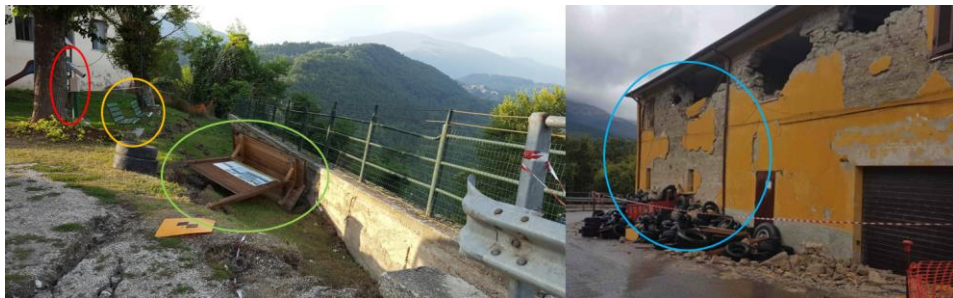
The accumulation of damage across seismic events is also evident by comparing the panoramic view of the village after the September and December field missions (Figure 6.26 and Figure 6.27). More precisely, it is seen that the retaining wall completely overturned, causing disruption of the adjacent road. It is noted that it was not possible to take the pictures from the same position, hence, colored circles are used to indicate the corresponding spots.

Figure 6.26. Representative pictures of landslide in eastern part of village (September 2016).

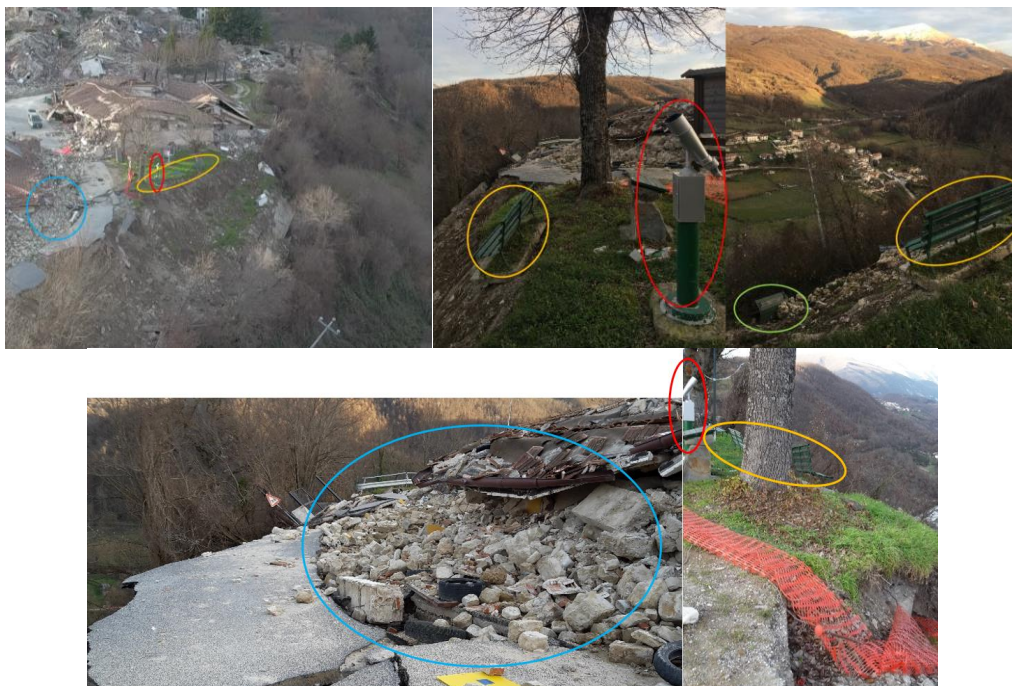
Figure 6.27. Representative pictures of landslide in the eastern part of village (December 2016).

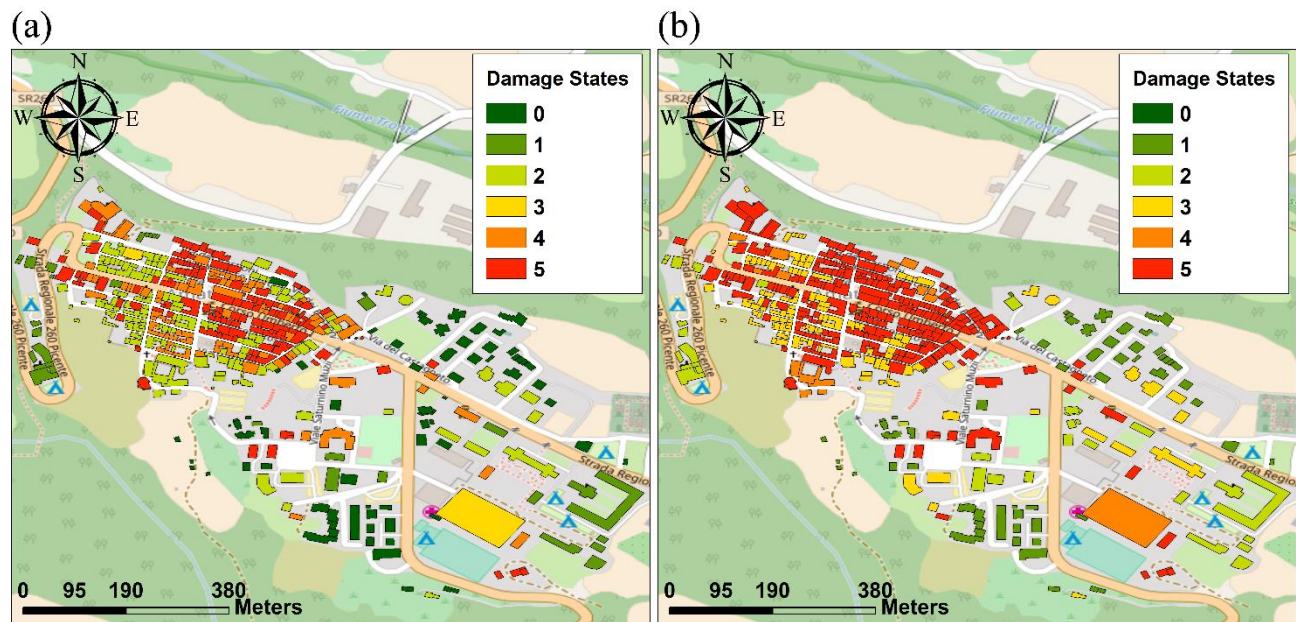
Amatrice's buildings were severely affected by August event sequence (Section 5.3.2 of GEER 2016). Many buildings that remained standing after the August events had only a small residual capacity, and then collapsed during September and October events. Figure 6.28 shows the multi-epoch damage evolution. This is also reflected in the histograms of red zone damage statistics in Figure 6.29, which show that the percentage of D5 structures increased from 23% to 42%. We distinguish performance of different structural systems qualitatively for a number of characteristic buildings, the locations of which are shown in Figure 6.30.

Figure 6.28. Evolution of damage after (a) the first seismic event and (b) the sequence of events.

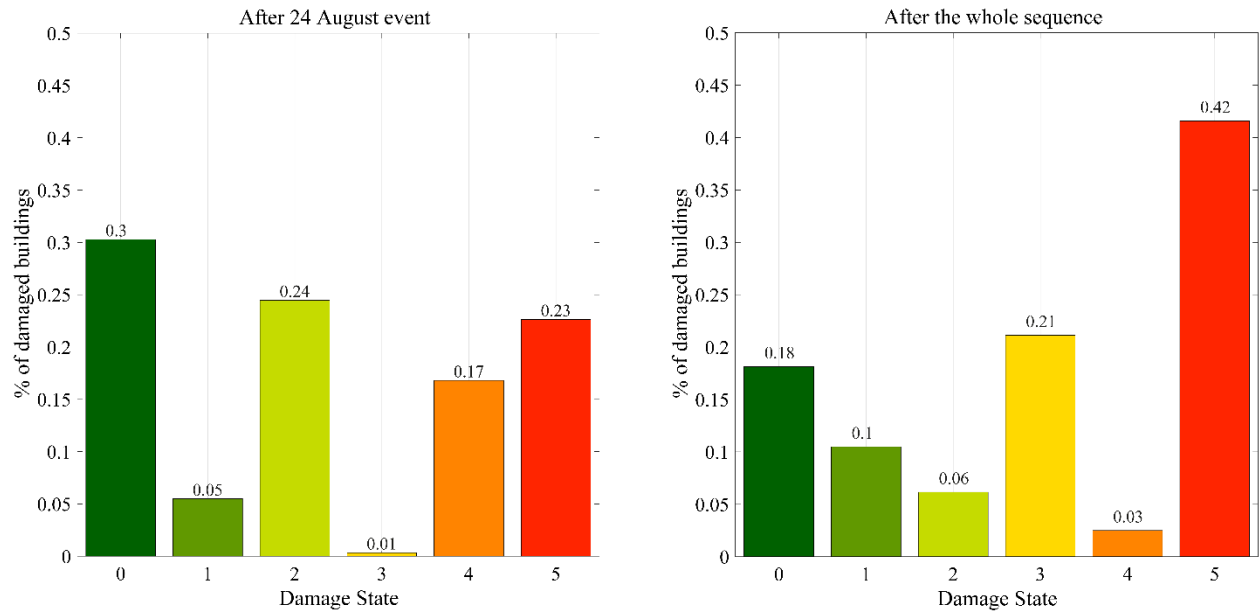
Figure 6.29. Percentage of damaged structures (a) in the aftermath of first event and (b) after the whole sequence.

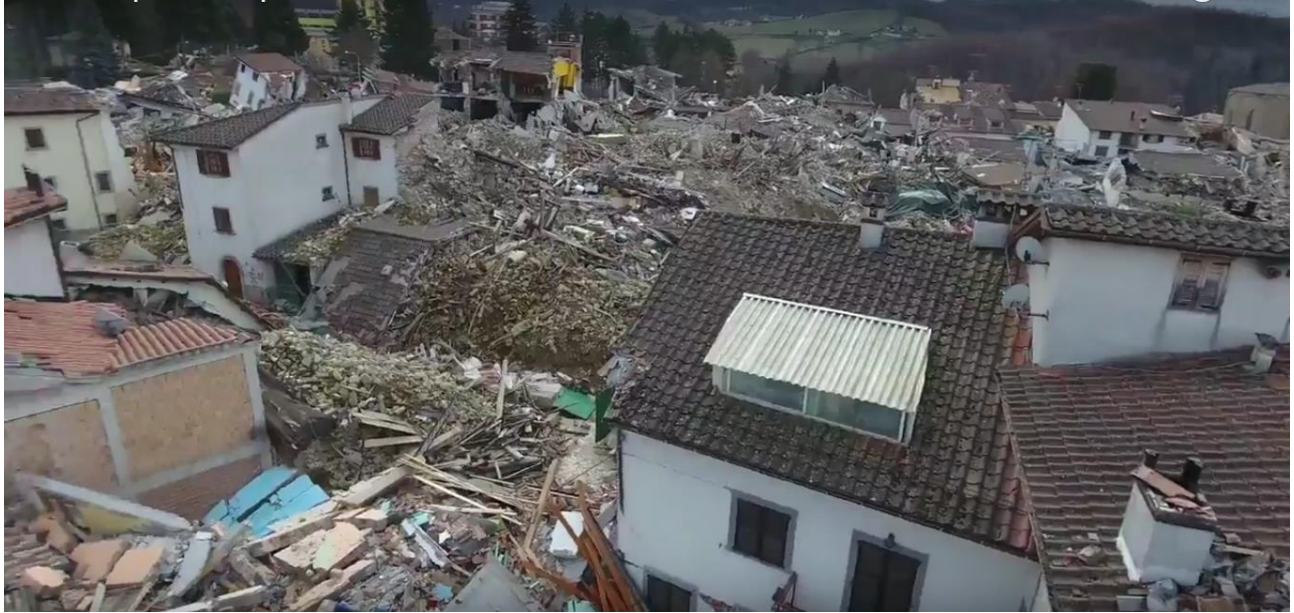
Figure 6.35. UAV image V4.

During the GEER mission in Amatrice, UAV imaging was performed near building S1. The UAV elevated above a fixed point and photographed across an azimuthal range. **Error! Reference source not found.** shows five angles cropped from online footage (<https://www.youtube.com/watch?v=djF5fkUrYkk>., last accessed April 17, 2017). Figure 6.32 to Figure 6.36 show these images.

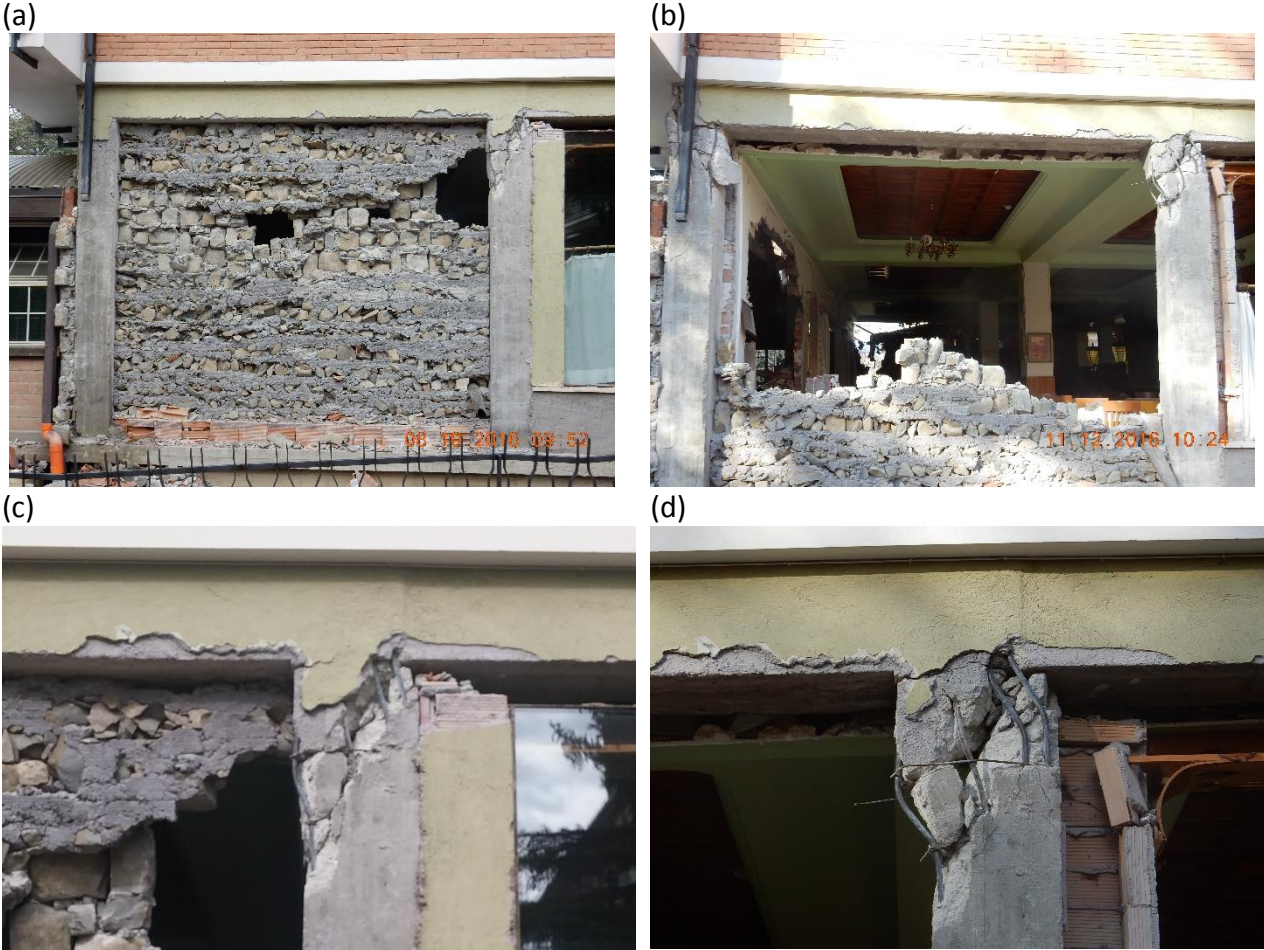
Figure 6.37. Building RC1.

Figure 6.37 illustrates building RC1 in the aftermath of the first event (a,c) and after the October sequence (b,d). It evident that the infill panel has failed out-of-plane after the seismic sequence (but not after the first main shock), whereas the shear failure at the top of the right column has been clearly pronounced. Figure 6.38 depicts building RC2, a dual shear wall – moment resisting frame built with the older Italian seismic code (The Italian National Annex DM 1996, Norme Tecniche per le Costruzioni, 1996; NTC96). Similar out of plane failure of the,

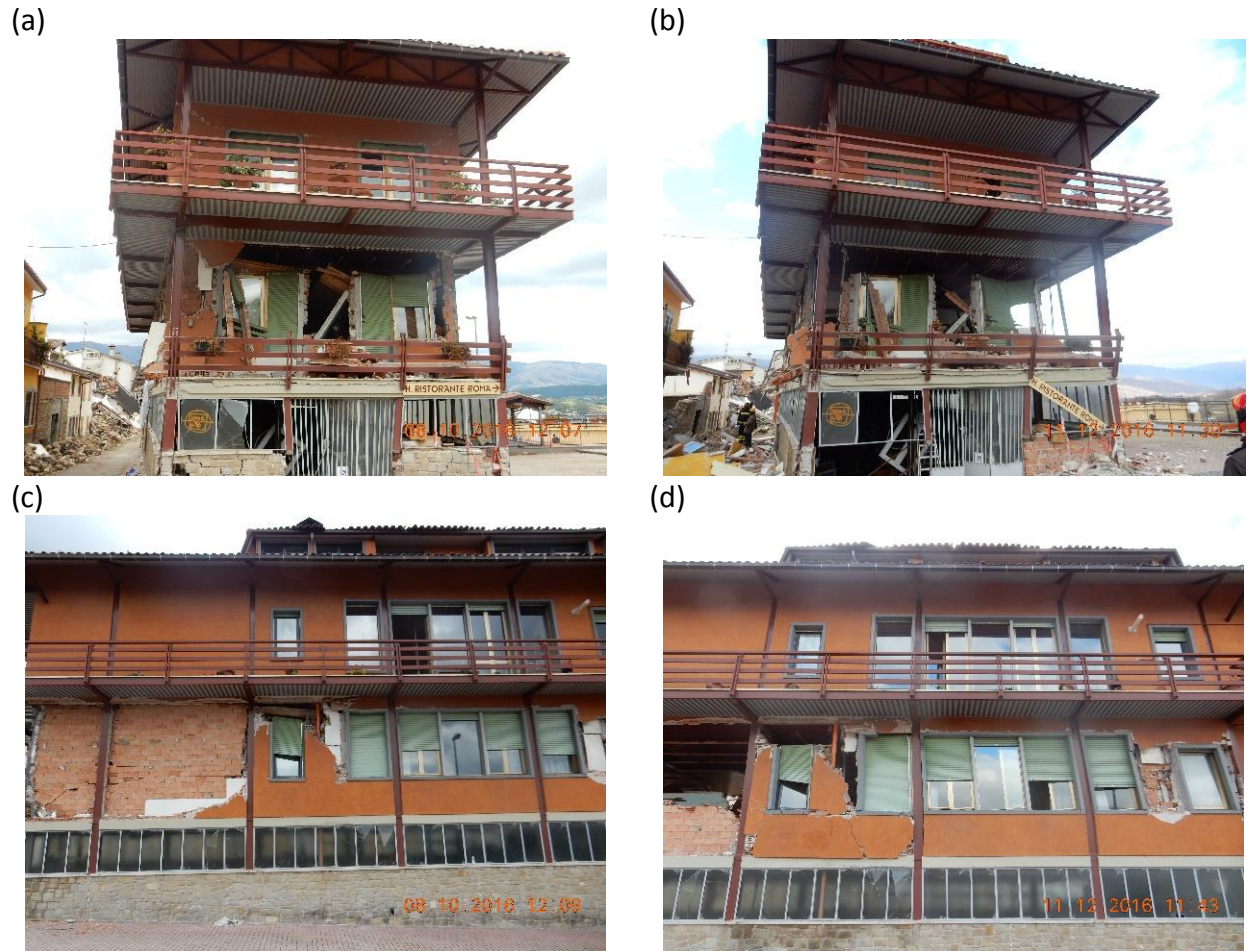
Figure 6.41. Building S1.

There is only one high-rise steel structure within the Amatrice red zone (Figure 6.41) built in the early 90's with the Italian seismic code of the time (The Italian National Annex DM 1996, Norme Tecniche per le Costruzioni, 1996; NTC96). It consists of a basement, a ground floor and two upper stories, alongside a shorter story on top that serves as a penthouse. Given the intensity of ground motion, its overall performance is deemed relatively satisfactory. Contrarily, Hotel Roma, one of Amatrice's most iconic structures, located a few meters from the steel building, collapsed completely. After the first event, damage was only concentrated to non-structural elements, with small local flange instability at the top of two front columns of the ground floor. At the end of the October event sequence, the building presented permanent deformation along the longer direction, as shown in Figure 6.41. Such permanent deformation is localized at the second level of the building with a visible inter-story drift. Preliminary finite element analyses of the building suggest that the fundamental mode period of the structure is approximately 0.75sec. The mode shape indicates an almost uncoupled translation along the long side, mainly due to the orientation of the steel columns whose strong axis is aligned with the short side of the building.

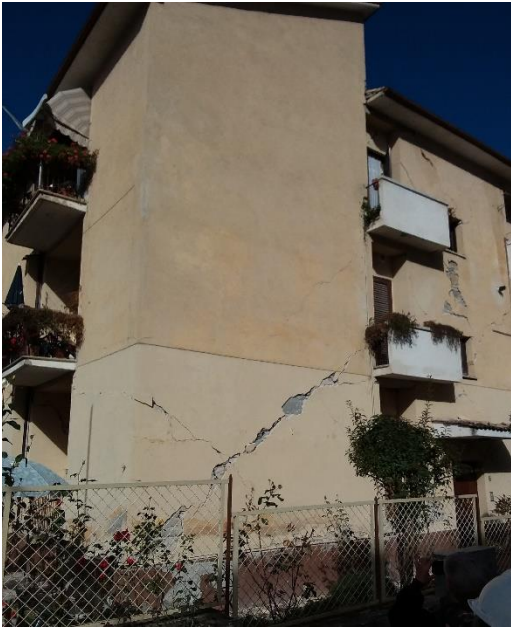
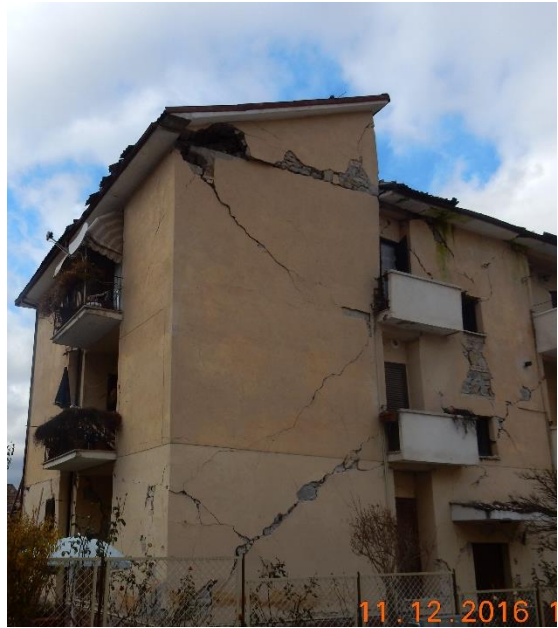
Figure 6.42. Building M1.

Figure 6.42 shows multi-epoch damage to a masonry building. Damage at the base of the structure is essentially unchanged, but new damage features are observed in the top story. Figure 6.43 shows the local police (“Carabinieri”) station. It is evident that diagonal cracks were extended in both sides of the building after multiple seismic events. Notably, the local retrofit by means of steel ties at the corners of the upper story mitigated further damage and possible collapse.

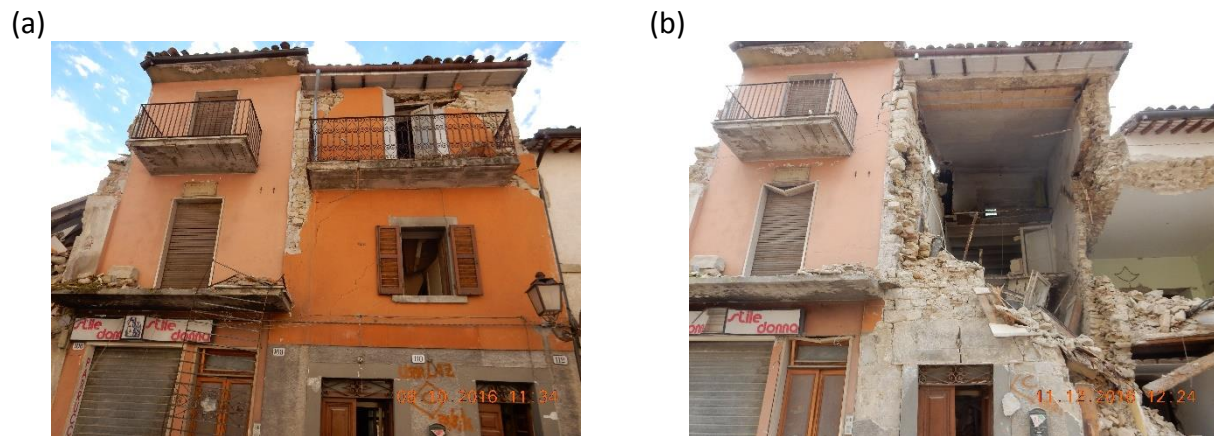
Figure 6.44. Building M3.

Figure 6.44 and Figure 6.45 present two buildings within the Amatrice red-zone, where initial damage of the outer masonry due to the first event evolved to partial collapse after the event sequence. This is also an interesting case in that such partial collapse is not always visible by satellite, thus highlighting the importance of careful on-site ground inspection. The soft-story of another masonry building is illustrated in Figure 6.45. Such a mechanism is presumably due to the higher stiffness of the upper part with respect to the ground floor, and due to the previous shear failures observed at the ground level in the aftermath of the first event. It is also a characteristic case where the evolution of damage in masonry structures under multiple seismic events, as well as the increase of the corresponding damage indeed, is strongly nonlinear. Figure 6.46 shows the complete collapse of a building that was heavily damaged from the first event.

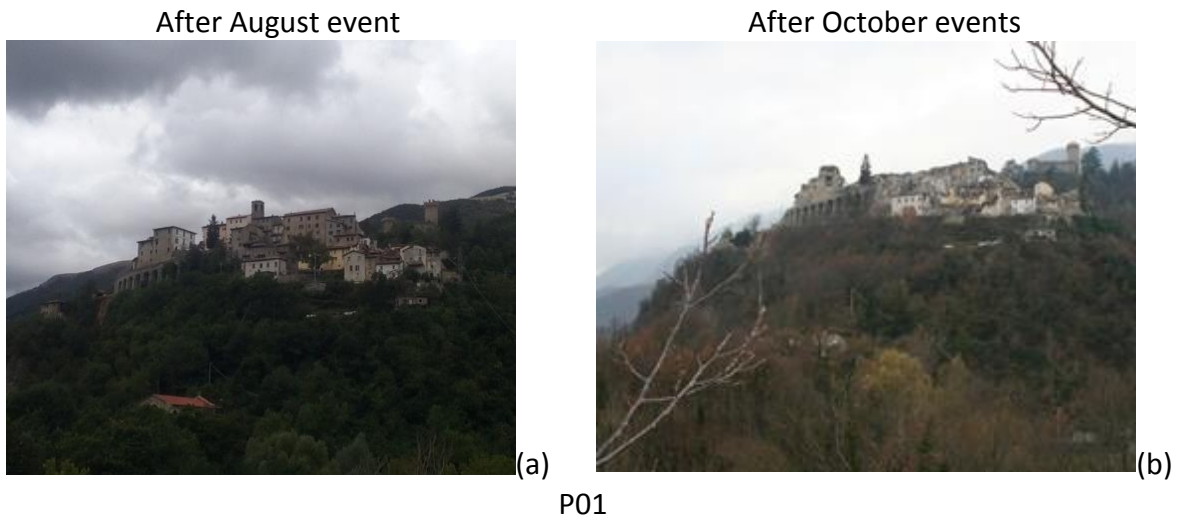
The photographs in Figure 6.48 show Arquata del Tronto after the August and October events, from which a substantial damage increase is evident following the 26 and 30 October earthquakes. Conversely, Borgo did not suffer appreciable cumulated damage, as shown in Figure 6.49 and Figure 6.50. Figure 6.51 shows the collapse of a structure onto the access road for Arquata village. At the time of our November reconnaissance, the village was not accessible and much of the village center was destroyed. The damage level assigned to Arquata del Tronto

Figure 6.48. Overview of Arquata del Tronto (a) after the 24 August earthquake, and (b) after the October events.

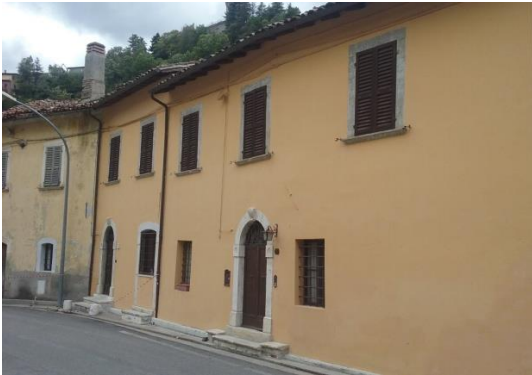
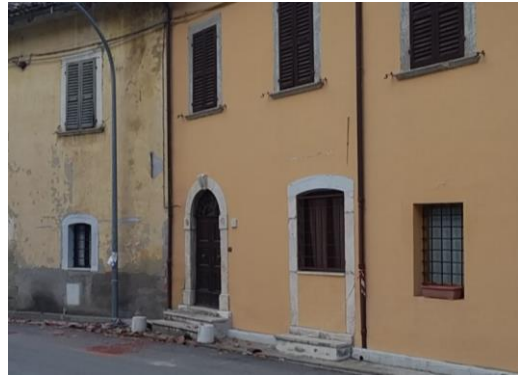
P03

Figure 6.49. A reinforced masonry building in Borgo (a) after the 24 August earthquake, and (b) after the October events.

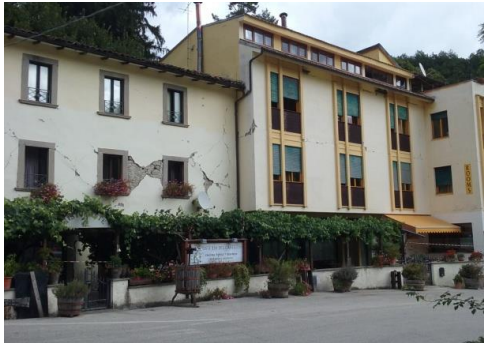
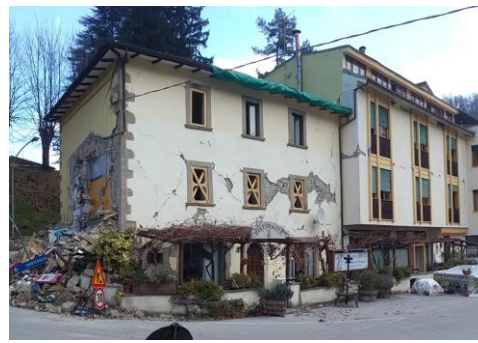
P06

Figure 6.50. A building in Borgo (a) after the 24 August earthquake, and (b) after the October events.

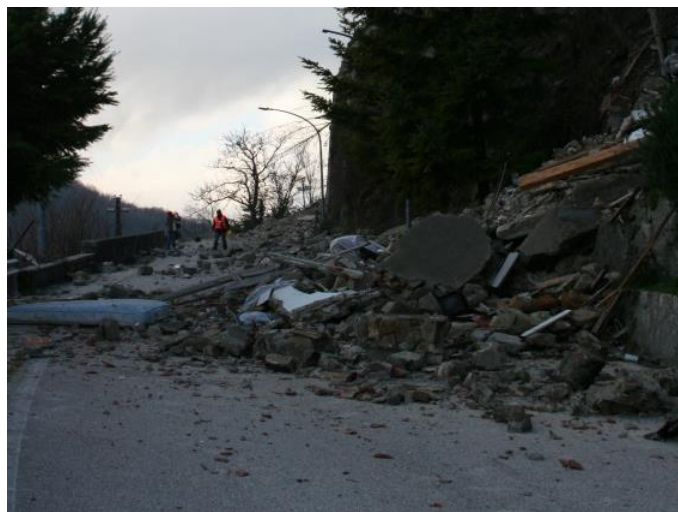
Figure 6.51. Access road to Arquata del Tronto after the October events.

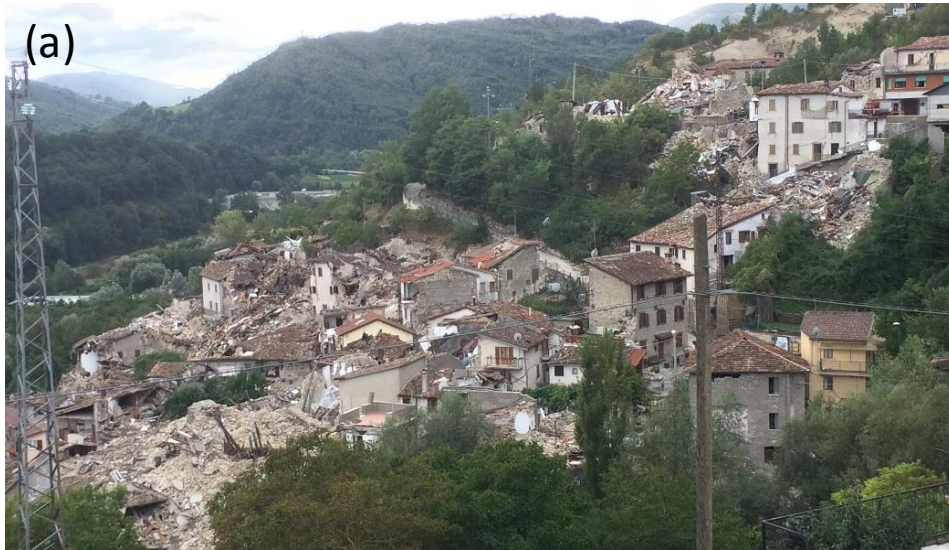
Figure 6.55 shows locations of selected buildings for which we show photos taken after the August and October events. The cumulative damage is also evident from Figure 6.56. Figure 6.57 shows a photographic overview of the hamlet taken from a common perspective after the August and October events. Figure 6.58 shows screenshots captured from 3D models created from images taken by UAVs. Table 6.4 summarizes locations and damage levels for all selected representative structures.

Figure 6.57. Overview of Pescara del Tronto from a common perspective (a) after the 24 August earthquake, and (b) after the October events.

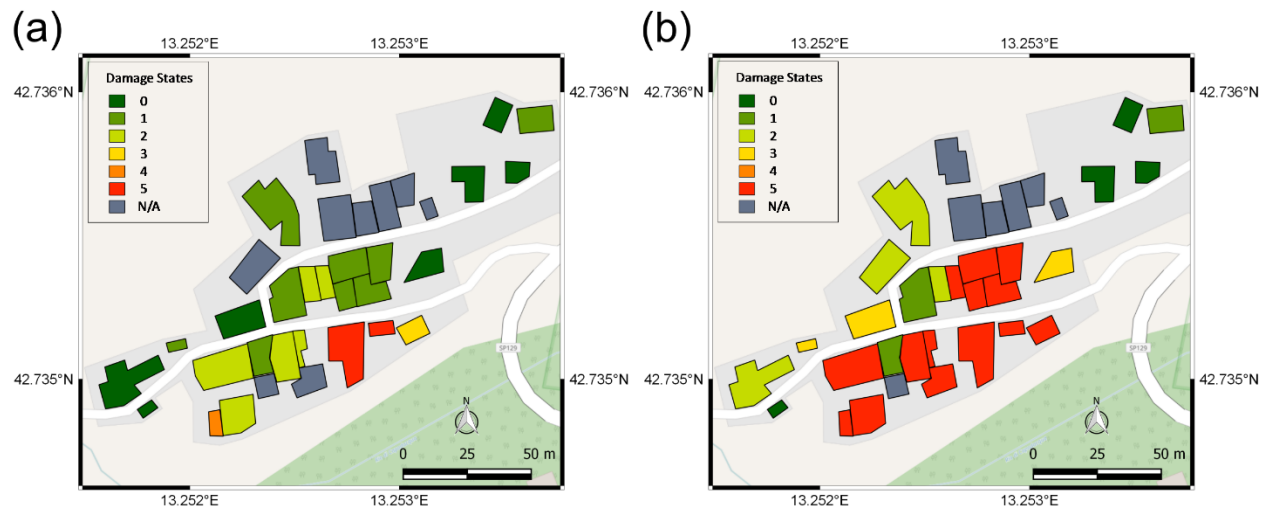
The 24 August earthquake produced major damage only to poorly constructed, unretrofitted, and unreinforced masonry buildings (GEER 2016). Damage levels increased markedly from the October events. Figure 6.59 and Figure 6.60 show the evolution of damages from the August (Figure 6.59a and Figure 6.60a) to the October events (Figure 6.59b and Figure 6.60b).

Figure 6.59. Mapped damage levels in Tufo: (a) after the 24 August, and (b) the October events.

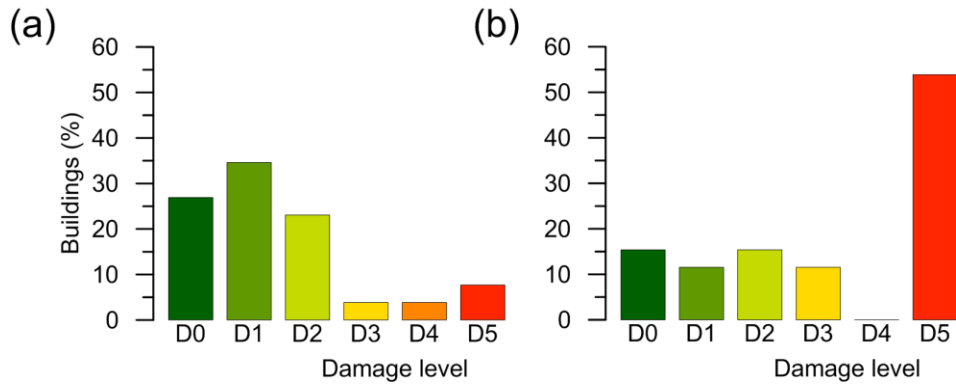
Figure 6.60. Histograms of damage levels in Tufo: (a) after the 24 August, and (b) the October events.

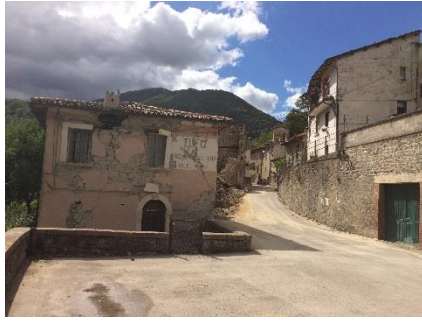
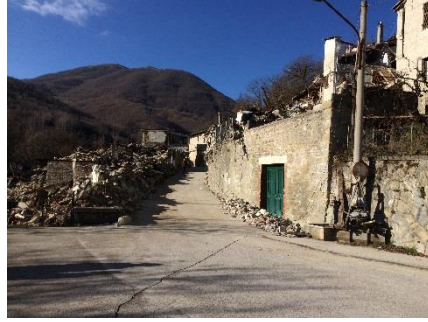
Figure 6.61 shows locations of selected buildings for which we show photos taken after the August and October events. Figure 6.62 shows these pictures, which were taken from a common perspective. Table 6.5 summarizes locations and damage levels for each of the representative structures. Structures M2, M3, and M4 (P1 and P2 in Figure 6.62) are unreinforced masonry buildings. They had damage levels ranging from D1-D3 after the August events and D5 (complete collapse) following the October events. We documented the performance of one reinforced concrete structure (RC1). It had no apparent damage from the August events and damage level D2 after the October events (P3 in Figure 6.62).

Picture	DATUM	Description	Location		September Damage Level	December Damage Level
			Lat.	Long.		
P1	WGS-84	Entrance of the historical center (M2-M3)	42.7353°	13.2532°	D3	D5
P2	WGS-84	Masonry buildings (M4)	42.7354°	13.2528°	D1	D5
P3	WGS-84	Reinforced concrete building (RC1)	42.7351°	13.2519°	D0	D2
P4	WGS-84	Santissima Maria Annunziata Church (M1)	42.7351°	13.2522°	D0	D3
P5	WGS-84	Santissima Maria Annunziata Church (M1)	42.7351°	13.2522°	D0	D3
P6	WGS-84	Santissima Maria Annunziata Church (M1)	42.7351°	13.2522°	D0	D3

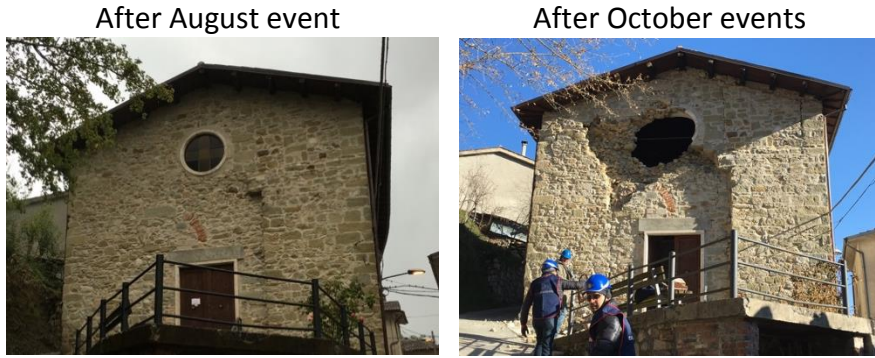
An important monument in Tufo is the *Santissima Maria Annunziata Church*. It is a church built in the XVII century that appears to have been recently retrofitted. The church had no apparent damage (D0) from the August events (P4, P5, and P6 in Figure 6.62) and damage level D3 (partial collapse of façade around the rose window; P4 in Figure 6.62) following the October events. Figure 6.62 also shows multiple layers of untied bricks and significant new cracks at corners (P5 and P6), possibly from lack of lateral reinforcement at the corner.

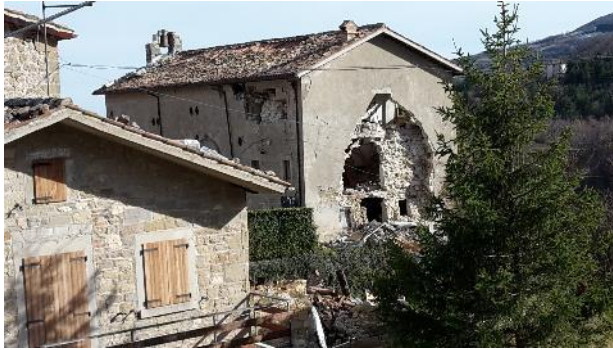
P05 (Castro)

Table 6.6 summarizes observed damage patterns for each hamlet. Most of these hamlets were visited (Astorara, Collefratte, Colleluce, Colle, Piano and Pistrino), although Balzo and Castro were assessed from afar due to limited access. In particular, the main access road to Castro was blocked by debris (see Picture P06 below).

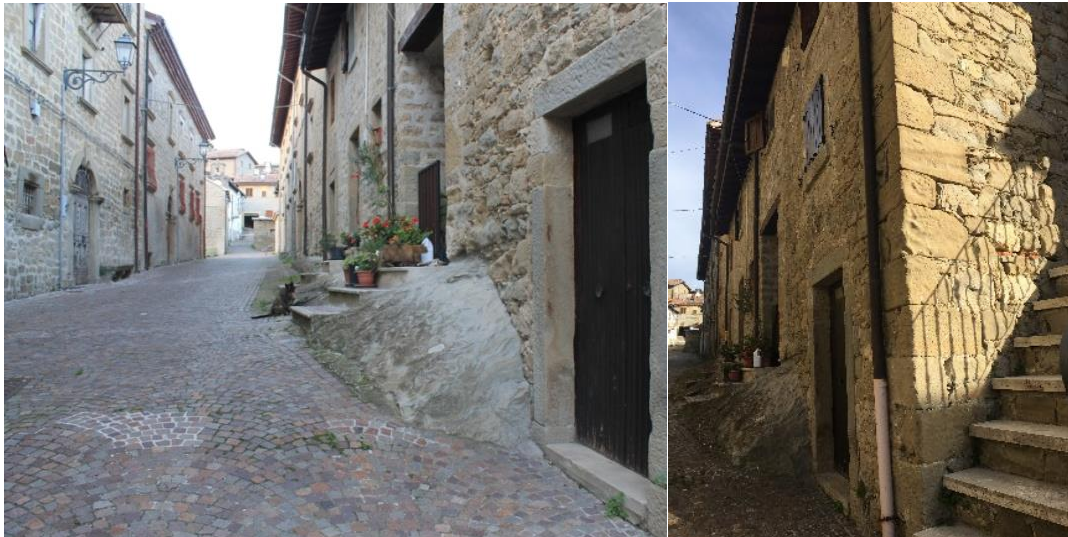
P14 (Piano)

Damage levels were variable across Montegallo, which is likely a result of variable ground motion levels (mostly as a result of different site effects) and variable construction types and quality. In general, we encountered significant increased damage levels (approximately one class, e.g., D2 to D3) following the October events. A notable exception is Piano, which showed no evidence of damage following either event sequence, despite some examples of apparently poor construction (P14 in Figure 6.63).

Colleluce	P13	Totally D4/5.
Piano	P14*	Generally D0/D1.
Pistrino	P15*-P16*-P17*	The initial part of the village (Pistrino di Sopra) was seriously damaged (D3/D4), whereas the other part (Pitrino di sotto, 1 km from Piano) showed minor problems (D0/D2) except for a collapsed small stones wall.

Picture	Hamlet	DATUM	Position		September damage Level	December damage Level
			Lat.	Long.		
P13	Colleluce	WGS-84	42.83805°	13.30722°	-	D4-D5
P14*	Piano	WGS-84	42.854116°	13.339129°	D0	D0
P15*	Pistrino	WGS-84	42.855579°	13.332649°	D0-D1	D0-D1
P16*	Pistrino	WGS-84	42.855579°	13.332642°	D0-D1	D0-D1
P17*	Pistrino	WGS-84	42.855579°	13.332649°	D0-D1	D0-D1
