Engineering Reconnaissance following the October 2016 Central Italy Earthquakes - Version 2

Engineering Reconnaissance Following the October 2016 Central Italy Earthquakes *Version 2*

Geotechnical Extreme Events Reconnaissance Association
Report No. GEER-050D
8 May 2017

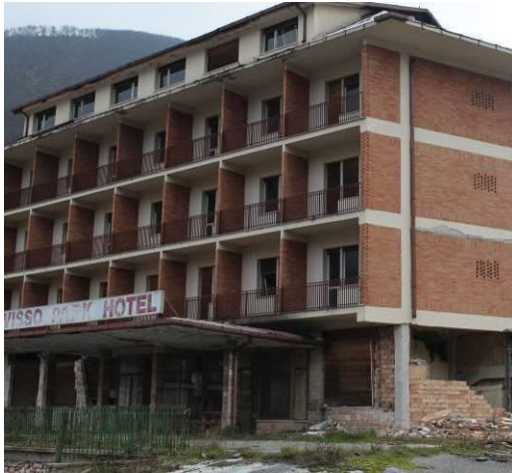
P01

The pictures are presented in Figure 6.66. The historical center consists mainly of unreinforced masonry structures (some of which have been recently retrofitted), 2-3 stories in height. Outside of the historical center, modern reinforced concrete structures were encountered (see P01-P02).

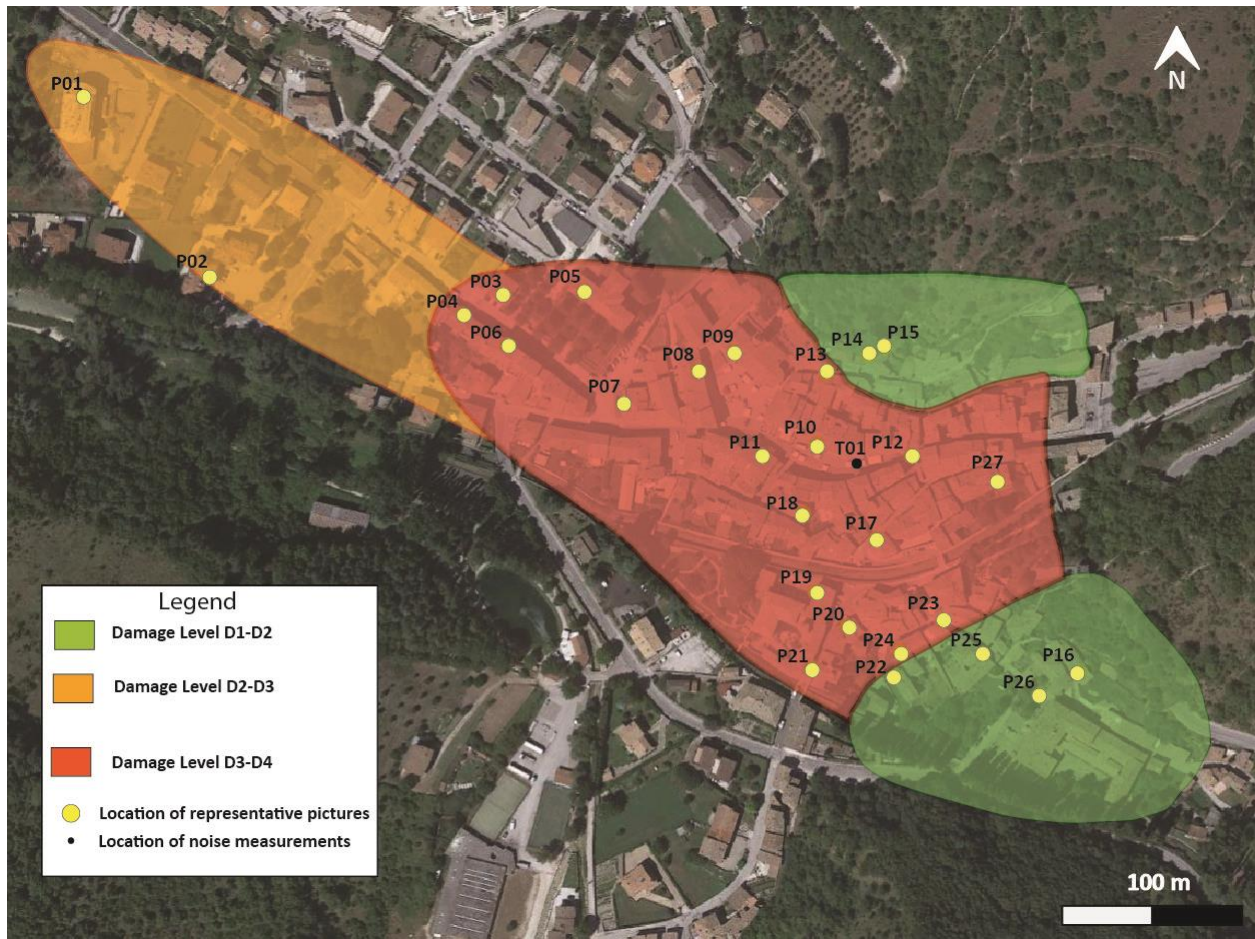
The village was significantly damaged by the October events. However, the degree of damage to buildings is spatially variable. A tentative damage zonation map is reported in Figure 6.67. Damage levels as high as D3-D4 are concentrated in the historical center, especially the portion founded on the quaternary continental deposits (alluvial deposits, eluvio-colluvial deposits, and widespread slope deposits). Minor damage (D1-D2) was encountered in the portion founded on the SCC rock (Scaglia Cinerea Formation). In the NW portion (outside the historical center), we encountered D2-D3 on average. This part of the village is located on quaternary deposits. However, the relatively minor vulnerability of buildings was probably responsible for the minor damage observed in this part of the historical center.

Figure 6.67. Damage zonation within the villages of Visso village.

The damage in Visso was likely related both to the presence of some vulnerable buildings in the historical center and to stratigraphic amplification effects related to the presence of quaternary soils resting on Scaglia rock formation (see also preliminary conclusions by Gaudiosi et al., 2016).

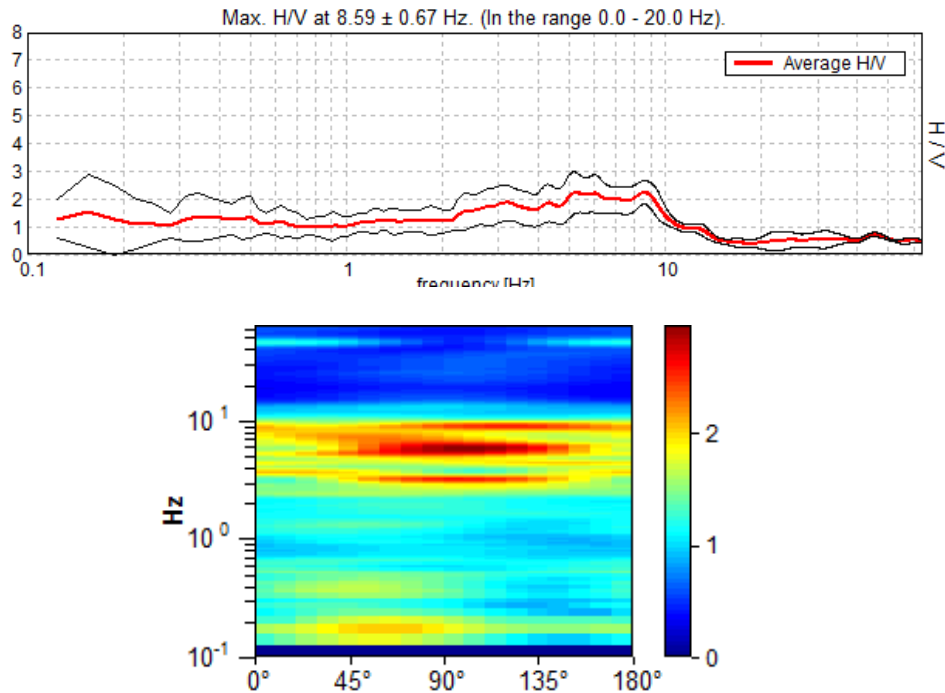
are reported in Figure 6.68. We observe no large H/V peaks at T1, suggesting the lack of a site condition producing a strong resonant site response.

Figure 6.68. Noise measurement T01 results in terms of H/V spectral ratio (up) and H/V polar plots (bottom).

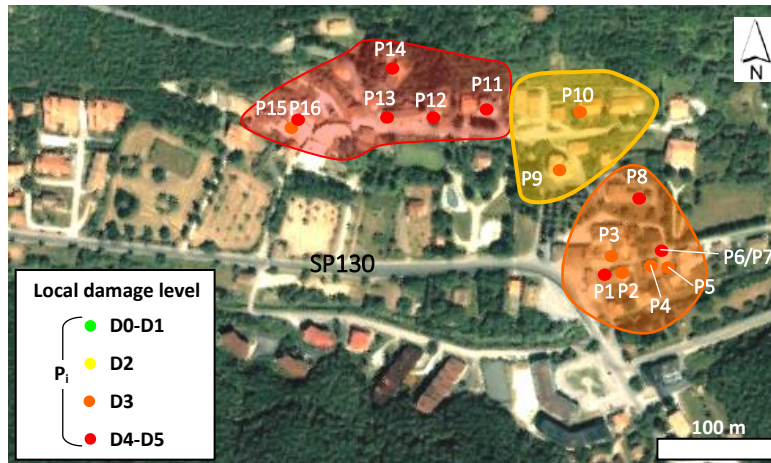
Figure 6.69 shows locations of representative structures inspected in Ussita and maps damage zones within the village. Damage levels were generally between D3 and D4. Figure 6.70 shows pictures of selected structures in the area of Ussita that experienced the higher level of damage.

Figure 6.69. Locations of representative structures inspected in Ussita, and damage zonation within the village.

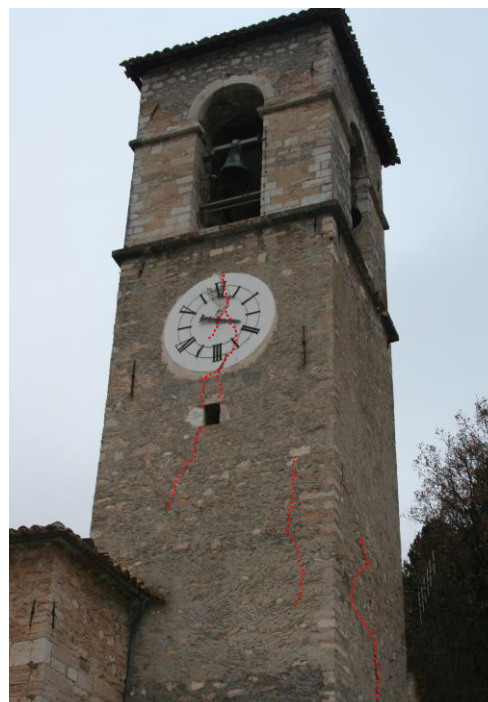
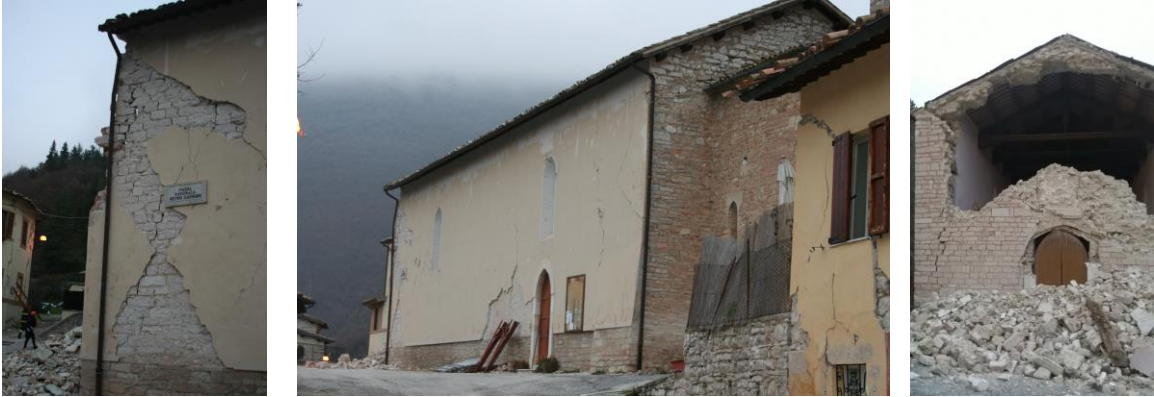
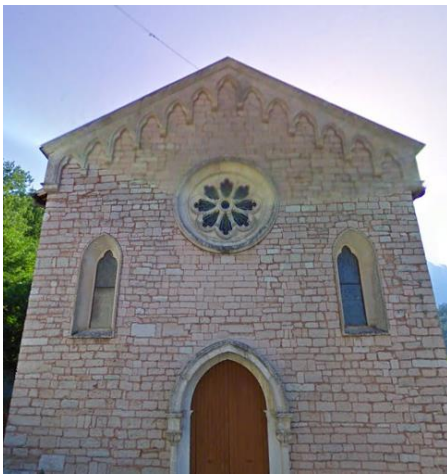
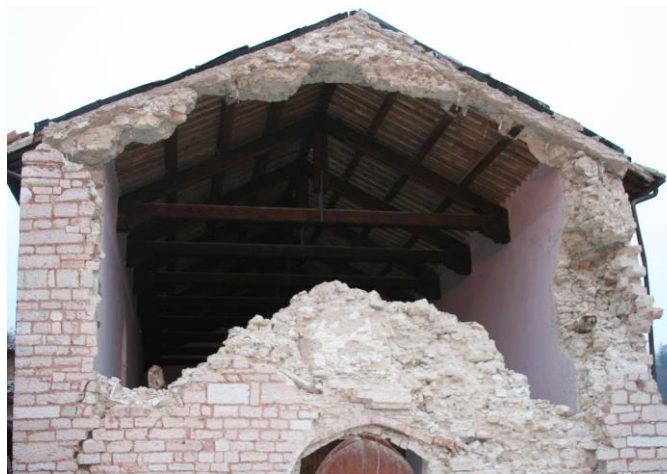
Figure 6.70. Representative pictures taken in Ussita (P13)

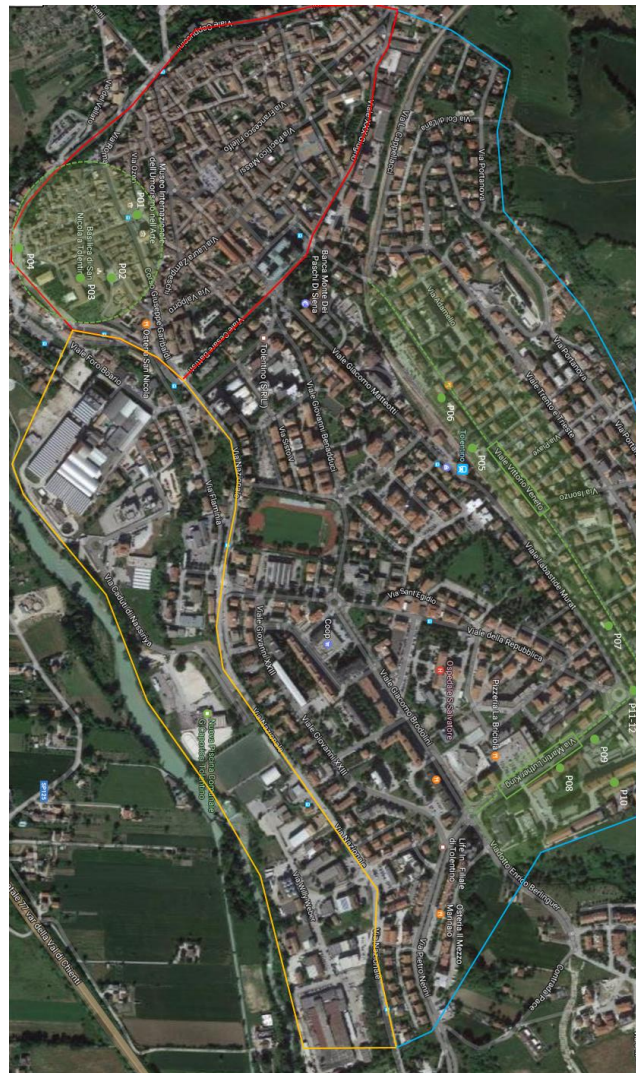
Very interesting is the Viale Vittorio Veneto-Viale Martin Luther King-Via Kennedy area. In this neighborhood, an evident site effect was observed, since diffused building damages are observed much more prominently than in the other parts of the town. In particular, the buildings along the eastern side of Martin Luther King road are recent reinforced concrete frames 5-to-8 floors above ground from the 1980s. Most of these buildings were seriously damaged and abandoned at the time of the reconnaissance. On the other side of the road, smaller buildings (most of them 3 floors above ground) suffered much less damage and were apparently in use at the time of the reconnaissance.

Figure 6.73. Tolentino reconnaissance map: in green the most damaged zones.

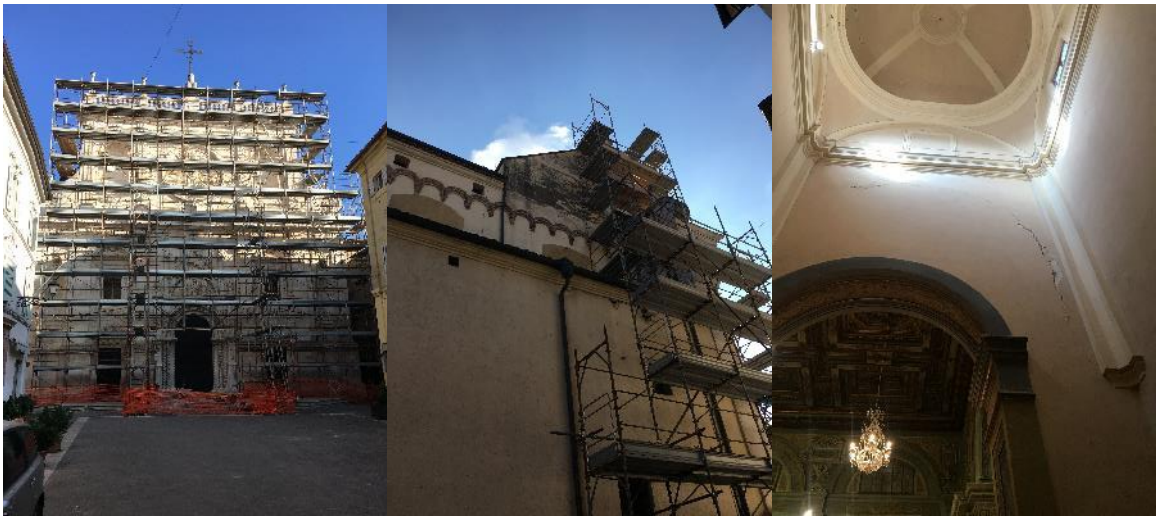
P02a-b-c Basilica di San Nicola (Saint Nicholas Church)

The San Nicola church is out of service and not accessible to the public as a result of diffused damage to the façade and the unstable wood decorated roof. The adjacent convent is a complex and heterogeneous building made by different and subsequent enlargements. For this reason, there are different states of damage inside the huge complex, depending on the structural type (masonry or reinforced concrete).

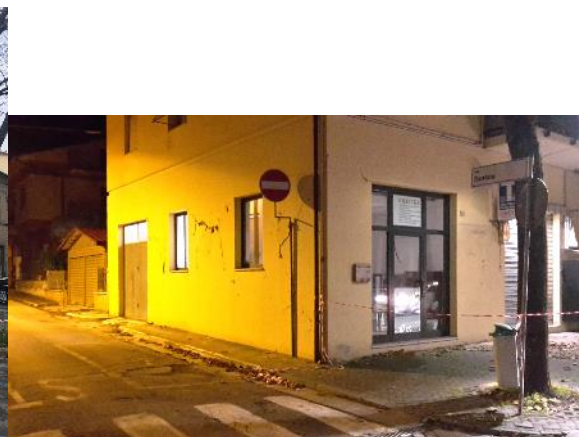
P05 (Viale Vittorio Veneto)

Picture	DATUM	Description	Location		October Damage Level
			Lat.	Long.	
P01a	WGS-84	Piazza della libertà (town hall)	43.20851°	13.28464°	D1-2
P01b	WGS-84	Piazza della libertà (bell tower)			
P02a	WGS-84	San Nicola Church (facade)	43.21344°	13.28864°	D2
P02b	WGS-84	San Nicola church (lateral facade)			
P02c	WGS-84	San Nicola Church (chapel)			
P02d	WGS-84	San Nicola church (damaged nave column)			
P02e	WGS-84	San Nicola church (damaged entrance wall)			
P02f	WGS-84	San Nicola church (retaining nest above the main altar)			
P03a	WGS-84	Monastery (retrofitted main tower)	43.20748°	13.2862°	D2
P03b	WGS-84	Monastery (damaged cloister walkway)			
P03c	WGS-84	Monastery (damaged room)			
P03d	WGS-84	Monastery (damaged room)			
P03e	WGS-84	Monastery (damaged room)			
P04	WGS-84	Viale Filzi	43.20673°	13.2849°	D1-2
P05	WGS-84	Viale Vittorio Veneto	43.21416°	13.28944°	D2

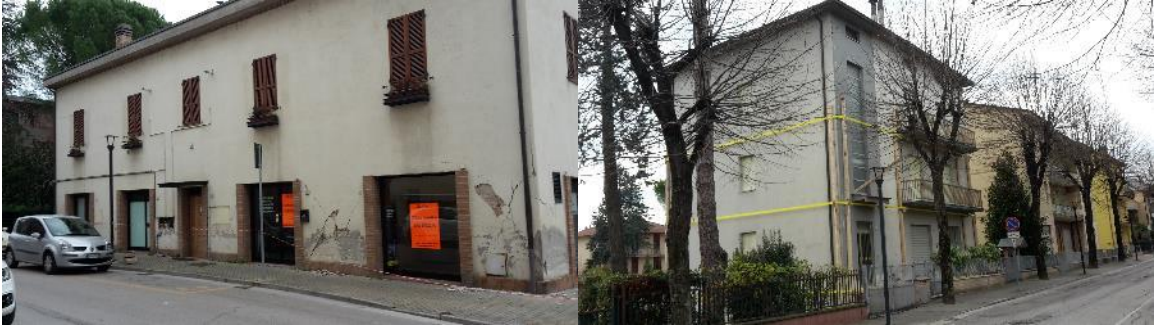
P06-P07 (Viale Vittorio Veneto)

Picture	DATUM	Description	Location		October Damage Level
			Lat.	Long.	
P06	WGS-84	Viale Vittorio Veneto	43.21399°	13.28918°	D2
P07	WGS-84	Viale Vittorio Veneto	43.21694°	13.29416°	D2
P08	WGS-84	Via Martin Luther King	43.21505°	13.29764°	D3
P09	WGS-84	Via Martin Luther King	43.21555°	13.2975°	D3
P10	WGS-84	Via Kennedy	43.21722°	13.29777°	D3
P11	WGS-84	Retaining wall	43.21874°	13.29686°	D3
P12	WGS-84	Damaged rail bridge	43.21874°	13.29686°	D2

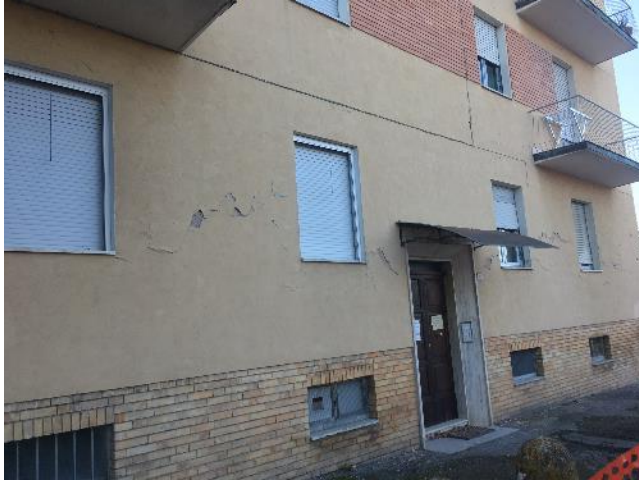
P1

Picture	DATUM	Description	Position		October Damage Level
			Lat.	Long.	
P01	WGS-84	Via Mazzini 76	43.22710°	13.18678°	D1-D2
P02	WGS-84	Via Mazzini 84	43.22605°	13.18883°	D2-D3
P03	WGS-84	Via Mazzini 86	43.2259°	13.1890°	D2
P04	WGS-84	Via Mazzini 91	43.2257°	13.1893°	D2
P05a	WGS-84	Via Mazzini 94	43.2255°	13.1897°	D4
P05b	WGS-84	Via Mazzini 94	43.2255°	13.1897°	D4
P06a	WGS-84	Via Mazzini 115	43.2249°	13.1907°	D4-D5
P06b	WGS-84	Via Mazzini 115	43.2249°	13.1907°	D4-D5
P06c	WGS-84	Via Mazzini 115	43.2249°	13.1907°	D4-D5
P07	WGS-84	Intersection Mazzini-Monti Sibillini	43.2255°	13.1897°	D2
P08	WGS-84	Via Monti Sibillini 6	43.2250°	13.1899°	D2
P09	WGS-84	Via Monti Sibillini 15	43.2248°	13.1902°	D2-D3
P10	WGS-84	Via Monte San Vicino	43.2246°	13.1898°	D0
P11	WGS-84	Via Rossini 1	43.2336°	13.1845°	D4
P12	WGS-84	Via Padre Giuseppe Zampa 30	43.2326°	13.1863°	D2
P13	WGS-84	Villa Collio	43.2369°	13.1841°	D2
P14	WGS-84	Smeducci Tower	43.2258°	13.1760°	D0

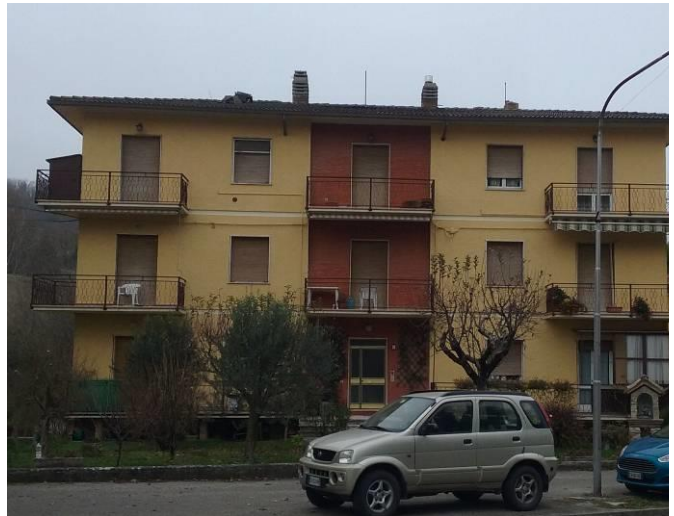
P17

Locations of representative photos taken in Pievebovigliana by the GEER team are reported in Figure 6.86. The pictures are presented in Figure 6.87. The historical center consists mainly of un-reinforced old masonry structures, 2-3 stories in height. Some of these structures have retrofitted. Outside of the historical center, isolated modern masonry and reinforced concrete structures were found (see P17-P18). Table 6.12 shows details and damage levels for the inspected structures.

Pievebovigliana was significantly damaged by the October events. However, the degree of damage to buildings is quite variable across the village. A preliminary damage zonation is reported in Figure 6.88. Damage levels as high as D3-D4 are concentrated in the southern portion (area of Castello or S. Maria Assunta church) built on a slight ridge oriented NNW-SSE that is comprised of Scaglia-Cinerea bedrock. Topographic site effects may have impacted structural performance in this area. The northern and central portions of the village generally have damage levels D2 to D2-D3. These areas are mainly located on alluvial terraced deposits. Minor damage was observed along the western portion of the village; the northern part of this area, located on alluvium, has relatively modern buildings (see P17) while the southern area is on bedrock at the toe of the Scaglia-Cinerea ridge.

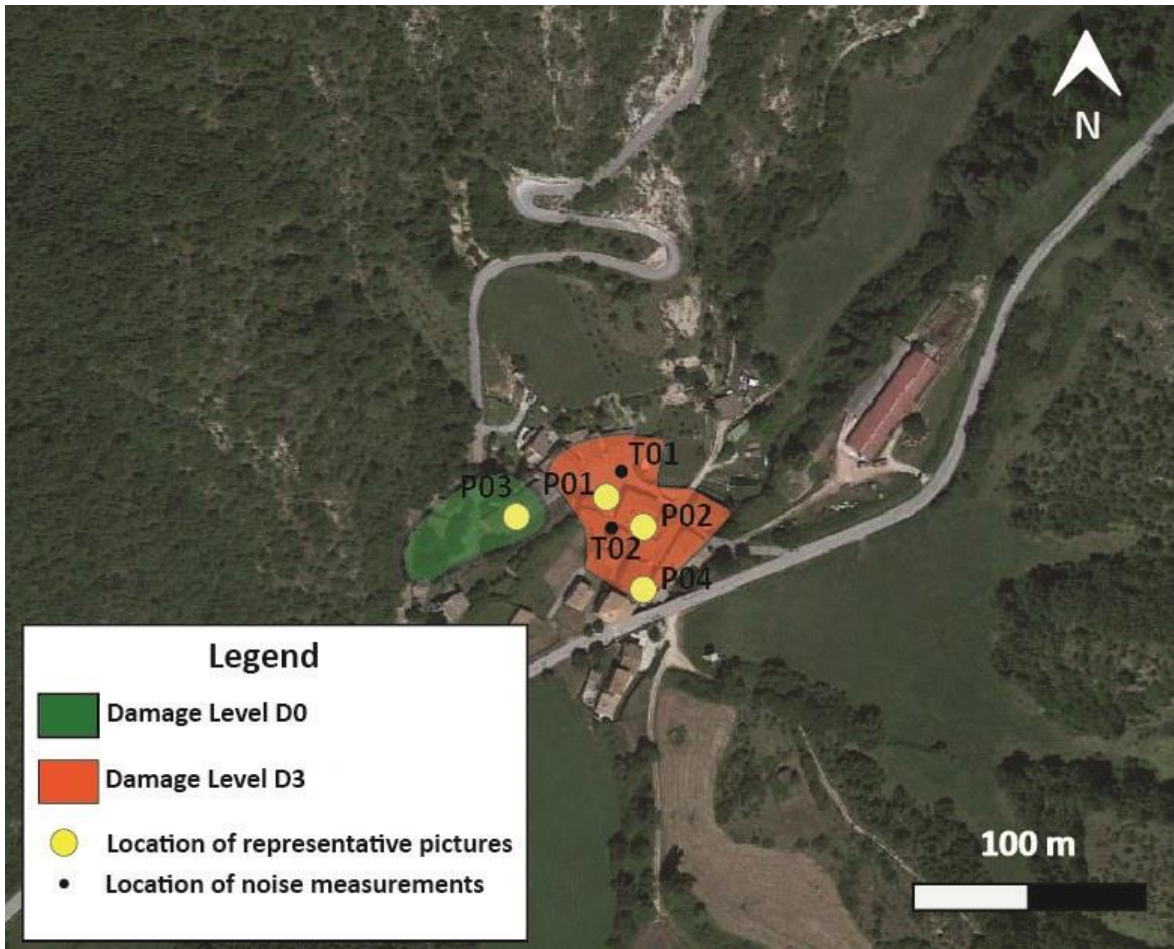
Figure 6.94. Locations of representative structures inspected in Fiume (Pieve Torina) and damage zonation (see Table 6.13 for details).

Fiume was significantly damaged by the October events. However, the degree of damage to buildings is strongly variable across the village (Figure 6.94). In particular, the eastern portion, founded on colluvial and alluvial deposits resting on bedrock, experienced high levels of damage (D3, see pictures P01-P02) whereas the western portion located on travertine rock had negligible damage (see P03).

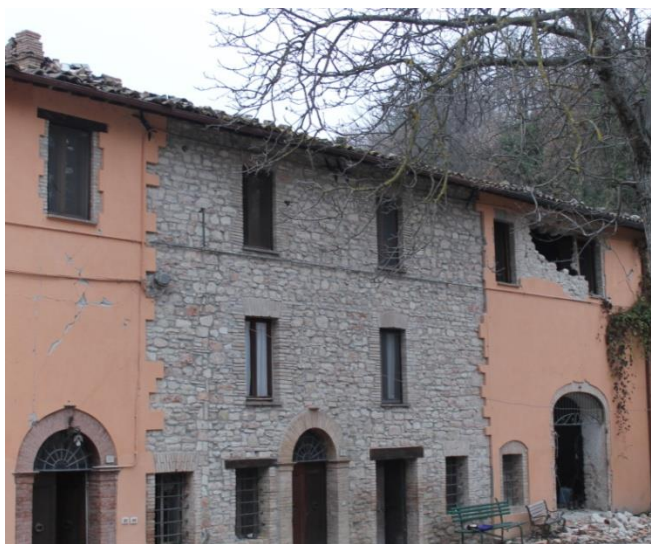
P01

the upper part (Casavecchia Alta) where several partial and full collapses took place (see P03-P04) with respect to Piè Casavecchia (P01-P02).

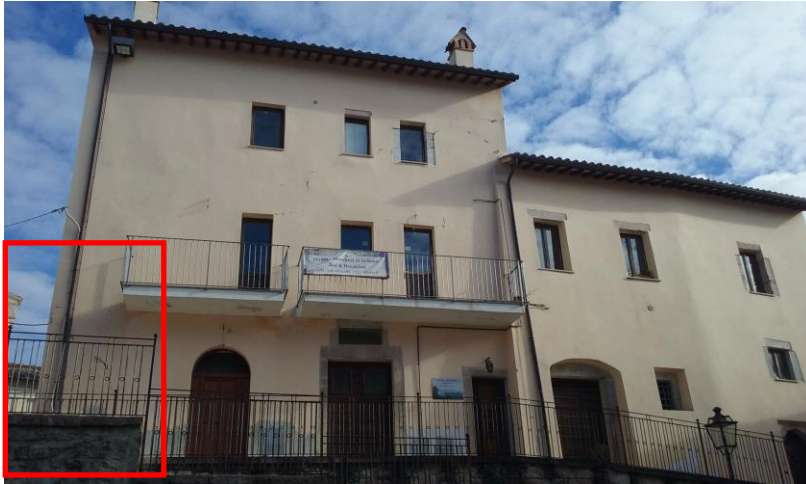
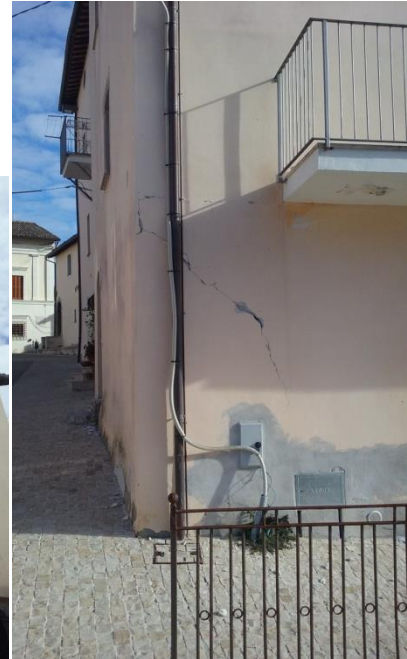
No or negligible damage was observed in the hamlets of Terne and Villamagina (on average D0-D1). Slightly higher damage (D1-D2) was reported in the upper part of Sellano (area of Santa Maria Assunta and Municipio, see P04 and P06).

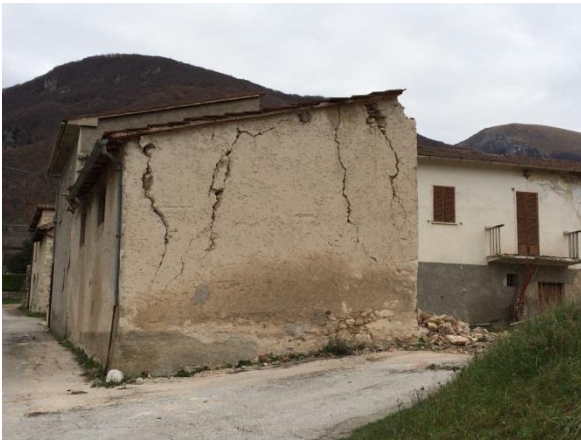
Picture	DATUM	Location		Damage Level	Notes
		Lat.	Long.		
P01	WGS-84	42.844373	13.101296	D2	
P02	WGS-84	42.844211	13.101267	D2	
P03	WGS-84	42.844400	13.101682	D1	
P04	WGS-84	42.844270	13.101787	D1	
P05	WGS-84	42.844039	13.101900	D1	
P06	WGS-84	42.844130	13.102034	D1	
P07	WGS-84	42.844310	13.102489	D1	
P08	WGS-84	42.844148	13.103076	D1	
P09	WGS-84	42.844152	13.103284	D4	
P10	WGS-84	42.844152	13.103527	D0	
P11	WGS-84	42.844028	13.103713	D5	
P12	WGS-84	42.844166	13.103785	D2	
P13	WGS-84	42.844177	13.103916	D5	
P14	WGS-84	42.843939	13.103436	D3	
P15	WGS-84	42.843826	13.103548	D0	
P16	WGS-84	42.843215	13.102244	D2	
P17	WGS-84	42.843167	13.102265	D2

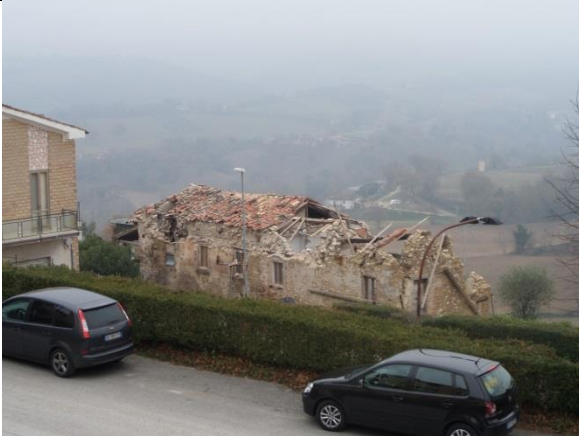
Picture	DATUM	Location		Damage Level	Notes
		Lat.	Long.		
P01	WGS-84	43.108198	13.258378	D5	
P02	WGS-84	43.108592	13.258880	D2	
P03	WGS-84	43.108566	13.257992	D1	
P04	WGS-84				
P05	WGS-84	43.108643	13.258125	D1	
P06	WGS-84	43.108739	13.258286	D1	
P07	WGS-84				
P08	WGS-84				
P09	WGS-84				
P10	WGS-84				
P11	WGS-84	43.108772	13.258107	D1	
P12	WGS-84	43.108713	13.257500	D0	
P13	WGS-84	43.108522	13.257597	D3-D4	
P14	WGS-84	43.108463	13.257340	D1	
P15	WGS-84	43.109235	13.258417	D2

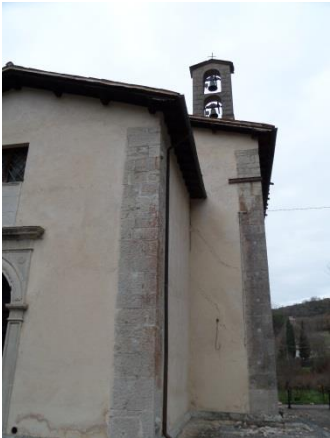
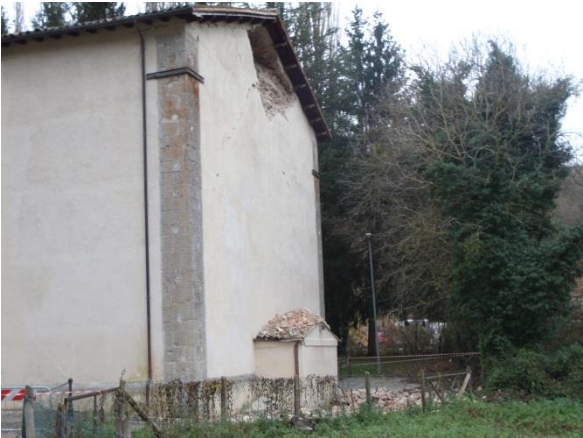
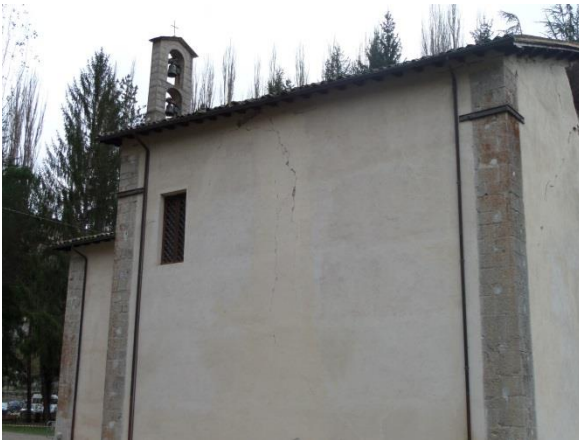
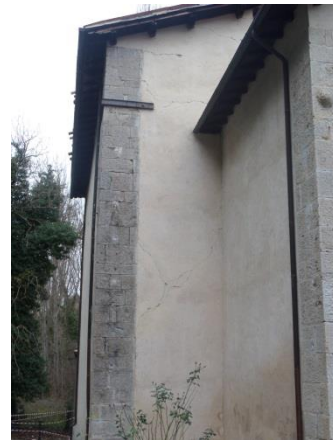
Figure 6.111. Representative pictures of church in Preci (Lat = 42.881418, Lon = 13.036290).

Guado. Ground motion levels are reported in Table 6.1. The main village was lightly damaged. Figure 6.110 shows the location of representative pictures taken in Preci, while Figure 6.111 shows a church with damage level D1.

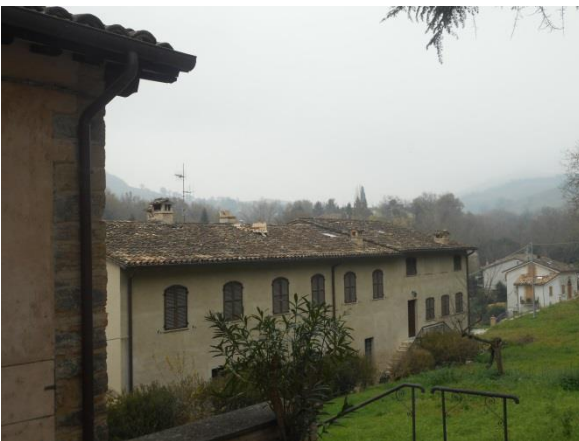
Picture	DATUM	Location		Damage Level	Notes
		Lat.	Long.		
P01	WGS-84	43.136801	13.226607	D1	
P02	WGS-84	43.137202	13.225963	D0	
P03	WGS-84	43.137617	13.226234	D1	
P04	WGS-84	43.137827	13.225873	D1	
P05	WGS-84	43.138038	13.226472	D2	
P06	WGS-84	43.138212	13.226377	D0	
P07	WGS-84	43.138370	13.226287	D0	
P08	WGS-84	43.138488	13.226146	D0	
P09	WGS-84	43.127572	13.220054	D3	
P10	WGS-84	43.127735	13.219258	D3	
P11	WGS-84

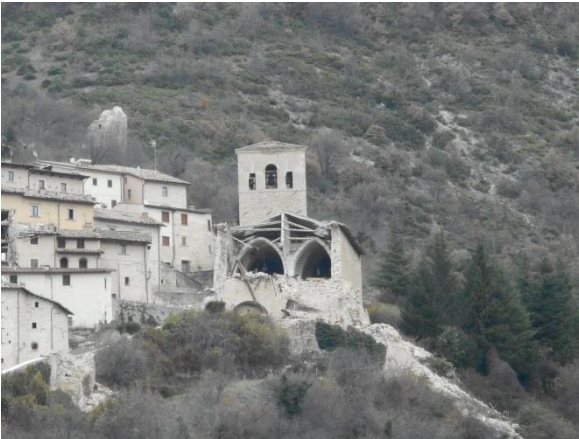
P01

<i>Picture</i>	<i>DATUM</i>	<i>Location</i>		<i>Damage Level</i>	<i>Notes</i>
		<i>Lat.</i>	<i>Long.</i>		
<i>P01</i>	<i>WGS-84</i>	<i>42.853422</i>	<i>13.101411</i>	<i>D4</i>	
<i>P02</i>	<i>WGS-84</i>	<i>42.853480</i>	<i>13.100616</i>	<i>D2-D5</i>	
<i>P03</i>	<i>WGS-84</i>	<i>42.853819</i>	<i>13.100276</i>	<i>D2-D5</i>

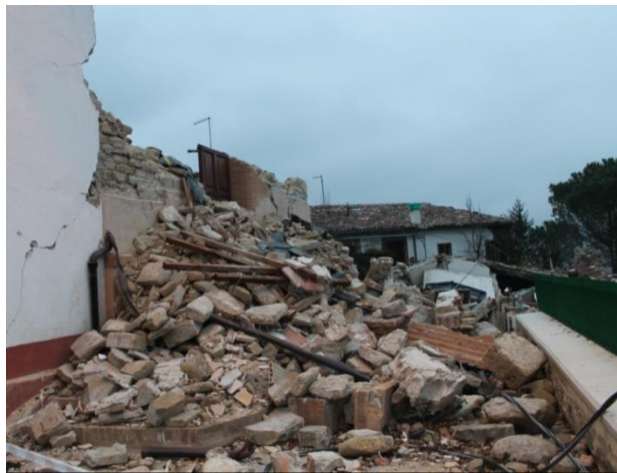
The village consists essentially of un-reinforced masonry structures, 2-3 stories in height. Some structures are retrofitted. The damage at the top of the ridge was quite high (D3-D4 on average) with several partial collapses (see P01- P03-P04).

San Lorenzo in Colpolina				
Picture	Datum	Location		Damage Level
		Lat	Long	
P01	WGS-84	43.086690°	13.124509°	D5
P02	WGS-84	43.086511°	13.124582°	D3-D4
P03	WGS-84	43.086319°	13.124638°	D4
P04	WGS-84	43.087064°	13.124486°	D4

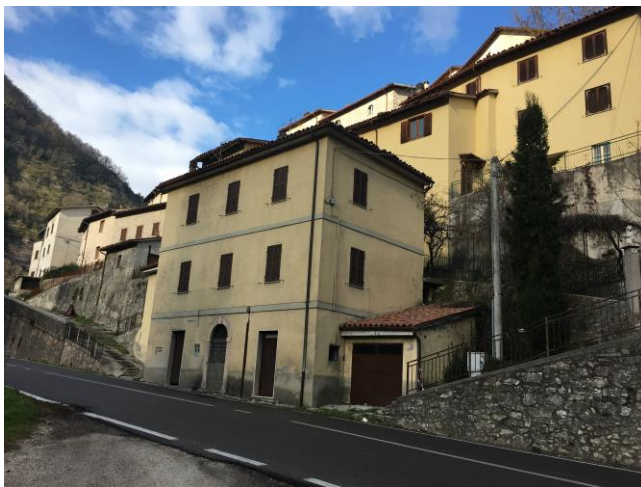
Serravalle				
Picture	Datum	Location		Damage Level
		Lat	Long	
P01	WGS-84	42.785802	13.022287	D0
P02	WGS-84	42.785816	13.022504	D0
P03	WGS-84	42.785852	13.022981	Do

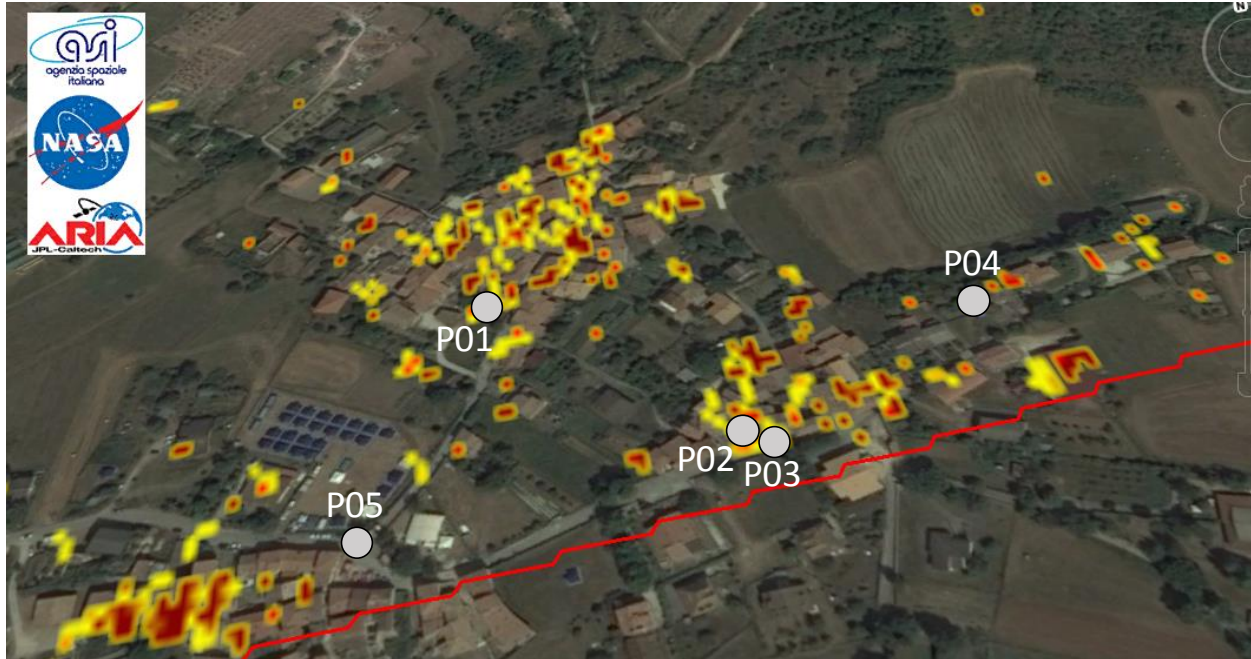
Figure 6.126. Damage proxy map of San Pellegrino (http://aria-share.jpl.nasa.gov/events/20161030-Italy_EQ/DPM/) along with the identification numbers of the structures with assigned damage level D5.

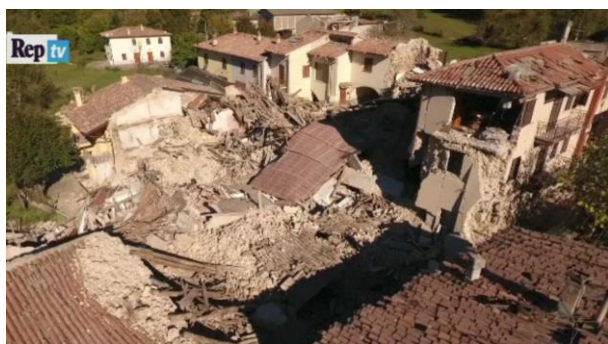
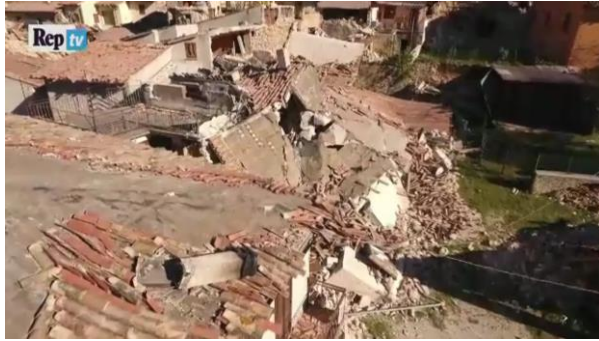
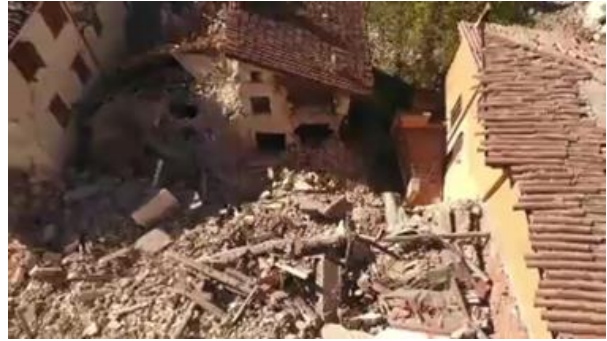
During our reconnaissance following the 30 October event, we observed extensive damages in almost all the masonry structures (classified as D3-D5) located mainly in the historical center of the town, which was in part not accessible. Some pictures of the damaged buildings in the historical center are shown in Figure 6.127 (source Repubblica.it, last accessed 21 April, 2017). In the new part of the town damages were concentrated on non-structural components of some of the reinforced concrete buildings recently constructed (classified as D2). Figure 6.128 shows multi-epoch pictures (before August and after 30 October, 2017) of selected locations. Table 6.24 summarizes the overall damage level observed in these locations.

Figure 6.127. Damaged constructions in the oldest part of San Pellegrino (<http://video.repubblica.it/dossier/terremoto-30-ottobre/terremoto-centro-italia-la-distruzione-a-san-pellegrino-di-norcia-dal-drone/257495/257761>).

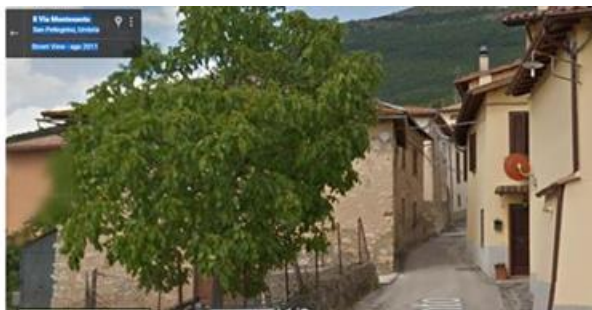
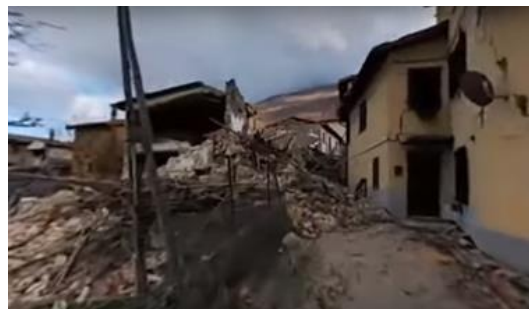
P01. Montesanto street

Figure 6.128. Pictures of the structures with assigned damage level D5 in San Pellegrino, before and after the October earthquake, along with their identification numbers.

<i>Picture</i>	<i>Damage Level</i>
<i>P01</i>	<i>D4</i>
<i>P02</i>	<i>D4</i>
<i>P03</i>	<i>D5</i>
<i>P04</i>	<i>D3/D4</i>
<i>P05</i>	<i>D4/D5</i>

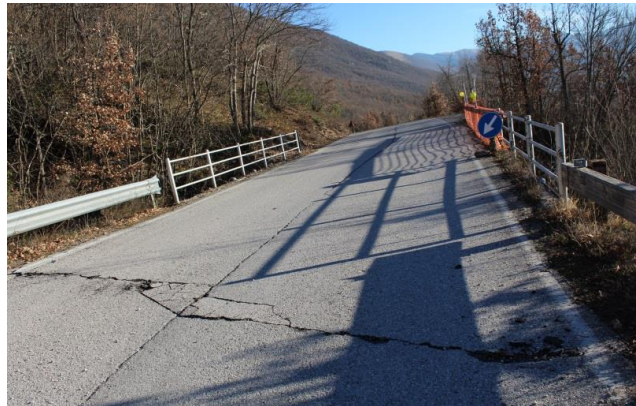
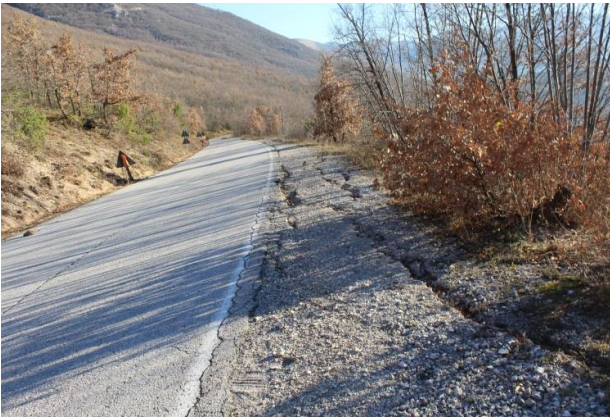
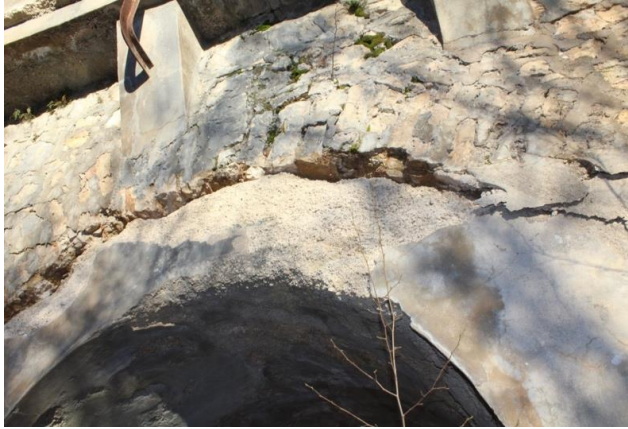
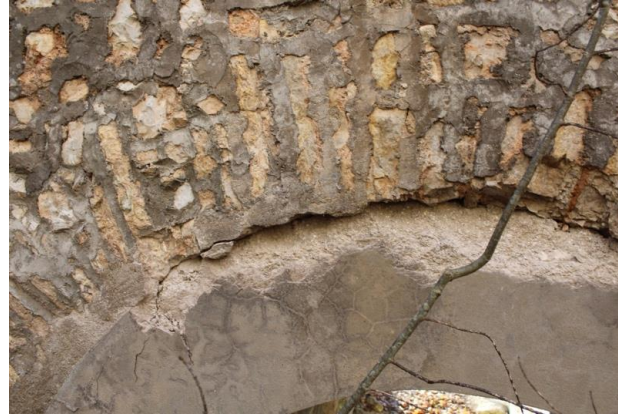
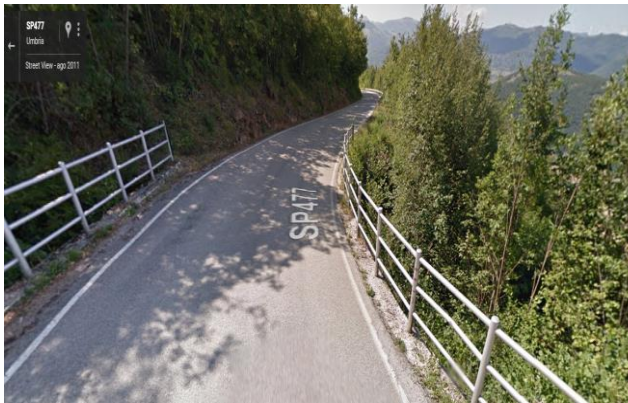
Figure 7.2 shows damage observed on the single arch masonry bridge along road SP477. The bridge did not appear seriously damaged, but several cracks were observed, especially in the road carriage. Transversal and longitudinal cracks along the road surface were documented (Figure 7.2a), with a measured maximum opening in the longitudinal direction of about 6 cm. From the visual inspection, the transversal cracks close to the road-bridge connection appear more recent when compared to those in the longitudinal direction. Longitudinal cracks also formed in road fill adjacent to the bridge (Figure 7.2b). Minor additional cracking was observed within the bridge arch (Figures 7.2c and 7.2d). Figure 7.2e (from Google earth) shows a photo of the bridge in December 2011, when no roadway cracks are evident. Because this bridge was not inspected in the reconnaissance performed following the August 2016 sequence, we cannot identify which events produced the observed effects.

Figure 7.2. Bridge along SP477 (42.782073 deg, 13.142383 deg): road surface cracks (a); longitudinal cracks along the road side (b); cracks between the bridge arch and the main structure (c-d); view of the bridge on December 2011 (e).

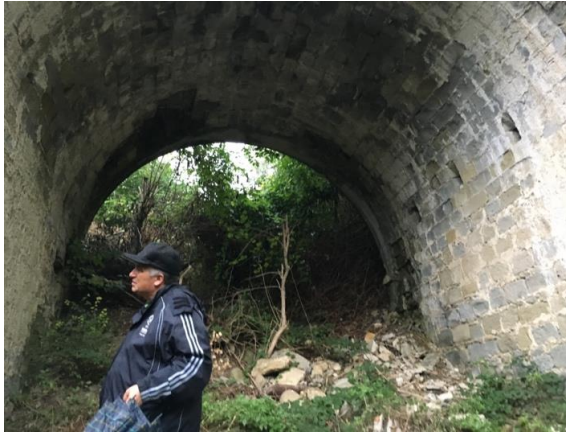
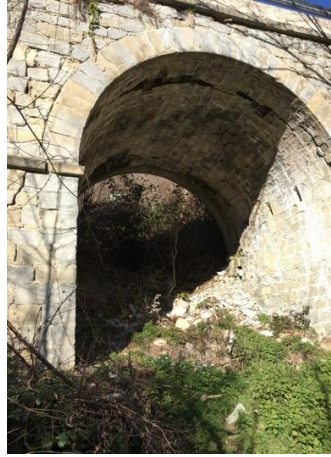
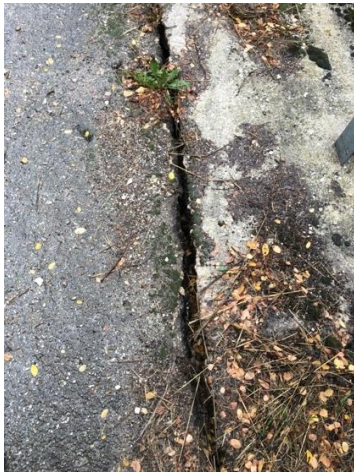
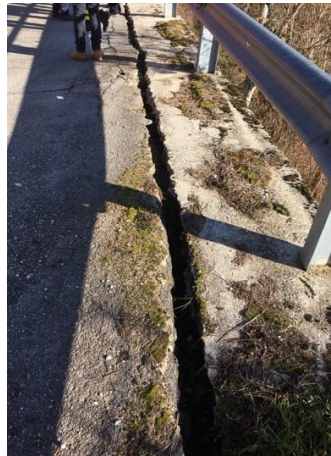
Figure 7.3 shows comparative pictures (taken after the 24 August and the October events) of the 1-span masonry bridge along the Trisungo route (along road SP129). The bridge presents additional cracks following the October events in the interior part of the arch (Figure 7.3b). The

width of the crack in the longitudinal direction (Figure 7.3d) has increased with respect to that observed in the first reconnaissance (Figure 7.3c). However, there was no additional spalling of masonry elements as had been observed following the first event.

Figure 7.3. Roman-era bridge along the Trisungo route (1 span bridge - Tufo area – Arquata del Tronto - N42.735981, E13.254862): view of the arch (a, b) and the road cracks (c, d) after the 24 August event (photo on September 7 2016 (a, c)) and after the 30 October event (photo on December 13 2016 (b, d)).

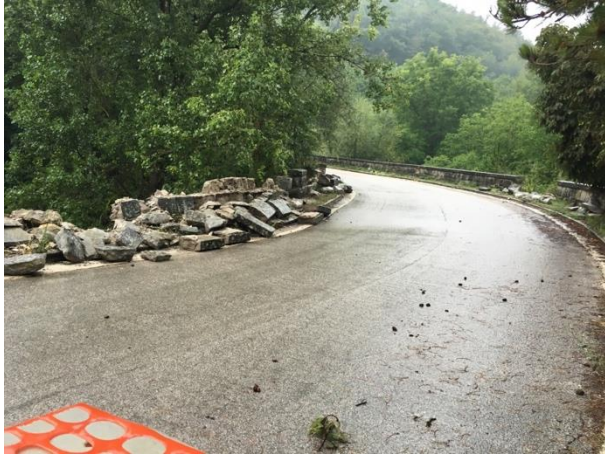
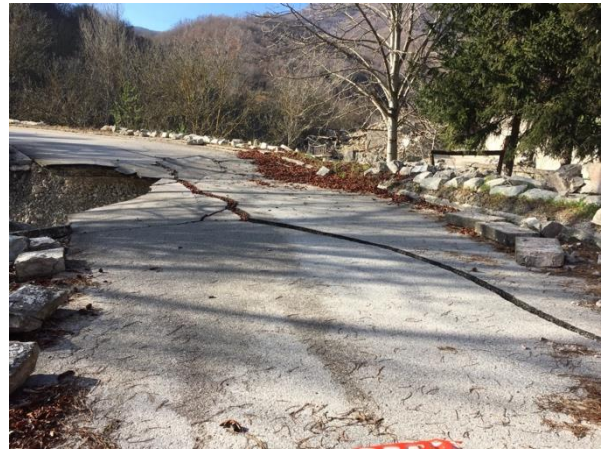
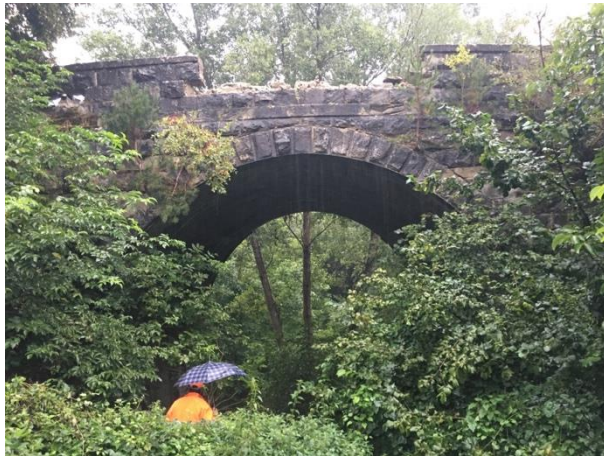
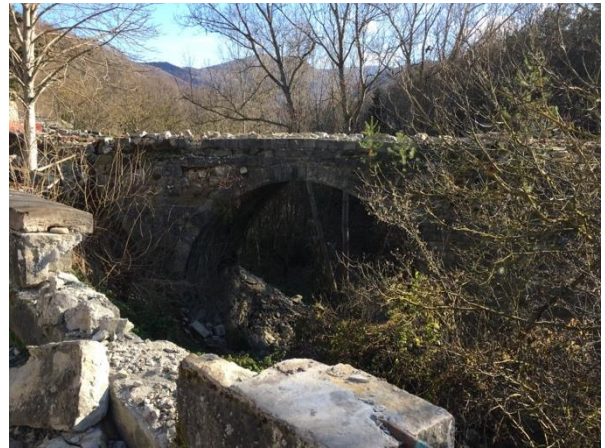
Figure 7.4 shows the response of the second arch along the Trisungo route (3 spans bridge) after the different events (24 August and October 2016). The incremental damage was significant: part of central arch, already damaged after the first event (Figures 7.4a and 7.4c), collapsed as a result of the October earthquakes (Figures 7.4b and 7.4d).

Figure 7.4. Roman-era bridge along the Trisungo route (3 spans bridge - Tufo area – Arquata del Tronto - N42.73538, E13.25365): (c) after the 24 August event (photo on September 7 2016) and (d) after the 30 October event (photo on December 13 2016).

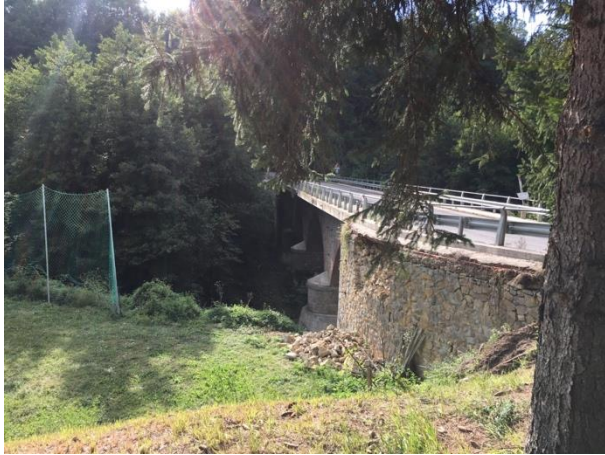
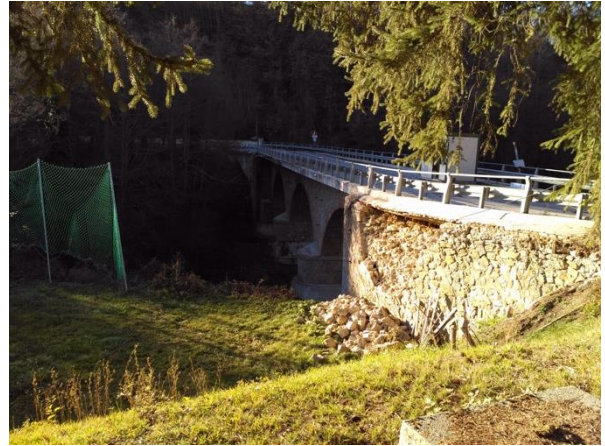
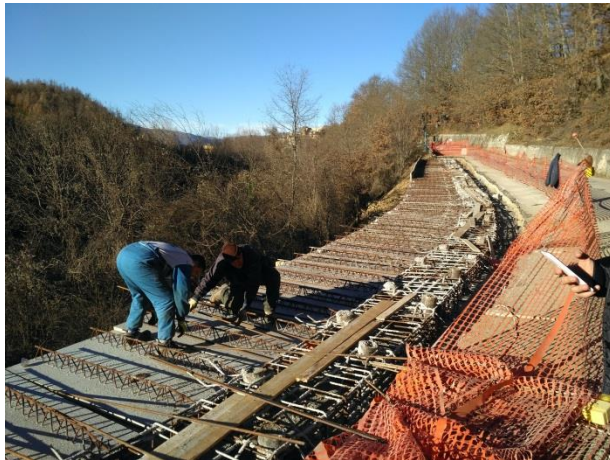
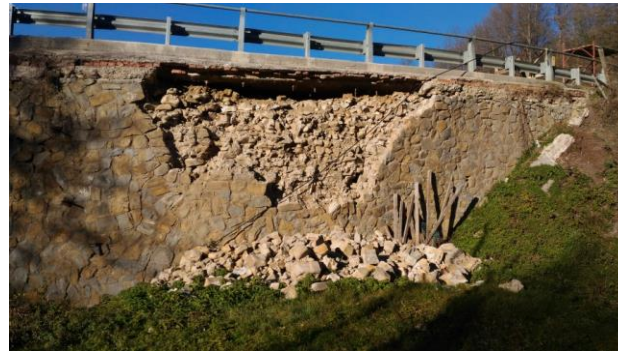
The Ponte a Tre Occhi (Three eyes) near Amatrice (Figure 7.5) also experienced additional damage, consisting mainly of spalling of outer-layer masonry elements located along abutment areas (not involving the three arches) (Figure 7.5b). At the time of the reconnaissance (December 2, 2016) repairs had been carried out on one of the two abutments (Figure 7.5c), while the bridge masonry and structure appeared to have not yet been repaired (Figure 7.5d).

Figure 7.5. Ponte a Tre Occhi (42.620668 deg, 13.290176deg): (a) after the 24 August event (photo on September 7 2016) and (b,c,d) after the 30 October event (photo on December 13 2016), repairing works (c) and bridge masonry collapse (d).

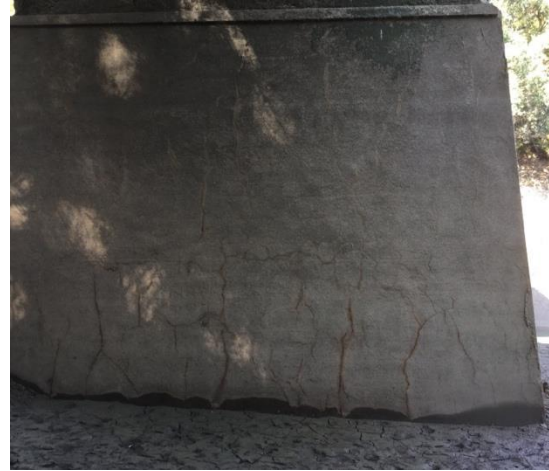
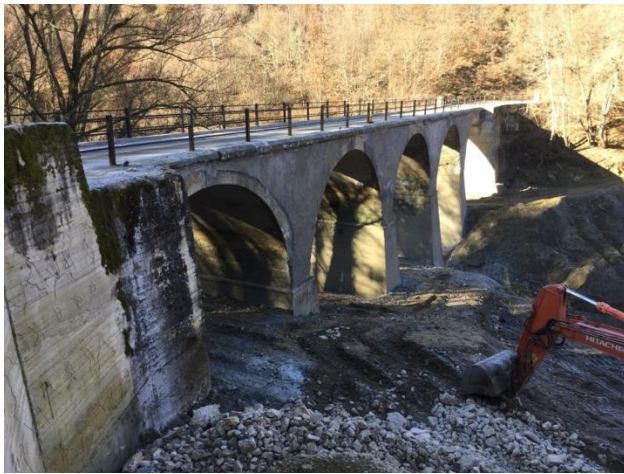
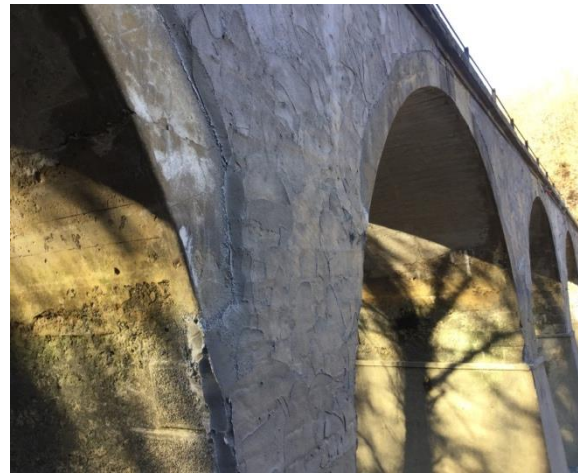
The Ponte a Cinque Occhi (Five eyes) along the internal road connecting SS4 (from the Casale Nibbi exit) to SR260 along Scandarello lake suffered additional damage during the October strong motions. The damage was concentrated in the arches and the piers as shown in Figures 7.6a and 7.6b. The bridge was retrofitted, as a rapid intervention, in early December 2016 with fiber-reinforced mortar and steel mesh (see Figures 7.6c and 7.6d). The latter intervention was aimed at restoring the structural capacity to the piers and the abutments. Construction was also carried out on the carriage way (bridge deck) and drainage ducts were installed.

Figure 7.6. Ponte a Cinque Occhi (42.623178 deg, 13.250428deg): increased sub-vertical cracks to the piers after the 30 October event at the top (a) and bottom (b) of the piers (photo on November 20 2016) and structural retrofitting of the bridge (c and d) (photo on December 15 2016).
